SALVAGING OLD PAVEMENTS BY RESURFACING

N. A. Billingsley, Jr., Sr. Laboratory Engineer, Texas Highway Department, District Eight

Two methods of salvaging old concrete pavement by resurfacing were compared to new construction on a section of highway built by District Eight of the Texas Highway Department. The purpose of this project was to determine the best method of rehabilitating an old section of highway containing concrete pavement.

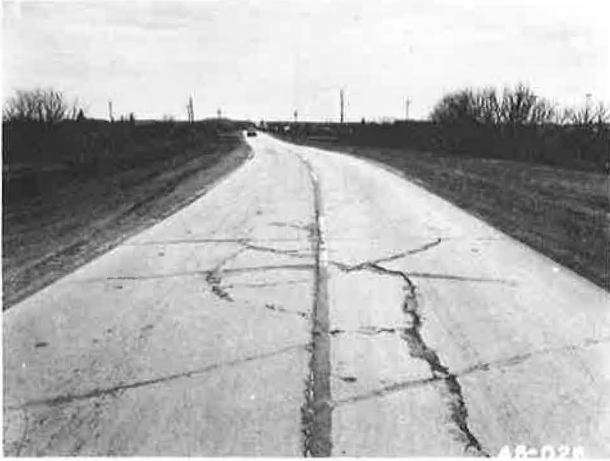
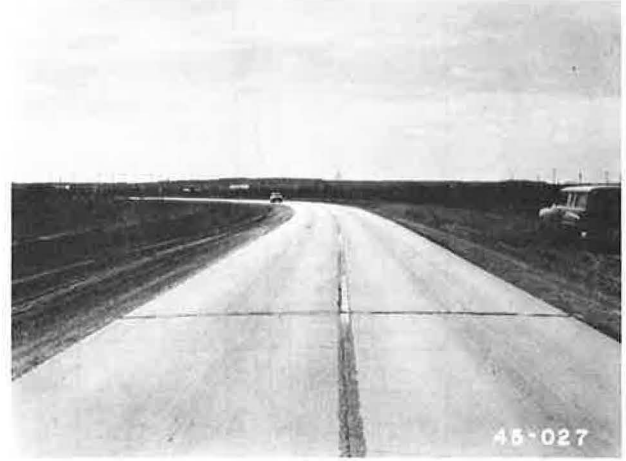
Figures 2 and 3 show the original pavement condition before overlay of HMAC surface.

Figure 2. Original pavement condition before overlay of HMAC surface.

Figure 3. Original pavement condition before overlay of HMAC surface.

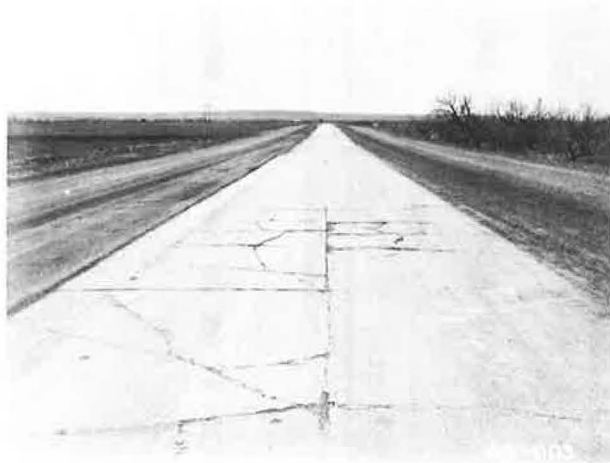
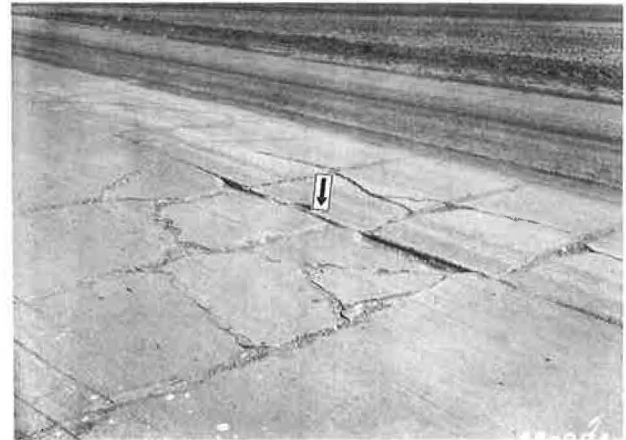
Figures 4 and 5 show the condition of the concrete pavement prior to construction.

Figure 4. Original pavement condition before it was broken up and recompactd.

Figure 5. Original pavement condition before it was broken up and recompactd.

The section of highway represented by typical section No. 2 had begun showing signs of distress by March 1959 (Fig. 22). By April 1961, the general condition of this section was good with the exception of one particular failure shown in Figure 23. It is believed that this failure resulted from faulty structure support. Comparison should be made between Figures 5, 10, and 23.

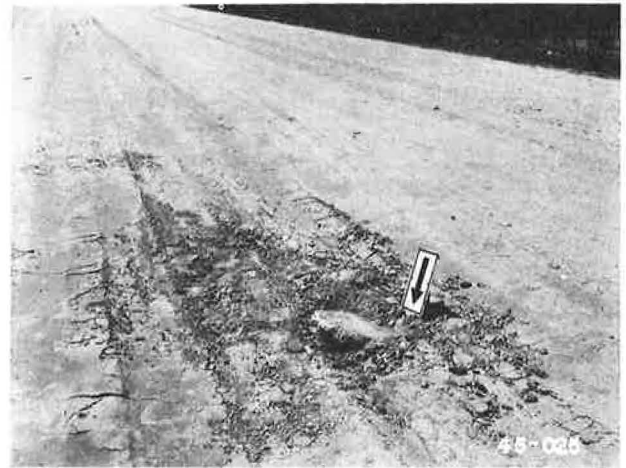
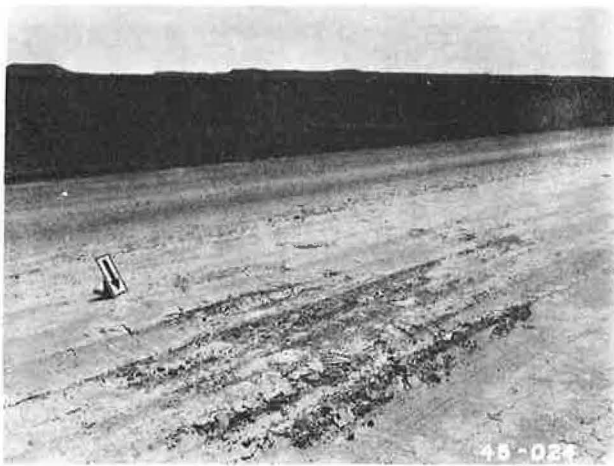
The heavy pneumatic rolling proved useful because it showed flaws in the seating of the old concrete pavement. Figures 10 and 11 indicate improper seating. These places were reworked to the satisfaction of the engineer before subsequent construction was performed. Figure 12 shows a section of the completed highway.

Figure 10. A condition indicating improper seating was found here.

Figure 11. A condition indicating improper seating was found here.

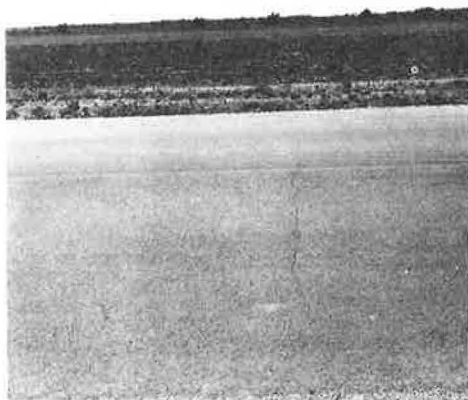
The first section to show signs of distress was that of section No. 1. Cracks began to show at joints of the old concrete pavement.

These cracks began to show (Fig. 13) within three months after job completion. Crack sealing operations were started (Fig. 14) on this section in January 1958. Figures 15, 16, and 17 show how one particular failure had progressed through March 1959, and Figure 18 shows the general condition of typical section No. 1 in April 1961.

Figure 13. First signs of distress on design section No. 1.

Figure 14. Crack sealing operations in progress.

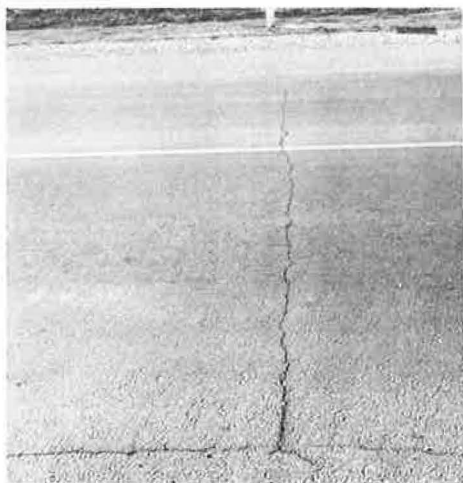
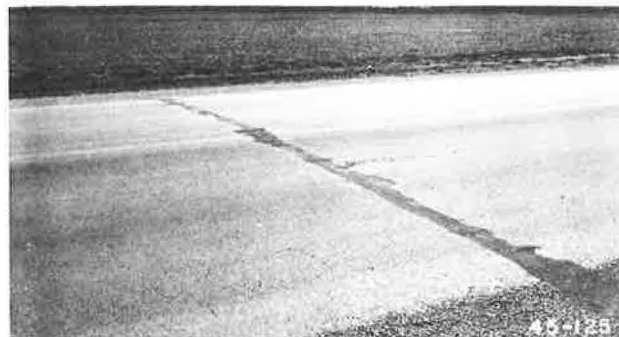
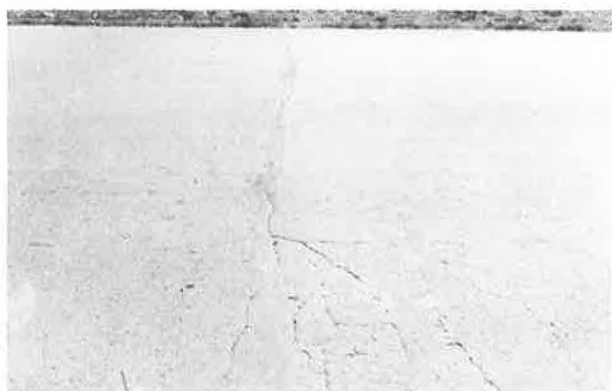
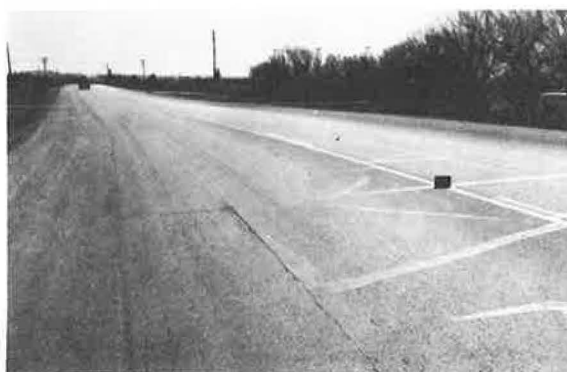
Figure 15. Progression of a particular cracking pattern through March 1959.

Figure 16. Progression of a particular cracking pattern through March 1959.

Figure 17. Progression of a particular cracking pattern through March 1959.

Figure 18. Progression of a particular cracking pattern through March 1959.

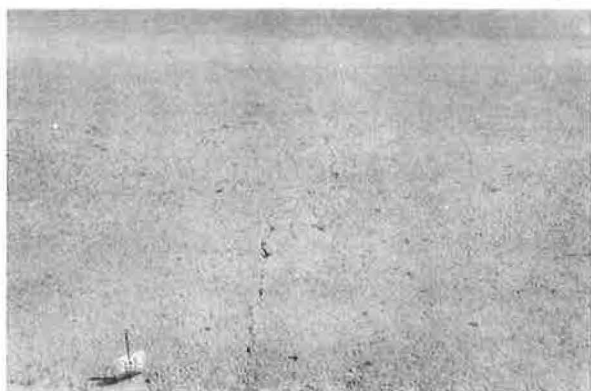
Figure 19. First sign of distress on design section No. 3.

The second section to show signs of distress was that of section No. 3. Figure 19 shows the type of distress first noticed in March 1959. This condition progressed to that shown in Figure 20 by April 1961; and Figure 21 shows the general condition of this section in April 1961.

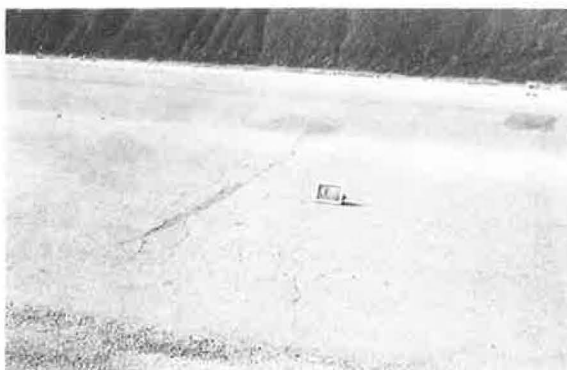
Figure 20. A typical failure pattern on design section No. 3, in 1961.

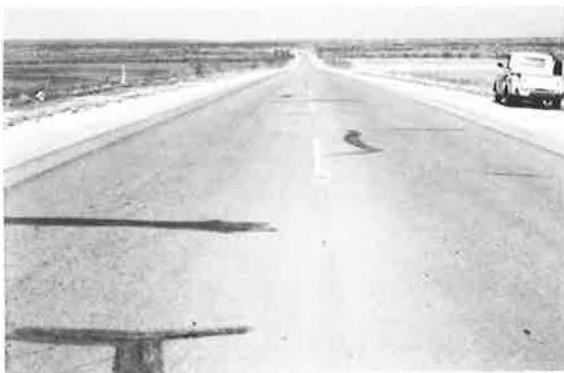
Figure 21. The general condition of design section No. 3 in 1961.

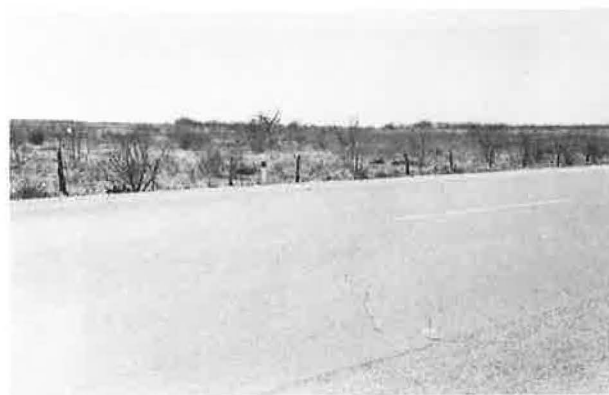
Figure 22. A typical failure pattern on design section No. 2 in 1959.

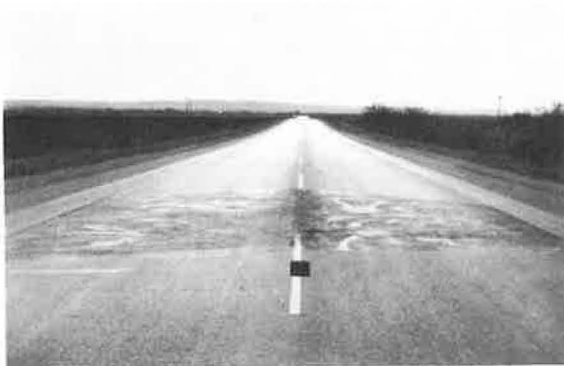
Figure 23. An isolated condition of design section No. 2 in 1964.

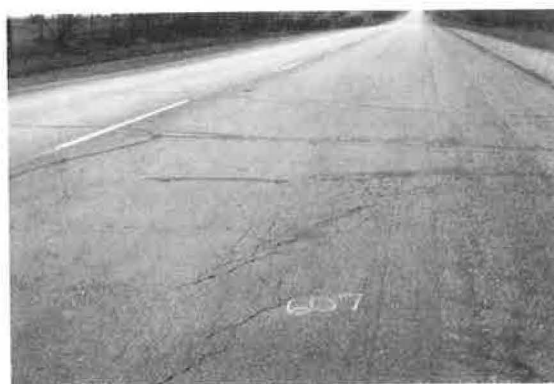
Figure 24. A typical failure condition showing distress of design section No. 2 in 1964.

Figure 24 shows a typical failure prior to seal coat application in the summer of 1964. After the seal coat was applied, the general appearance of the highway was good on all sections. The present serviceability rating is 3.7 to 4.1 on all sections. Cracking was pronounced but distortion and rutting were of minor proportions before application of the seal coat.
