# Tire Chips in the Base Course of a Local Road

Ronald I. Frascoia and Robert F. Cauley, *Vermont Agency of Transportation*

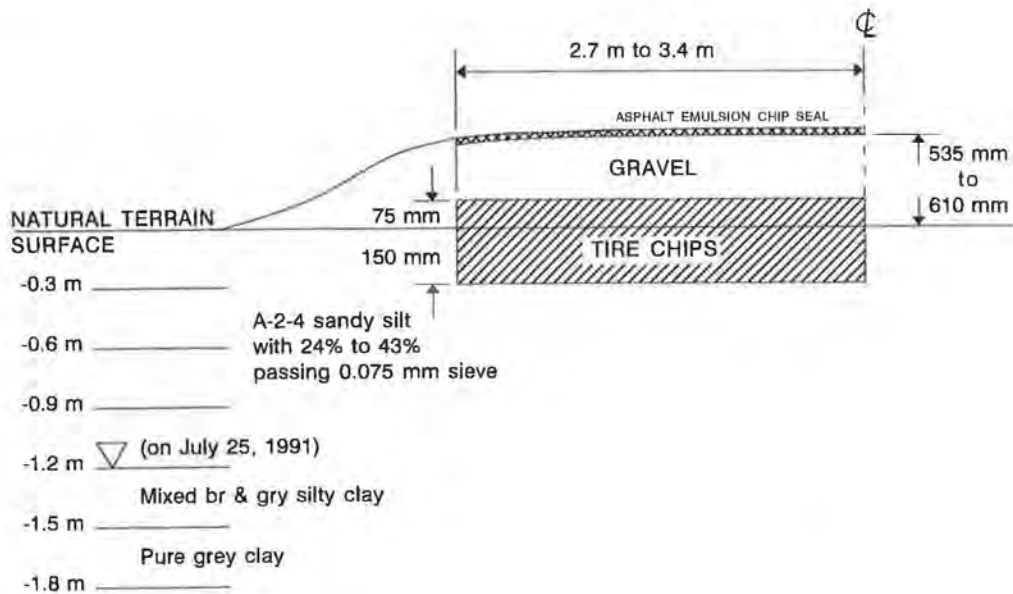
FIGURE 4 Typical section of TH 4, Georgia, Vermont: fall 1992.

In the autumn of 1992, a chip seal (Figure 4) was placed over the initial section of roadway treated in 1990. The process included the placement of a layer of pea stone, a 4.5-L/m<sup>2</sup> (1-gal/yd<sup>2</sup>) application of asphalt emulsion, and a mixed 6.4-mm (1/4-in.) and 9.5-mm (3/8-in.) stone surface topping.

Falling weight deflectometer (FWD) tests were taken on the 2-month-old chip seal surface in November 1992. The test values indicated a significant deflection of the test surface, which would suggest that the tire chip layer allows too much deflection under heavy loads for any future bituminous pavement to survive without additional gravel cover over the tire chip layer.

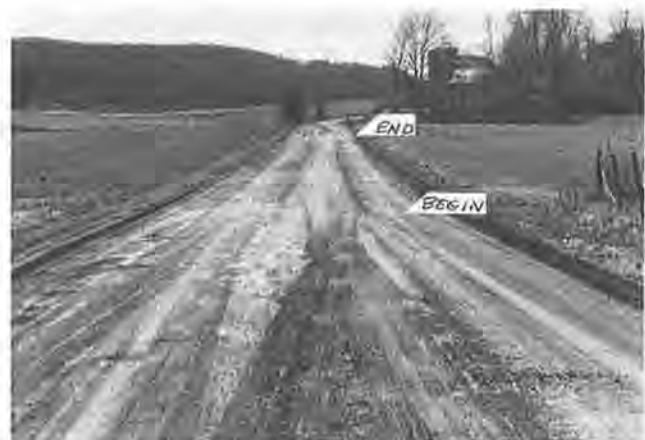
FIGURE 5 Overview of tire chip section, April 3, 1991. Note surface moisture on adjacent untreated sections.

vation was measured. The roadway surface within the test section was visibly dry and free of any rutting. A few fine, longitudinal and transverse cracks were visible on the northerly half of the test section, with most noted in the southbound lane. The water table averaged 305 mm (12 in.) below the natural terrain surface or 151 mm (six in.) below the estimated bottom of the tire chips. The water table elevation was 140 mm (5.5 in.) higher than that recorded the previous November.

By comparison, the untreated roadway portions north and south of the tire chip section were in poor condition. The surfaces were visibly wet and revealed numerous ruts, cracks, and boils. The poor areas were soft to walk on and water could be drawn to the surface with a tamping action. It must be noted, however, that in general, TH 4 was in better overall shape than in other years, because of a milder winter with below-average snowfall and a dry spring season.

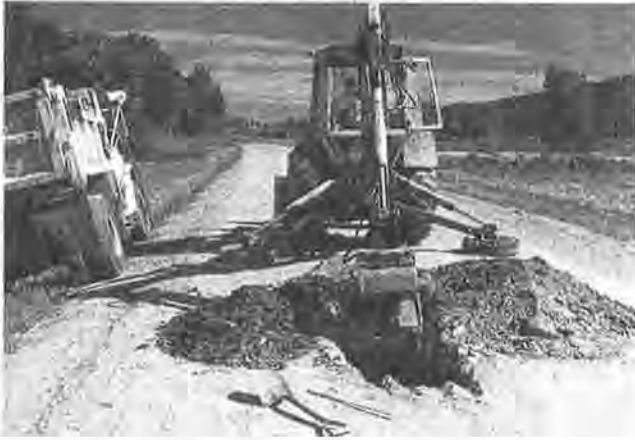
The 60-cm × 180-cm (2-ft × 6-ft) test pit was dug in the left wheelpath of the southbound lane, 7.6 m (25 ft) north of the southerly well point placed in 1990 (Figures 10 and 11). The pit revealed 530 mm (21 in.) of gravel over 200 to 230 mm (8 to 9 in.) of tightly compacted tire chips. The top 150 mm (6 in.) of gravel contained 8 percent minus 0.075 mm (No. 200) sieve material, whereas the remainder averaged 15 percent minus 0.075 mm material. The top side of the chips

FIGURE 10 Excavating test pit in 1990 construction project.

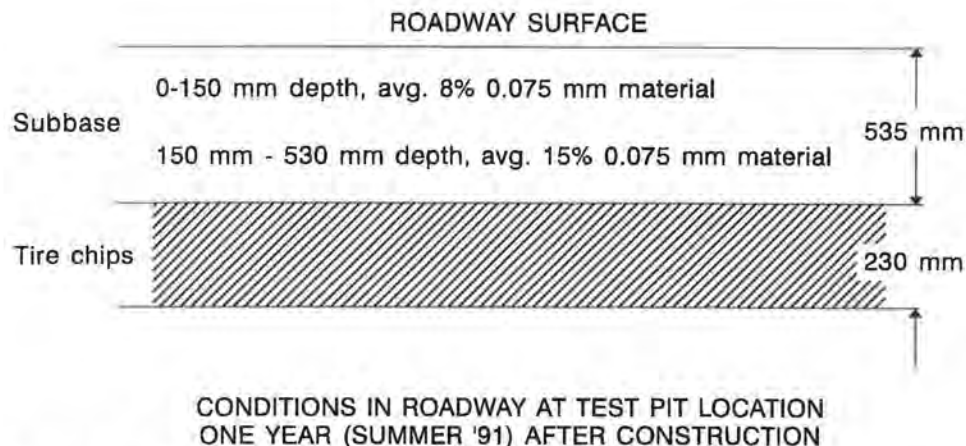
FIGURE 11 Conditions on roadway at test pit location one year after construction (summer 1991).

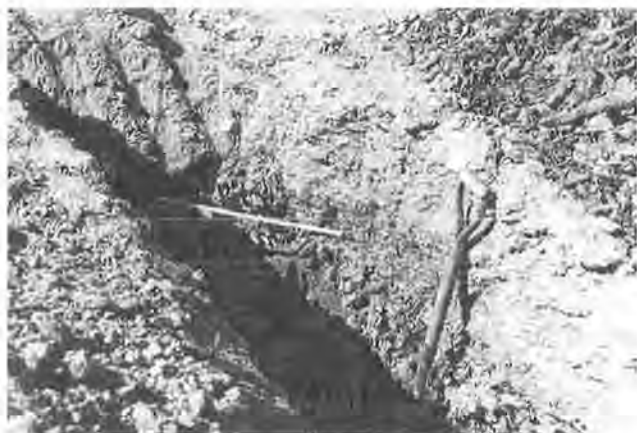
showed a trace of moisture whereas the bottom side was dry. The silty sand beneath the chips contained enough moisture for it to hold together when squeezed (Figure 12). No attempt was made to locate the water table elevation.

FIGURE 12 Base consisted of 20 to 22 in. of dirty gravel over  $\pm 8$  in. of compacted tire chips; gravel was dry, whereas silty sand subgrade contained enough moisture to hold together when squeezed.
