Cracking, Fracture Assessment, and Repairs of Green River Bridge, I-26

John W. Fisher and Eric J. Kaufmann, *Lehigh University*
Michael J. Koob, *Wiss, Janney, Elstner Associates, Inc.*
Gerald White, *North Carolina Department of Transportation*

The Green River Bridge, I-26 near Asheville, North Carolina, was opened to traffic in 1969. In October 1992, during an inspection, two long transverse cracks were discovered in the bottom flange plate of a main girder; these cracks resulted in closure of the eastbound bridge. Numerous shorter cracks were observed at the web to flange plate connecting fillet welds throughout the girders. The Green River Bridge is a five-span, twin structure having a total length of 320 m (1,050 ft). Each bridge is a two-girder system, and ASTM A441 modified Corten B weathering steel was used to fabricate the bridge. The investigation into the cause of the cracking included metallographic and fractographic examination of core samples containing cracks, chemical composition and toughness testing of material, and instrumentation and field testing to determine live load stress levels. Test results of the flange plate material containing the large cracks showed

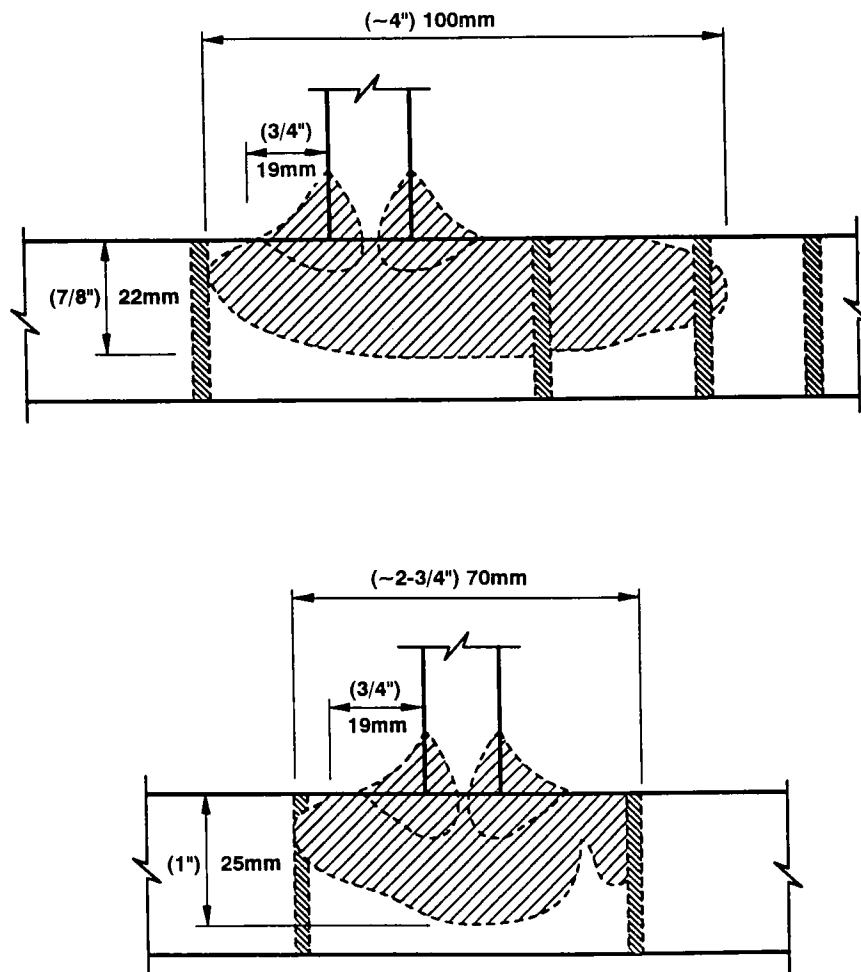
FIGURE 3 Projected crack geometry on plane perpendicular to girder flange: *top*, schematic of crack in flange at Core 17; *bottom*, schematic of crack in flange at Core 25.

The large cracks observed in Girder 301G1-3 at Cores 17 and 25 were evaluated for fatigue and fracture susceptibility. Figure 3 shows a schematic of the cracks projected on a plane perpendicular to the bending stresses in the girder flange. As discussed previously, the crack tip nearest the bottom surface of the flange exhibits a nearly horizontal orientation and hence is not

The most severe crack appears to be in Core 25 (Figure 14), where a circumscribed elliptical-shaped crack is exhibited. At that location the crack tip is nearly perpendicular to the bending stresses in the girder flange and hence most likely to be susceptible to crack extension.

For Core 25, $a = 25.4$ mm (1 in.) and $c = 35.6$ mm (1.4 in.). At Point A, where some evidence of crack extension may exist, Equation 2 results in $F_c = 0.71$.

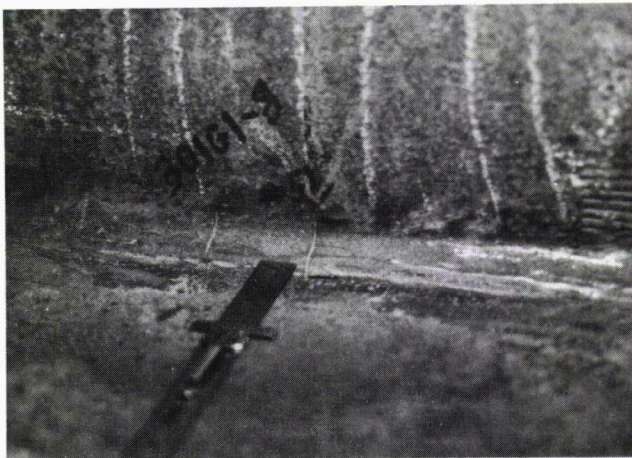
In October 1992, during a North Carolina Department of Transportation (NCDOT) inspection by an engineering consultant, two long transverse cracks were found in the bottom flange plate of a main girder 7.3 m (14 ft) deep. These cracks measured 100 and 70 mm (4 and 2³/₄ in.), respectively, and extended through the web-to-flange plate fillet weld with extension into the bottom flange plate (Figure 3). Further inspection found many shorter cracks, of lengths up to 19 mm (3/4 in.) at the web-to-flange plate connecting fillet welds throughout the girders. Two typical cracks with lengths of approximately 19 mm (3/4 in.) are shown in Figure 4.

FIGURE 4 Typical cracking found in web-to-flange plate fillet weld. Magnetic particles highlight two cracks.

- All of the evaluated cracks appear to have resulted from hydrogen-related cold cracking. The many transverse cracks in longitudinal fillet welds of all the bridge girders appear to be cold cracks.

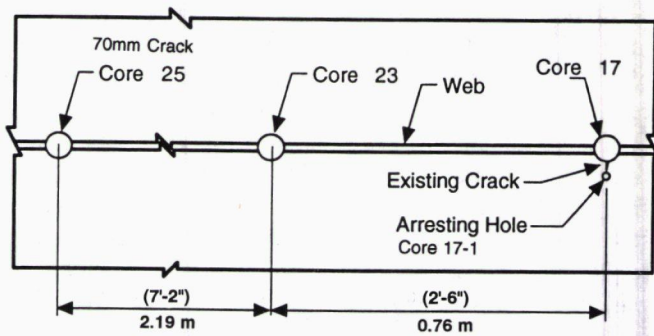
FIGURE 6 Partial schematic plan of Girder 301G1-3 at location where Cores 17, 17-1, 23, and 25 were removed.

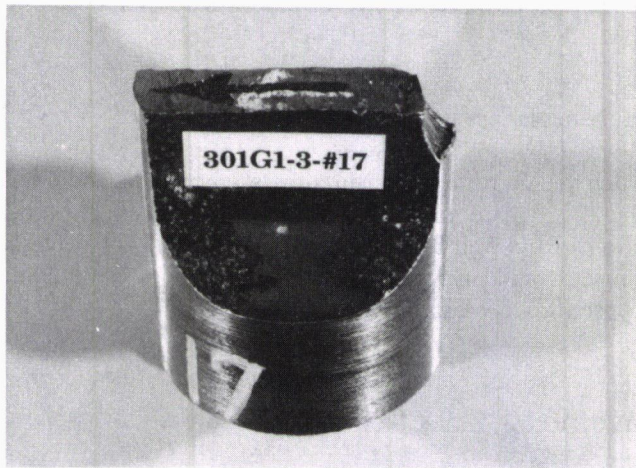
FIGURE 7 Core 17 showing transverse weld metal crack extending into flange; Cores 23 and 25 are similar. Arrow on web indicates west direction.

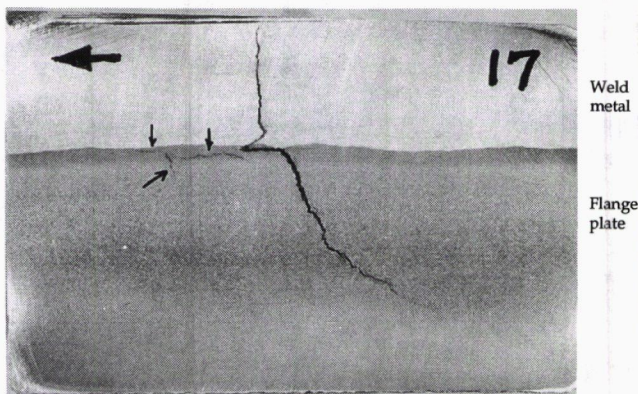
FIGURE 8 Longitudinal section through Core 17 showing transverse weld metal crack and propagation of crack into flange. Arrows show HAZ crack that propagated into base metal adjacent to primary crack.

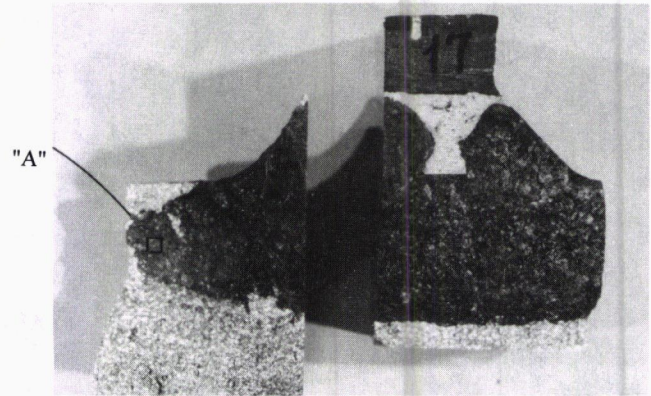
Cores 17 and 25, which contained the largest cracks, were opened to expose the crack surface. Figure 9 shows the crack surfaces from Core 17, where the transverse weld metal cracks and crack propagation into the flange are outlined clearly. The crack tip on one side was included; however, on the other side it can be seen to extend to the edge of the core. The crack surfaces show heavy accumulation of corrosion product, indicating exposure to the environment for several years.

The crack surface is also very coarse in appearance, unlike most fatigue crack surfaces. The crack geometry shows that it propagated to within 10 mm ($\frac{3}{8}$ in.) of the underside surface of the bottom flange. No indication of crack propagation beyond the weld metal and into the web plate is indicated.

FIGURE 9 Exposed crack surface of Core 17 showing heavy oxidation.

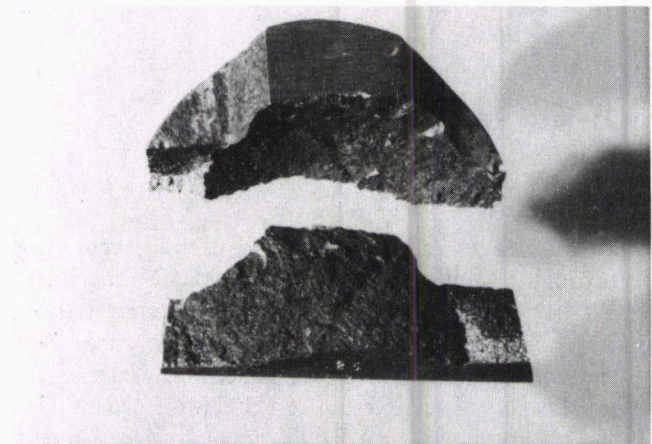
The crack surfaces from Core 25 were similar in appearance, as seen in Figure 10. The crack tip was inadvertently removed while obtaining a slice of the core for material testing. The crack tip extended into the flange about 3 mm ($\frac{1}{8}$ in.) farther than shown and to within 6 mm ($\frac{1}{4}$ in.) of the underside surface of the bottom flange plate. Heavy oxidation of the crack surface is also exhibited. Figure 10 shows two views of the fractured core; the crack in Core 25 extended into the girder flange similarly to the curved path exhibited in Core 17.

FIGURE 10 Exposed crack surface of Core 25 showing path of crack into flange plate.

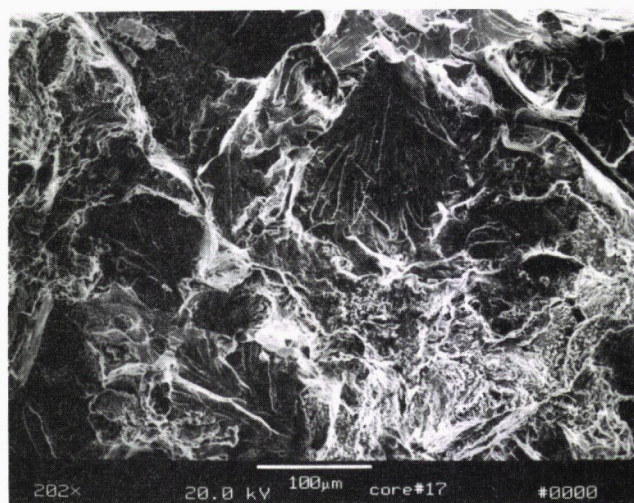
FIGURE 11 SEM micrograph of Area A (see Figure 9) of Core 17 showing cleavage fracture and corrosion product on crack surface (150 \times).

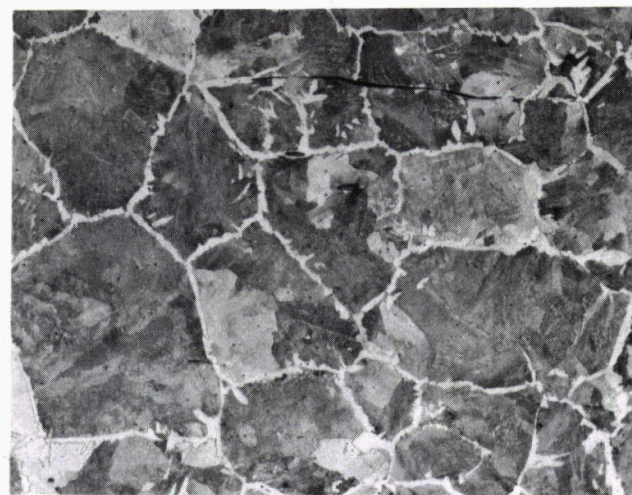
The microstructure of the 32-mm (1 $\frac{1}{4}$ -in.) flange plate obtained from Core 17 at mid-thickness is shown in Figure 12. The microstructure is predominantly pearlite with a small amount of ferrite outlining large prior austenite grain boundaries. The microstructure is typical of an annealed medium carbon steel (0.40 to 0.80 weight percent carbon) and explains the very low CVN test results obtained.

FIGURE 12 Flange plate microstructure of Core 17 (77 \times).

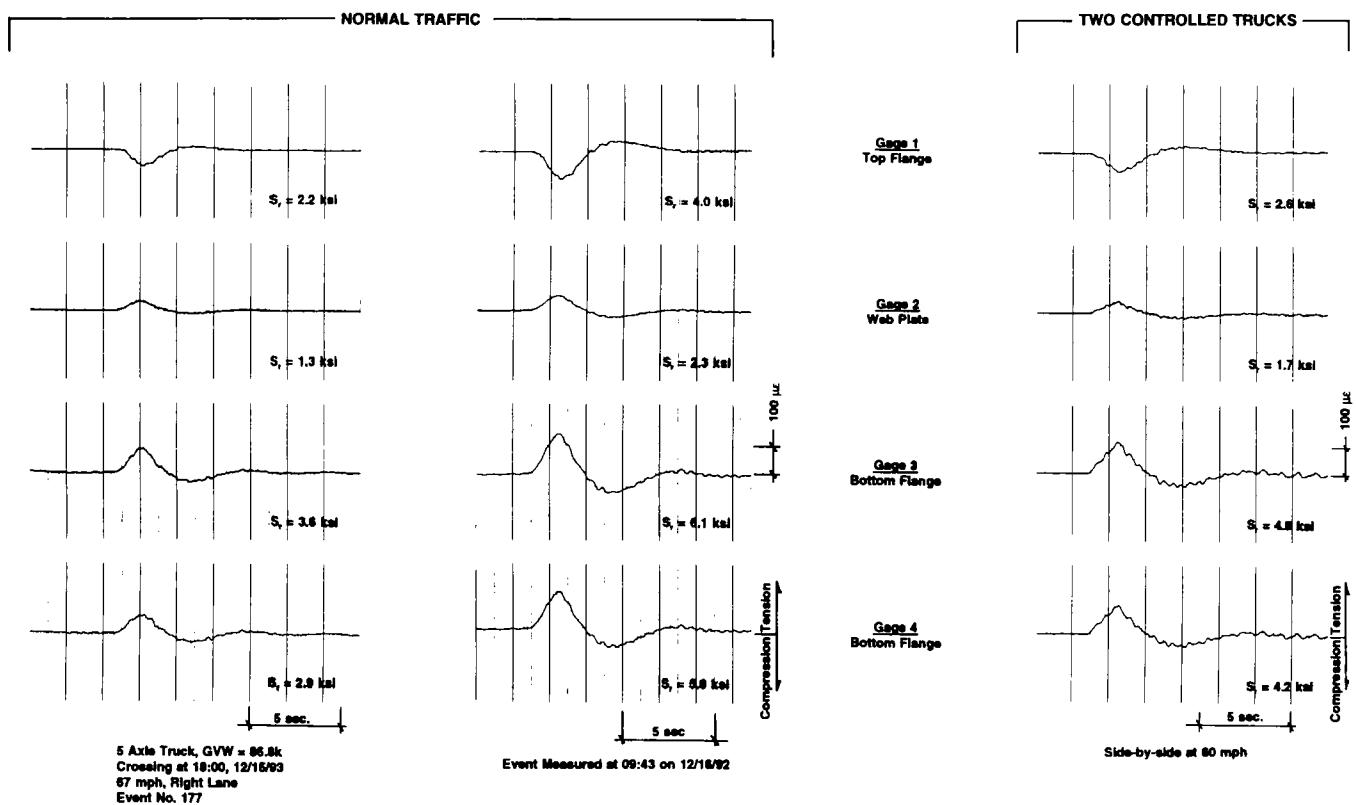
FIGURE 14 Dynamic strain gauge data measured at Section A (1 ksi = 6.9 MPa).

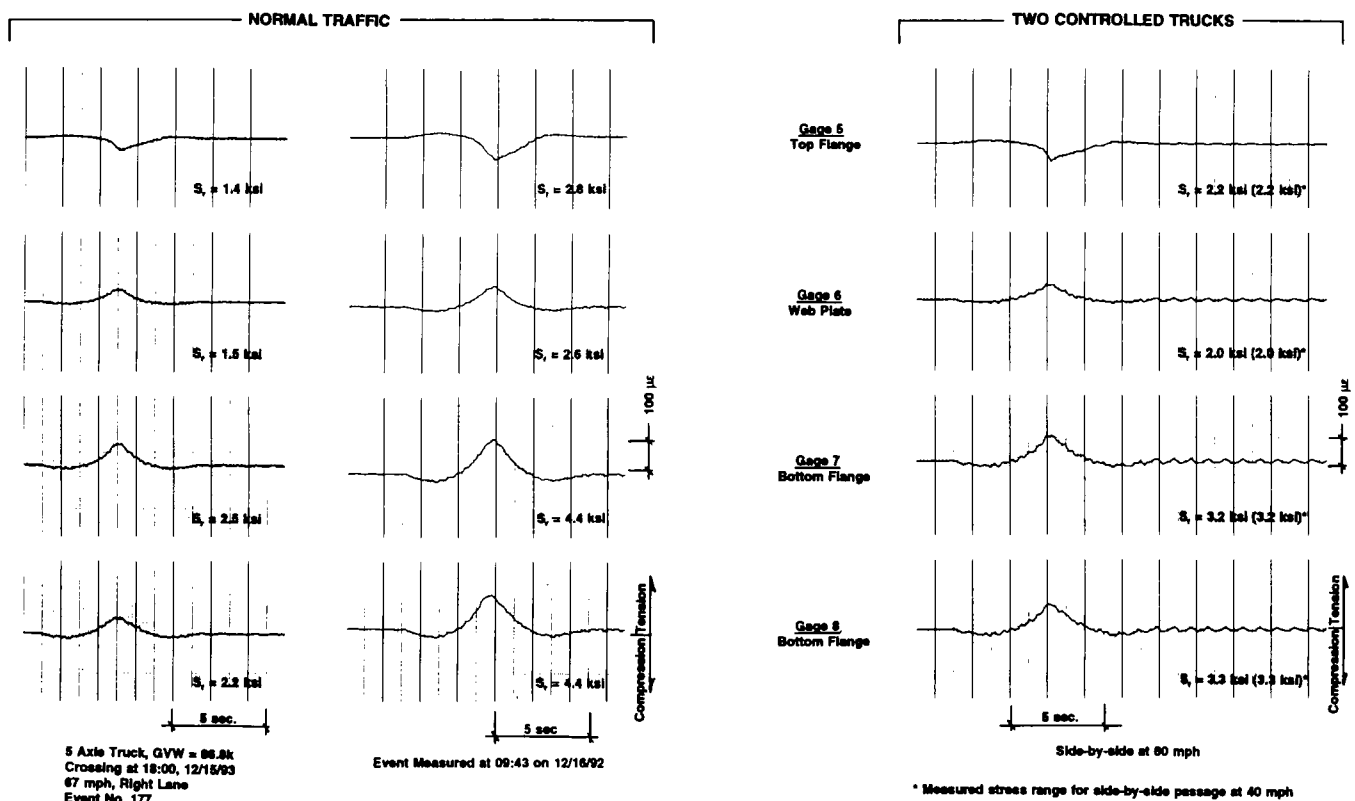
FIGURE 15 Dynamic strain gauge data measured at Section B (1 ksi = 6.9 MPa).
