# Crack Evaluation and Repair of Cantilever Bracket Tie Plates of Edison Bridge

John W. Fisher, Ben T. Yen, Eric J. Kaufmann, and Zuo-Zhang Ma,  
*Lehigh University*  
Thomas A. Fisher, *HNTB Corporation*

The Edison Bridge on Route 9 over the Raritan River in New Jersey is a riveted two-girder floor beam structure that was built in 1944. Cracks were discovered in several tie plates connecting the cantilever brackets to the main girder and floor beam in the continuous span, the 25.8-m (84-ft, 6-in.) spans, and the 40.4-m (132-ft, 6-in.) spans. Several cracked tie plates were removed so that the cause of cracking could be evaluated. The investigation included metallographic and fractographic examinations of crack surface areas that were not damaged extensively by corrosion. Striation spacing measurements showed that the cyclic stress driving the crack was independent of crack length, characteristic of displacement-induced fatigue. Field testing to determine the live load stress levels confirmed that in-plane bending of tie plates was the principal cause of the fatigue cracking and that the cantilever bending stresses were negligible. The measurements also suggested that a loss of f

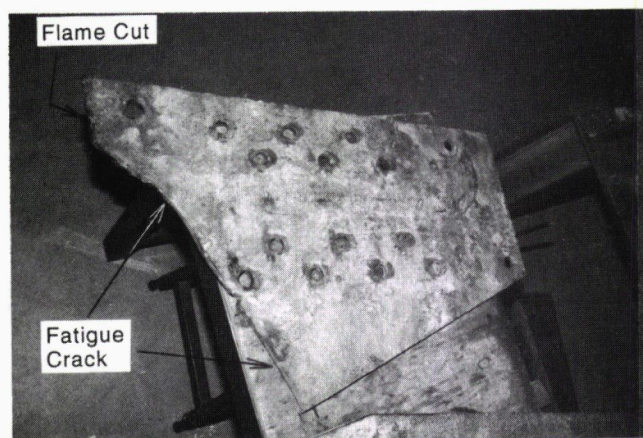
Three cracked tie plates were removed from the structure for examination. A tie plate removed from the eighth 40.4-m (132-ft, 6-in.) span southbound had a crack that extended nearly across the width of the plate. Figure 3 shows one of the plate sections and the diagonal crack that extended about two-thirds across the tie plate. The balance was flame cut during removal. A section of tie plate containing a crack removed from the 183-m (600-ft) continuous span 15.2 m (50 ft) south of Pier 2 was also delivered for examination. A view of the cracked plate is given in Figure 4, with the balance of the plate cut away.

The cracks in all tie plates initiated along the tapered edge of the plate several inches from the start of the taper on the bracket side, as is apparent in Figures 3 and 4. This edge was probably a flame-cut edge given the overall shape of the tie plate, although corrosion has since eroded the original plate edge surface and all evidence of the cutting method. The plates also showed substantial general corrosion damage over the surface as well. The extent of corrosion on all three tie plates indicates that they were debonded from the overlying haunched slab for a substantial period of time. The crack in Tie Plate 3 initiated from the plate edge and propagated to a rivet hole (Figure 4). The crack reinitiated at the rivet hole and continued to propagate across the tie plate.

The length of the crack in Figure 3 was 432 mm (17 in.). The crack shown in Figure 4 for Tie Plate 3 was 279 mm (11 in.) long. No other cracks were detected elsewhere in the tie plate.

Fatigue crack growth was also detected in Tie Plate 1, seen in Figure 3. The crack origin was covered completely with corrosion product, which obscured any detail of crack initiation. Efforts to remove the corrosion product at the crack origin and over most of the crack surface were not successful since the corrosion process had completely consumed the underlying fracture features. Closer to the crack tip, some areas were free of corrosion and some evidence of fatigue beachmarks could be seen (Figure 7). The crack surface in this area was examined further with the SEM. Figure 8 shows a high-magnification micrograph ( $2,040\times$ ) showing well-defined fatigue striations.

FIGURE 3 View of cracked tie plate 1 from 30.4-m span.

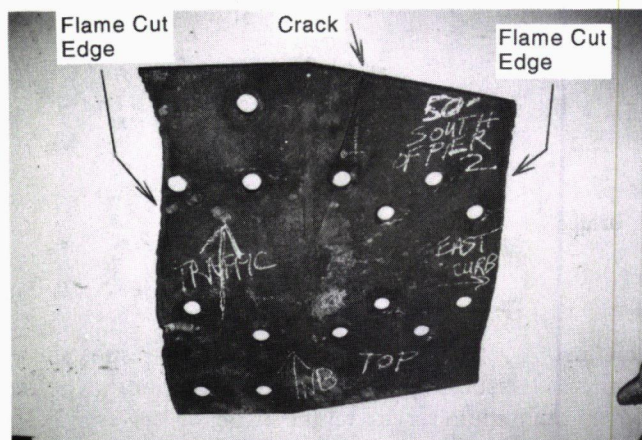
FIGURE 4 Crack in Tie Plate 3 from 183-m continuous span.

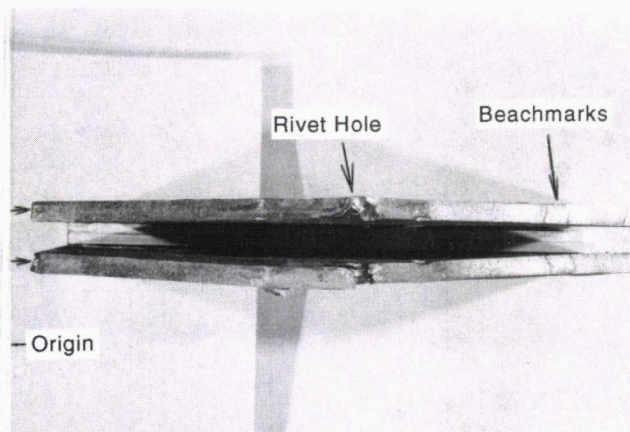
A view of the crack surface from Tie Plate 3 is shown in Figure 5. The smooth and flat surface is typical of fatigue cracking. The crack surface from Tie Plate 3 was also found to be free of corrosion product near the crack tip region. The crack origin region was covered with a heavy layer of corrosion product that could not be lifted from the surface. Beachmarks are clearly seen on the crack surface near the crack tip. A low-magnification ( $7\times$ ) SEM micrograph of this area also shows finer beachmark detail than can be seen with the unaided eye. The surface in this area was also examined at higher magnification for fatigue striations. Figure 6 shows an SEM micrograph at  $2,040\times$  magnification that shows the fatigue striations on the crack surface, which is located 241 mm (9.5 in.) from the origin.

FIGURE 5 Crack surface of Tie Plate 3 showing beachmarks, rivet hole, and crack origin.

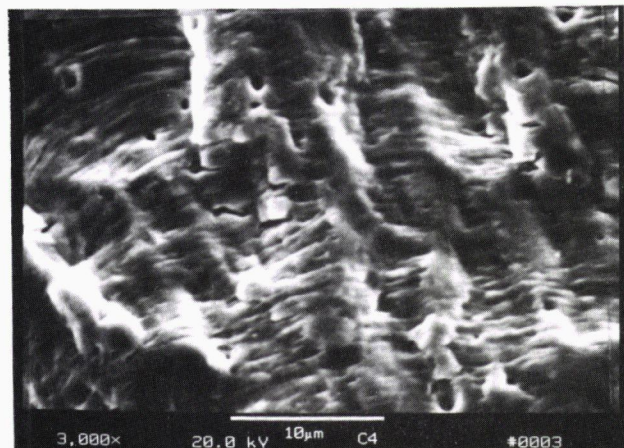
FIGURE 6 SEM micrograph showing fatigue striations in Tie Plate 3 beachmark area (2,040X).

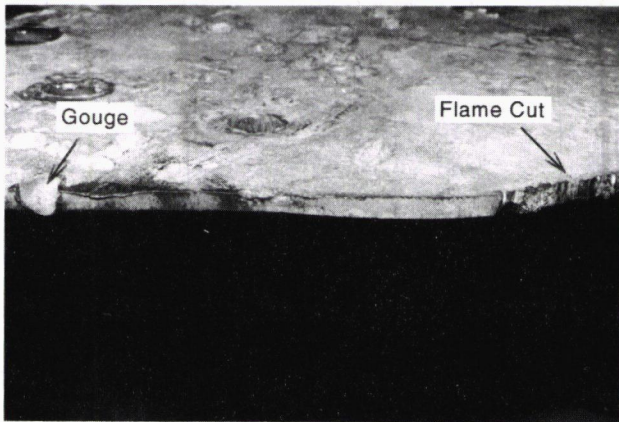
FIGURE 7 Crack surface in Tie Plate 1 near flame-cut end.

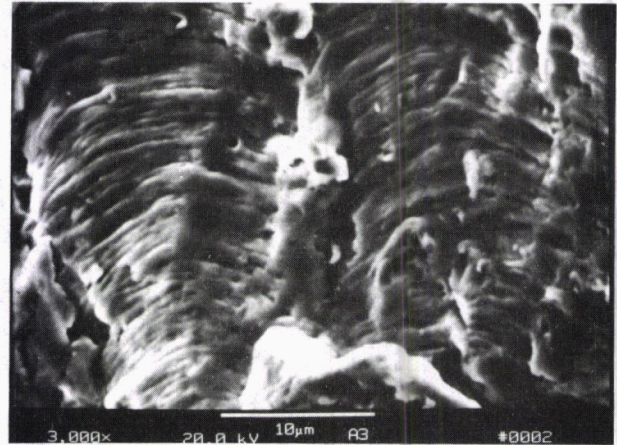
FIGURE 8 SEM micrograph showing fatigue striations in Tie Plate 1 near crack tip (2,040 $\times$ ).

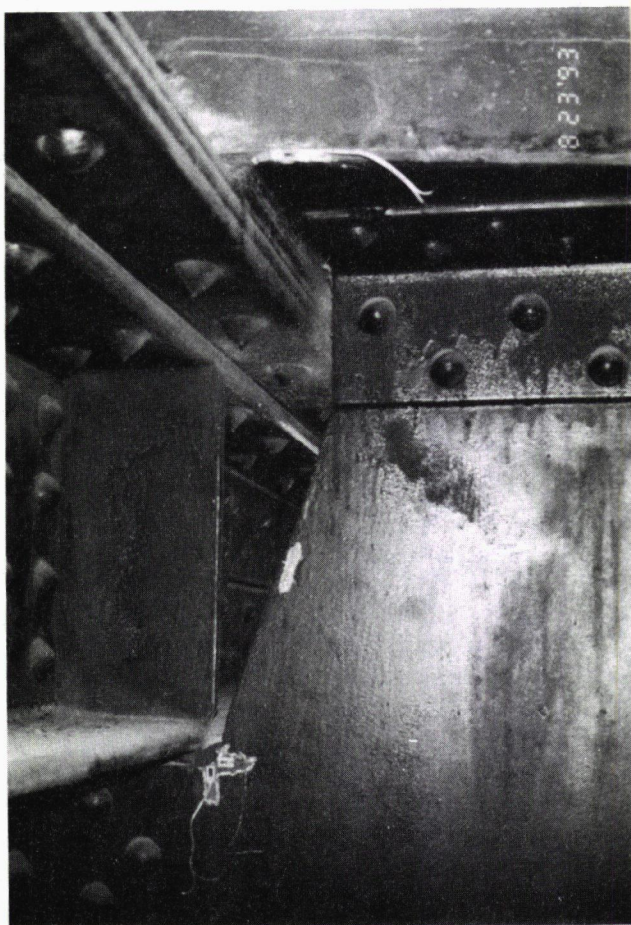
tained on several tie plates of the spans shown in Figure 1. Gauges were also placed on the web copes of the floor beam cantilever brackets and on one cross section of the east girder. Figure 10 shows the strain gauges on the bracket web cope and the edge of the tie plate near the location at which the fatigue cracks were observed to develop before repair. The gauges were installed on each edge of the tie plate as well as on the floor beam side.

FIGURE 10 View of gauges on tie plate edge and at bracket cope.

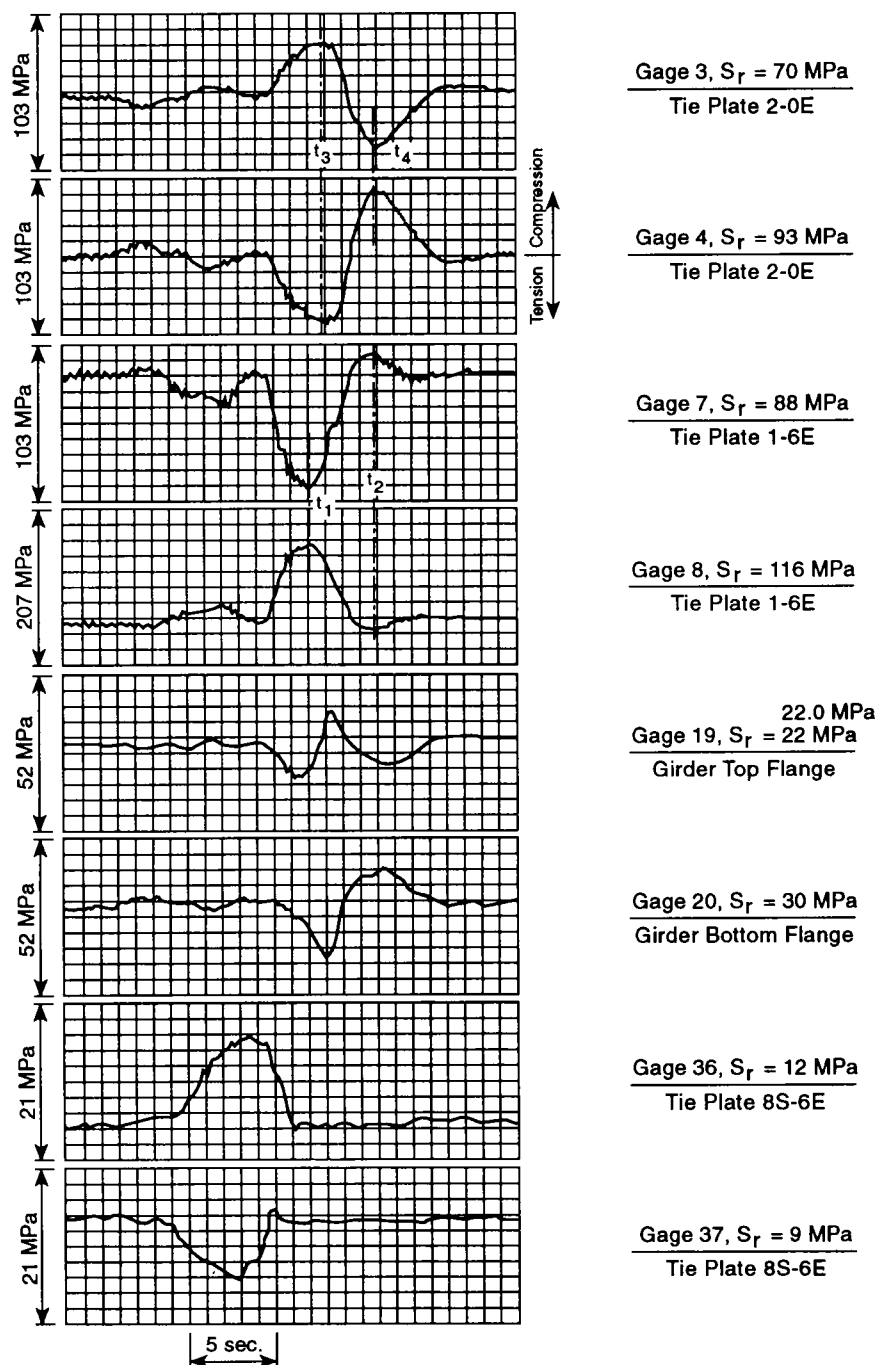
The recorded strain variation at each strain gauge was examined through an oscilloscope. Figure 11 shows strain-time records for several gauges in the area of Pier 2 during passage of a northbound truck. The upward excursion of a trace indicates live load compression; downward is tension. The stress range was defined by

FIGURE 11 Typical strain-time response of tie plates and main girder in 61-m span (see Figure 1).

- The stress ranges in the flanges of the east girder are comparable to those recorded at similar girders. The maximum stress range was 30 MPa (4.4 ksi) at the Bottom Flange Gauge 20, and 22 MPa (3.2 ksi) at the Top Flange Gauge 19 (see Figure 11).

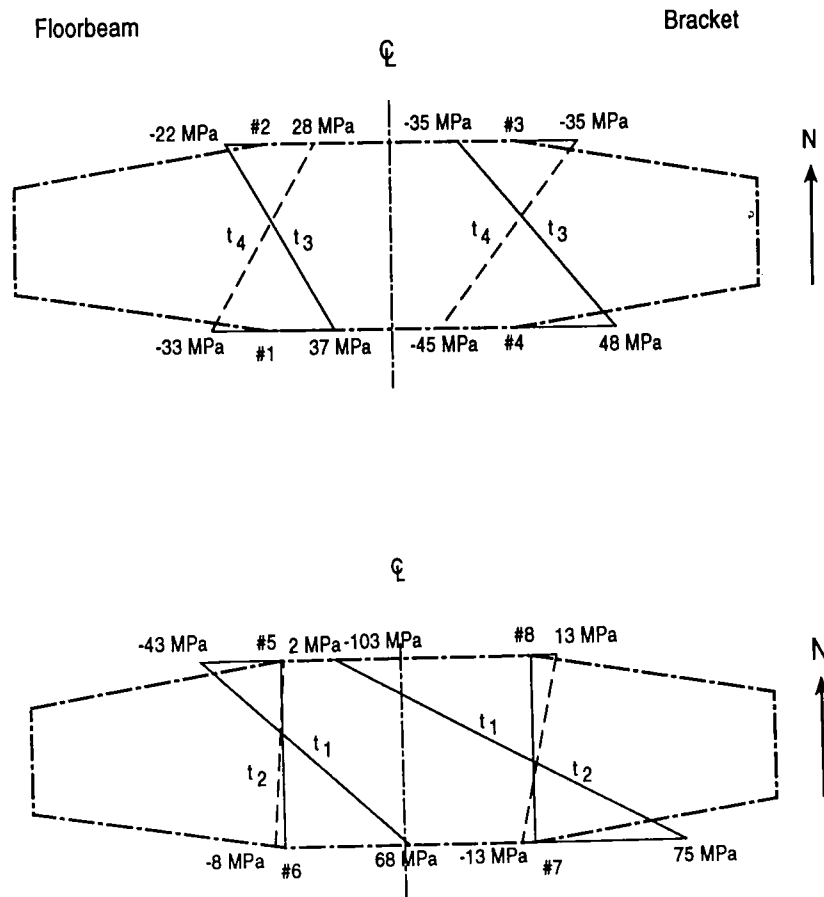
- The tie plates are bending horizontally when trucks travel on the bridge. This is depicted by the opposite excursion of strain traces for Gauges 1 and 2, 3 and 4, and 7 and 8, in Figure 12, as well as for other strain gauge pairs in the north-south direction on all tie plates. From the response of gauges at Pier 2 and at floor beam 1-6E, 15.2 m (50 ft) south of Pier 2, it is apparent that the vehicles are traveling about 15.2 m/sec (50 ft/sec). The peak excursion at Pier 2 in one direction occurs as

the vehicle moves from the end span at Pier 1 to Pier 2. The stress cycle reverses as the vehicle continues for about 45.7 m (150 ft) in 3 sec and then returns gradually to its starting point after about 4 more seconds (~61 m or 200 ft). Figure 12 (top) shows the simultaneous stresses in Gauges 1 through 4 at the moments of peak stresses due to a northbound truck, corresponding to the strain traces at times  $t_3$  and  $t_4$ , which are identified by the vertical lines in Figure 11. These stress gradients show the full reversal of the stress cycle at Pier 2-0E. A similar plot of the instantaneous gradients at Tie Plate 1-6E is shown in Figure 12 (bottom). The maximum stress range due to this truck was 93 MPa (13.5 ksi) at Gauge 4. The same truck induced the maximum live load stresses in Tie Plate 1-6E with the maximum stress range equal to 116 MPa (16.8 ksi) at Gauge 8.

FIGURE 12 Stress gradients in tie plates of 61-m Span 1 during passage of northbound truck: *top*, Tie Plate 2-0E; *bottom*, Tie Plate 1-6E.

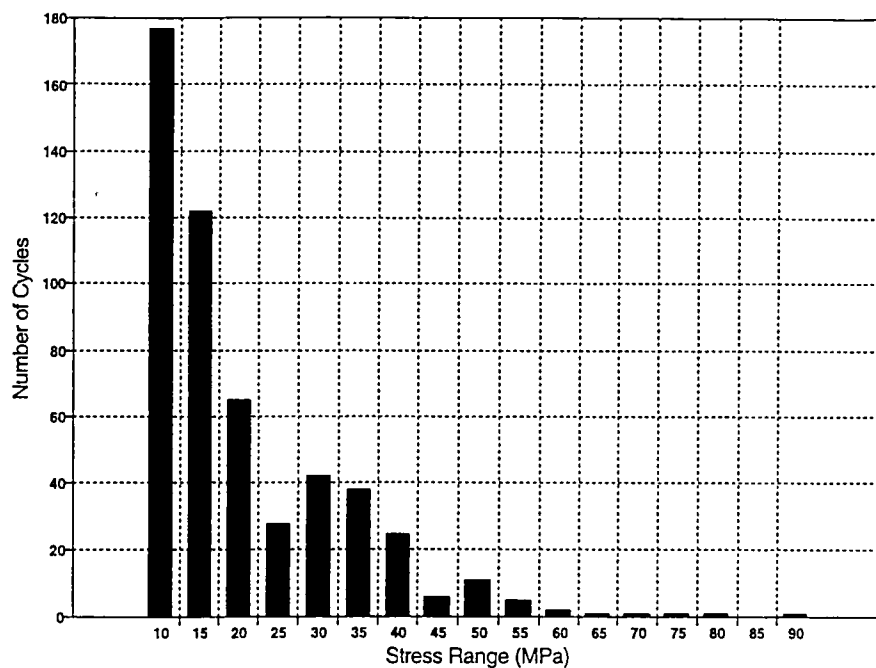
The stress range spectra for Gauges 4 and 8 on the east side near Pier 2 are shown in Figures 13 and 14. These plots show the skewed distribution characteristics of the truck gross vehicle weight distribution. Between 526 and 689 stress cycles greater than 10 MPa (1.5 ksi) were observed at these gauges during the 3 hr 20 min of record at Pier 2. None of the stress cycles at Pier 1 was high enough to warrant developing a stress range spectra, as the maximum stress range was 23 MPa (3.4 ksi).

FIGURE 13 Stress range histogram for Gauge 4 on Tie Plate FB2-0E.

For Gauge 4 with a maximum stress range of 93 MPa (13.5 ksi), the effective stress range for the spectrum shown in Figure 13 was 25 MPa (3.6 ksi). For Gauge 8 shown in Figure 14, the maximum stress range was 116 MPa (16.8 ksi) and the effective stress range was 36 MPa (5.2 ksi).

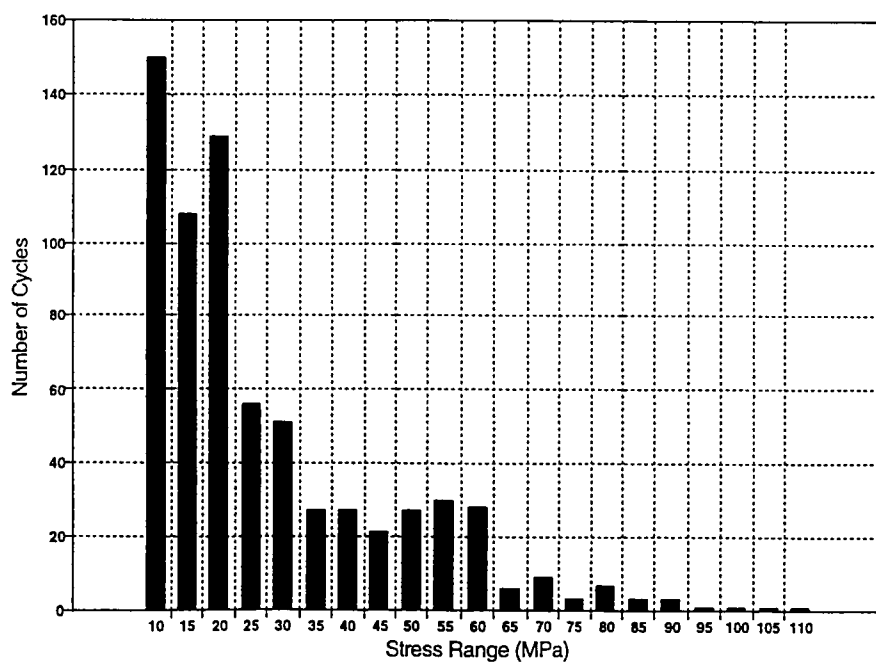
FIGURE 14 Stress range histogram for Gauge 8 on Tie Plate FB1-6E.

At FB1-6E with reduced composite behavior, the stress range spectrum plotted in Figure 14 suggests that

stress cycles large enough to initiate a fatigue crack are occurring more than 20 times each hour. This corresponds to about 175,000 damaging stress cycles a year. At flame-cut tie plate edges and corrosion-notched locations, fatigue cracks are likely to develop after 2 to  $4 \times 10^6$  cycles. This would correspond to 11 to 15 years of service after such stress cycles start to occur. It is not possible to establish when this loss of composite action occurred in the past.
