# Evaluation of Fatigue-Sensitive Details Used in Moline Viaduct, Illinois

Richard A. Walther and Michael J. Koob, *Wiss, Janney, Elstner Associates, Inc.*

A comprehensive study was undertaken to assess the performance of fatigue-sensitive details used in the Moline Viaduct. This 26-span, 872-m (2,860-ft) structure constructed in 1973 is located on Interstate 74 in Rock Island County, Illinois. The complex bridge superstructure includes variations in span length and width along with curved and superelevated geometries. The superstructure is fabricated from ASTM A36 steel and includes longitudinal plate girders supported by box-shaped cross-girders at the mainline piers. The cross-girder extends continuously through the web plates of the longitudinal girders. Full-penetration welds are used to complete the girder to cross-girder connection. This detail is considered potentially fracture sensitive by an FHWA notice dated April 24, 1978. This notice was issued following the brittle fracture of several steel support bents of the Chicago Transit Authority's Dan Ryan Transit Structure in January 1978. A brief discussion of these brittle fractures is presented to introduce the fatigue b

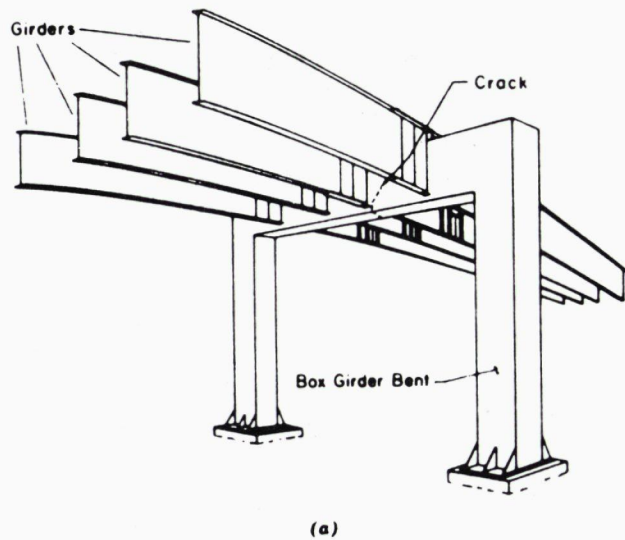
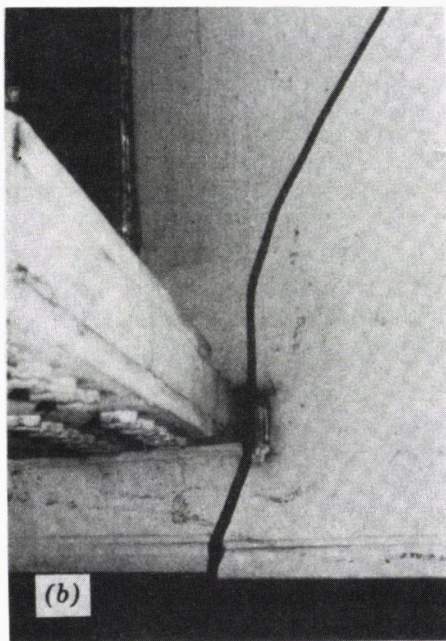
FIGURE 3 Fracture in CTA Dan Ryan Transit Structure, slotted member detail (1): (a) location of fracture; (b) close-up view of cracked box girder web.

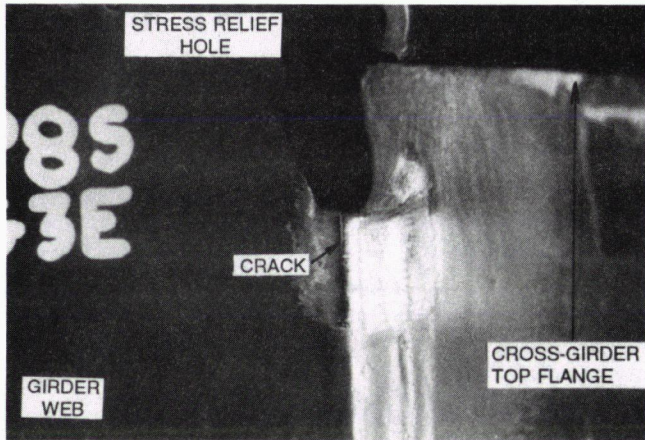
Because many of the 82 cracks were similar in orientation and location, it was possible to categorize the cracks into several types. The most predominant cracking occurred at weld terminations (Figure 5) located at the top corners of the longitudinal girder to cross-girder connection or at weld intersections (Figure 6). In total, 50 of the 82 cracks were located at the top corner connection. Crack lengths varied from 0.3 cm (0.12 in.) to 5.1 cm (2 in.), with an average length of 1.3 cm (0.5 in.). Fifteen of the 32 cracks discovered at the bottom corner weld termination or intersection were located in northbound Piers 1 through 4, where prefabricated stress relief holes had been omitted (Figure 7). Cracks originated from the tight-fit gap between the cross-girder tension flange and girder web and extended horizontally along the groove weld toe. Several cracks were observed to turn and extend downward. Crack lengths ranged from 0.3 cm (0.12 in.) to 2.5 cm (1 in.) and averaged 1.6 cm (0.63-in.).

FIGURE 5 Typical crack at top flange stress relief hole.

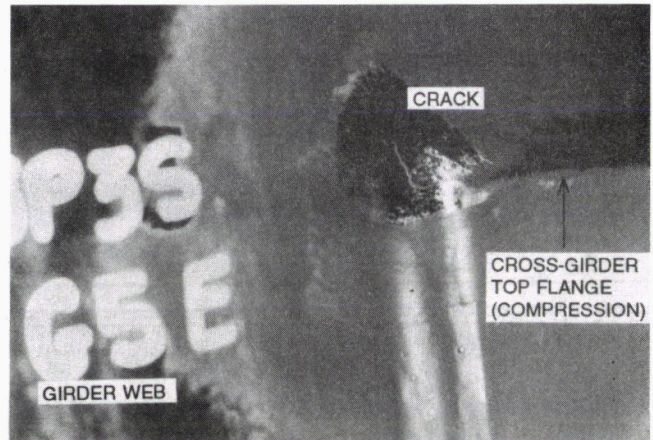
FIGURE 6 Typical crack at top flange weld intersection.

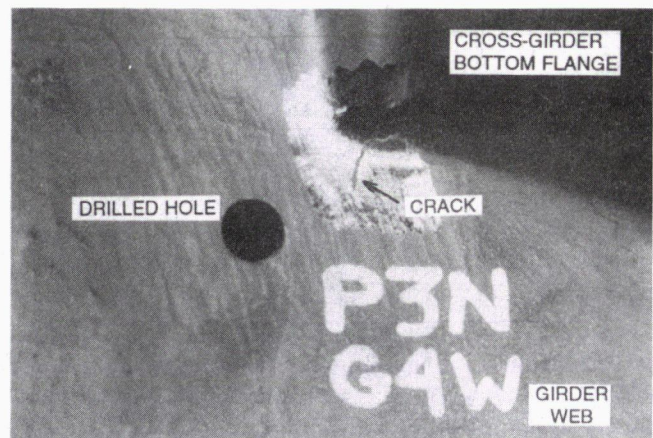
Subsequently drilled 1.6-cm (0.63-in.)-diameter stress relief holes were provided in northbound Piers 1 through 4. The holes were poorly positioned and did not intercept the crack tip. From Figure 7 it can be observed that crack propagation is not likely to intersect the drilled hole.

FIGURE 7 Typical crack at bottom flange stress relief hole.

3. New 5.1-cm (2-in.)-diameter half-circle stress relief holes should be provided in northbound Piers 1 through 4 where stress relief holes were omitted during fabrication.
