After-Fracture Redundancy of Two-Girder Bridge: Testing I-40 Bridges Over Rio Grande

R. L. Idriss, K. R. White, C. B. Woodward, and D. V. Jauregui,
New Mexico State University

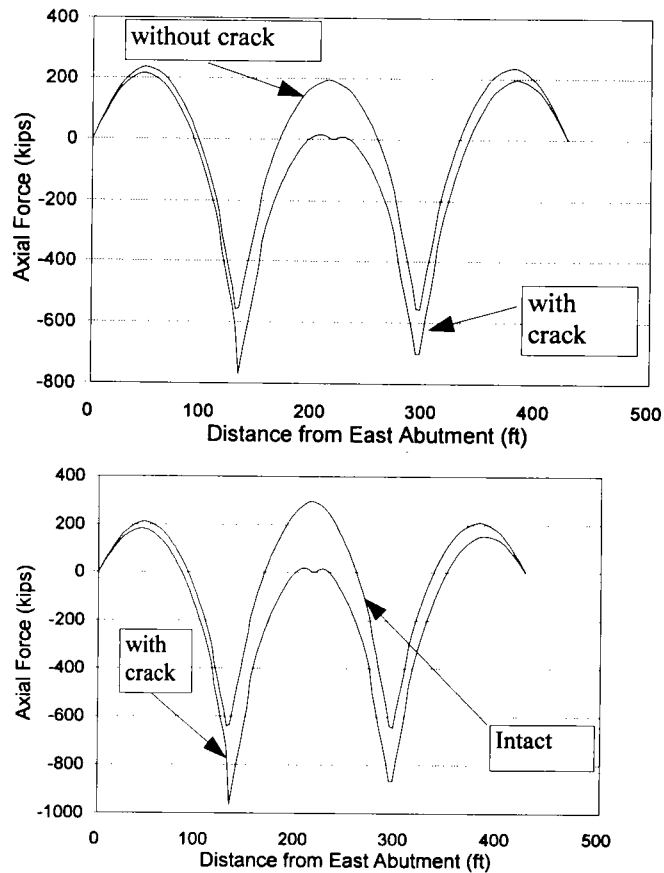
FIGURE 5 *Top:* North girder bottom flange forces; *bottom:* north girder bottom flange forces under dead load plus two HS-20 truck loadings, no impact (1 kip = 4.45 kN, 1 ft = 0.305 m).

1. Most of the load was observed to be redistributed longitudinally via the north damaged girder to the interior supports, as demonstrated by the large increase in negative moment at the interior supports after fracture (Figure 5), and

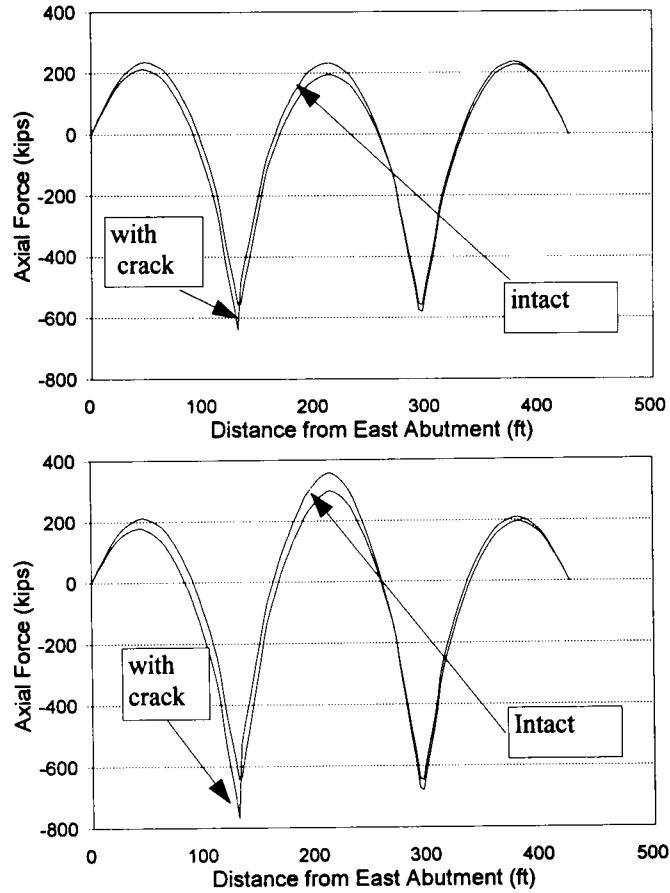
FIGURE 6 *Top*: south girder bottom flange forces under dead load; *bottom*: south girder bottom flange forces under dead load plus two HS-20 truck loadings, no impact (1 kip = 4.45 kN, 1 ft = 0.305 m).

2. Some of the load was redistributed in the transverse direction to the intact girder because of the torsional rigidity of the deck, floor beam, and bracing system as shown by the increase in positive moment at midspan of the central span (Figure 6).
