Rapid Rehabilitation or Replacement of Bridge Decks Under Concurrent Traffic Conditions

George E. Ramey

More than 4.8 km (3 mi) of major Interstate bridges [three to five lanes wide, with approximately 55 742 m² (600,000 ft²) of deck] near downtown Birmingham, Alabama, have significant levels of deck cracking and deterioration. The bridges are part of the I-65 and I-59/20 Interstate highway system through the city and are approximately 30 years old.

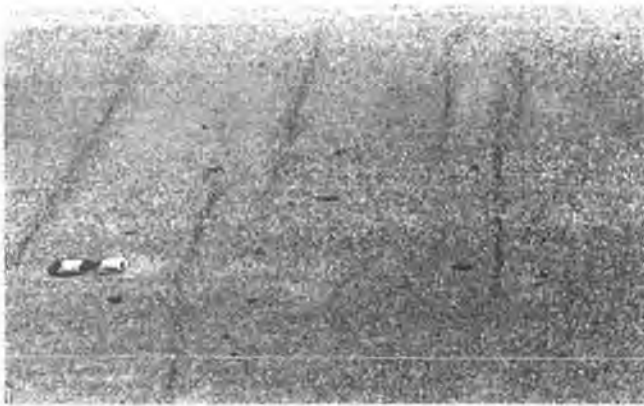
Typical photographs showing the state of cracking and deterioration of the I-65 and I-59/20 bridges are presented in Figures 1 through 4. Obviously, the decks are showing significant cracking. Alabama Department of Transportation (ALDOT) bridge inspectors indicate that about 5 to 7 years ago they began to see longitudinal cracks in the top of the deck above the edges of the support girders. These cracks are continuing to grow in length and width and are beginning to combine with older transverse cracks (which are almost everywhere) to form surface spalls, as shown in Figure 4.

FIGURE 1 Close-up of transverse cracking on I-65 bridge.

From the Phase 1 work, it appears that the deck cracking is primarily the result of early drying and thermal shrinkage, early concrete obstructed settlement, thin and flexible deck [approximately 16.5 cm (6.5 in.) thickness], light and flexible superstructure, and heavy traffic volume and truck loading (80,000 one-way average daily traffic in 1998).

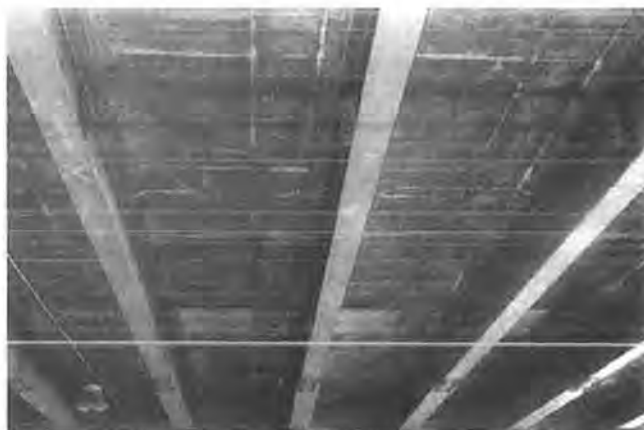
- Extensive fine cracking on the deck undersides, with a concern for future underside spalling problems, which would create a safety hazard and additional maintenance requirements; and

FIGURE 2 Underside of I-65 bridge.

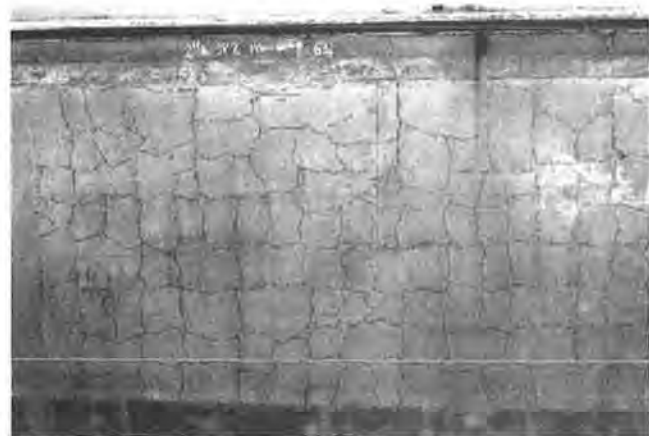
FIGURE 3 Close-up of underside of I-65 bridge at midspan with hairline cracks highlighted.

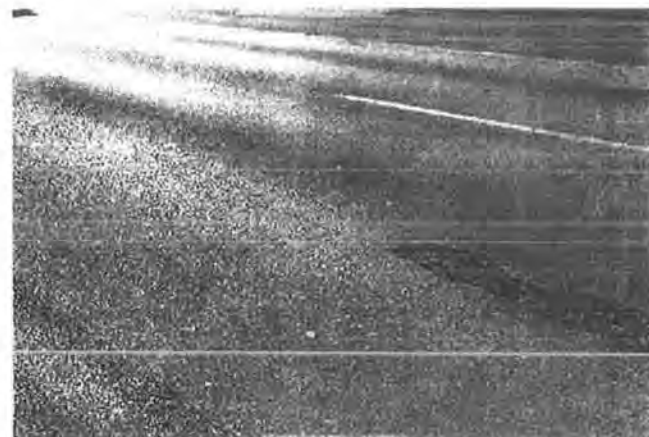
FIGURE 4 I-65 deck surface spall.

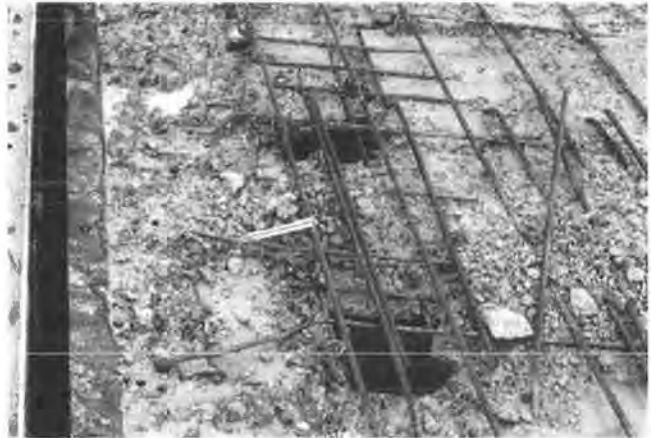
FIGURE 7 Hydrodemolition portion of deck near an expansion joint with two sizable blow-outs—I-285 bridge, Georgia.

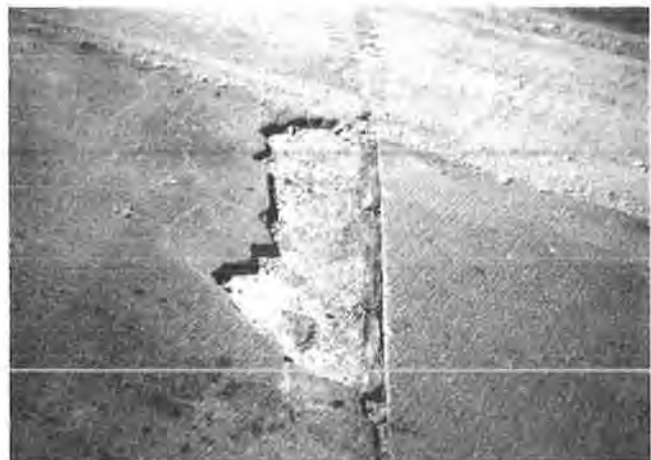
FIGURE 9 Typical deck damage at joints, Kentucky bridge.

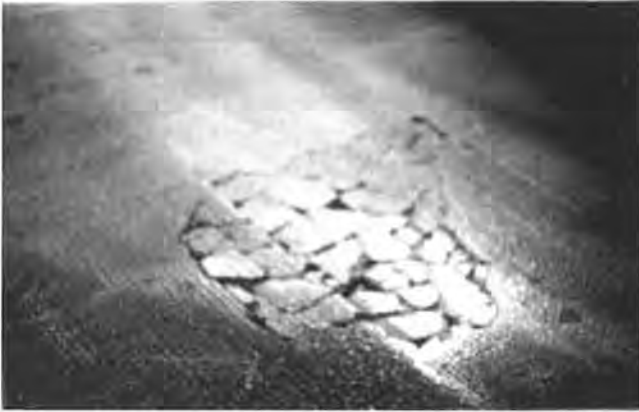
FIGURE 10 Typical deck damage away from joints, Kentucky bridge.
