Rejuvenating Highway Pavement

J. L. STACKHOUSE, Maintenance Engineer
Washington State Highway Commission

The paper describes the resurfacing with a flexible pavement of the Roy Junction - Muck Creek section of Primary State Highway 5, located 6 miles south of Tacoma, Washington, on the route to Mount Rainier National Park that was originally paved in August 1914 with a 16-foot-wide portland-cement-concrete pavement. This section, 5.46 miles in length, was widened to 22 feet in 1940, using a 3-inch-depth asphaltic-concrete-base mixture as a widening medium and the widened roadway was resurfaced with an average thickness of $2\frac{1}{2}$ inches of asphaltic concrete material.

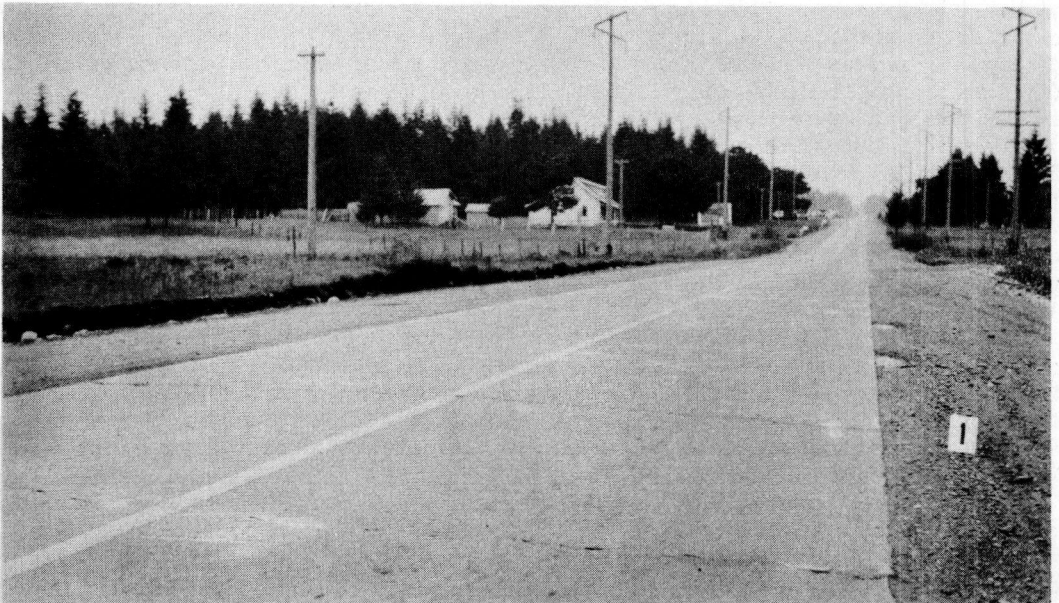
Figure 2.

Figure 2 shows the old pavement as it appeared in March 1940, or nearly 26 years after it was constructed. Note the transverse cracks and the indications of pumping movement of the slabs at the expansion joints by the light patches near the center line. Figure 3, taken in September 1940, illustrates the resurfaced pavement at the same location as Figure 2, while Figure 4 was taken in October 1954, showing the conditions of this pavement 14 years later. These three views were taken at the north end of the project at the same location.

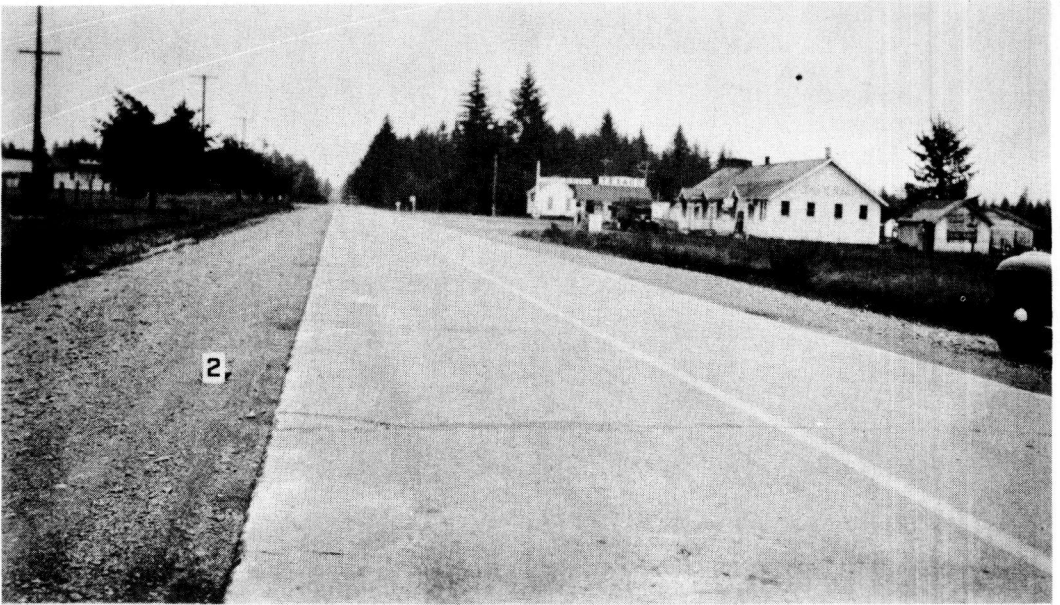
Figure 5.

Figure 5 reveals the condition of the old pavement at approximately the center of the project and although some of the corners of the slabs are broken and the expansion joints

are chipped, the 26-year old pavement is in fair condition at this point.

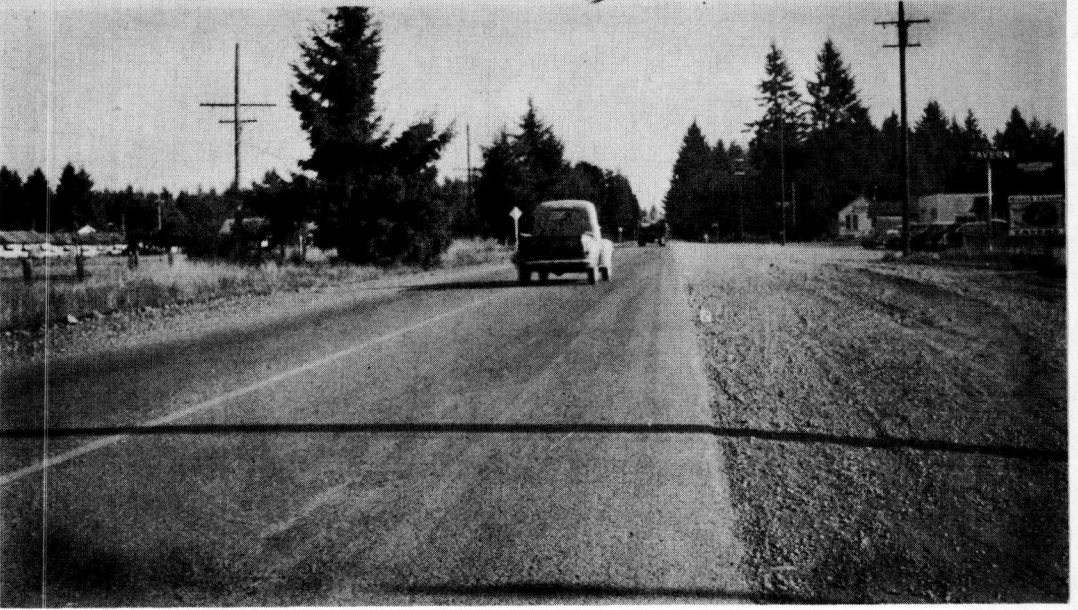
Figure 7.

Figure 6 exhibits the completed resurfacing work in September 1940, showing the rather granular texture of the wearing surface. Figure 7 discloses this same area in October 1954, or 14 years later.

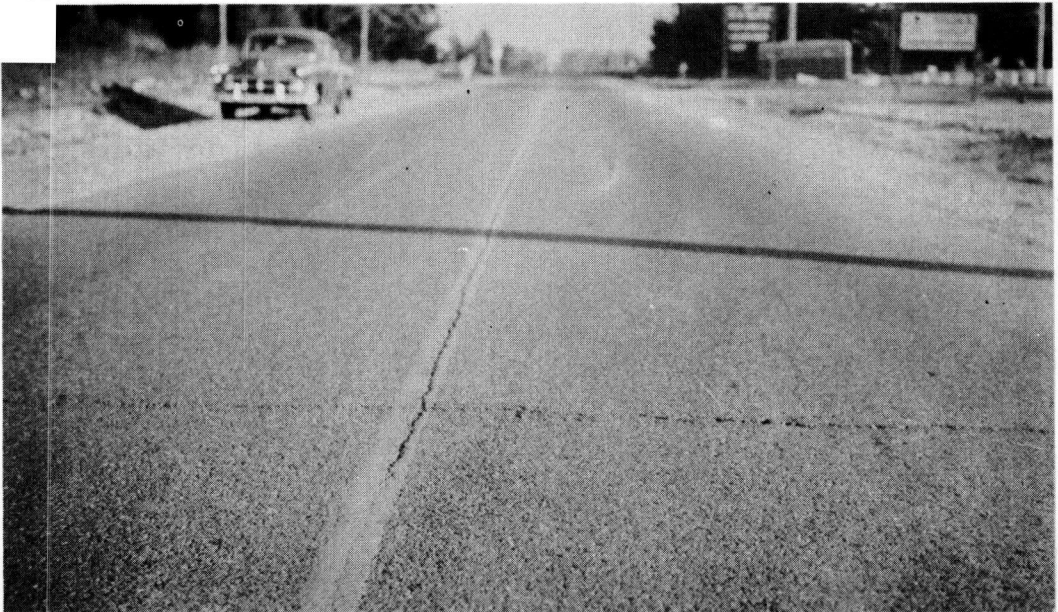
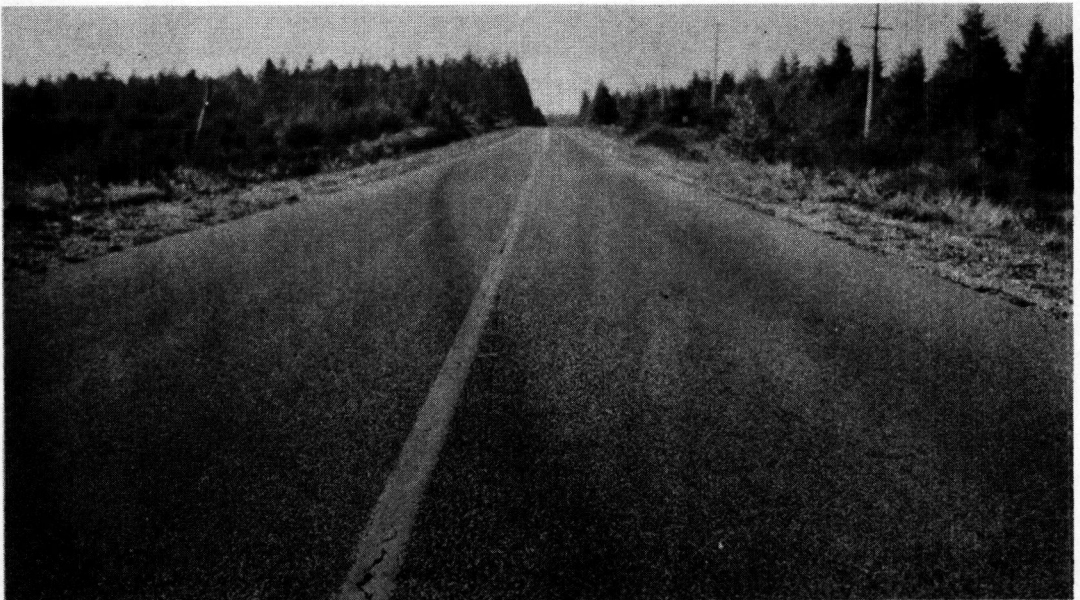
general classes that are common in this type of construction. The first class is where a relatively thin flexible pavement is placed over a rigid pavement or base and the expansion joint pattern in the rigid base reflects through to the new surface after a few years. The second class of crack pattern is where the nonrigid base under the widened area is lacking in thickness or contains plastic material which causes the pavement to yield under traffic during wet weather or during the early spring thawing period.

Figures 11 and 12 illustrate the first type of crack pattern that developed in this pavement to a minor extent the second year after it was laid. The second type of

It has been observed from the inspection of many sections resurfaced with a flexible pavement that pavements with overlay thickness of a minimum of 2½ to 3 inches suffer less from expansion-joint cracks eventually showing through than do pavements having thinner overlays. Also, where an old pavement is to be widened and resurfaced with asphalt concrete, it is mandatory to get the most-thorough compaction possible of the base material under the widened asphaltic concrete. Other observations are that when an old pavement is resurfaced, it is profitable to remove the old shoulder material to an elevation slightly below the bottom of the old pavement, so that all impounded water under the pavement will be drained.

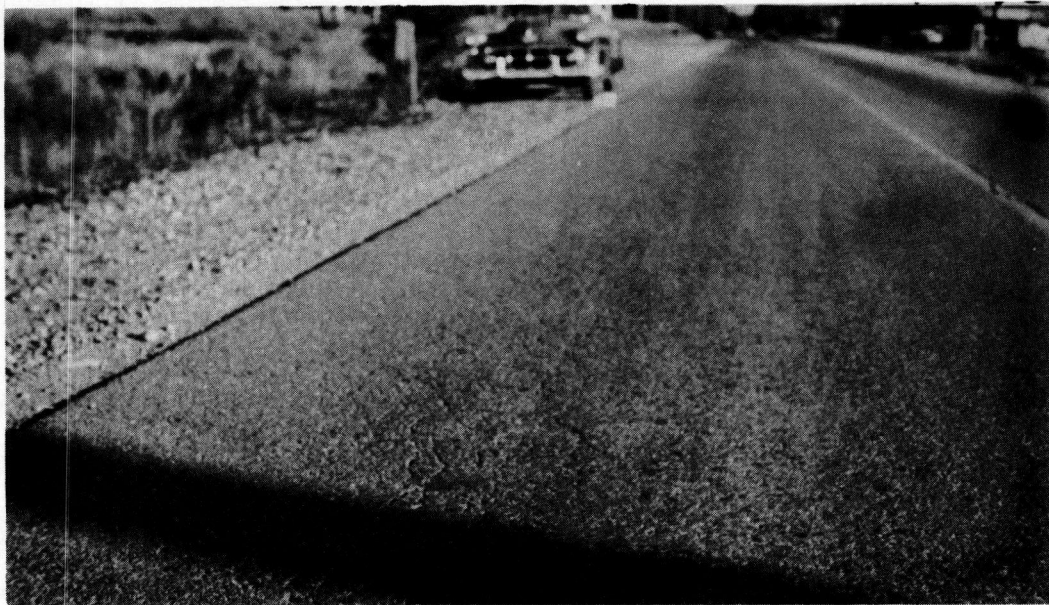
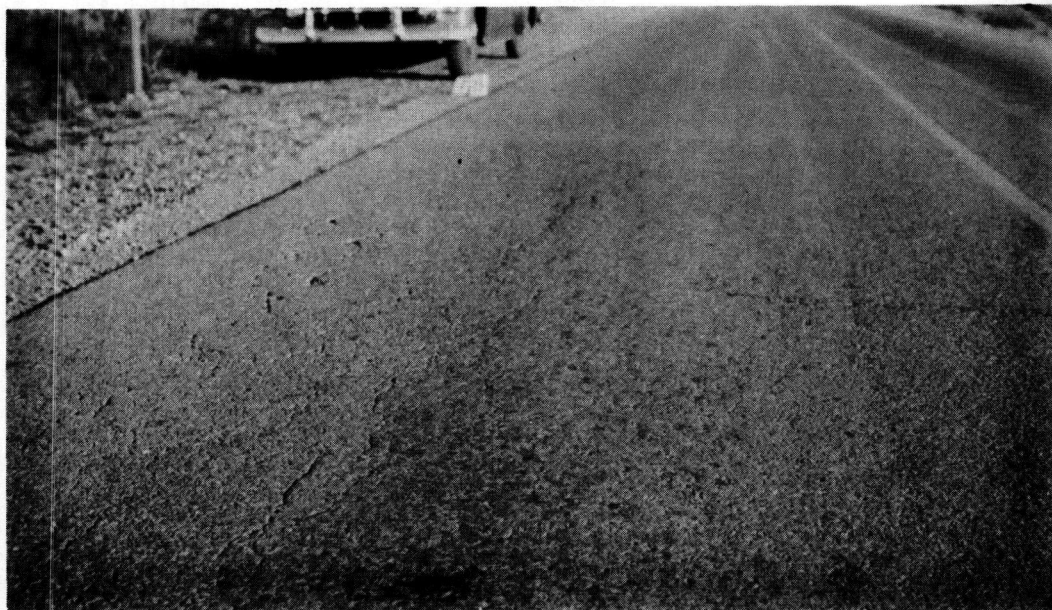
crack pattern in Figures 13 and 14 indicates the foundation under the asphalt concrete pavement has yielded and caused the surface to form an irregular crack pattern, sometimes called alligator cracks. There are cases where this type crack will form due to lack of compaction of the widened area, and the area, under traffic, will compact and subside causing the cracks to form. However, cracks caused from lack of compaction will usually heal up in following years and will not recur when the base material is unyielding. The cracks over the old concrete pavement are less noticeable during the summer and early fall months before cool weather causes the old pavement to contract. To date little patching has been done on this asphalt-concrete resurfacing, and the cracks have never been poured with a crack-filling material. However, such areas as shown in Figures 13 and 14 will need attention in the next year, since they are becoming progressively wider and allowing more water to reach the base or foundation.

The engineers of this department have been surprised to find large quantities of water under old pavements, even when the underlying soil has been sandy in character. The excavated shoulder area should then be replaced with a granular, free-draining aggregate. It has been found that when old rigid pavements are found to have slabs rocking or moving under traffic, it is good insurance from future maintenance to subseal these pavements with a low-penetration, air-blown asphalt to seal the joints from beneath and fill in depressions under the slabs. The rule observed by the Washington highway department on whether or not a rigid pavement needs undersealing before resurfacing depends on the observed pumping action of the slabs. Where no action is noted, subsealing is usually omitted.
