Conditioning an Existing Concrete Pavement For Bituminous Resurfacing

FRED W. KIMBLE, Flexible Pavements Engineer
Ohio Department of Highways

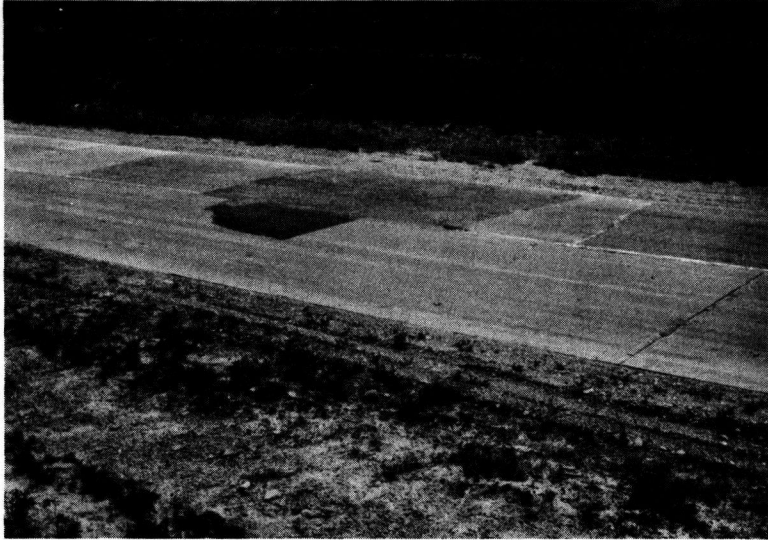
Figure 1. Condition of old pavement prior to resurfacing. Fore-ground is passing lane.

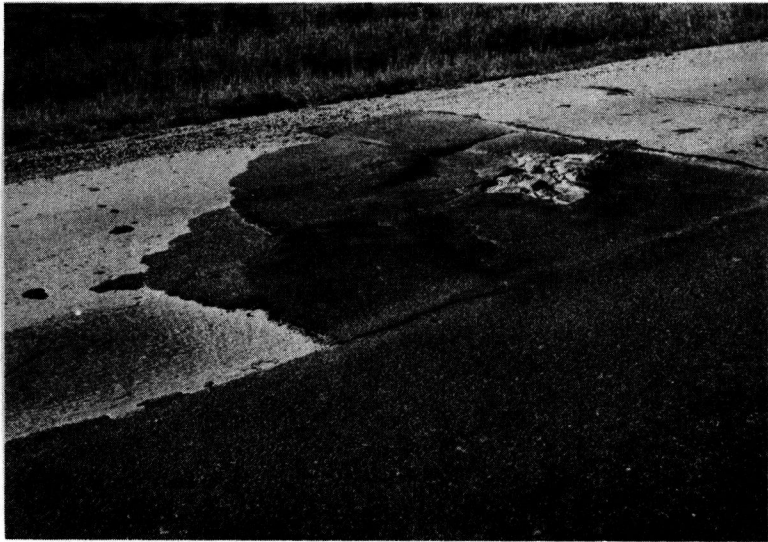
Figure 2. Condition of old pavement prior to resurfacing. Fore-ground example of extensive bituminous patching. Background example of numerous corner breaks.

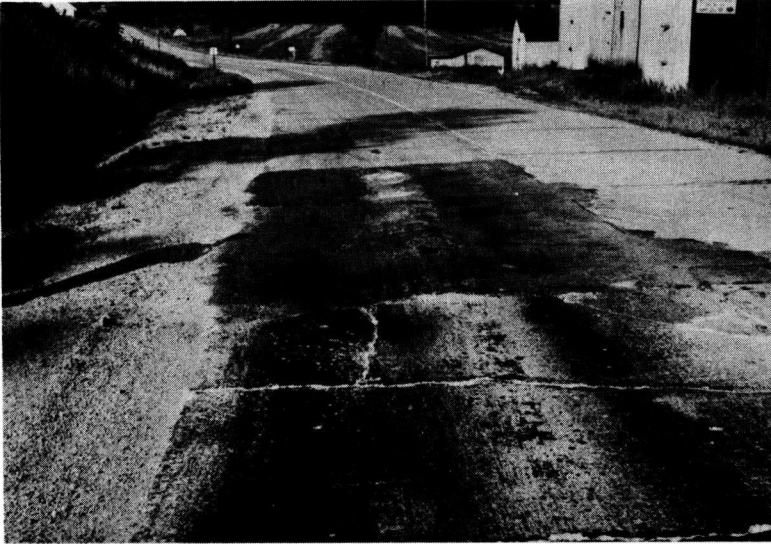
Figure 3. Condition of old pavement prior to resurfacing. View shows faulted and pumping slabs and extensive bituminous patching.

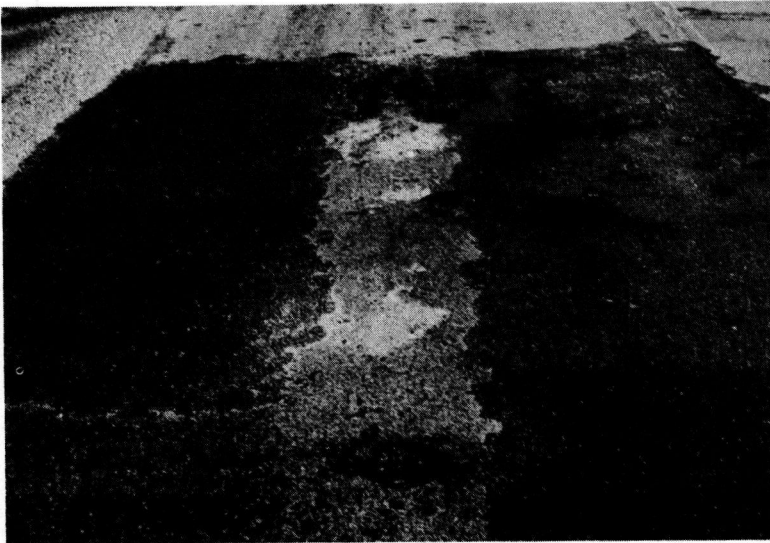
Figure 4. Condition of old pavement prior to resurfacing. View shows a pumping joint that has broken through an extensive bituminous patch.

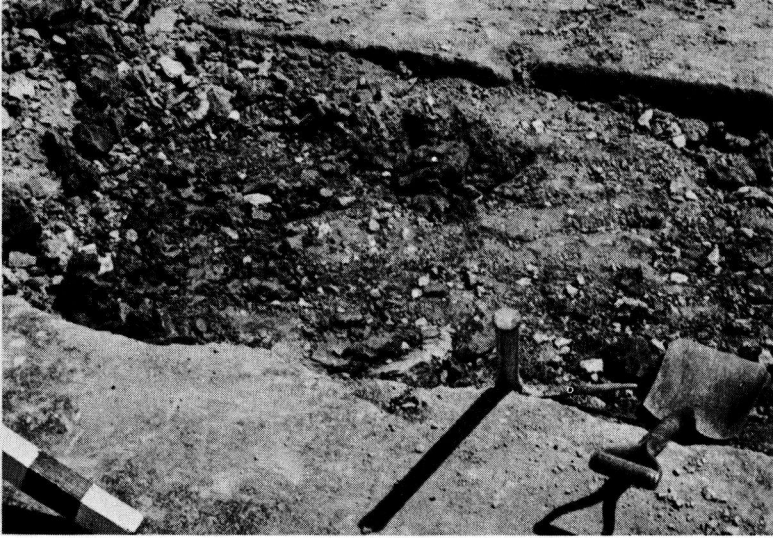
Figure 5. View showing old concrete removed preparatory to patching. This is a minimum width removal of 4 feet.

Pavement marked for removal was broken into small pieces with a gravity hammer. The edges of the removal areas were trimmed, where necessary, with pneumatic drills and chisels. The minimum size of removal area was 4 feet by 4 feet. The edges of all patches were parallel and at right angles to the centerline of the pavement. This prac-

tice necessitated the removal of some sound pavement in areas of triangular corner breaks. It was felt that if small triangular patches were placed, however, they would soon be rocking under the traffic load. Figure 5 illustrates a minimum width of removal.

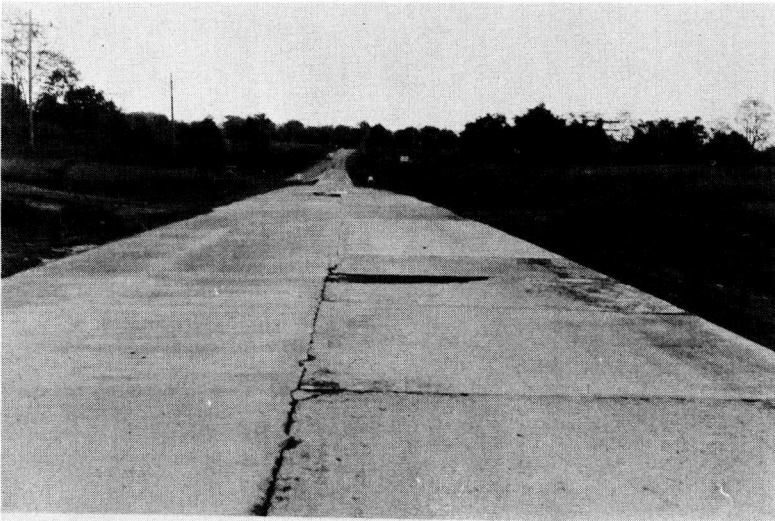
Figure 6. View showing a large size plain concrete patch on left. Right side partially patched. Surface of patches were float finished and were not edged.

The plain-cement-concrete patches were all placed 9 inches thick, except in the minimum-sized areas. The thickness in the 4-by-4-foot areas was increased to 12 inches. The edges of this size patch were undercut about 3 inches. It was believed that this treatment of the small patches would better enable them to resist moving under the traffic load. Figure 6 illustrates some of these patches. The surface of the patches was given a float finish and no edging was done.

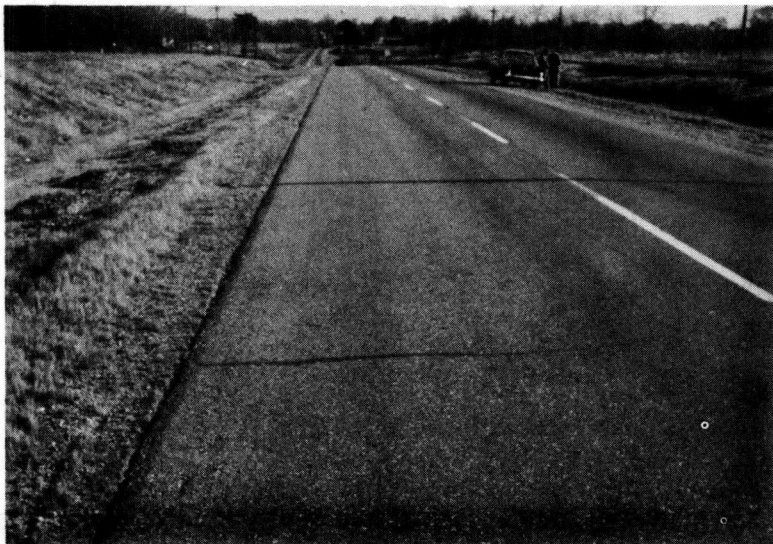
Figure 7. Typical condition of the resurfaced pavement December 1, 1954.

Annual condition surveys have been made each May since the project was completed. The pavement and drains were carefully checked and a record made (see Table 1). The pavement was last examined on December 1, 1954. Figures 7 and 8 illustrate the present general condition of the pavement.

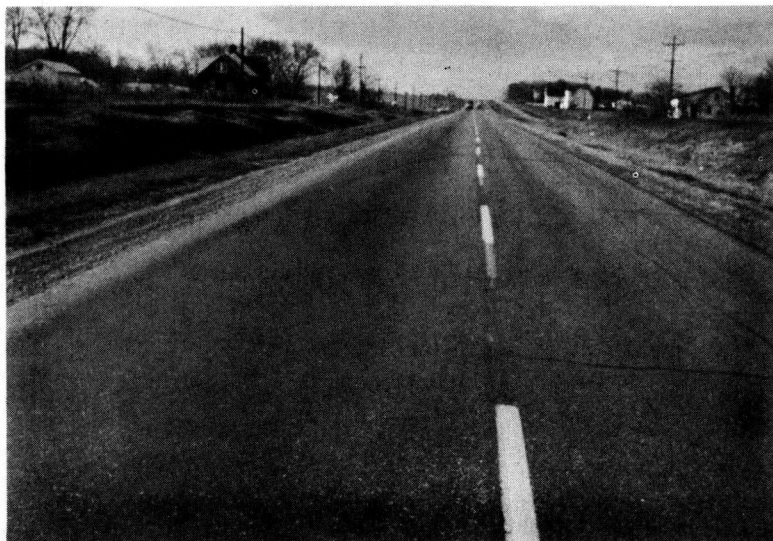
Figure 8. Typical condition of the resurfaced pavement December 1, 1954.

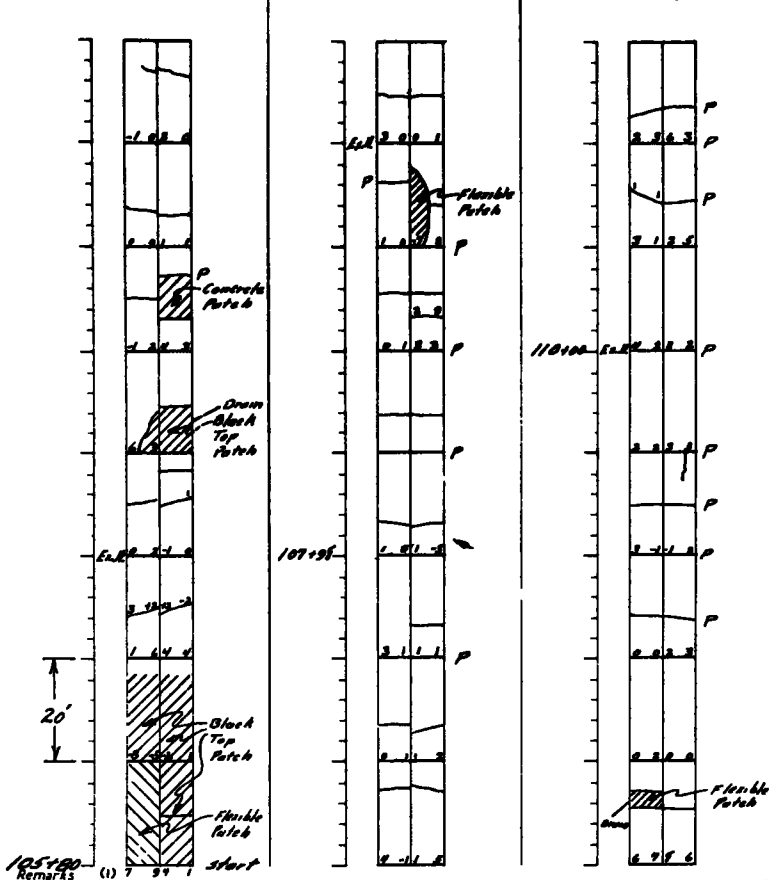
Figure 9.

material, installing drains, and then placing pavement patches of either plain portland-cement concrete or of the flexible type. Before any work started, an accurate condition survey of the pavement was made and recorded on a condition survey form (see Figure 9 for an example). The survey noted all faulted joints and extent of the faulting, patches, cracks and breaks in the slabs, pumping joints, and other conditions considered to have an influence on the resurfacing. Figures 1 through 4 illustrate the condition of removal

Remarks (1) 7 9 1 short
light surface treatment on right lane.
Undersealed
(1) Faulting recorded in sixteenths of an inch
(2) P = Tamping cracks or joints
