Bulletin 166

*Field Studies of
Methods and Materials for
Joint and Crack Sealing*

A Field Study of Joint and Crack Resealing Methods and Materials

Field Testing of Materials for Sealing Cracks and Joints in Bituminous Concrete Resurfacings

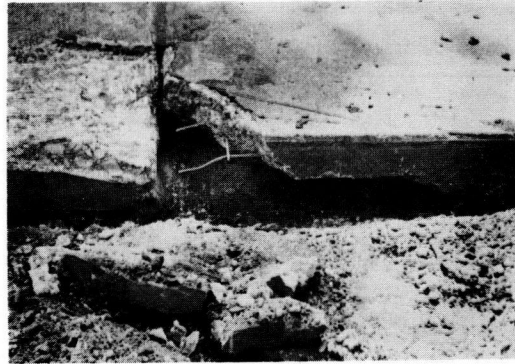
It was found that usually only one corner break was apparent at the pavement edge. Removal of a section of the shoulder always indicated, however, that the other corner was also broken. It appeared that compressive stress at the joint caused the upper corner of one slab and the lower corner of the other to shear off at an angle of about 30 deg to the horizontal. This condition is apparent in Figure 14 and is typical of all corner breaks examined in detail.

FIGURE 14. CORNER BREAK WITH LOOSE AND UNSOUND MATERIAL REMOVED.

Figures 14 through 17 show the various steps used in making these repairs. The loose and unsound concrete was removed with an air hammer and the joint filler and groove form set in place. A wide board was used as a form for the pavement edge. A very thin water slurry of cement containing 10 percent by weight of a well known anti-shrink admixture was brushed into the faces of the old concrete for a bond coat. A grout made of 60 volumes of gravel of 1-in. maximum size, 40 volumes of No. 8 sand,

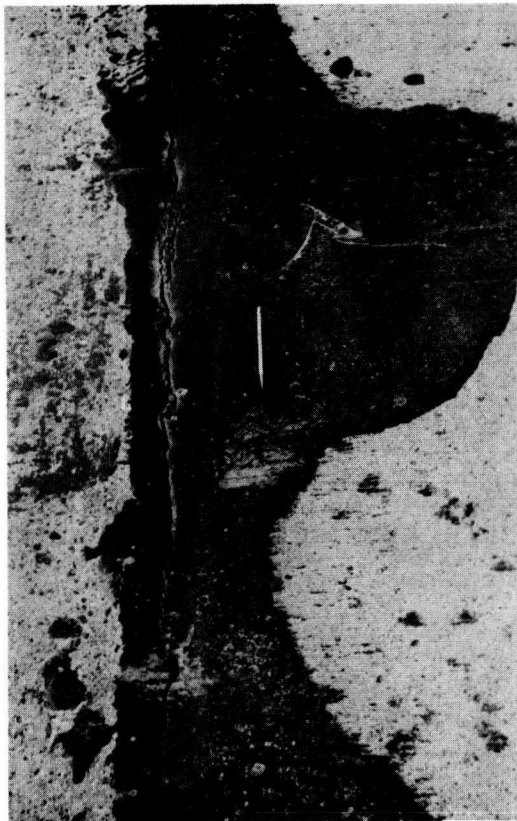
In the $2\frac{1}{2}$ yr survey it was found that the only major changes since the previous survey had occurred with Brands A and B sealers in transverse joints. With the exception of a few adhesion failures, all of the Brand A failures had now become manifested as cohesion failures. The deterioration of Brand B sealer had continued to a point where all transverse joints containing this material had failed in adhesion. The remainder of the maintenance repairs appeared to be in exactly the same condition as they were at the time of the previous survey one year earlier. The Brand C sealer still showed adhesion failures in only a few transverse joints with most of them in good condition. Transverse joints and open cracks containing Brands D, E and F were still well sealed with no apparent failures of any kind, while the longitudinal joint and the closed cracks were still maintaining an excellent seal regardless of the brand of sealer used. Typical condition of joints sealed with the six different brands of material are shown in the photographs of Figures 18 through 23, taken during the third survey in March, 1956.

FIGURE 18. FAILURE MAINLY IN COHESION ; TYPICAL OF BRAND A FAILURES AT 2 1/2 YEARS.

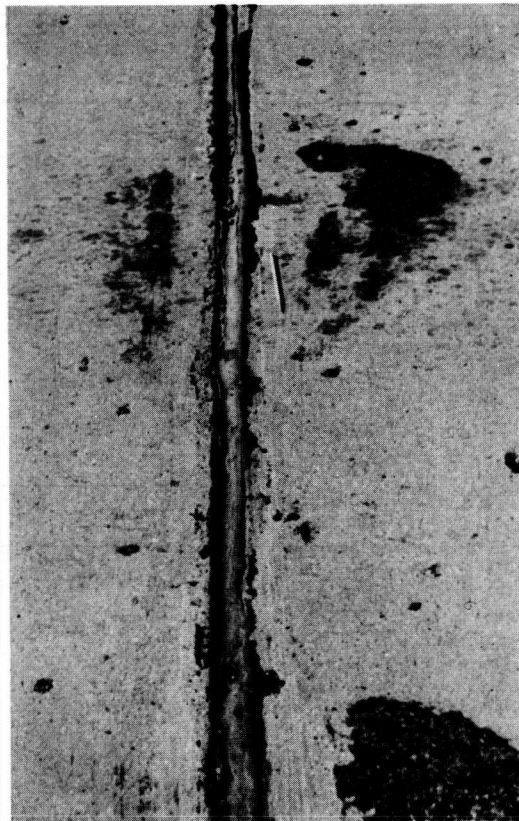
FIGURE 19. ADHESION FAILURE ; TYPICAL OF JOINTS RESEALED WITH BRAND B AT 2 1/2 YEARS.

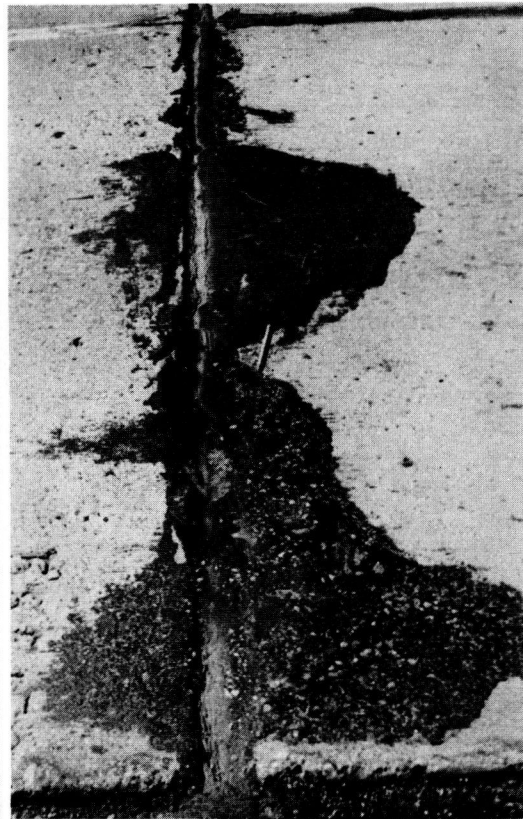
FIGURE 20. SEAL STILL INTACT. TYPICAL OF JOINTS CONTAINING BRAND C AT 2 1/2 YEARS.

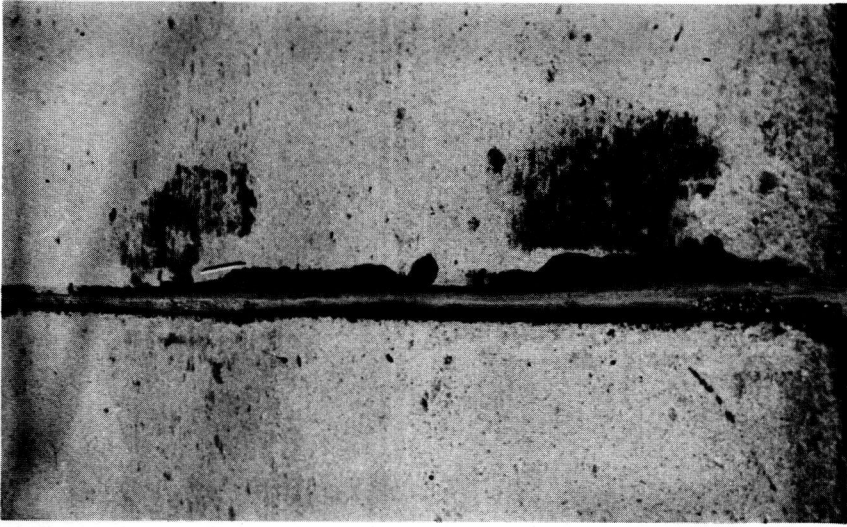
FIGURE 23. BRAND F; IN GOOD
CONDITION AT 2 1/2 YEARS.

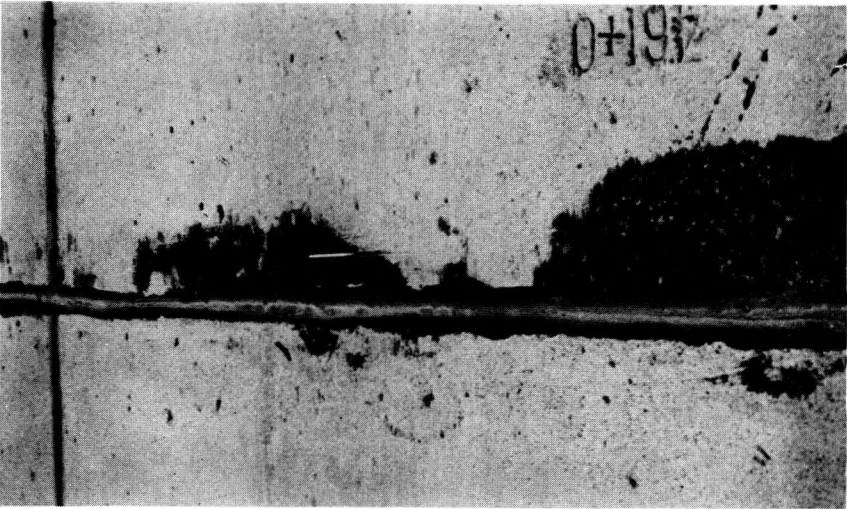
FIGURE 22. BRAND E; IN GOOD
CONDITION AT 2 1/2 YEARS.

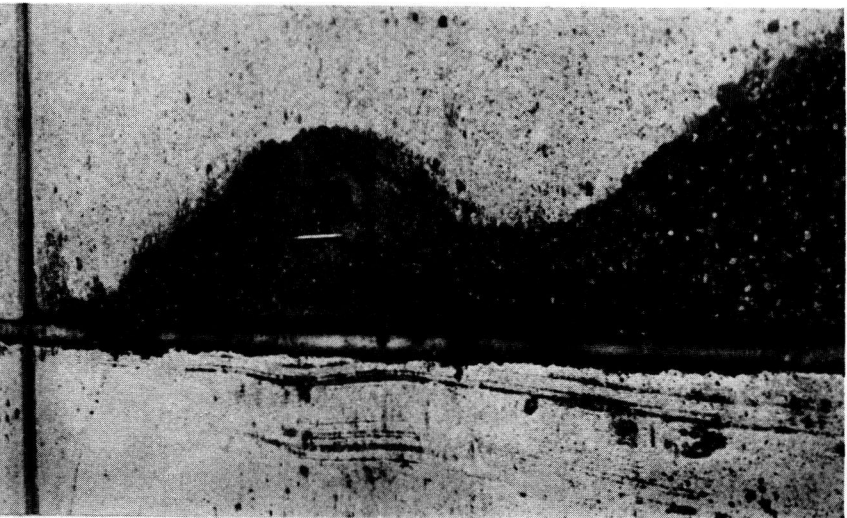
FIGURE 21. BRAND D; IN GOOD
CONDITION AT 2 1/2 YEARS.

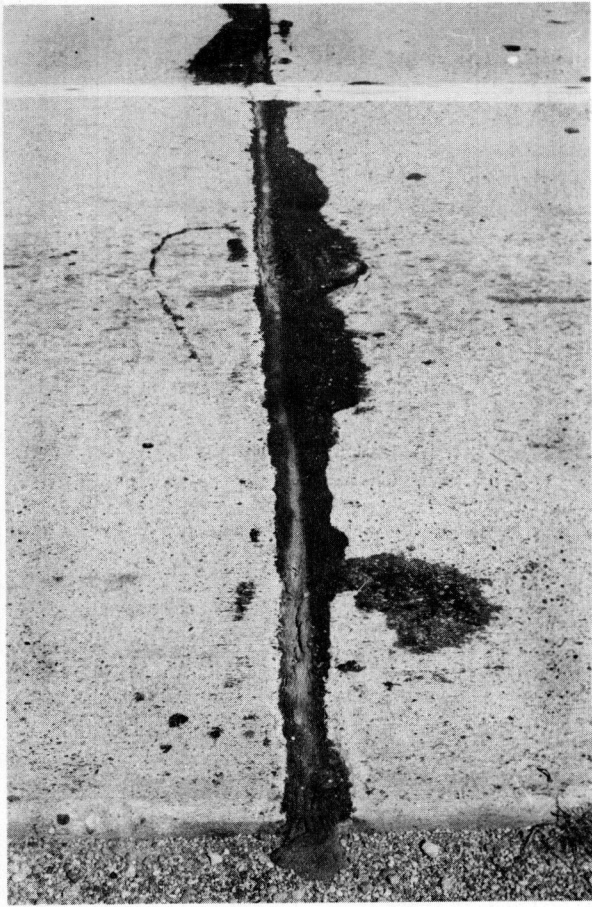
There was little change in the condition of the project when the fourth survey was made in October 1956, except what appeared to be a progression of failure in the Brand C material, Figure 24. On closer examination, however, it was found that the visible cracking and wrinkling of the sealer extended only slightly below the surface, with the seal still intact.

FIGURE 24. TYPICAL OF SURFACE CRACKING AND WRINKLING OF BRAND C AT 3 YEARS. SEAL STILL INTACT.

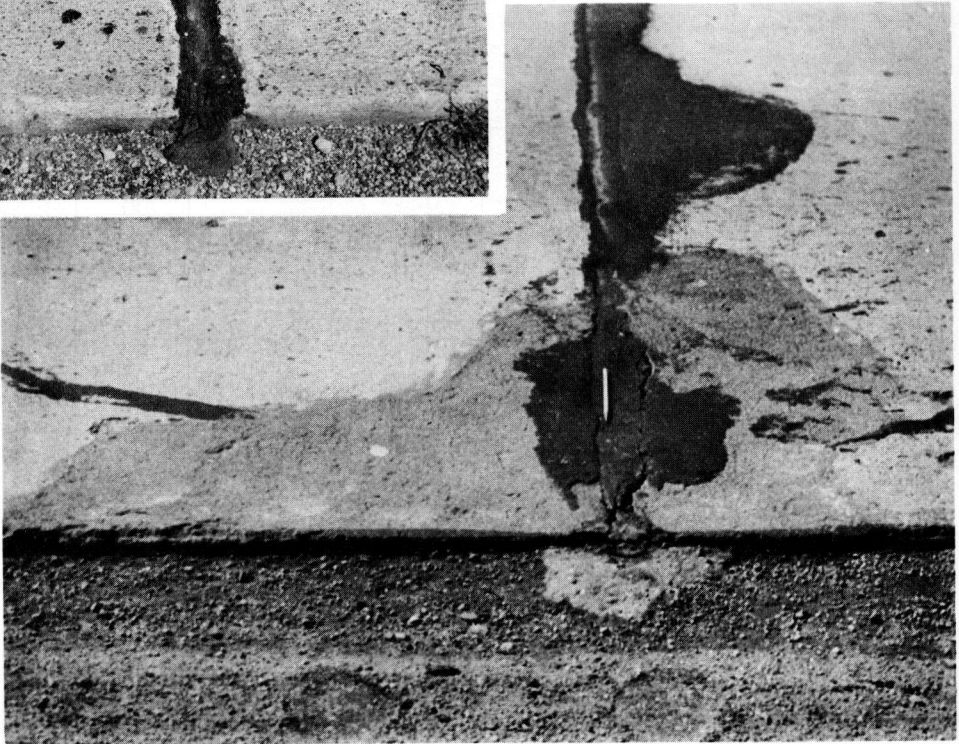
The concrete patches still remained bonded to the old concrete after $2\frac{1}{2}$ yr and appeared to be sound, although some surface scaling was apparent (Figure 25).

FIGURE 25. REPAIRED CORNER BREAK AFTER 2 1/2 YEARS.

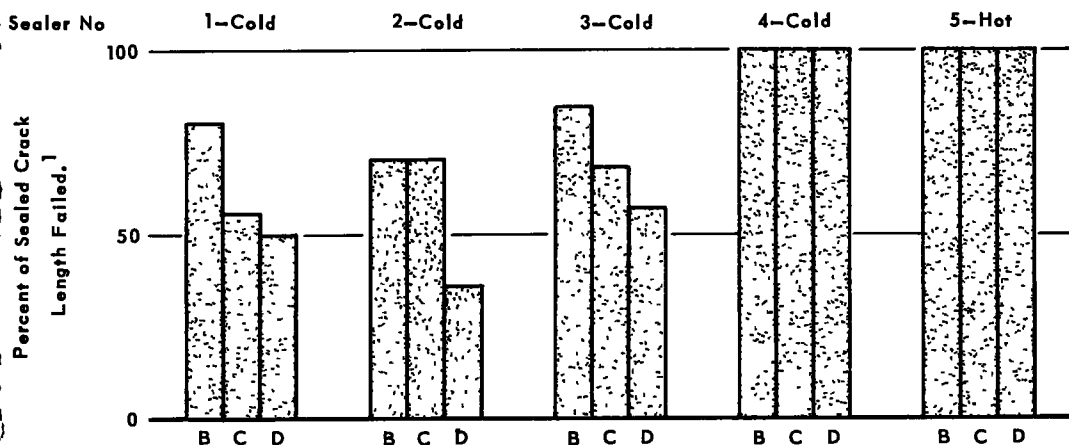
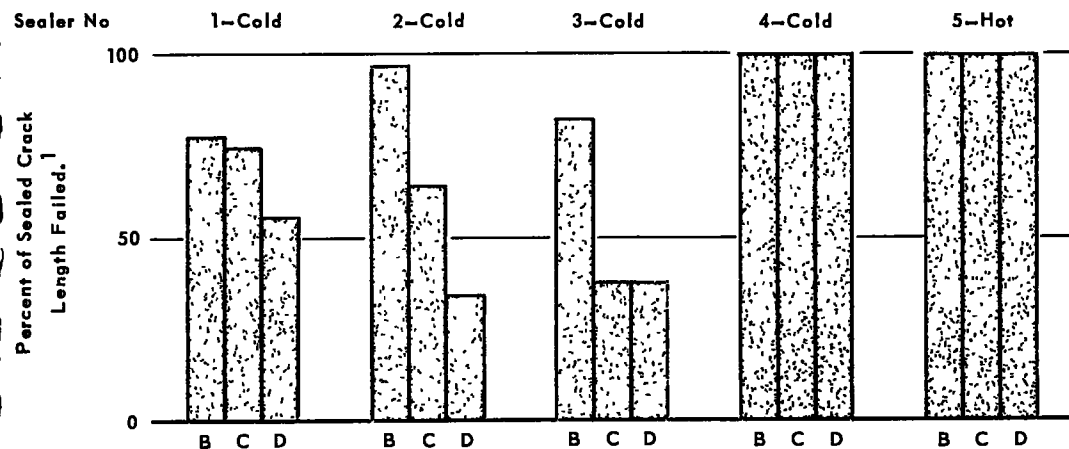
Figure 5. Randolph crack sealing, October 1955. Results after one year.

1. All failures were primarily in adhesion, except for sealer 3 which failed in cohesion.
2. "B" cracks are 1/8 inch or less in width.
3. "C" cracks are 1/8 inch to 1/4 inch wide.
4. "D" cracks are 1/4 inch or more in width.

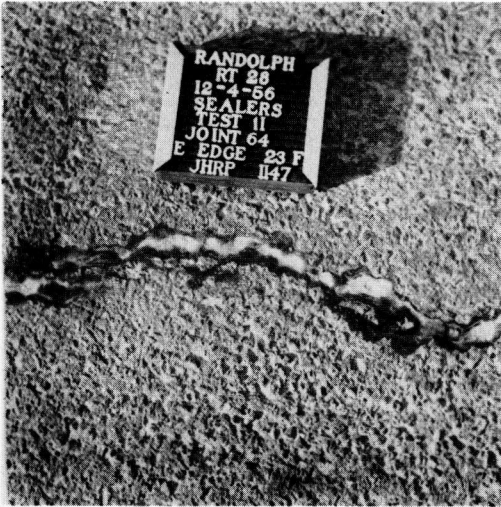
Figure 6. Crack $\frac{1}{4}$ inch or wider with Sealer 1 in good condition.

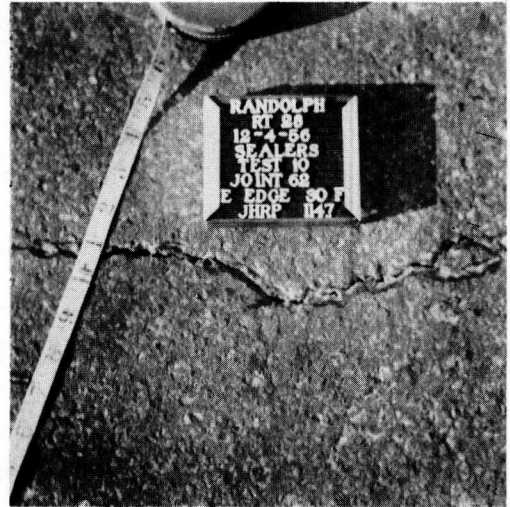
Figure 7. Crack below $\frac{1}{4}$ inch width was not well sealed.

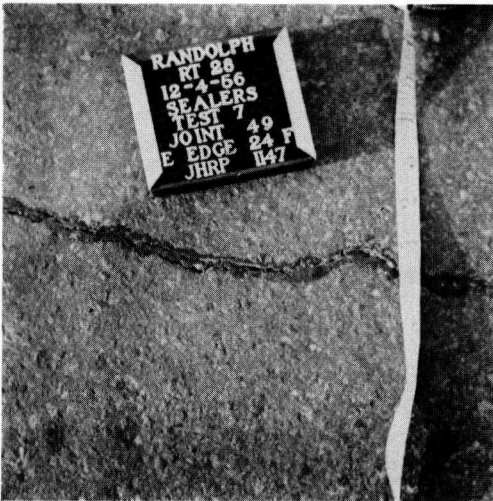
Figure 8. Sealer failed in adhesion.

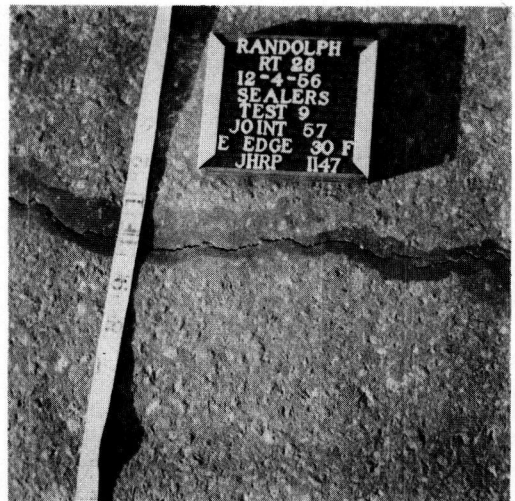
Figure 9. Sealer failed in cohesion.

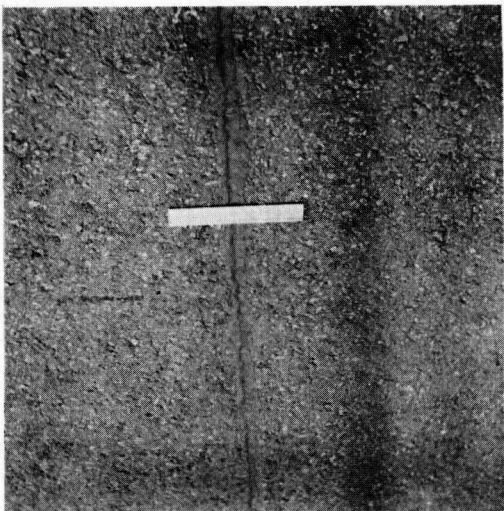
Figure 14. Typical joint with a good seal.

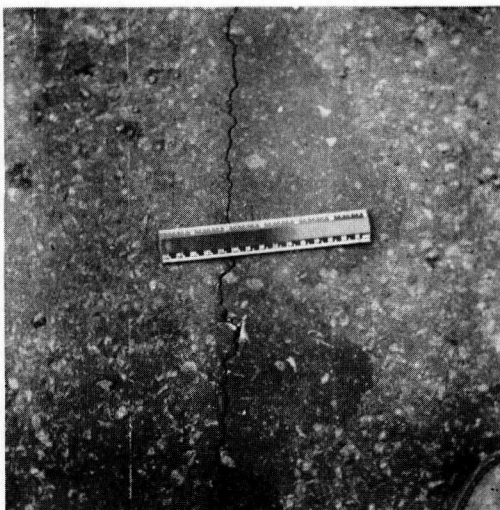
Figure 15. Sawed groove partially closed by traffic. Cohesion and pavement failure resulted.

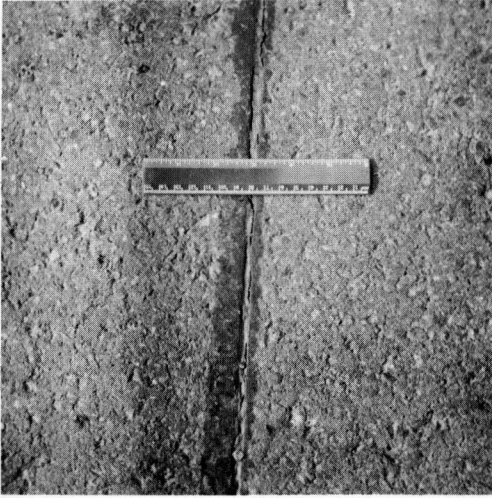
Figure 16. Very few adhesion failures were found.

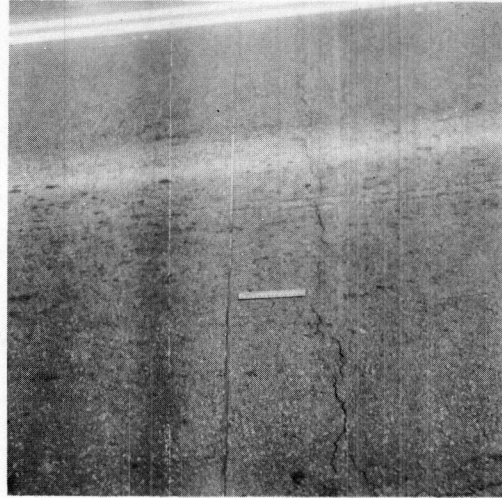
Inadvertently one groove at Walpole was not sawed directly over the underlying joint and a parallel reflection crack has developed about a foot away (Fig. 17).

Figure 17. Groove was not sawed directly above underlying joint.
