**Bulletin 182**

***Corrosion of Reinforcing Steel  
And Repair of Concrete  
In a Marine Environment***

## CAUSES AND REPAIR OF DETERIORATION TO A CALIFORNIA BRIDGE DUE TO CORROSION OF REINFORCING STEEL IN A MARINE ENVIRONMENT:

# **Causes and Repair of Deterioration to a California Bridge Due to Corrosion of Reinforcing Steel in a Marine Environment**

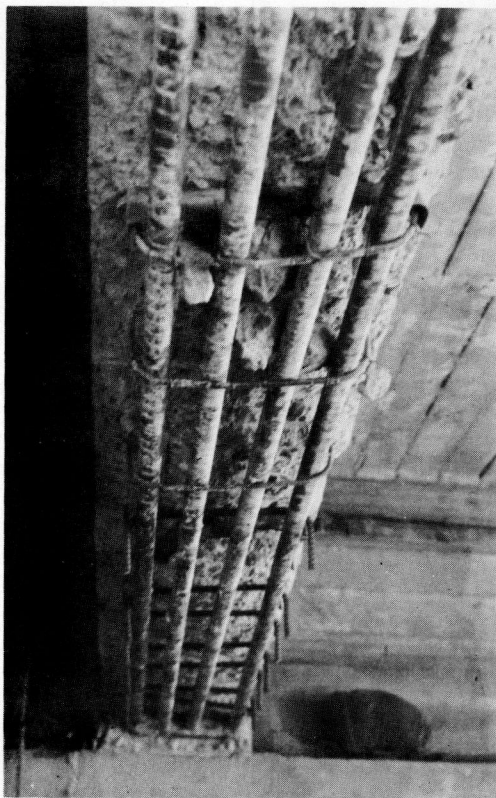
Figure 6 shows the spotty and discontinuous areas of corrosion in a beam bottom as disclosed upon removal of concrete. The stirrups with ends turned down are replacement parts that will later be welded into proper position where corroded stirrups have been cut away at the end of the beam. Figure 7 shows severe corrosion of  $\frac{3}{8}$ -in. round stirrups at the lower bend. Figure 8 shows an area of a beam bottom where deterioration has advanced to such a degree as to completely spall off the concrete, exposing the steel.

Figure 6. Beam bottom after chipping and before sandblasting, showing spotty and discontinuous areas of corrosion on reinforcement. Stirrup replacements at end of beam yet to be installed.

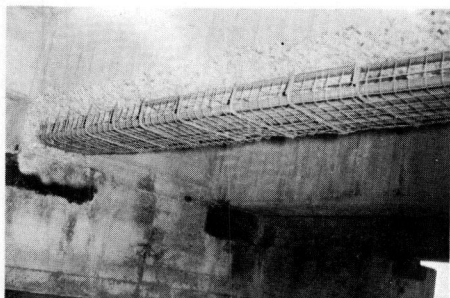
Figure 11. Beam bottom with stirrups replaced and wire mesh in place, ready for shotcrete.

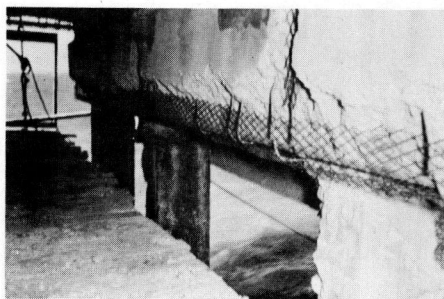
Figure 12. Cap corner ready for shotcrete. Note vertical chases cut to remedy corrosion on stirrup legs.

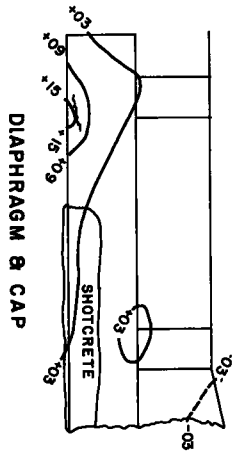
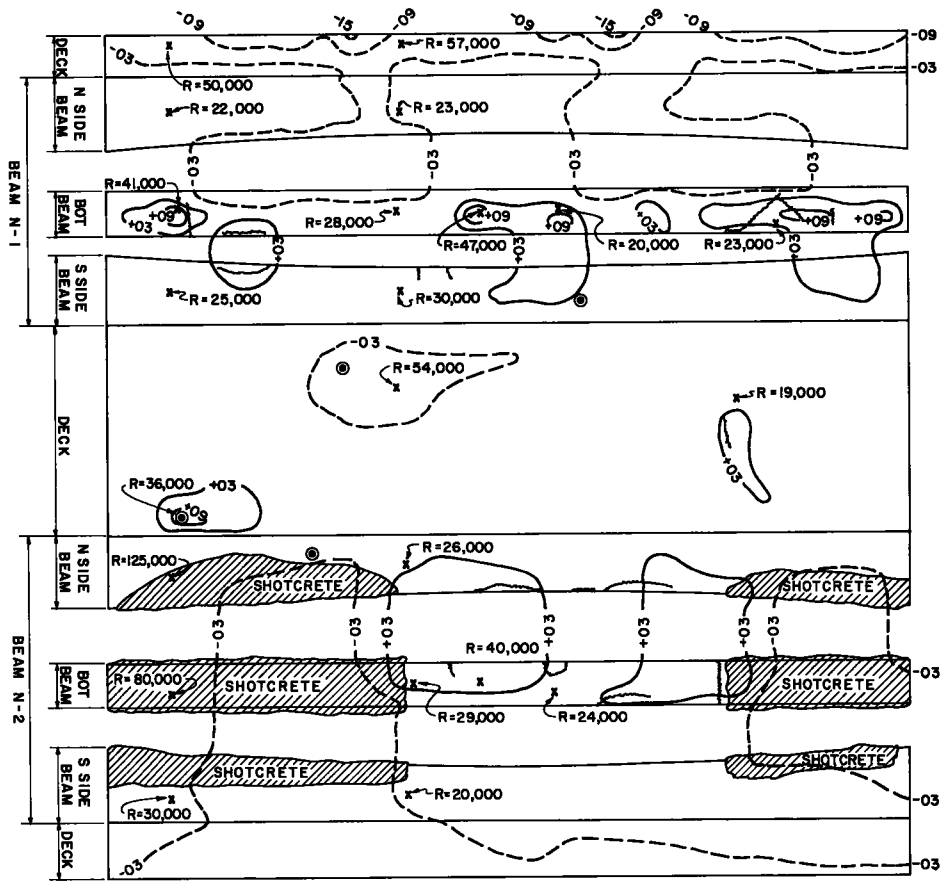
Figure 16. Equipotential contours, Span 70.

Figure 16 represents the conditions found in span 70. About 60 percent of the bottom on one beam was repaired with shotcrete in 1951. Cracks have appeared in the remainder of this beam and also in the adjacent beam. These cracks presumably occurred since the beams were repaired. The equipotential contours indicate the measured electrical potentials. The corrosion of the steel occurs in the anodic areas.

It will be noted that the steel in repaired areas is now cathodic to the steel in the

original concrete; presumably the steel that is now encased in shotcrete was in an anodic area before the repair. Anodic areas are present at locations adjacent to the shotcrete and elsewhere in the beams where cracking has occurred. Two anodic areas have developed in the deck slab and may be the result of creating cathodic areas within the shotcrete or the loss of the previously anodic location. Anodes are present in the caps and piles, including portions that have been repaired with shotcrete. The average resistivity of the concrete in the anodic areas is 30,000 ohm-cm, and in the cathodic areas 54,000 ohm-cm.

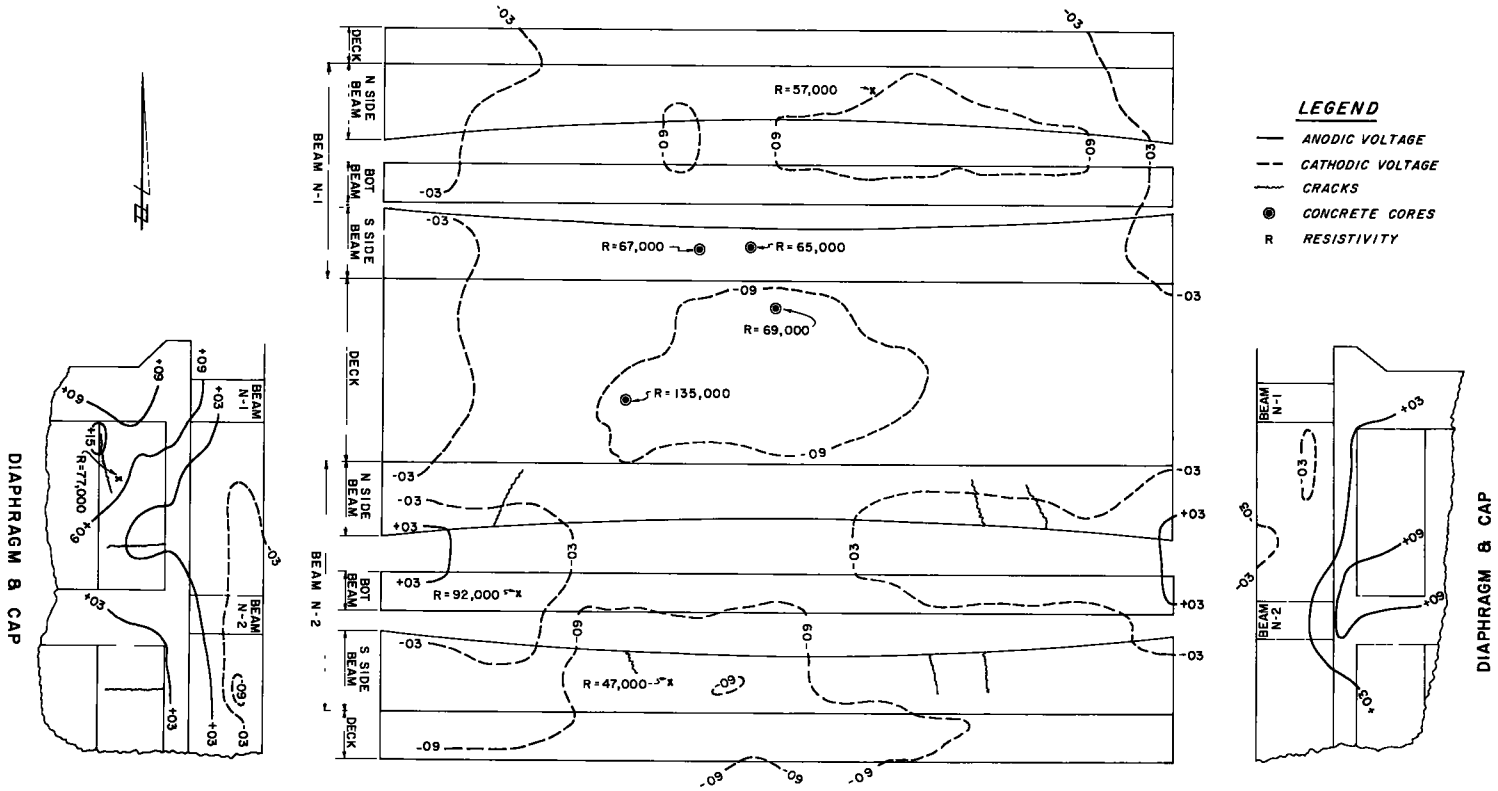
Figure 17. Equipotential contours, Span 163.

Figure 17 represents span 163, which is adjacent to the steel lift span section and is higher above the bay than other concrete spans. The deck unit is free from longitudinal cracking, although there are faint or embryo anodes starting at the ends of one beam. Otherwise, no strong corrosion cells are indicated by the electrical measurements in this deck unit. There are strong anodes in the diaphragms and caps, and

cracks in the concrete were observed in one diaphragm. The resistivity, measured in cathodic areas, averages 76,000 ohm-cm.

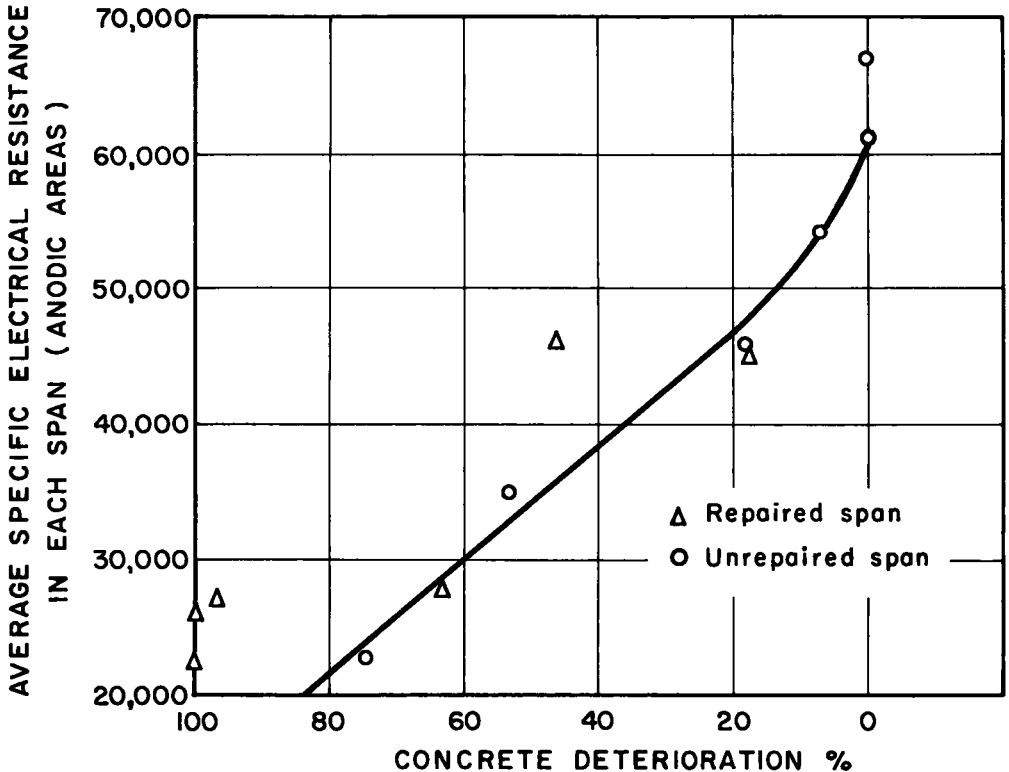
Figure 19. Specific electrical resistance against concrete deterioration.

Figure 19 is a plot of deterioration against resistivity at anodic areas. The general trend is that increasing resistivity is accompanied by decreasing deterioration. Resistivity of 60,000 ohm-cm apparently is required to inhibit or prevent the start of accelerated corrosion in this concrete.

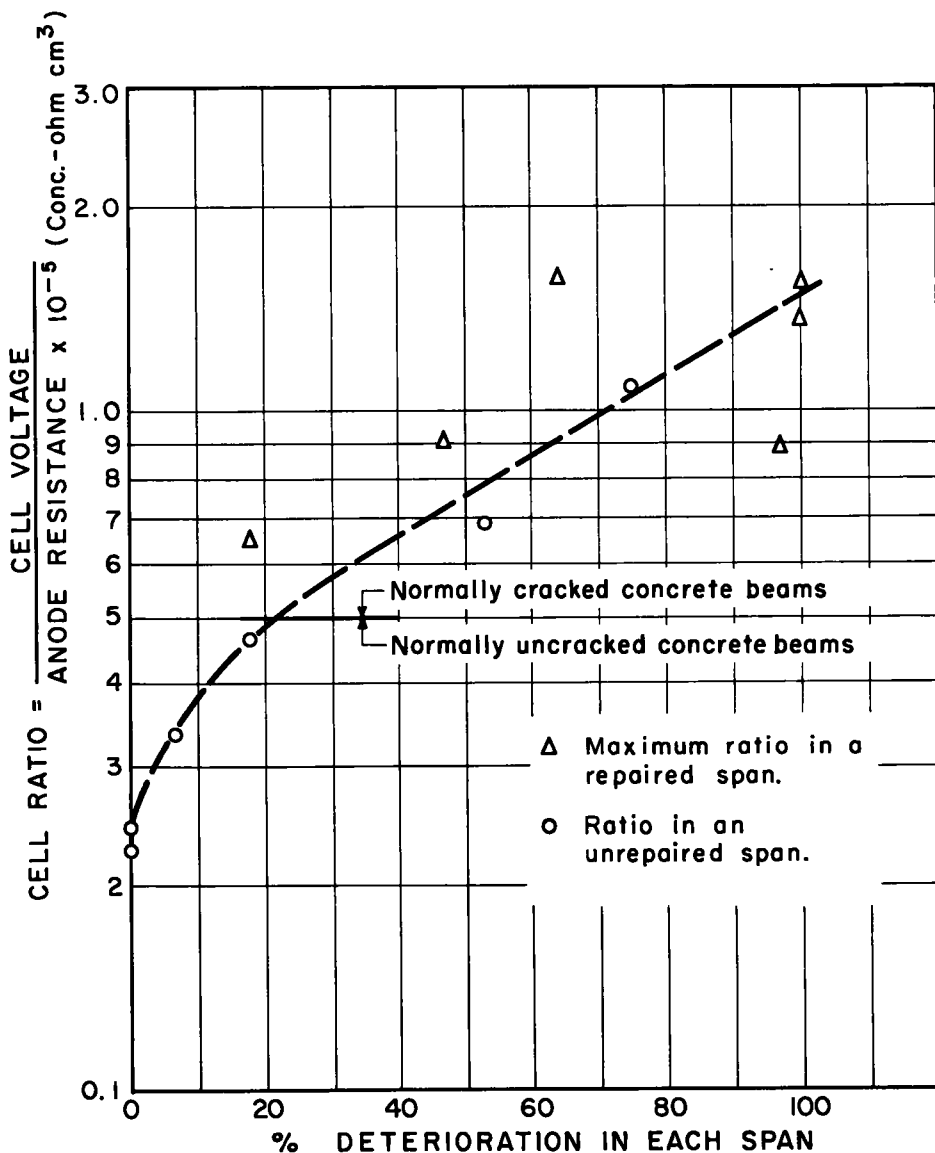
Figure 20. Corrosion cell ratio against concrete deterioration.

ity. Figure 20 is a plot of deterioration in the several spans against the ratio  $\frac{\text{potential}}{\text{resistivity}}$ , which for convenience has been designated as the "cell ratio." The value of potential used in the cell ratio is the maximum voltage differential between the cathode (which is generally in the deck) and the anode (which is generally in a beam). The resistivity value of the concrete used in this ratio was measured at anodic areas.

The curve indicates that there is a definite relationship between the cell ratio and de-
