Evaluation of Pulse Velocity Tests

BAILEY TREMPER, Supervising Materials and Research Engineer, California Division of Highways, Sacramento

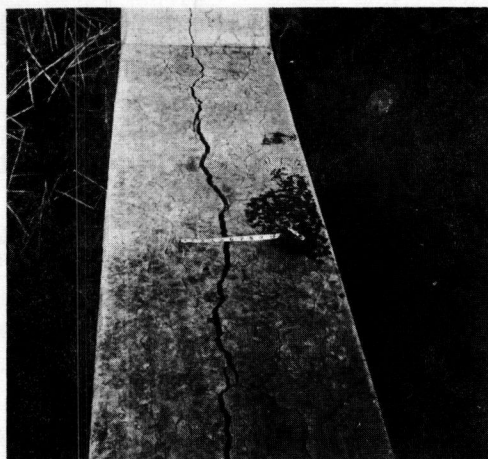
Figure 1. Crack in top face of bridge strut, December 1953.

A horizontal strut between columns of the Pismo Beach structure was observed to have a longitudinal crack which in 1953 had a surface width of $\frac{3}{4}$ in. The depth of the crack estimated from pulse velocity measurements at various distances was 6 in. In 1955, the surface width of the crack had increased to $1\frac{1}{2}$ in. and its depth was estimated to be 28 in. Top and side view of this strut are shown in Figures 1, 2, and 3.

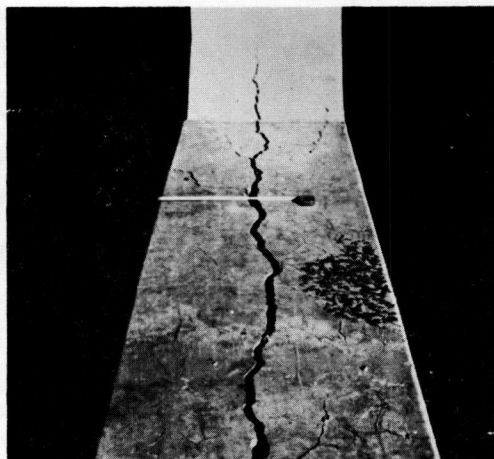
Figure 2. Same view as Figure 1, November 1955.

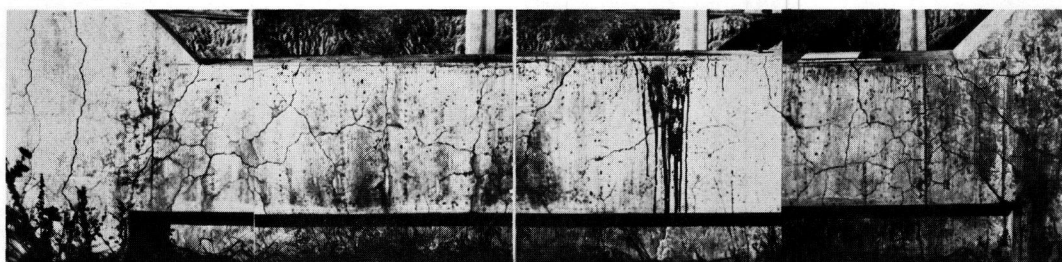
Figure 3. Side of strut shown in Figures 1 and 2.
