A Ten-Year Report on the Illinois Continuously-Reinforced Pavement

J. D. LINDSAY, Engineer of Materials,
Illinois Division of Highways, Springfield, Illinois

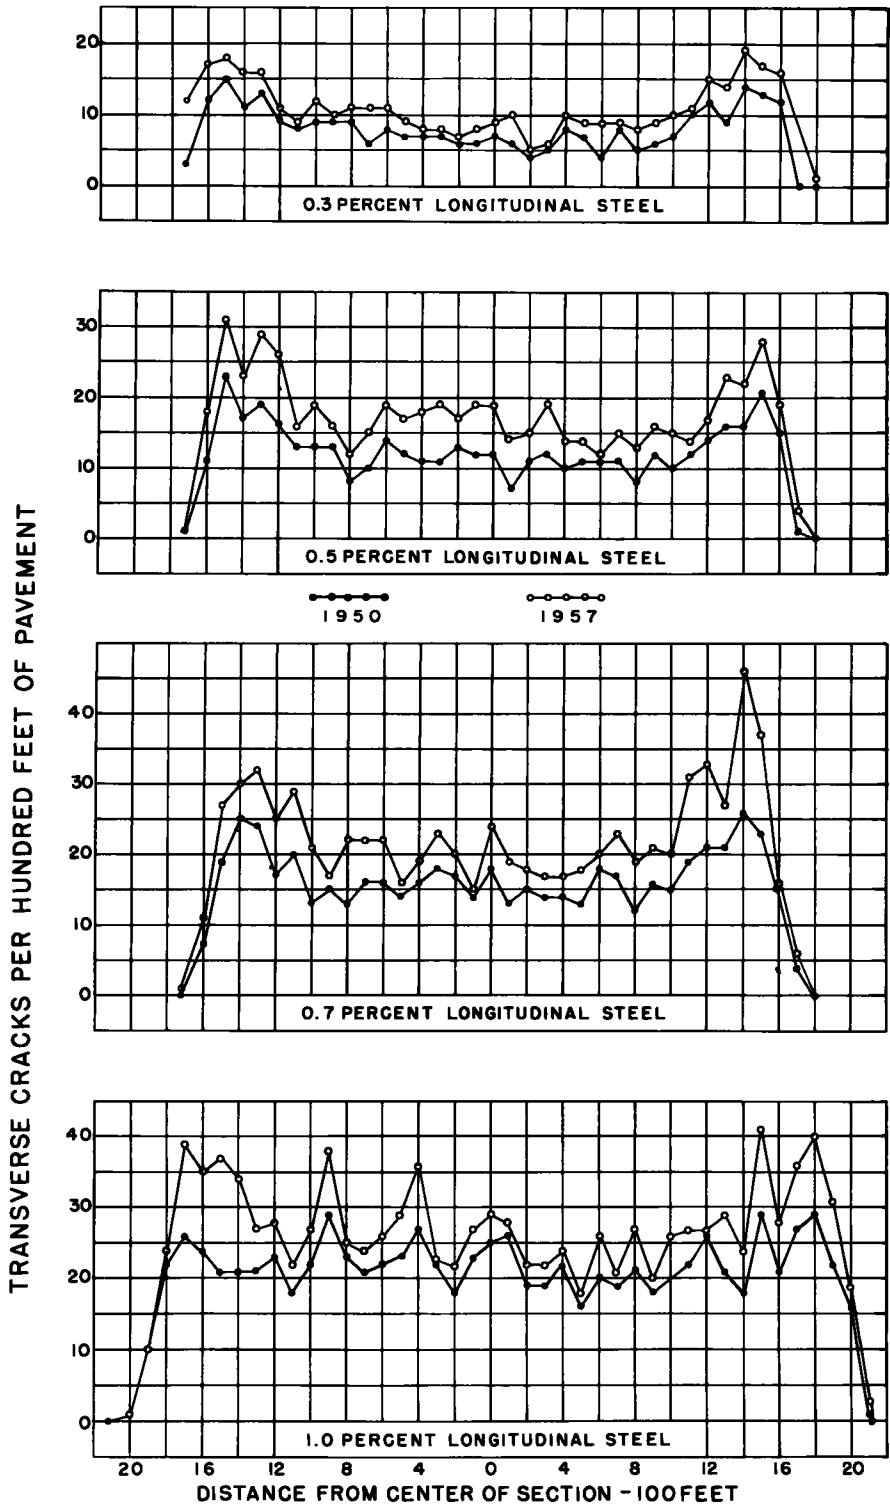
Figure 1 shows the distribution of cracking throughout each of the sections of 7-in. pavement at the age of 3 years and again at 10 years. It will be seen that in 1950 and 1957 the frequency for successive 100-ft increments increased at a reasonably uniform rate from the ends of the slab to a maximum at a distance ranging from 200 to 500 ft from the ends, then decreased uniformly for several hundred feet, and finally became fairly stable over the central 1,600 to 2,000 ft.

Figure 1. Comparison of frequency distribution of transverse cracks for all sections, 7-in. pavement, 1950 and 1957.

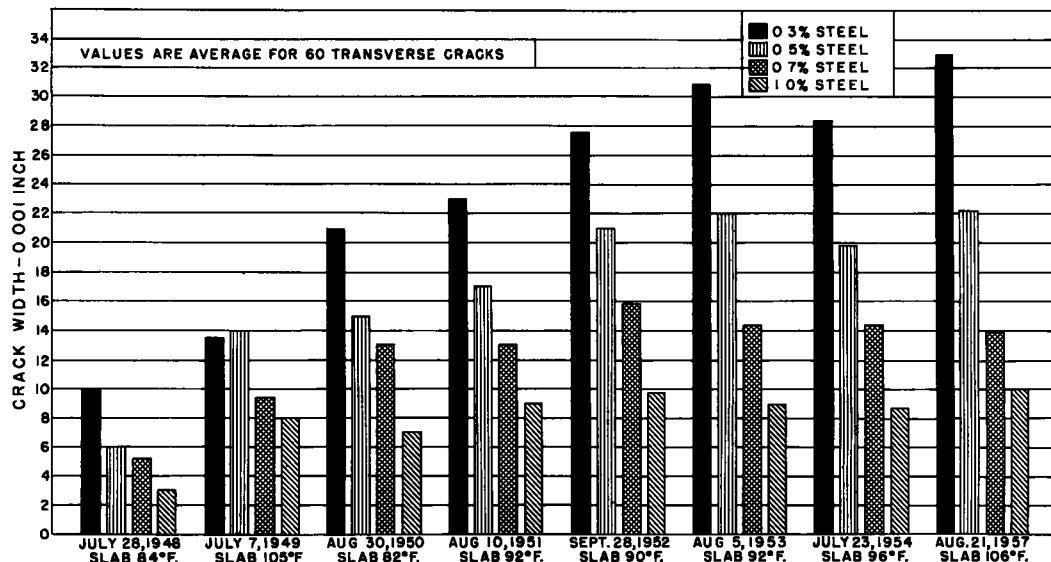
Figure 4. Effect of amount of longitudinal reinforcing steel on width of representative cracks, 7-in. sections.

It is readily apparent from these charts that the cracks have become wider with time and also that the influence of time is less in the more heavily reinforced sections. In the 9 years since the first measurements were made on the 7-in. sections, the average crack width in the 0.3 percent section has been increased by 0.023 in. ; that in the 0.5 percent section by 0.016 in. ; that in the 0.7 percent section by 0.009 in. ; and that in the 1.0 percent section by 0.006 in.

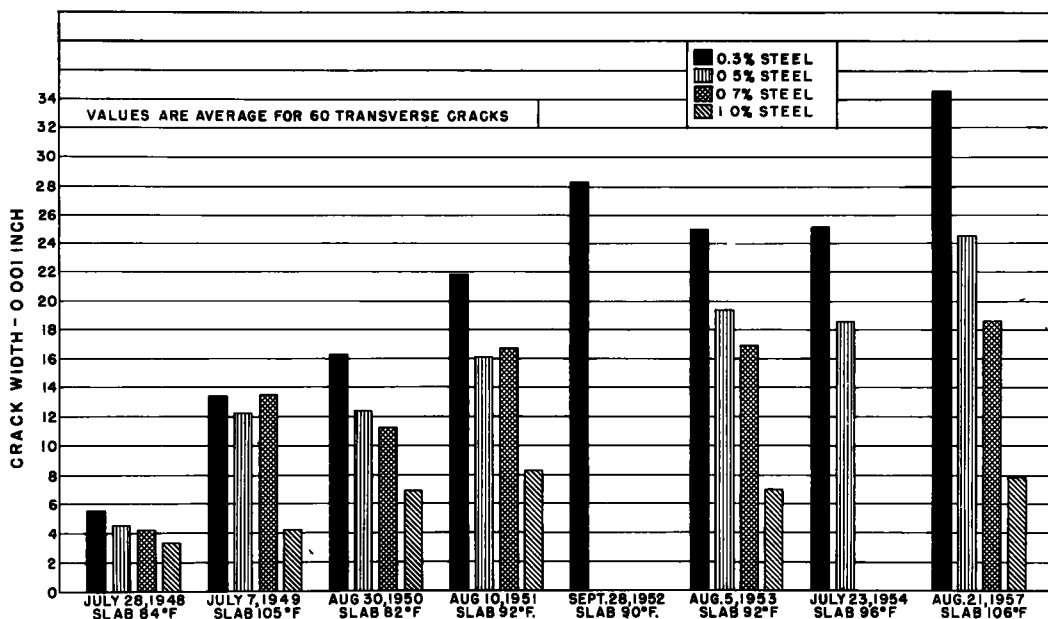
Figure 5. Effect of amount of longitudinal reinforcing steel on width of representative cracks, 8-in. sections.

The corresponding values for the 8-in. pavement are 0.028 in. for the 0.3 percent steel; 0.020 in. for the 0.5 percent steel; 0.014 in. for the 0.7 percent steel, and 0.0045 in. for the 1.0 percent steel. Except for the section with 1.0 percent steel, the cracks in the 8-in. pavement have shown greater increase in width than those in the 7-in. pavement. The probable reason for this is that 7-in. sections, being built in the fall of 1947, were on the average approximately 6 months older than the 8-in. sections (except Section 7 with 1.0 percent steel, which was also built in 1947) when the initial readings were taken. This difference in age may account for the crack widths at the time of the initial readings being greater in the 7-in. pavement than in the 8-in. pavement.

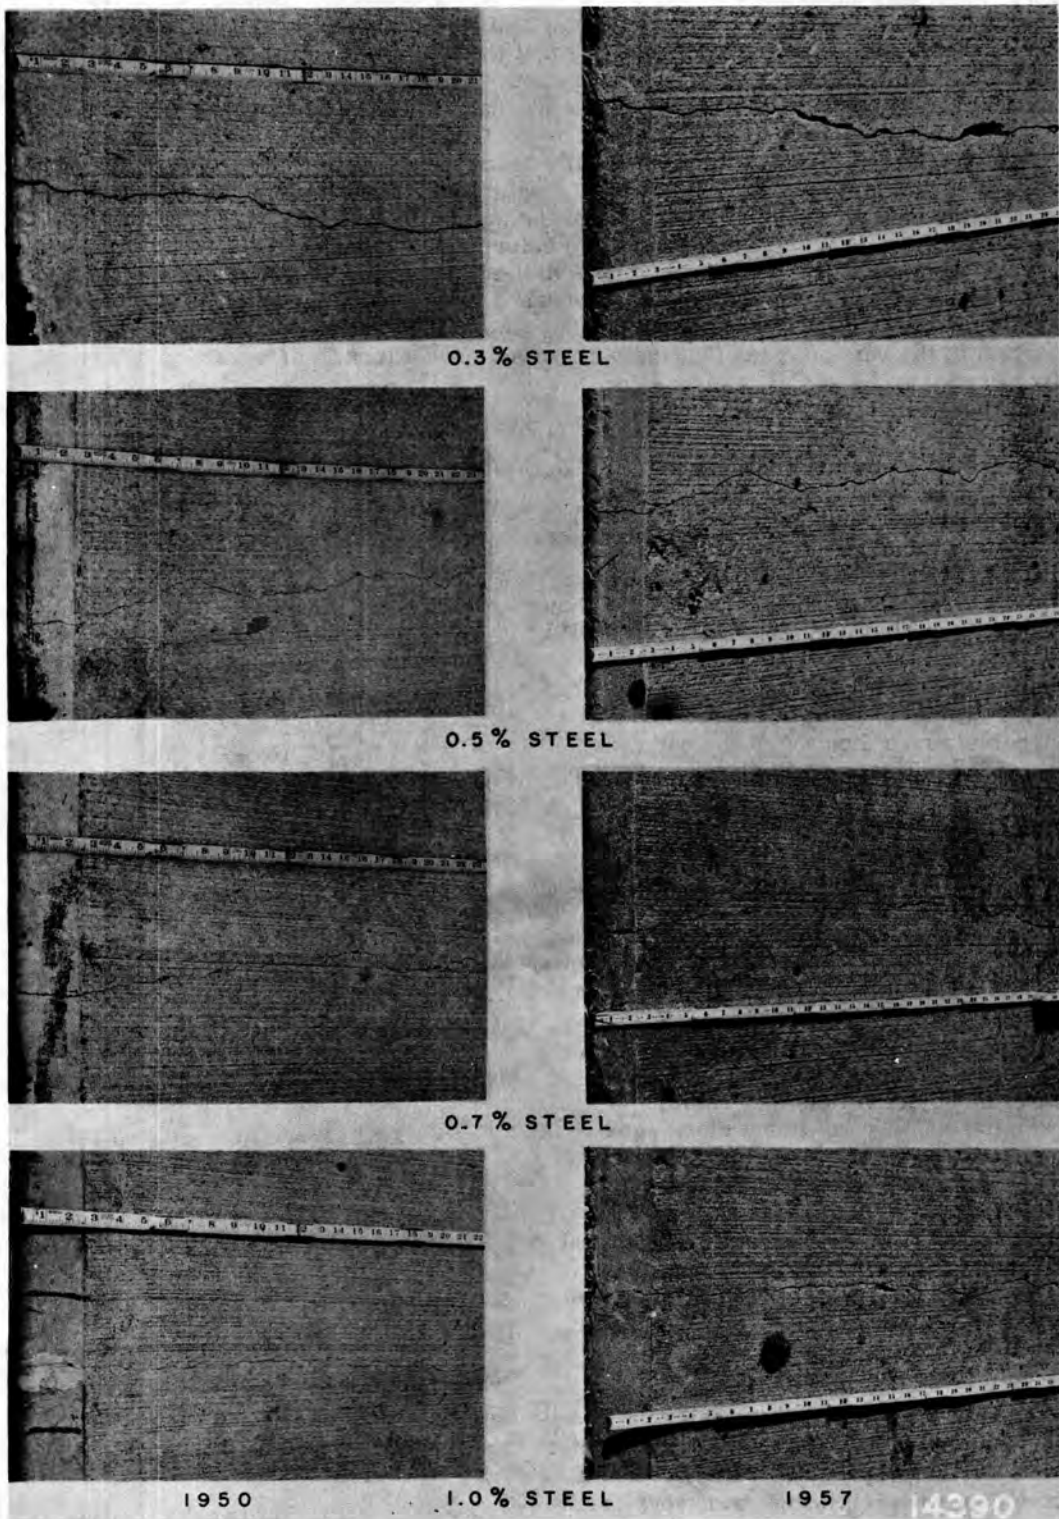
The appearance of the cracks for the most part is good. Although there has been some raveling along the edges, their appearance is by no means unsightly, even on close inspection. In fact they are not visible from a vehicle travelling 30 mph, except at a few locations where maintenance forces, misunderstanding instructions, poured a number of cracks with asphalt. Figure 6 shows a typical crack in each section of 7-in. pavement at the age of 3 years and the same cracks when the pavement was approximately 10 years old.

Figure 6. Typical transverse cracks in 7-in. sections, 1950-57.

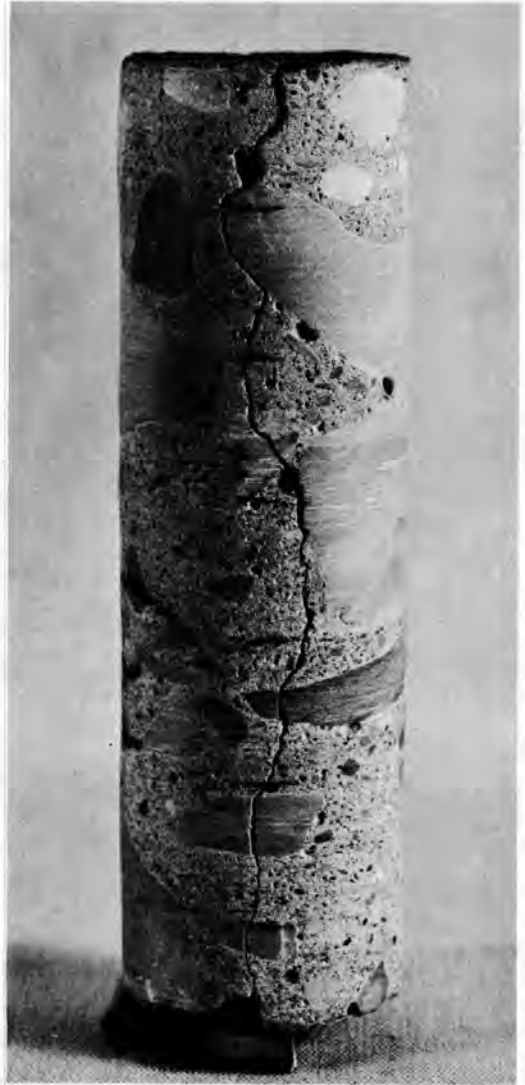
Although there are a number of these wide cracks in the 0.3 percent sections, they are by no means representative. To check on the condition of the steel at a more representative crack, a 2-in. core was taken so as to intersect a bar at a crack just 13 ft from the one in which the steel was broken. The crack width at the depth of the steel was approximately 0.015 in. and the bar appeared to be tightly bonded in the concrete, even in the region of the crack, in spite of the presence of a sizeable air void on top of the bar near the crack. This core is shown in Figure 7.

Figure 7. Core through representative transverse crack in 7-in. pavement with 0.3 percent steel.

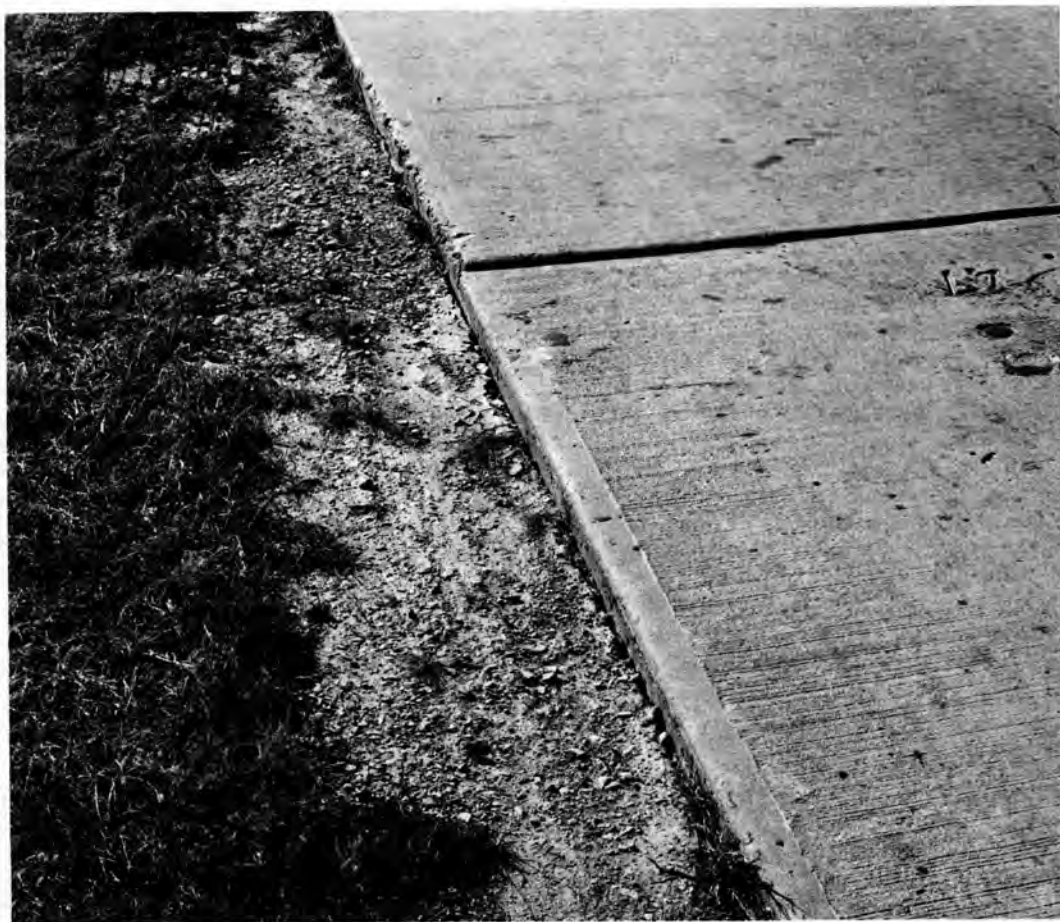
A little edge pumping away from expansion joints and construction joints has been observed in some sections, particularly those with 0.3 and 0.5 percent steel. This pumping is not extensive or severe and does not seem to have affected the performance

Figure 8. Edge pumping near construction joint in 7-in. pavement with 0.3 percent steel.

of the pavement. It seems to occur particularly where the shoulders have become considerably lower than the pavement surface.

Although pumping has not been a serious problem except at expansion joints and construction joints, some has occurred, and it is recommended that a granular sub-base be used. It is believed that a 3-in. layer would be sufficient to control pumping, but greater depths might be required in some cases to counteract the effect of frost action in frost-susceptible soils.

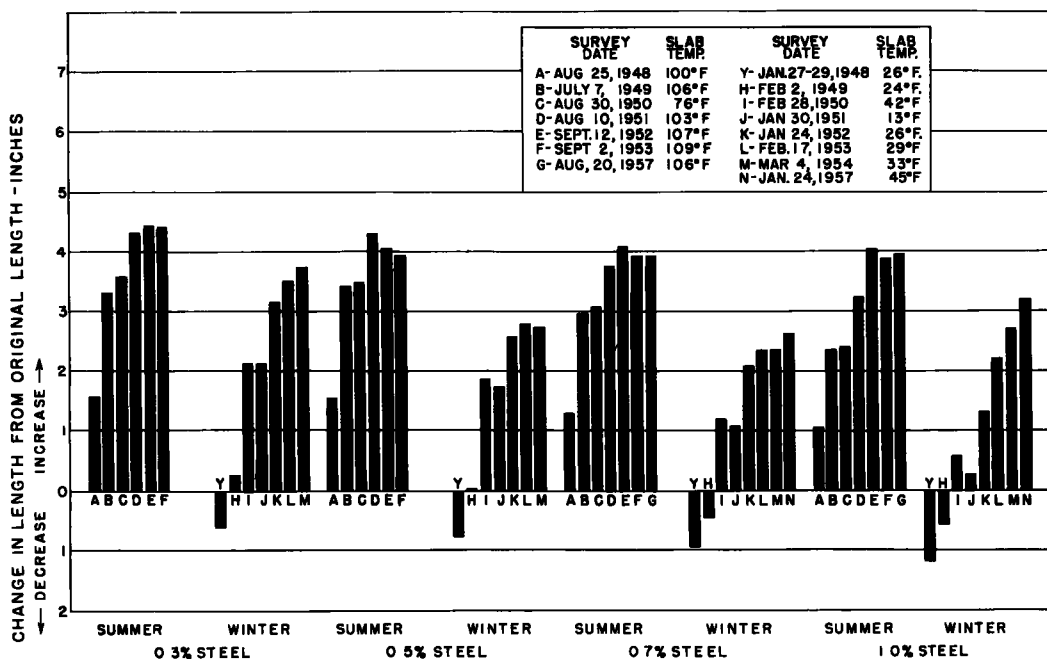
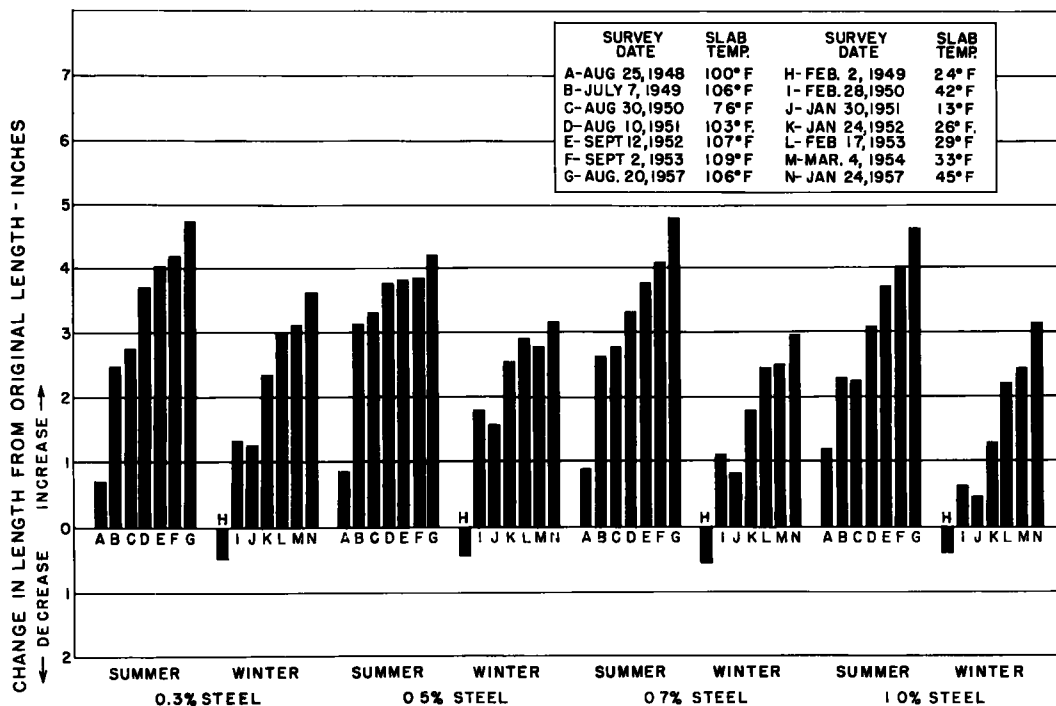
Of more significance, however, is the permanent increase that has occurred in the length of every section. Figures 9 and 10 indicate that all the sections are now on the average approximately 4 in. longer than their original lengths. In the summer of 1957 the expansion joints, which were nominally 4 in. wide when constructed, appeared to be tightly closed. In fact, at several of these joints large spalls have occurred due to localized compression where the joint faces were irregular. Some of these areas were so extensive that major repairs were required.

Figure 9. Seasonal changes in length of 7-in. test sections containing various percentages of reinforcing steel.

Figure 10. Seasonal changes in length of 8-in. test sections containing various percentages of reinforcing steel.
