Ten-Year Report on Experimental Continuously-Reinforced Concrete Pavements in New Jersey

WILLIAM VAN BREEMEN, Research Engineer,
New Jersey State Highway Department

This paper reports on the behavior and performance of two experimental sections of continuously-reinforced concrete pavement constructed in New Jersey in 1947. These sections, each approximately 1 mi long, have been subjected to relatively heavy truck traffic.

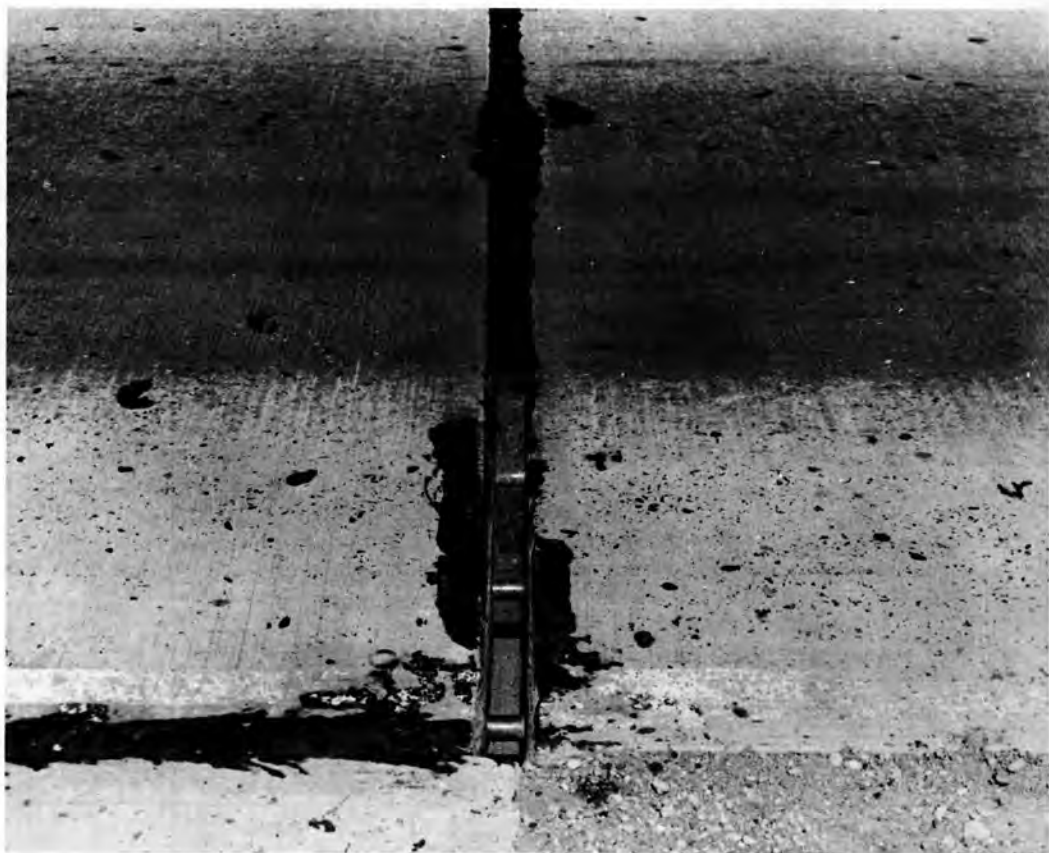
2. The greatest increase in width has occurred at the joint at the south end of the outside lane, which on June 20, 1957, was 1.61 in. wider than at the time of construction, despite a 94F pavement temperature. Conditions at this joint on August 7, 1957, are shown in Figure 3, a portion of the joint space having been cleaned out. As will be noted, the joint space was found to be completely filled with infiltrated sand and gravel, in combination with the cork filler, which had become compressed to the point of refusal. These infiltrated materials were in a highly compacted condition.

Figure 3. Terminal joint at south end of 8-in. section.

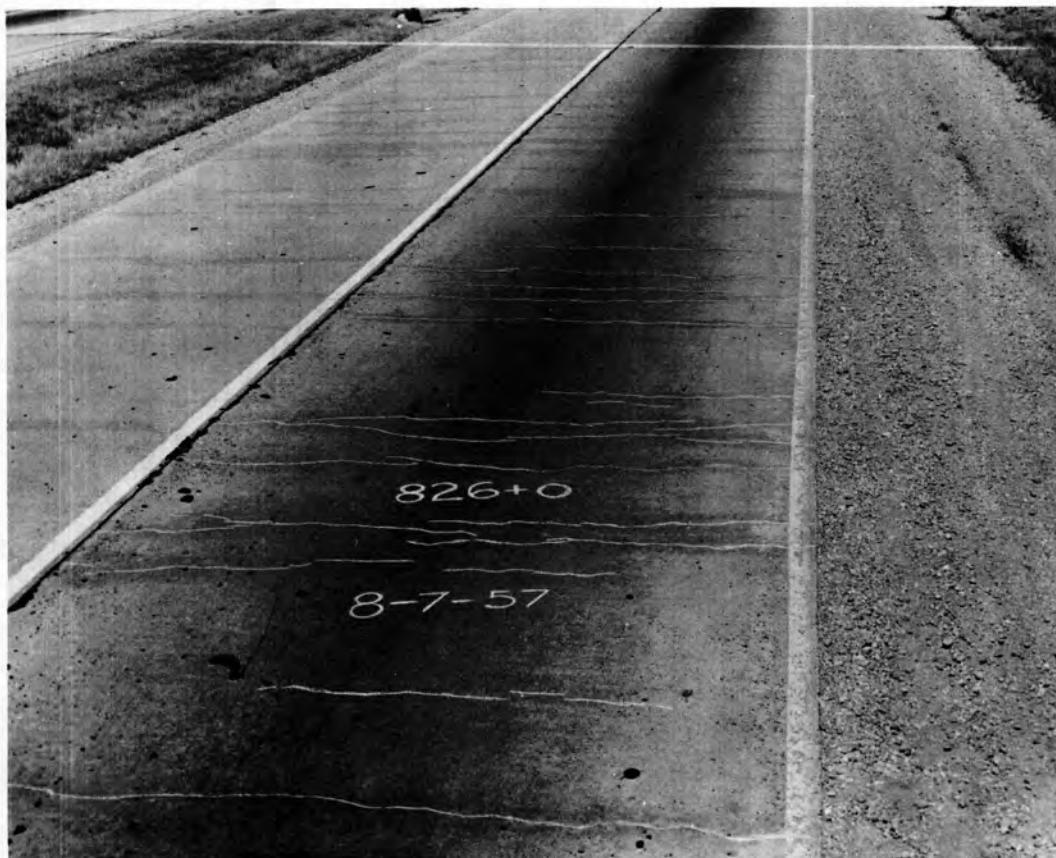
The present typical crack pattern in the 8-in. section is shown in Figure 8, the cracks in the outside lane having been traced with yellow keel, for photographic reasons. This pattern is also typical of the 10-in. section. It will be noted that there are dark streaks across the lanes, especially across the inside lane. These streaks, which are about 4 in. wide and dark grey in color, are coincident with the cracks. Apparently they are due to the exudation of a substance derived from the concrete during wet weather, but the nature of this substance is not known.

Figure 8. Typical crack pattern, 8-in. section.

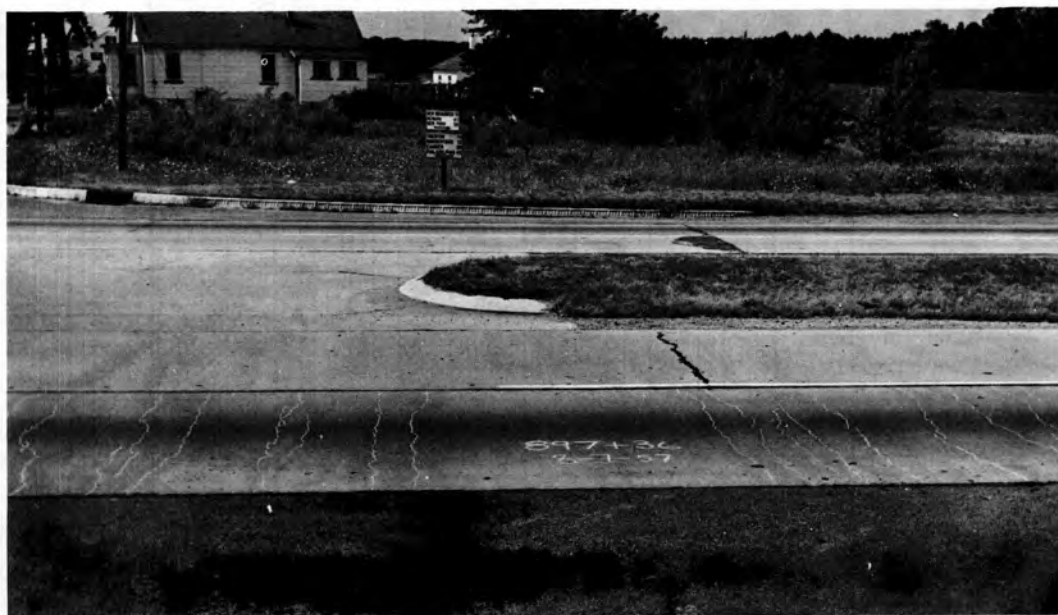
The variable spacing of the cracks is shown in Figure 9, the lane in the foreground being the outside lane of the 10-in. section approximately 1,800 ft from the north end.

Figure 9. Variable crack spacing, 10-in. section.

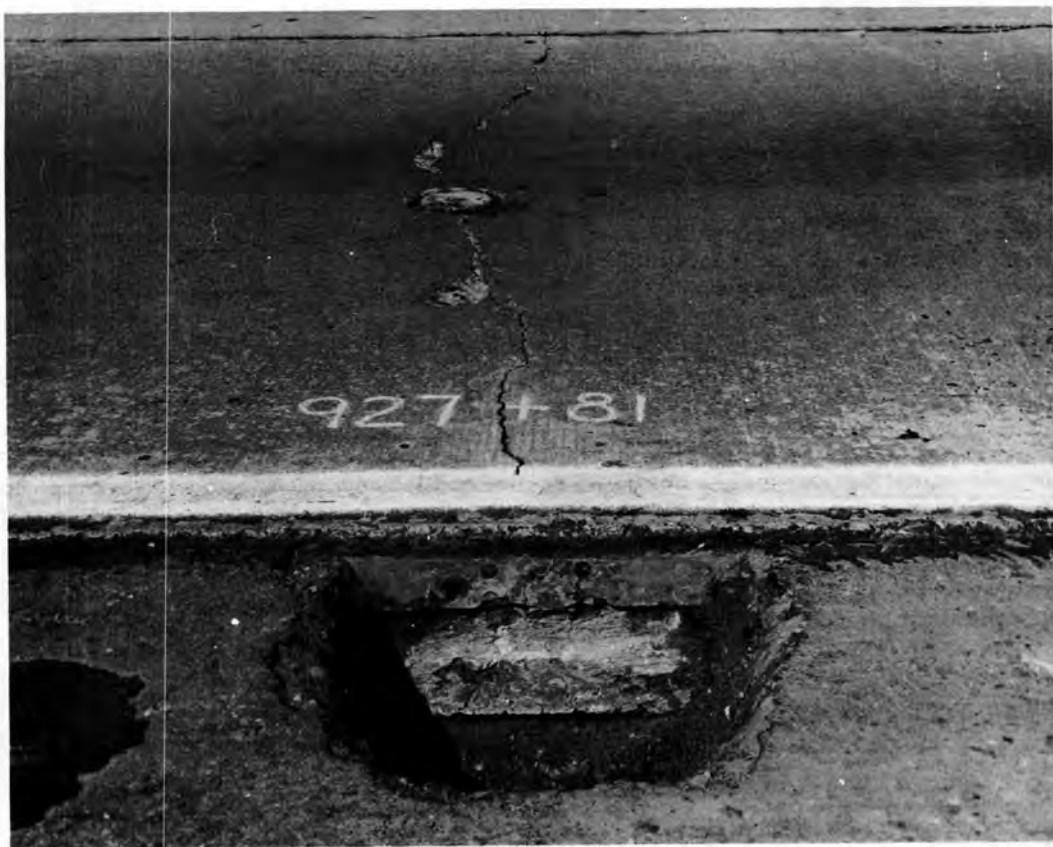
Figure 10 shows one of the wider cracks in the outside lane of the 10-in. section, and the exposed shoulder edge of the pavement. It also shows the location of the core obtained at this crack.

In this instance the upper line of steel was found to be 6 in., instead of the specified 2 in., below the surface. This however, is apparently a localized condition, because it was not found to be anywhere near the same degree in connection with the other cores. At any rate, during the drilling operations the core broke in two at this line of steel, and there was a general breaking-up of the concrete for about the next inch. The lower 3 in. of the core remained intact, however, and in this portion the crack was of only microscopic width. From a careful inspection of the entire core it appears that this crack was of appreciable width clear down to the upper line of steel. It therefore seems that installing the steel a considerable distance below the surface might tend not only to promote wide cracks at the surface, but also to promote wide cracks of appreciable depth. Incidentally, measurements show that this crack is not at a hump in the grade line.

Figure 10. Crack in 10-in. section, Sta. 927+81.

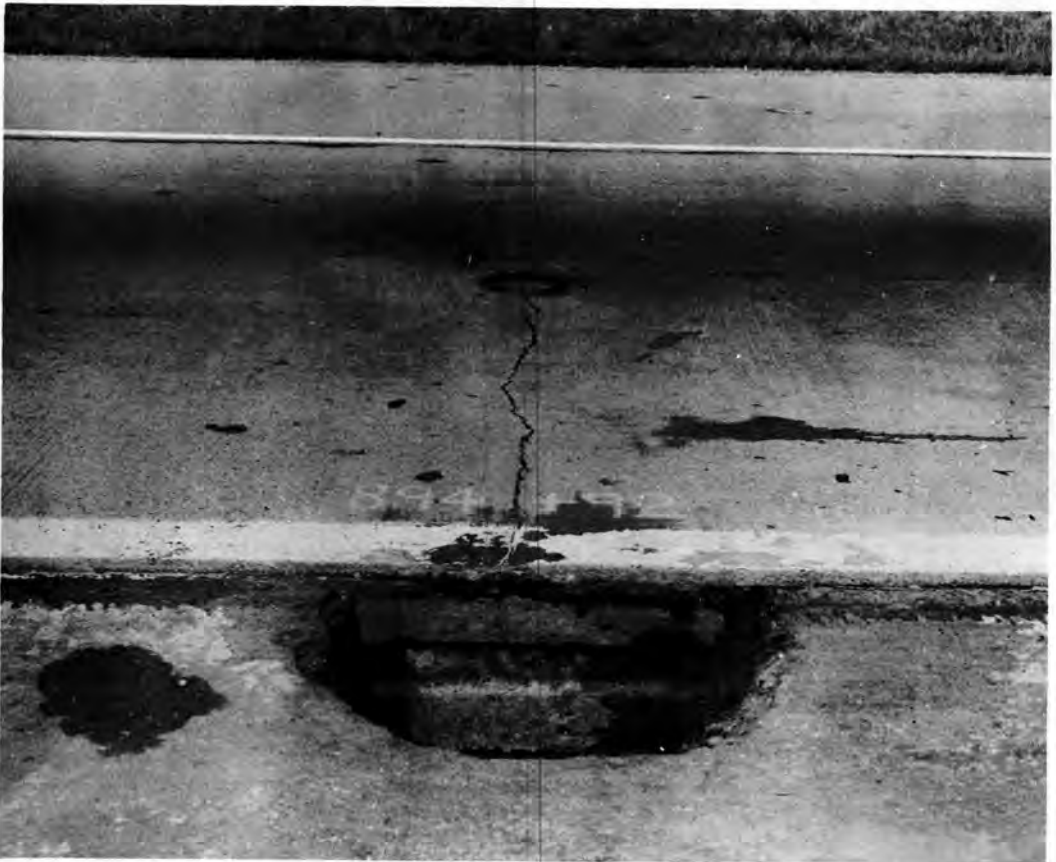
Figure 11 shows a crack and the exposed edge of the pavement at 894+92 in the outside lane of the 10-in. section, the difference in crack width at the surface and in the lower portion of the pavement being clearly apparent.

Figure 11. Crack in 10-in. section, Sta. 894+92.

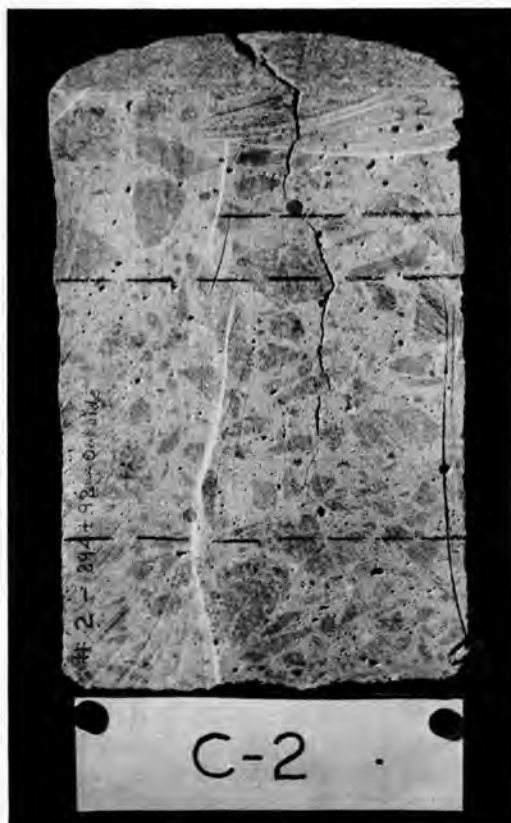
The core (C-2) obtained at this crack is shown in Figure 12, the location of the steel

Figure 12. Core at crack in 10-in. section, Sta. 894+92.

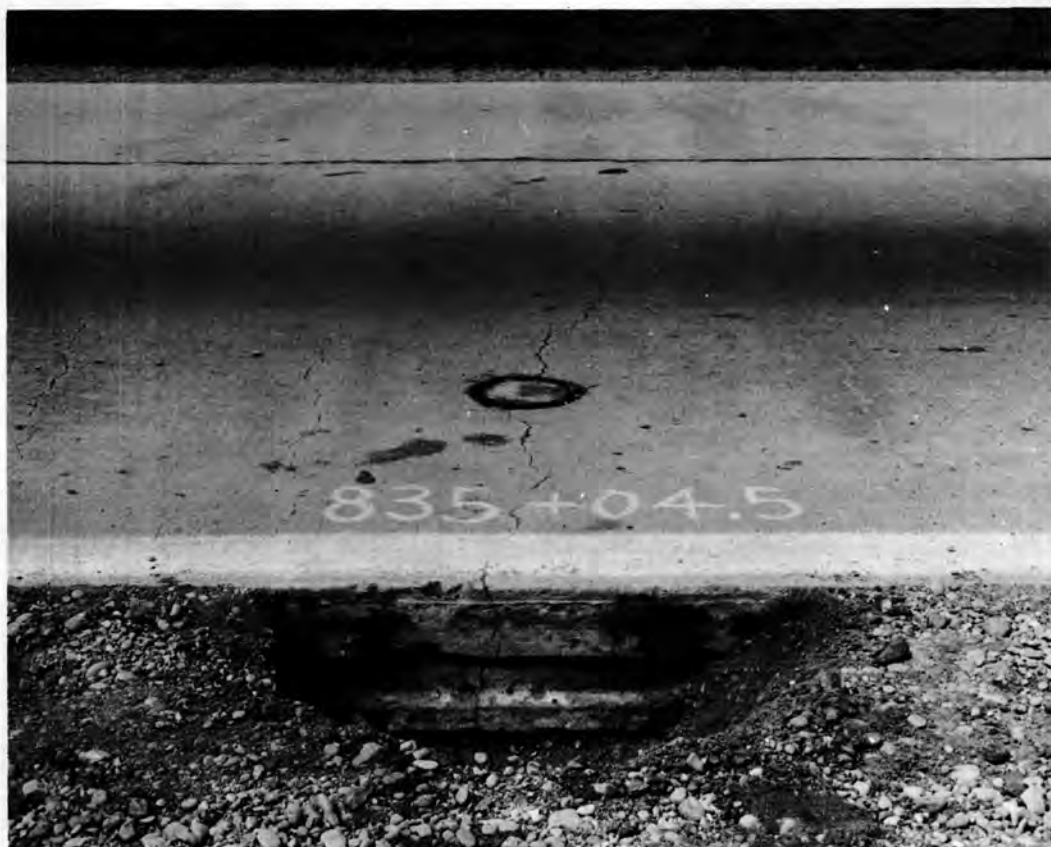
Figure 15 shows a crack and the exposed pavement edge at 835+04.5 in the outside lane of the 8-in. section.

Figure 15. Crack in 8-in. section, Sta. 835+04.5.

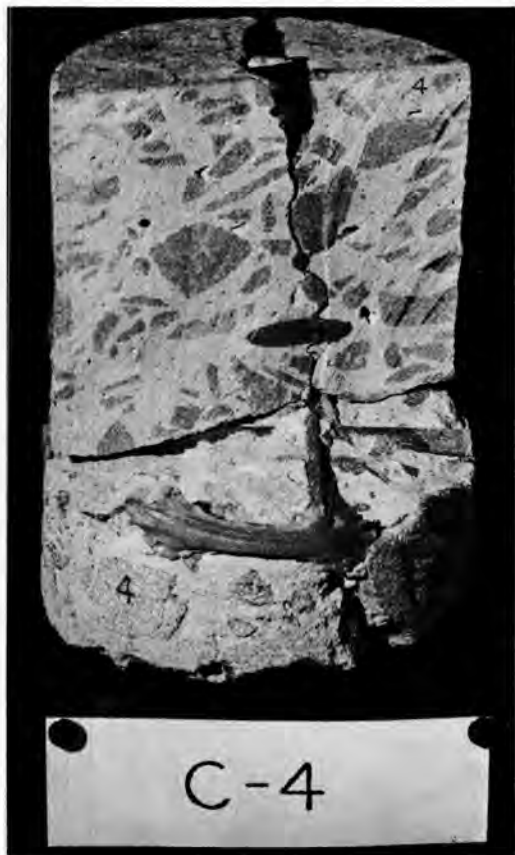
Figure 18 shows a core (C-4) obtained at a badly ravelled crack, which had been sealed, about 4 ft north of a construction joint at 849+34 in the outside lane of the 8-in. section. This core broke in two during the drilling operations. As will be noted, the crack is quite wide in the upper third of the pavement (above the upper line of steel). In the lower two-thirds, however, the crack was found to be only about 0.01 in. wide. It is apparent that the conditions at this crack are none too good. In addition to rather serious raveling at the pavement surface, appreciable rusting was found in connection with the lower line of steel, especially of the transverse member.

Figure 18. Core at crack near construction joint, 8-in. section.

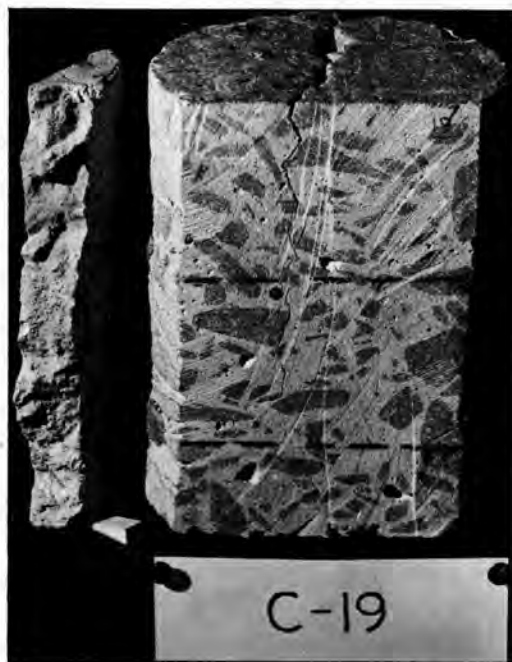
Figure 17 shows a core (C-19) obtained at a ravelled crack at 823+08 in the outside lane of the 8-in. section, and also shows a thin slice of concrete sawed from the side of the core. In this instance the slice did come apart at the crack. Despite the extreme narrowness of this crack in the lower portion of the core, the cracked surfaces were discolored for the full depth of the pavement. Moreover, the crack contained what appeared to be very finely divided silty materials, from brown to almost black in color. Similar materials, incidentally, were found in all of the cracks examined.

Figure 17. Core at crack in 8-in. section, Sta. 823+08.

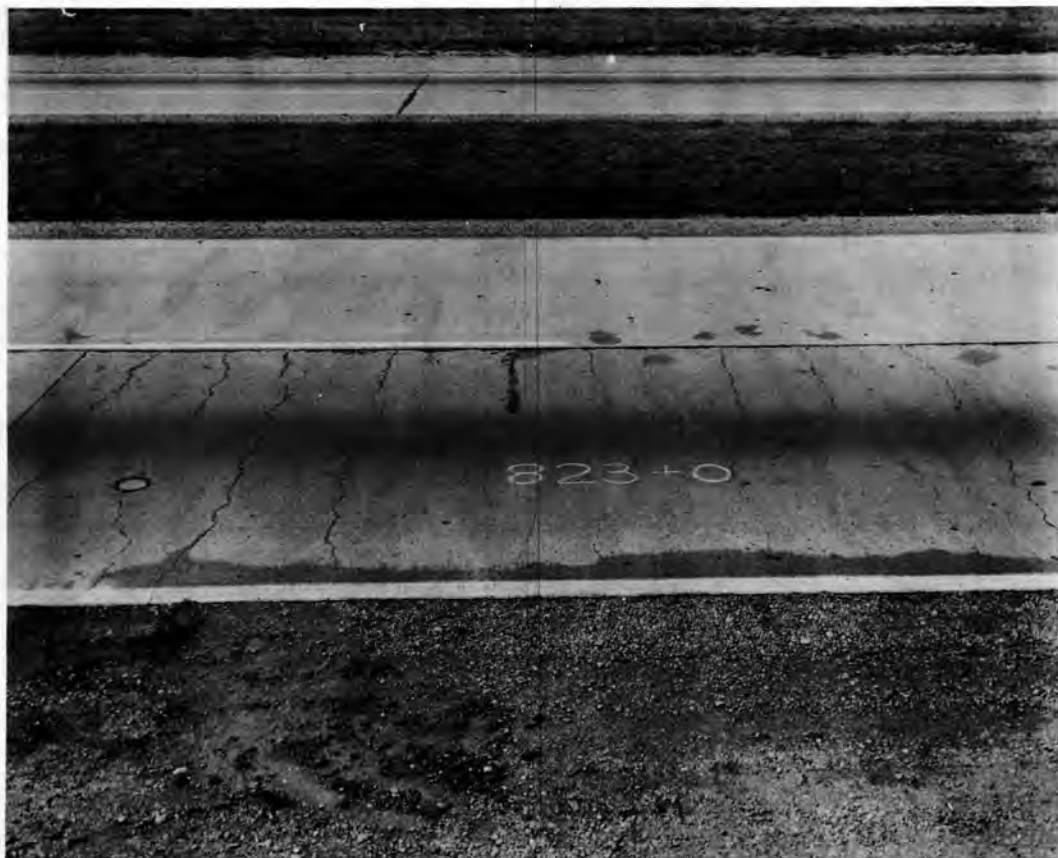
Rather severe cracking has occurred, however, in the immediate vicinity of several of these joints, for a distance of 20 ft or more, but only on the northerly side. (Construction was from south to north.) The severity of this cracking is shown in Figure 19, the construction joint being about 3 ft to the left of the core hole. But despite what would appear to be the very poor condition of the pavement, no failures other than excessive ravelling at some of the cracks have occurred in any of these areas. As suggested previously, the reason for the absence of failure appears to be that the cracks are much narrower in the lower portion of the pavement than at the surface.

It is generally believed that the difference in cracking on one side of the joint, as compared with the other, has been due primarily to having attached together two sections of pavement which necessarily had, at the time of attachment, materially different tensile strengths.

Figure 19. Cracking near construction joint, 8-in. section.

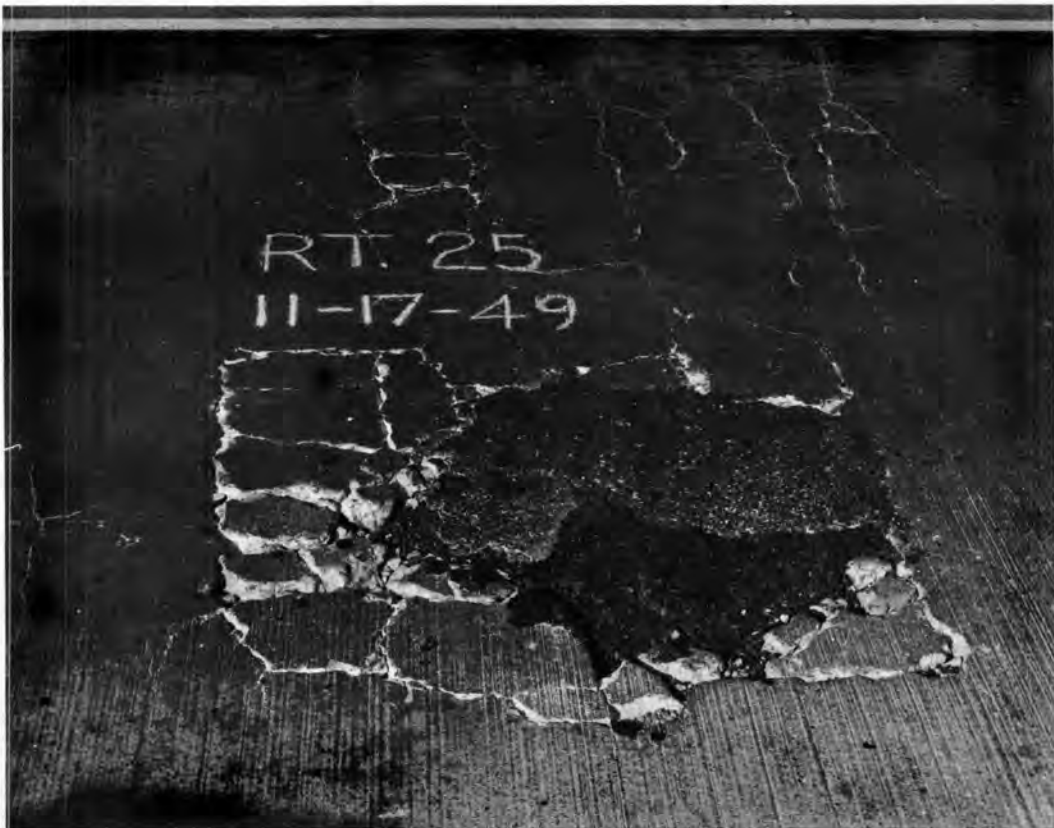
this being evident from severe cracking and the exudation of a whitish-colored substance from the cracks during wet weather. Pictures were taken periodically in this location to obtain a photographic record of the failure as it progressed. Figure 20 shows this failure on November 17, 1949.

The cause of these three failures is unknown. However, there appear to be several possible causes: namely, (a) an excessively wet batch of concrete, (b) a batch of concrete deficient in cement, (c)

poor consolidation of the concrete and resulting inadequate bond with the reinforcing steel, (d) a localized weakness in the subgrade, and/or (e) a horizontal plane of cleavage at the upper line of steel. In addition, a pavement of this design is under a high degree of tension in cold weather, at least during early life, and this tension may have been an important contributory cause.

Figure 20. Failure in 10-in. section, Nov. 17, 1949.

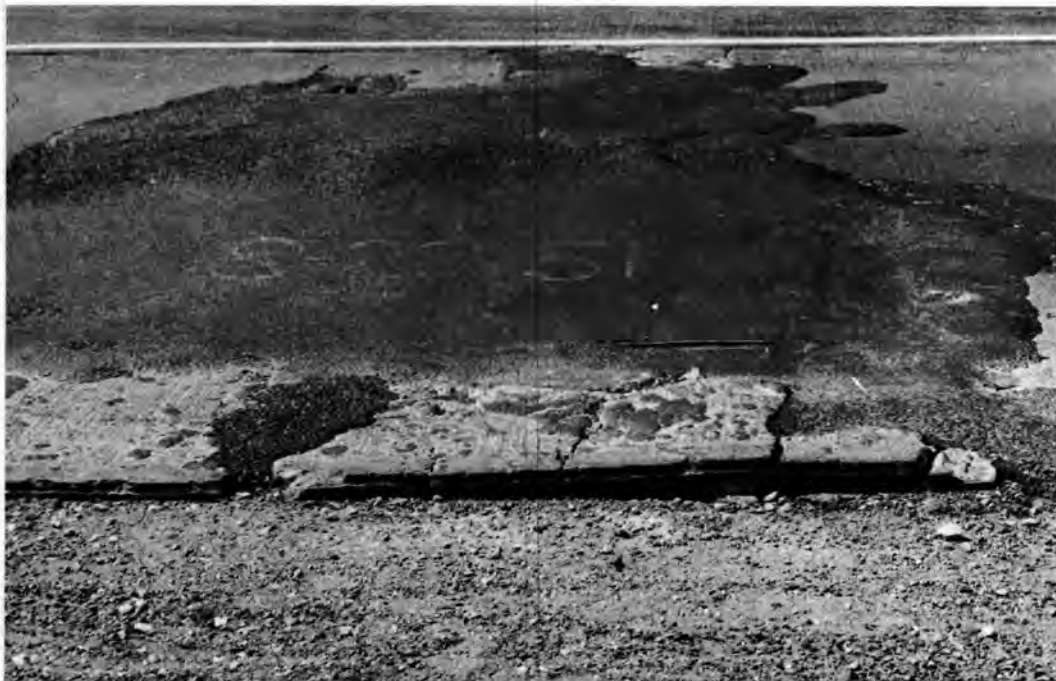
Figure 21. Failure in 10-in. section, Aug. 23, 1951.

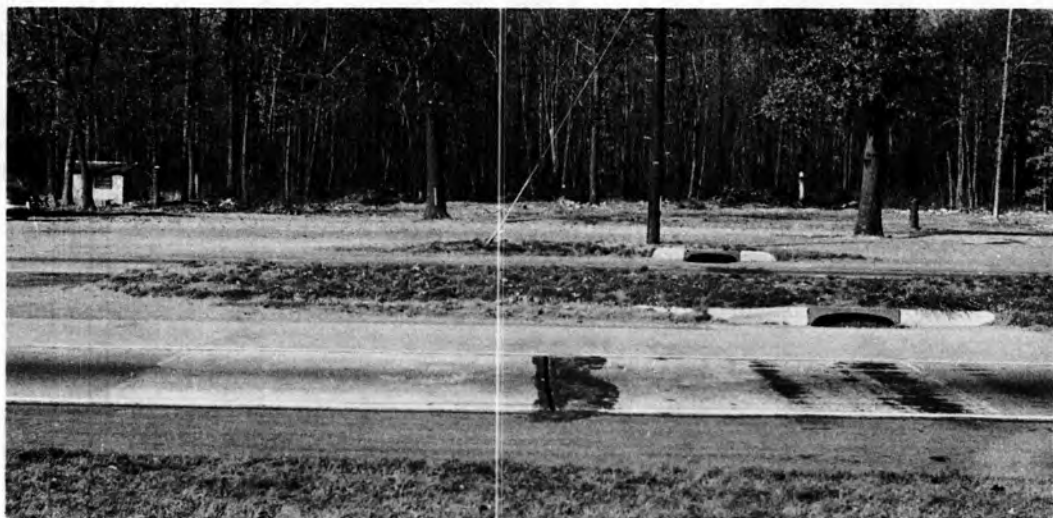
Figure 22. Repaired area, 10-in. section, August 1957.

In October 1954 this area was repaired with concrete, which involved replacement of 25 ft of the lane and installation of a dowelled expansion joint at the center of the repaired area. Figure 22 shows this area in August 1957. The black discoloration on the pavement adjacent to the joint is due to extrusion of a large quantity of joint-sealing compound which had been inadvertently poured into the joint space while in an open condition during cold weather.

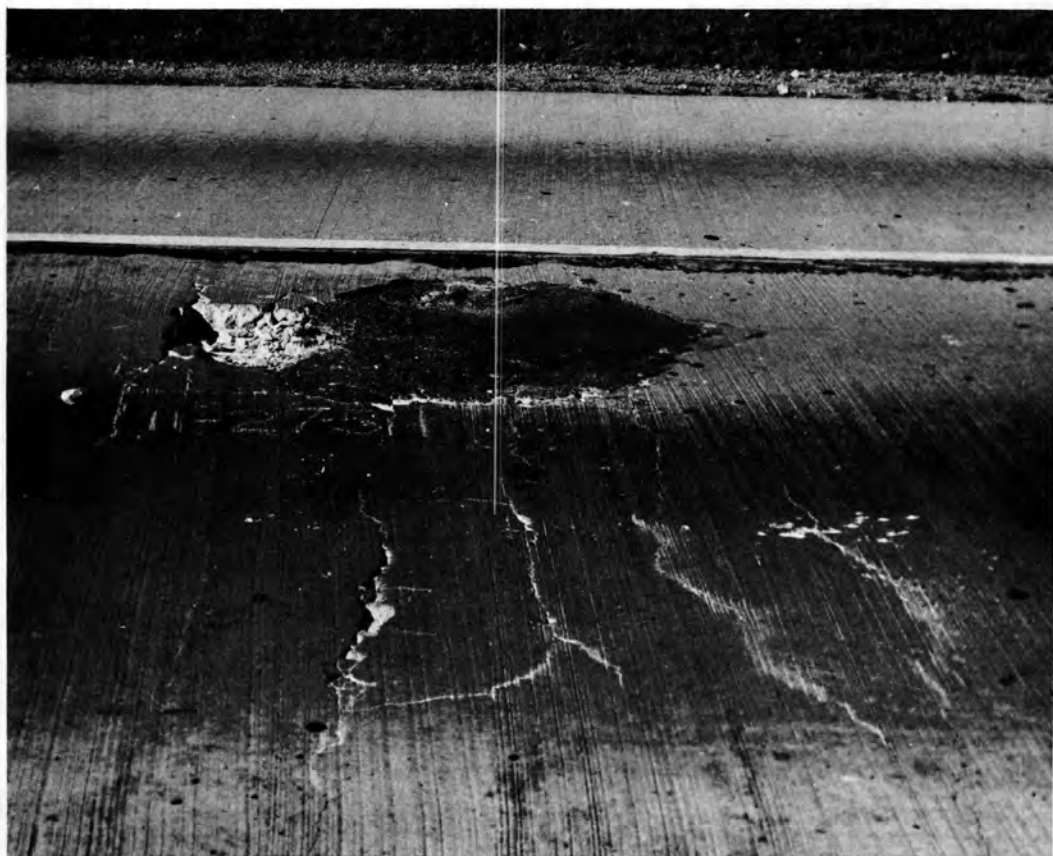
Mention was also made previously of two similar failures which occurred in the outside lane of the 8-in. section. The first of these failures occurred at a point 569 ft from the north end, and first became apparent in May 1951. Conditions at this point

six months later (November 27, 1951) are shown in Figure 23.

Figure 23. Failed area, 8-in. section, Nov. 27, 1951.

In October 1954 the damaged concrete in these areas was removed and replaced with new concrete. In conjunction with this work a dowelled expansion joint with 3/4-in. bituminized-fiber filler was installed at the center of each of these areas. Consequently, since October 1954 the outside lane has consisted of three independent sections (from south to north, 4,861, 197, and 372 ft long). The inside lane, however, is still intact.

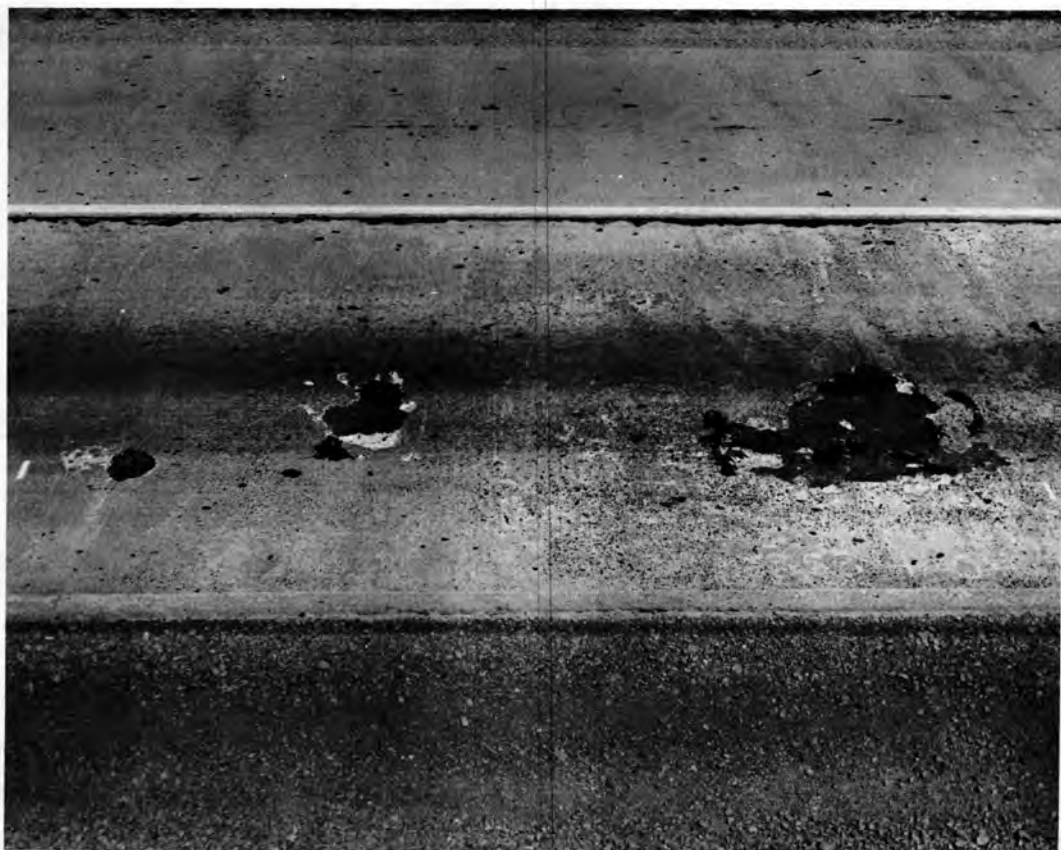
have occurred in the outside lanes, and a localized area in the outside lane of the 8-in. section is undergoing slow deterioration. In addition, there has been rather pronounced ravelling at some of the cracks in the outside lanes of both sections. Because of this ravelling, a few of these cracks have been poured with joint-sealing compound. The inside lanes, on the other hand, are still in first-class condition.

Figure 24. Deteriorating area, 8-in. section.

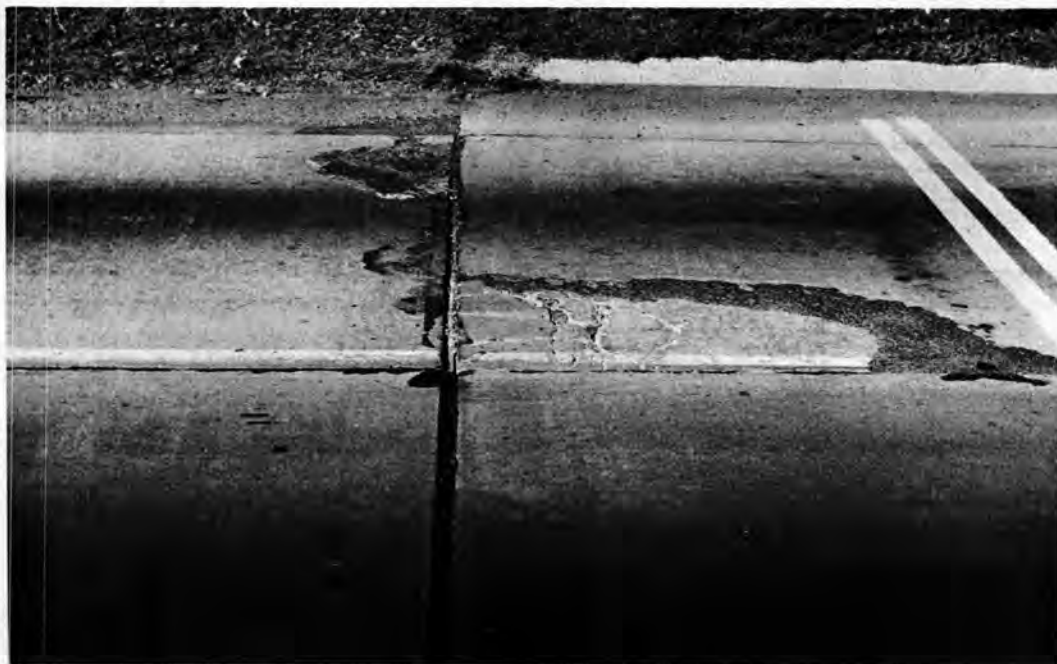
Figure 25. Ruptured terminal joint, 10-in. section, August 1957.
