# Continuously-Reinforced Concrete Pavement in Pennsylvania

F. C. WITKOSKI, Director of Research, and  
R. K. SHAFFER, Materials Engineer, Pennsylvania Department of Highways

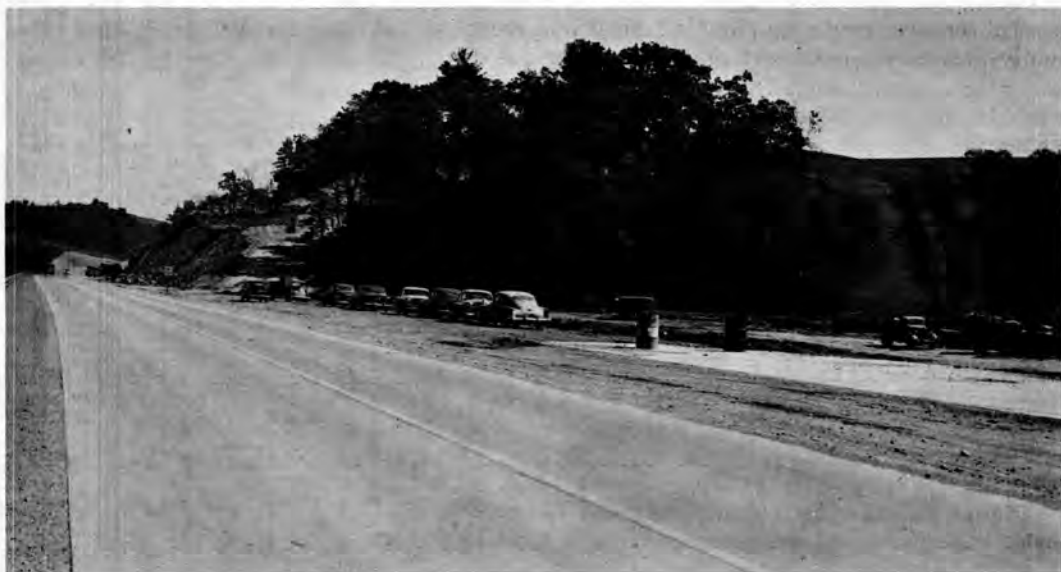
Figure 2. Slide area near Station 246, eastbound lanes.

As mentioned previously, the bulk of the paving was placed in the spring and early summer. In June 1957, however, a serious slide condition developed near station 246,

right, necessitating removal of large quantities of cut material (Fig. 2). As a result, a portion of the eastbound lanes from station 237+05 to 255+00 was not paved until October 1957. The pavement was opened to traffic on August 30, 1957, but eastbound traffic was detoured onto one of the westbound lanes, where one-way traffic was maintained from station 233 to 272. The entire roadway was opened to traffic on November 8, 1957.

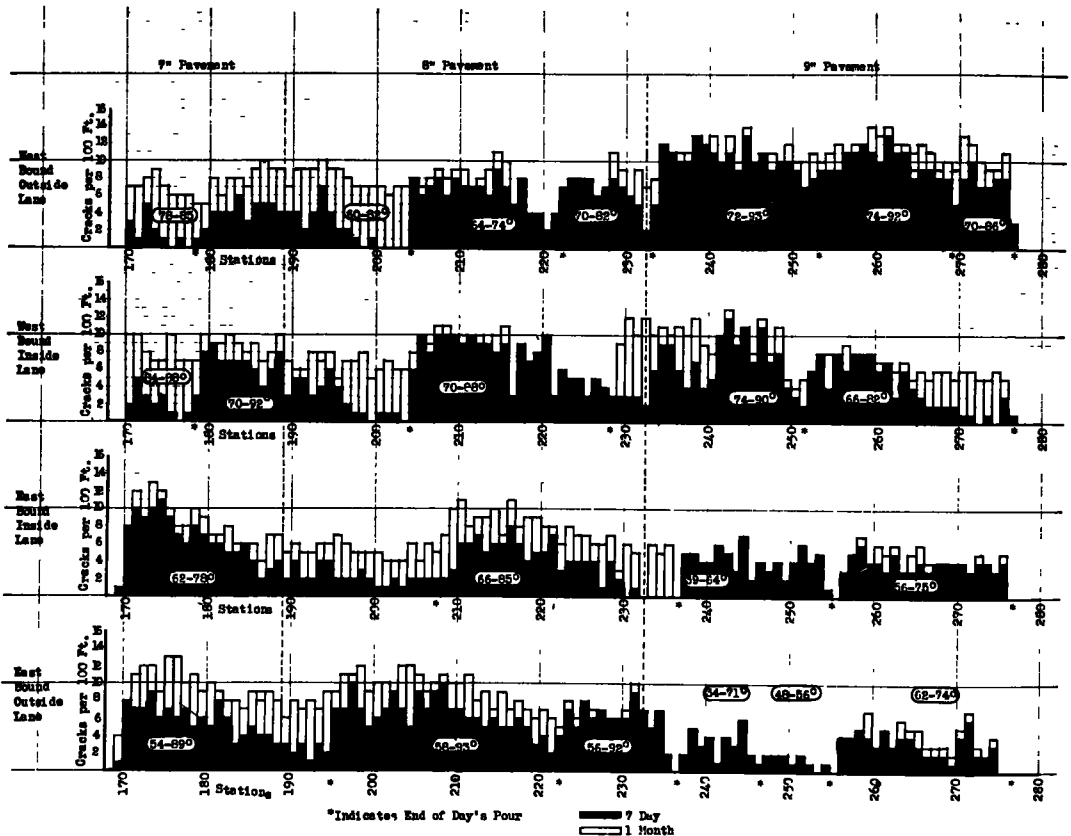
Figure 8. Crack frequency survey.

The data in Figure 8 show some interesting patterns. This graph indicates the number of cracks per 100 ft, continuously, for all four lanes from the beginning of the experimental section to the end. It is interesting to note the variance in the number of cracks per 100 ft at the beginning and the end of each day's run. This condition is most noticeable for the 7-day count and is a little less obvious at the 1-month count. Considering the 500 ft at each end of all pours, the number of cracks per 100 ft for the 7-day count at the beginning is 6.3; at the end, 3.1.

The same data for the 1-month count reveal that at the beginning of all sections there is an average of 8.8 cracks per 100 ft and at the end the average is 6.2 cracks per 100 ft. Thus there is a growing

tendency for the cracks to level off at a more uniform rate. It might be mentioned that the over-all crack average at one month was 7.2 cracks per 100 ft. It is thought that the crack pattern, as described, can be attributed to the fact that as the previous day's concrete is curing it pulls the freshly placed concrete, resulting in many cracks in the first several hundred feet. As more fresh concrete is placed, the bulk is such that the effect is diminished and fewer cracks appear. This pattern substantiates a similar condition noted by Van Breemen (2) who says, "This method of construction naturally involves the attachment together of sections of pavement having, at the time of attachment, materially different tensile strengths."

One exception to this pattern is a stretch running from station 235 to station 276 in the left outside lane, involving a period of three days when the air temperature ranged from 72F to 93F daily. Here, the crack pattern is quite uniformly high throughout, averaging 9.7 cracks per 100 ft at 7 days and 11.3 cracks per 100 ft at one month. It is believed that the high temperatures were the cause of this higher-than-usual crack pattern.

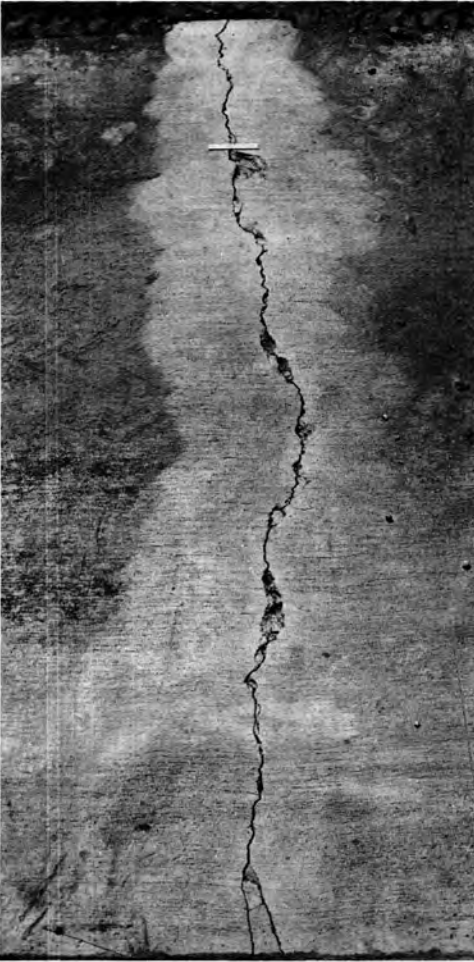
Figure 9. Crack at station 228+85.

The average crack width as established by the section under survey is approximately 0.009 in. There are, however, some serious cracks which have developed. These are principally at stations 228+85, westbound inside (Figure 9); 254+46, westbound outside (Figures 10 and 11); 233+51, westbound outside; and 267+96 westbound outside lane in 8-in. and 9-in. concrete with special subgrade of 6- to 9-in. depths. It is perhaps significant that two of these cracks occurred in the same day's run, 3 ft from the beginning and 7 ft from the end. This particular section was placed on one of the hot days (72F - 93F). Another crack also occurred 6 ft from the beginning of a day's run. All of these cracks are severely spalled and in some spots loss of small pieces of concrete has occurred.

These cracks appeared approximately two months after completion of the paving. As the cooler weather of late summer and fall approached, the cracks began to widen, and became quite serious. When the last crack width readings were recorded (at the 3-month survey, the weather was still quite warm and the crack widths averaged 0.12 to 0.20 in. With the advent of cold weather, these cracks assumed widths of 0.25 to 0.35 in. When the cracks reached this condition, a decision was made to remove 10-in. cores from the cracked areas to determine the cause of the cracking. These cores revealed that the wide cracks occurred either because the bar mats failed to meet or because of insufficient overlap of the bar mats.

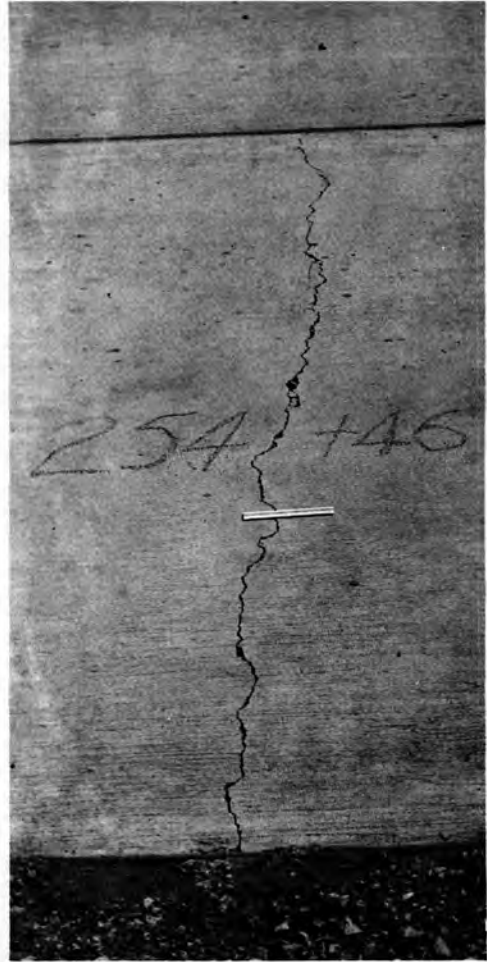
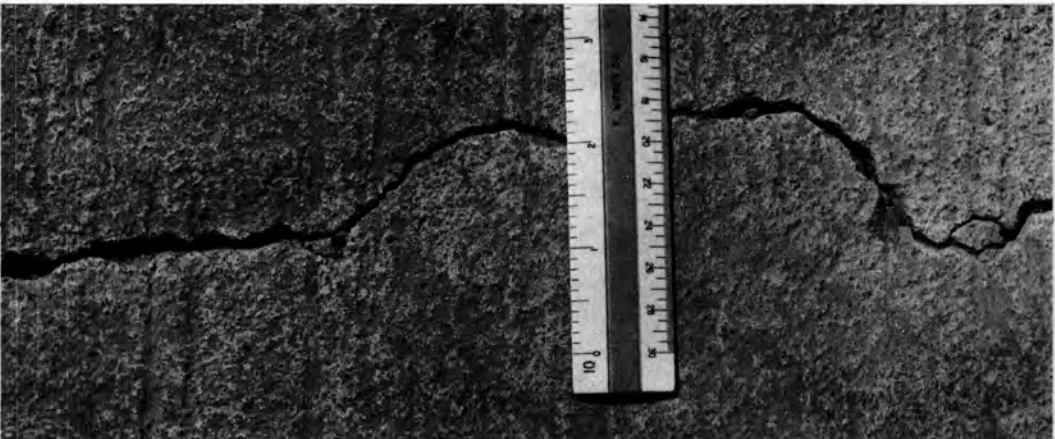
Figure 10. Crack at station 254+46.

Figure 11. Crack at station 254+46.

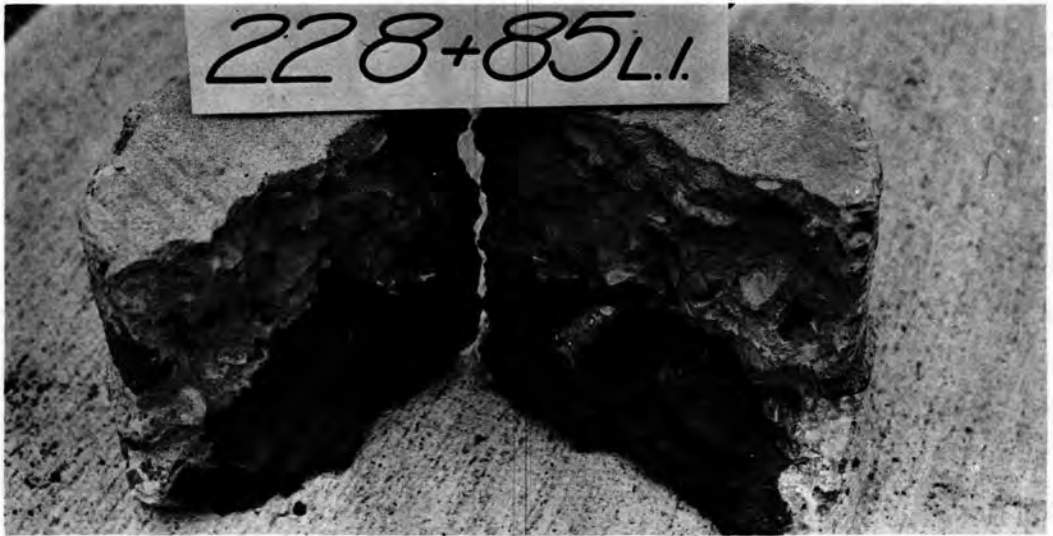
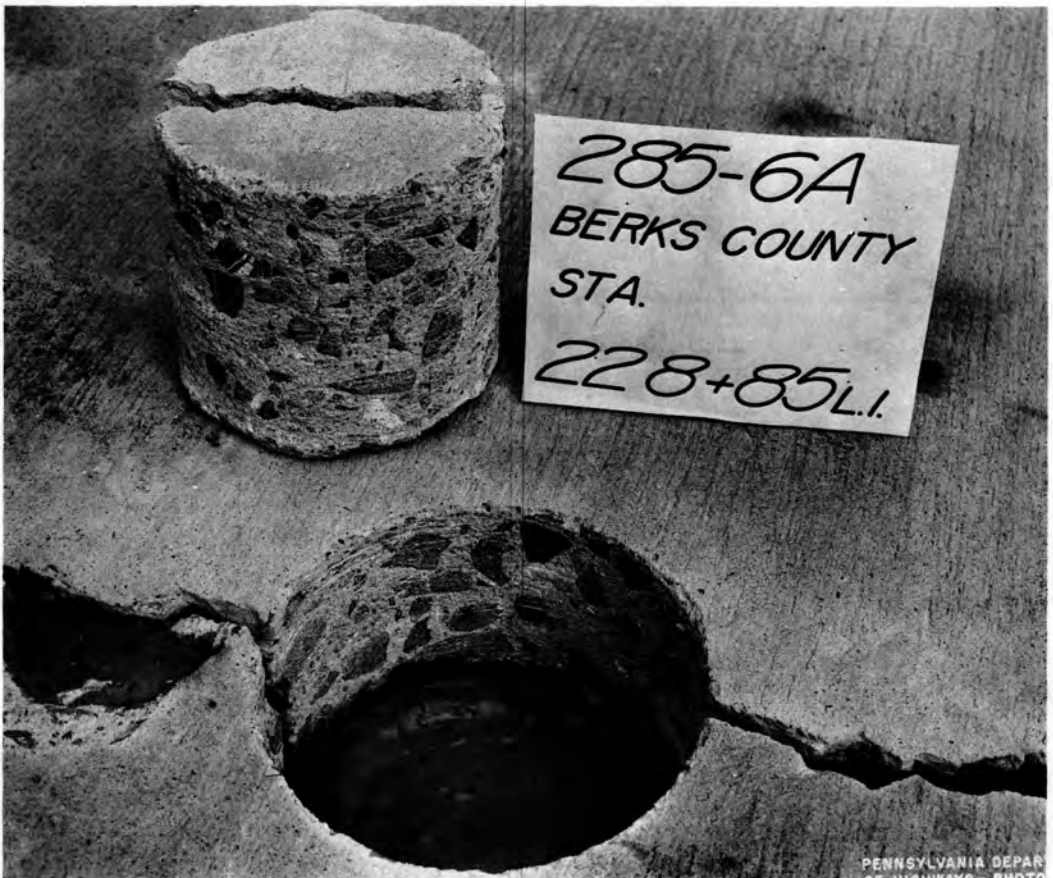
Figure 12 shows a core taken on the crack 5 ft from the beginning of a day's run. The bar protruding from the right half of the core terminates in the core half on the left. The bar mats probably failed to meet by an estimated  $\frac{1}{2}$  in. Figure 13 is another view of the same crack.

Figure 12. Separate halves of core at station 228+85.

Figure 13. Location of core removed from pavement at station 228+85.

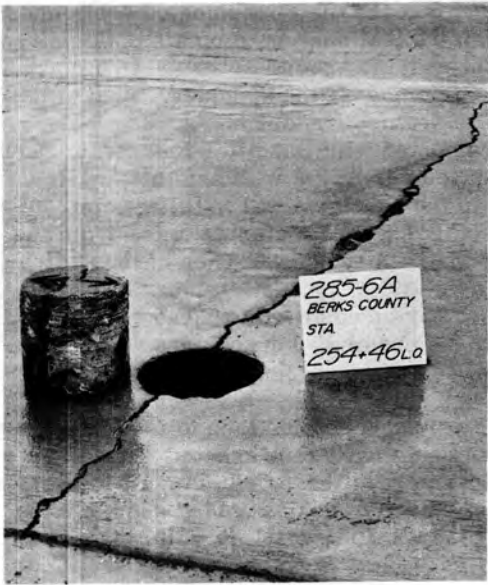
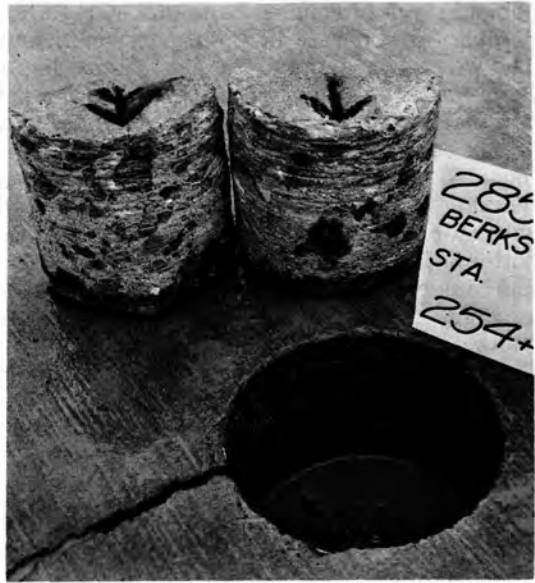
Figures 14 and 15 show the crack at station 254+46, which was 10 ft from the end of a day's run. No reinforcing steel was found in one-half of this core, indicating that the steel failed to meet by at least 5 in., and perhaps considerably more. The left half of the core shows one bar of steel, the right half a lack of steel; the steel bar is visible in the pavement.

Figure 14. Core from pavement crack at station 254+46.

Figure 15. Close-up of core shown in Figure 14.

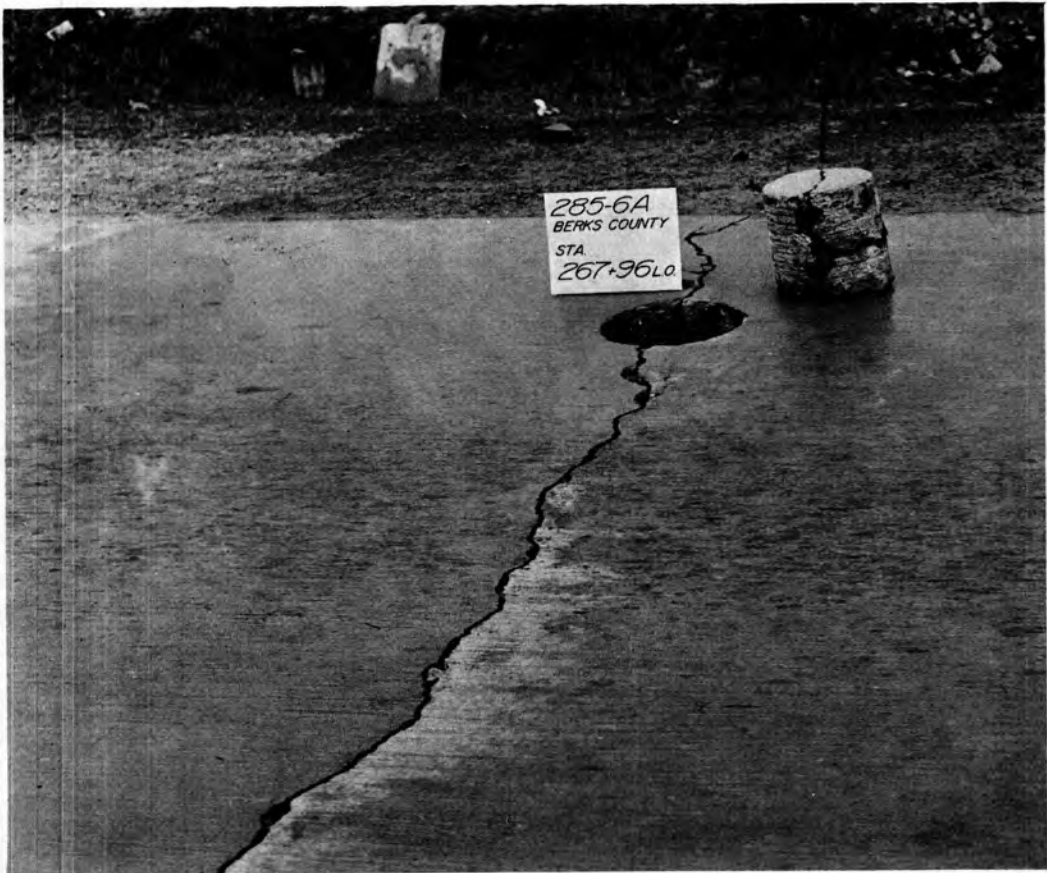
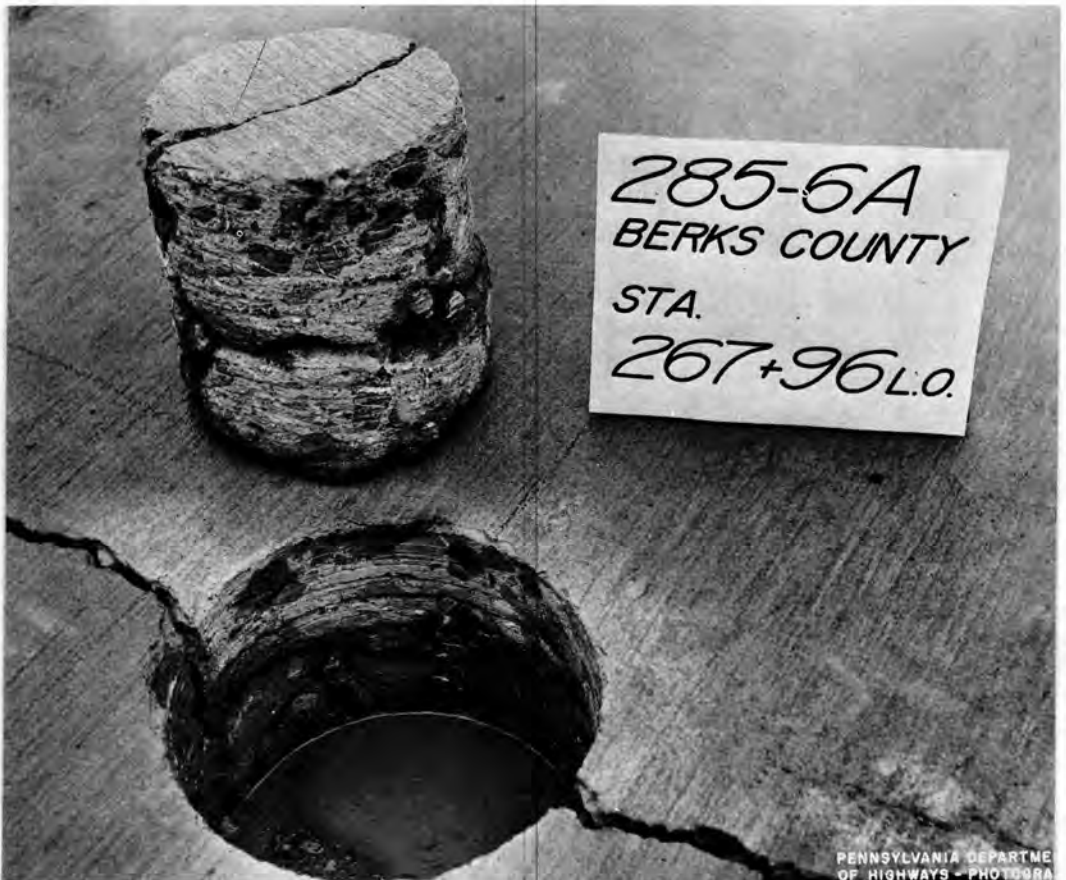
The crack at station 267+96 is shown in Figures 16 and 17. Two bars of reinforcing steel are visible in the core and in the pavement. The crack is 200 ft from the end of a day's run. The core indicated that the crack occurred at an overlap, but it was not possible to determine the length of the overlap, except that one half of the core had one steel bar and the other half had two bars, indicating that the overlap could have ranged from a minimum of 5 in. to the prescribed 12 in.

Figure 16. Pavement crack and core at station 267+96.

Figure 17. Close-up of core shown in Figure 16.
