Fifteen-Year Report on Experimental Concrete Pavement Project in Oregon

G. S. PAXSON, Assistant State Highway Engineer
Oregon State Highway Department

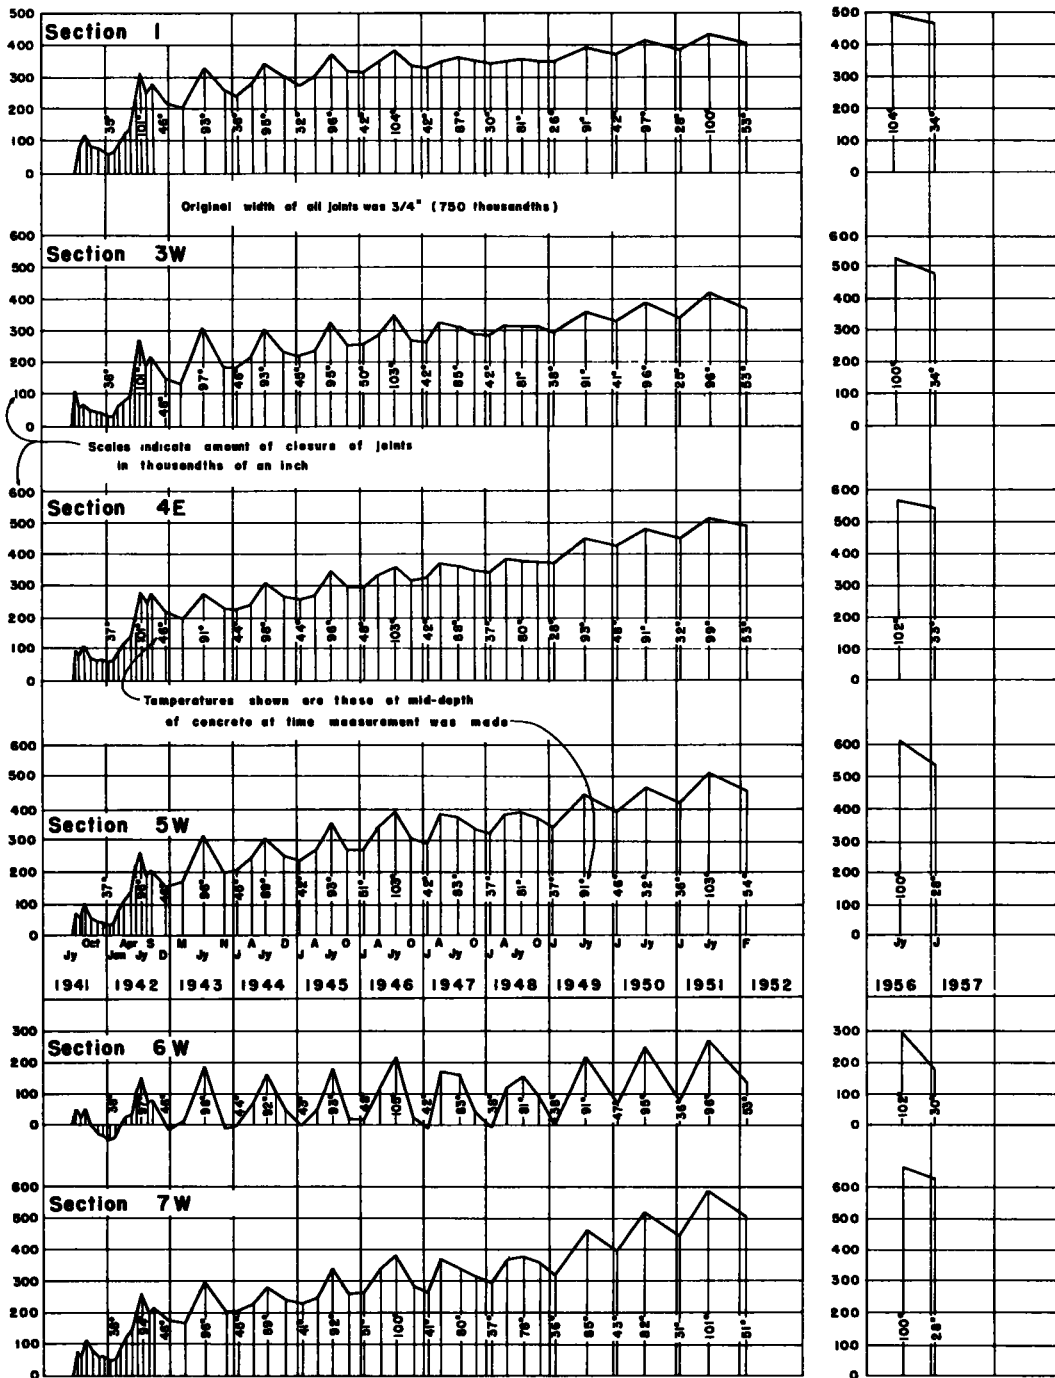
Figure 1. Closure of expansion joints.

Figure 1 shows the average closure of the expansion joints in each section for the first 10 years (during which measurements were made semi-annually or more often) and including the 15-yr measurements. The latest measurements indicate the average annual rate of closure for the period from 10 to 15 years is approximately equal to the rate existing for the period from 2 to 10 years for all sections except Section 7W. A change in rate of closure for this section was inevitable since the original joint width of $\frac{3}{4}$ -in. would have been exceeded had the former rate continued during the past five years. In July 1956, the average closure for the five expansion joints in this section was 0.660 in. and the maximum was 0.709 in. These values indicate an average remaining opening of about $\frac{3}{32}$ in. and a minimum of about $\frac{1}{32}$ in.; however, it is likely that aggregate particles from adjacent slabs are now in contact at some joints, thereby increasing the resistance to further closure. It seems probable that within a few years the expansion joints in this section will cease to serve their intended function entirely. The situation prevailing in Section 1 will then exist; that is, all joints will act as contraction joints. In the center of the mile-long Section 1, very little, if any, relief for

the contraction joints will be provided by the expansion joints at each end. There is no indication of any distress in the center of this section that could be attributed to compression and it seems reasonable that no such distress should be anticipated in other sections in which the expansion joints are closer together.

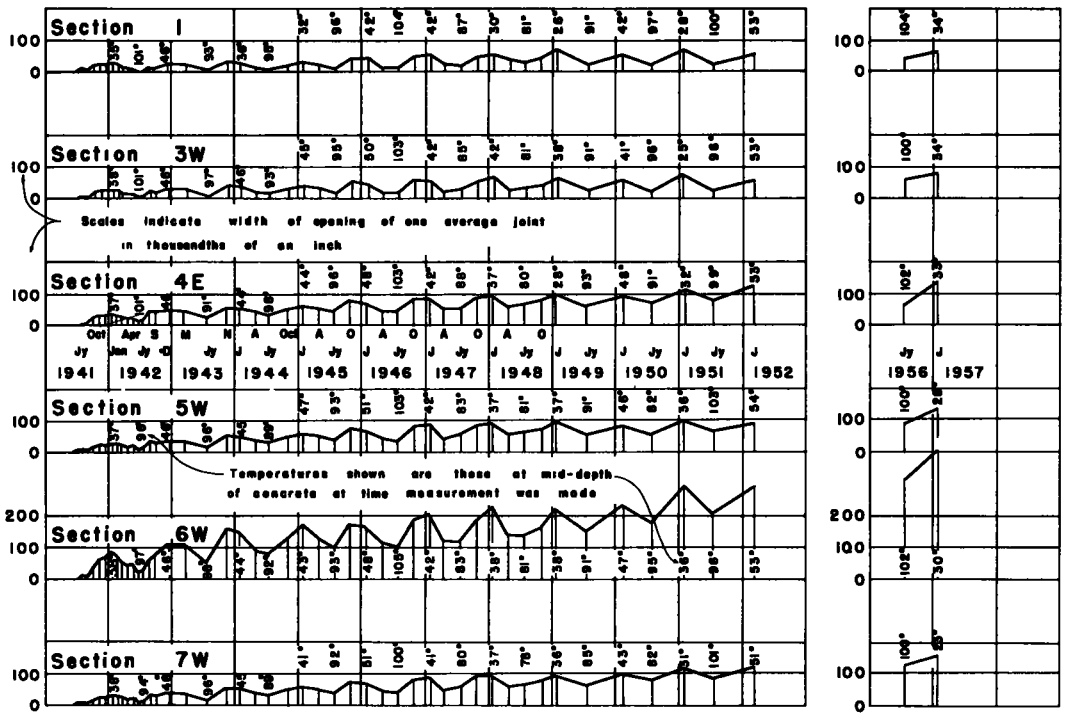
Figure 2. Opening of contraction joints.

Figure 2 shows the average opening of contraction joints within each section at the various times measurements were made. The joints were measured during each of the first 10 years and again after 15 years of service. These joints do not show the significant change prevailing in the expansion joints; however, a comparison of July measurements for the years 1951 and 1956 shows the joints generally did not close as completely in the latter year as in the former. Although the reason for this is not known, the most plausible explanation is that incompressible particles get into the joints during cool periods, thus preventing their closure at higher temperatures. Prevention of thermal expansion naturally causes compressive stresses in the slab; however, there is little likelihood that these stresses would reach the ultimate strength of the concrete even though all expansion were prevented.
