# Latex-Modified Mortar in the Restoration of Bridge Structures

S. M. CARDONE, M. G. BROWN, and A. A. HILL, Respectively,  
Chief, Maintenance Operations Division and Chemical Engineer, Michigan State  
Highway Department; and Coatings Technical Service, Dow Chemical Company

A synthetic latex emulsion admixture was used with portland cement mortar in thin patching mixtures. Laboratory study showed improvement in shear bond strength, compressive strength, tensile strength, and a reduction of water-cement ratio as compared to regular mortar. The latex emulsion was added in amounts of 10 to 20 percent based on latex solids to cement weight. It was used in mortars having sand-cement ratios of 3:1 and 2:1 by weight.

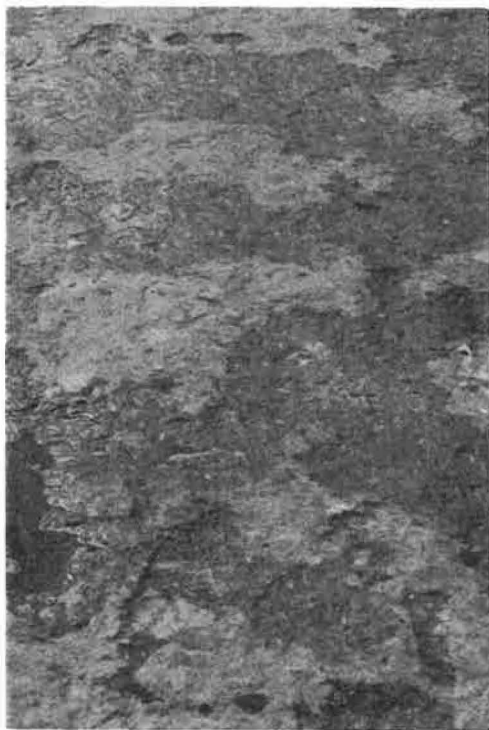
Figure 3. Typical scaled and polished concrete deck surface.

four-lane roadway with two 5-ft sidewalks, consisting of about 58 ft of concrete roadway at each end of 38 ft of open steel grid. It was built in 1940, with crushed limestone coarse aggregate, natural sand, and non-air-entrained cement. The roadway had become badly scaled from weathering and de-icing salts, and highly polished from traffic (Fig. 3). The unsound and scaled surface was removed with a cutting machine (Fig. 4), so that a latex-portland cement mortar layer of  $\frac{1}{2}$ -in. minimum thickness could be applied. Some areas of the filled-grid walk sections were chipped out to squared edges (Fig. 5). Small air chisels and sandblasting equipment were also used to prepare the deck for thin patching. Narrow steel strike-off bars were greased and set with anchor bolts along the edge of each lane, so that the proper depth of patch and crown of the deck surface would be maintained during screeding and finishing operations. These bars were removed after the latex-cement mortar had cured.

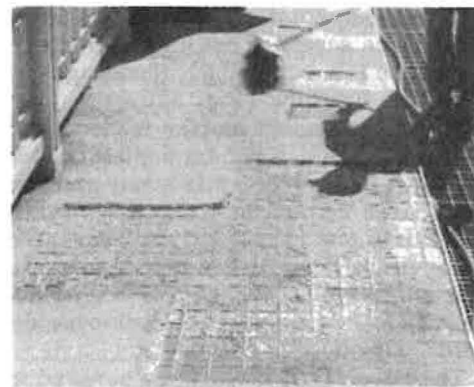
Figure 5. North sidewalk patches chipped to squared edges.

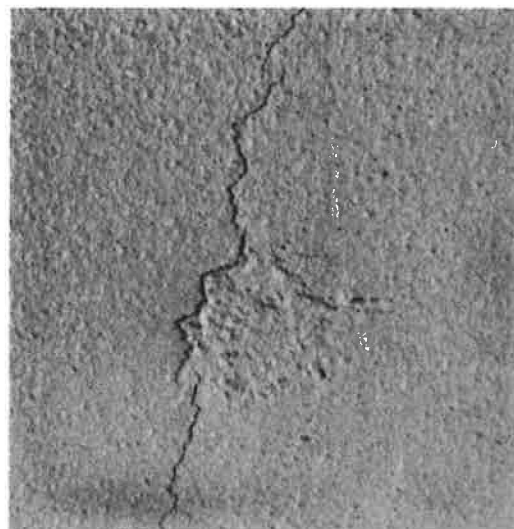
A nominal sand-cement ratio of 3:1 and a latex solids content of 20 percent, based on the cement weight, were used for all batches. During mixing, trouble was encountered with the moist sand balling up with the cement. Most of the large sand and cement lumps were screened out as the mortar was placed, but some smaller ones were finished into the thin surfacing. Shrinkage cracks appeared through a few of these lumps soon after finishing (Fig. 8).

Figure 8. Shrinkage crack adjacent to sand-cement lump.

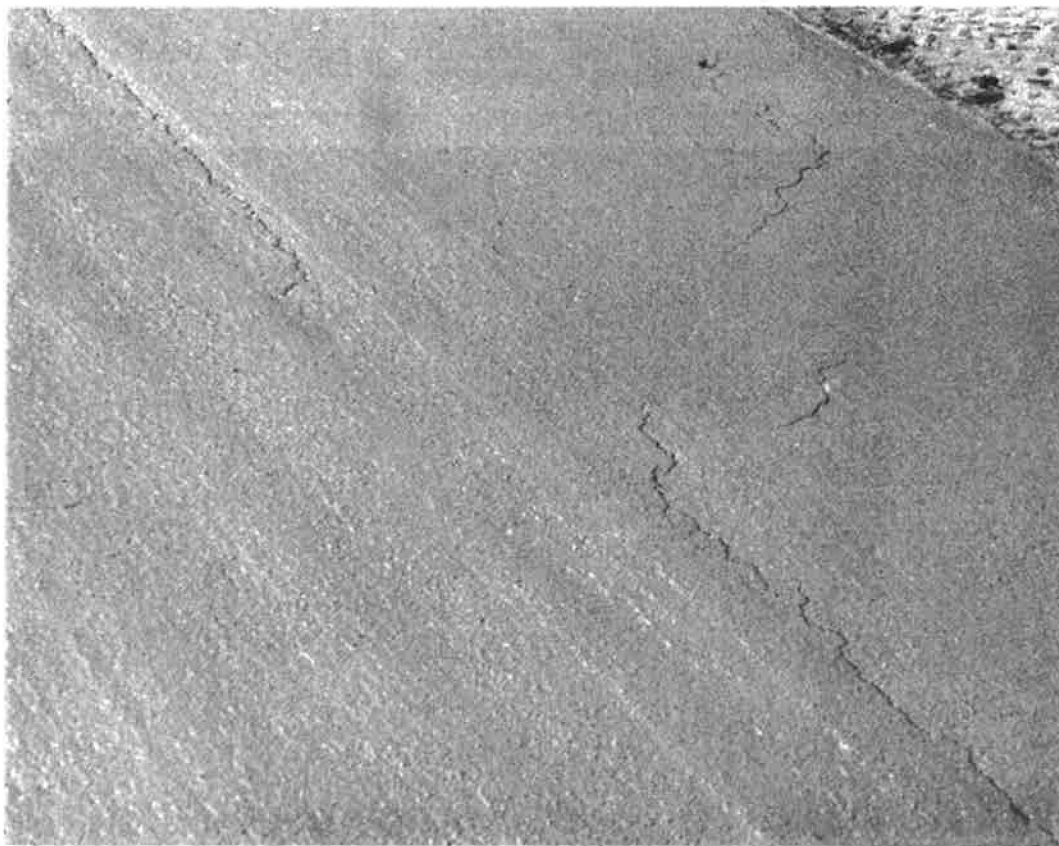
The latex-cement mortar tended to form a surface skin which produced shrinkage cracks (Fig. 9), if not immediately covered with wet burlap. This was especially true when the weather was sunny and windy.

Figure 9. Shrinkage cracks in latex-mortar surface on west end of Lane D when not quickly covered with wet burlap.

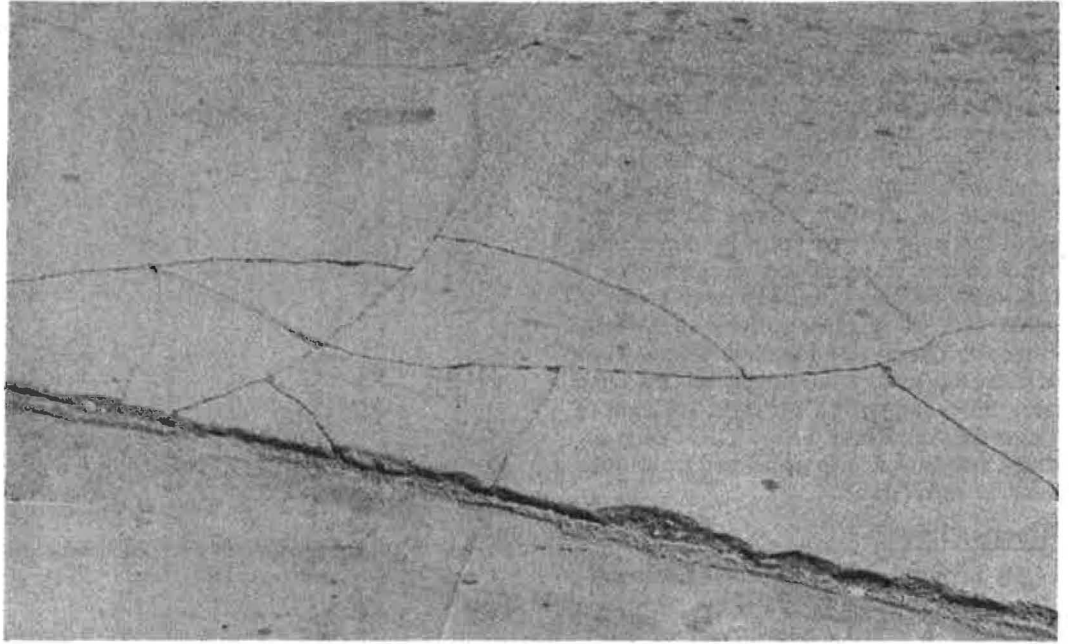
On April 15, 1958, the latex-cement mortar thin surfacing on the Cheboygan bridge was appraised after exposure to its first winter. Two quite extensive areas were badly cracked and loosened from the substrate. Figure 10 is a close-up of the east end of Lane F, containing cracked and loosened latex-cement mortar which had been applied over a dry substrate. A similar failure of the latex-cement mortar was found at the west end of Lane D, where the prepared base had been broomed with a straight solution of Latex 560 emulsion (Fig. 11). Only these two test areas appeared to be losing bond in April 1958.

Figure 10. Extensive cracking and loose latex mortar on east end of Lane F after one winter (April 1958).

that a large portion of the latex-cement mortar resurfacing had loosened and would need replacing. Almost all the area applied over a wet substrate remained intact, but the other three methods of surface preparation exhibited the following degrees of failure:

- Dry and untreated—80 percent;
- Latex bond coat—about 50 percent; and
- Latex-cement slurry—100 percent.

All these loosened areas were removed and cleaned with pneumatic chisels and sandblasting. It was decided that these areas should be repaired using a latex-cement mortar containing the newer X2130.1 experimental latex emulsion. The tests reported in Table 1 had shown that this latex emulsion was superior to Latex 560 in some properties; in particular, the shear bond strength was about double.

On September 27 and October 6, 1958, the Latex X2130.1-cement mortar was used to replace all the loosened areas. The materials were handled and mixed essentially the same way as in September 1957. Mix data for the three mortar batches involved are given in Table 4 and the deck placement is shown in Figure 12. The deck areas to be replaced were cleared of loose patch material and then washed and soaked with water just before resurfacing.

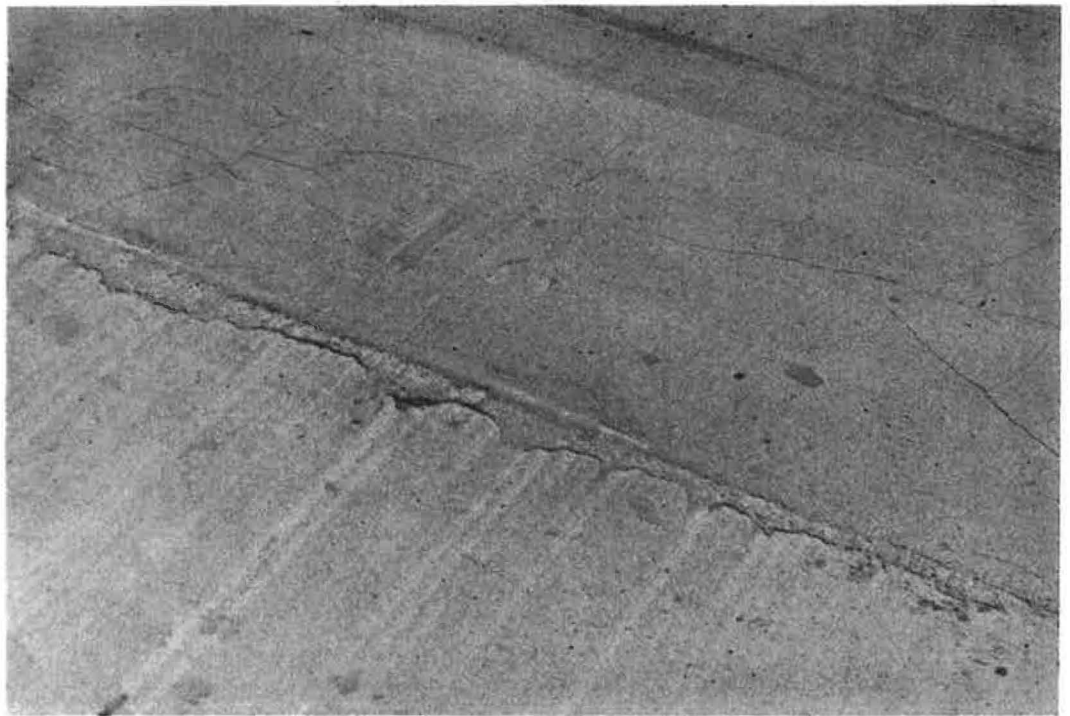
Figure 11. Cracking and loose mortar in west end of Lane D after one winter (April 1958).

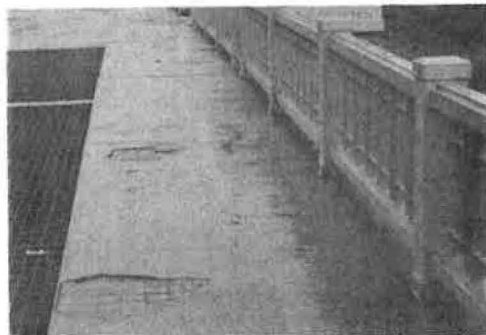
On April 14, 1959, another inspection trip was made to the bridge site. The remaining 1957 sections and those reapplied in 1958 were still bonded to the old bridge deck. A few newly spalled areas were found in the old concrete surface of sidewalk areas J and K, bordering some of the 1957 latex-mortar patches (Fig. 13). However, all the latex mortar areas appeared sound.

Figure 13. Newly spalled areas in north sidewalk, some adjacent to patches.

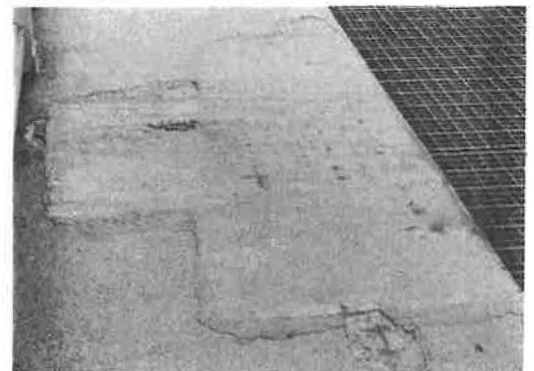
The bridge was examined again on August 7, 1959. The sidewalk spalling in the original concrete around the latex-mortar patches observed in April was spreading even farther (Fig. 14). This breakdown of old concrete over the filled grid sidewalk may gradually loosen the adjacent latex-mortar patches. Surface dampness because of rain during this inspection made the fine crack network in the September 1958 repair work especially clear (Fig. 15), but patches seemed to be bonded to the concrete. General views of the sound latex-mortar resurfaced lanes after two years of exposure are shown in Figure 16.

Figure 14. Further failure around large latex-mortar patch in north sidewalk.

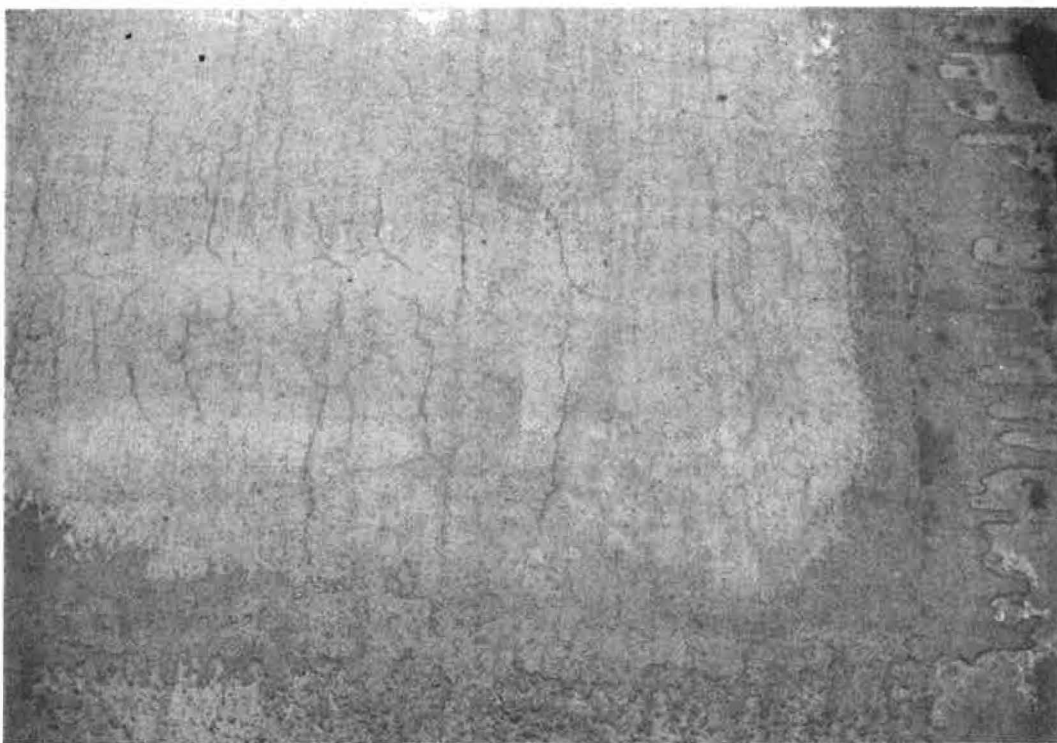
Figure 15. Network of shrinkage cracks in latex-mortar resurfacing on southeast lane, after one winter.

The patching mixes of fall 1958 may have been too rich in cement, having a sand-cement ratio of 1.8:1 as compared to the ratio of 2.8:1 used in September 1957. Excessive refinishing necessitated by considerable rain during placement may have promoted the extensive crack formation which occurred in the areas patched September 27, 1958. Similar Latex X2130.1 mixes placed under more normal conditions one week later showed no cracks after one year of exposure.

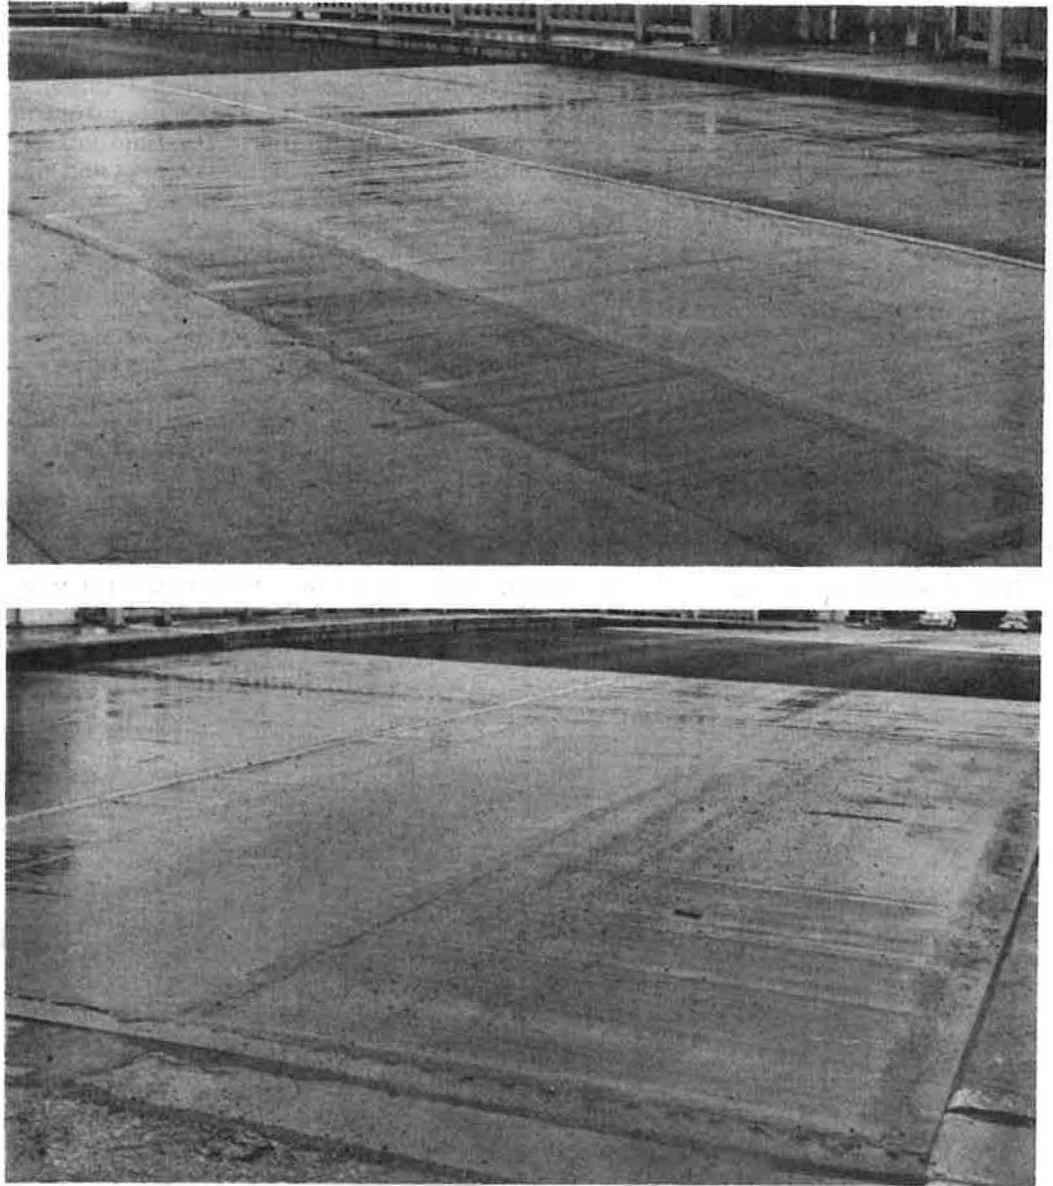
Figure 16. General views of the bridge deck showing over-all sound condition of latex-mortar lanes in August 1959, after two winters; east end (upper) and west end (lower).

The two lanes of Latex 560 mortar placed over a wet substrate are intact after two years, and the Latex X2130.1 mortar areas are sound after one year. These lanes will be examined and evaluated after additional winters of exposure. Further field exposures using latex-modified mortar would be valuable, preferably using the Saran-type emulsion and employing higher sand-cement ratios or leaner mixes with several latex-cement ratios.
