# HIGHWAY RESEARCH BOARD

Bulletin 260

***Repair of Structures and Pavement by  
Thin Concrete Patching***

# Latex-Modified Mortar in the Restoration of Bridge Structures

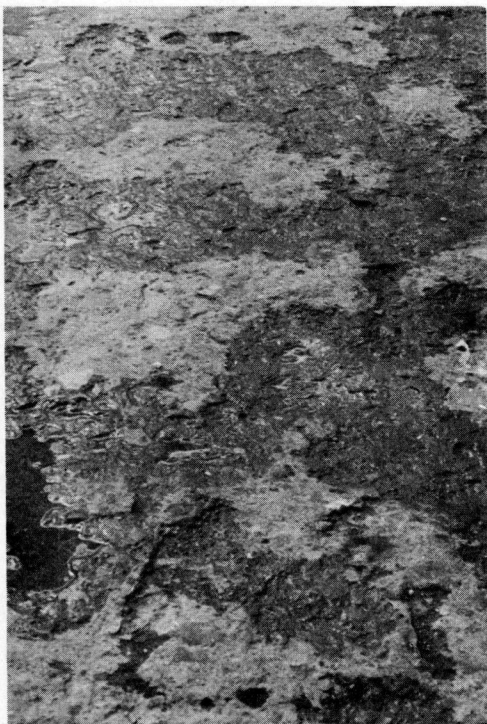
Figure 3. Typical scaled and polished concrete deck surface.

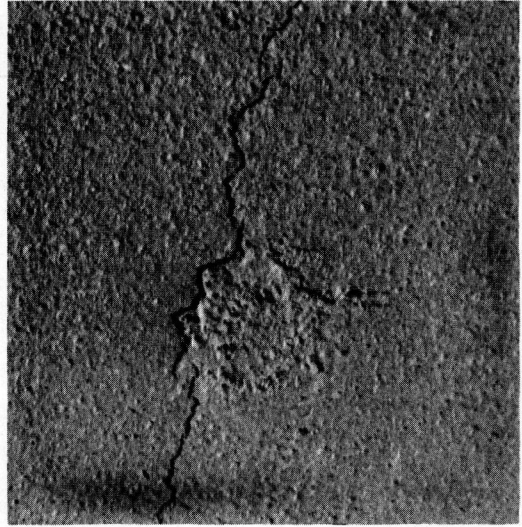
A nominal sand-cement ratio of 3:1 and a latex solids content of 20 percent, based on the cement weight, were used for all batches. During mixing, trouble was encountered with the moist sand balling up with the cement. Most of the large sand and cement lumps were screened out as the mortar was placed, but some smaller ones were finished into the thin surfacing. Shrinkage cracks appeared through a few of these lumps soon after finishing (Fig. 8).

Figure 8. Shrinkage crack adjacent to sand-cement lump.

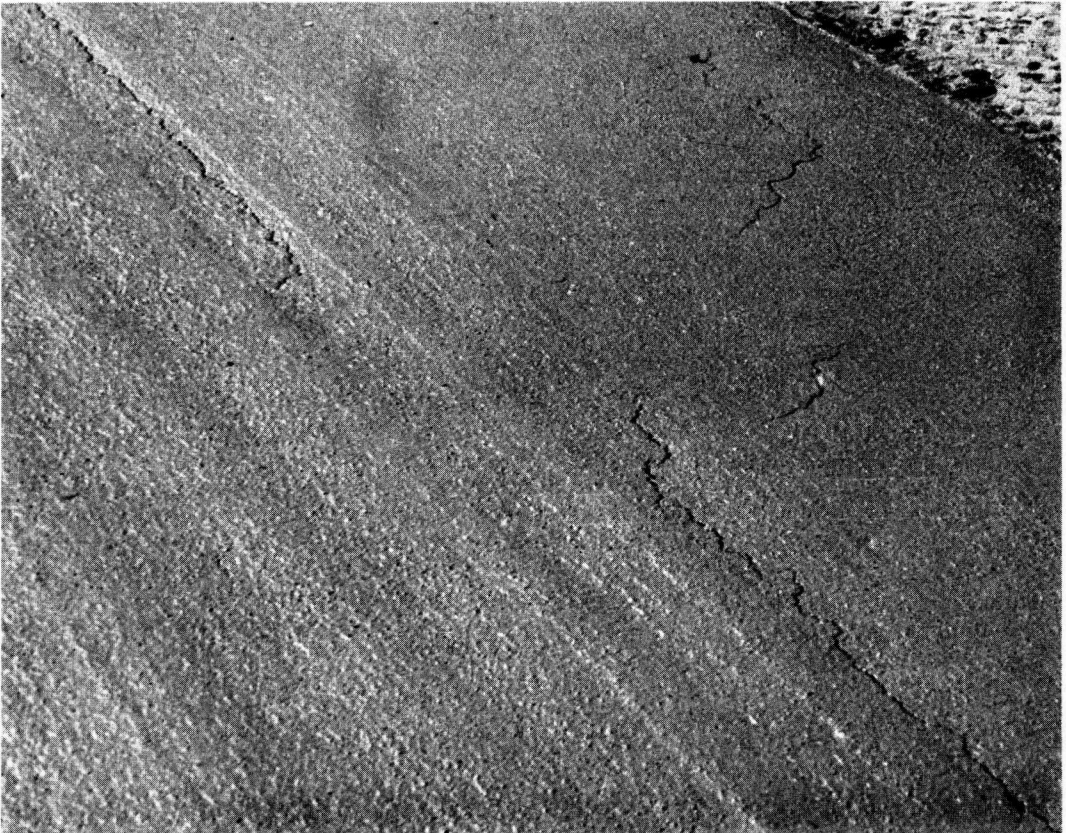
The latex-cement mortar tended to form a surface skin which produced shrinkage cracks (Fig. 9), if not immediately covered with wet burlap. This was especially true when the weather was sunny and windy.

Figure 9. Shrinkage cracks in latex-mortar surface on west end of Lane D when not quickly covered with wet burlap.

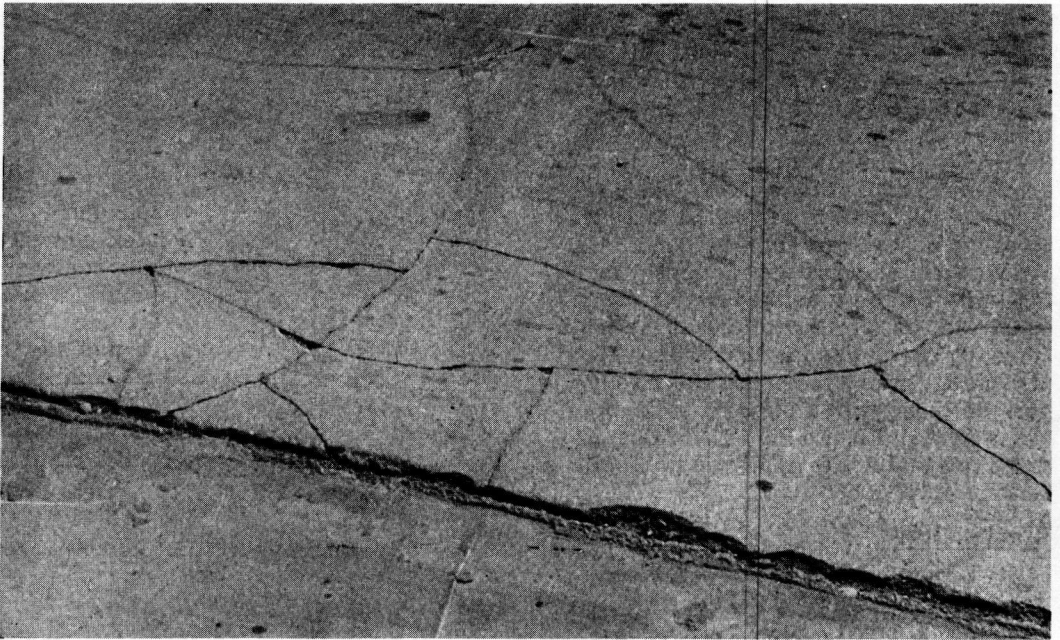
On April 15, 1958, the latex-cement mortar thin surfacing on the Cheboygan bridge was appraised after exposure to its first winter. Two quite extensive areas were badly cracked and loosened from the substrate. Figure 10 is a close-up of the east end of Lane F, containing cracked and loosened latex-cement mortar which had been applied over a dry substrate. A similar failure of the latex-cement mortar was found at the west end of Lane D, where the prepared base had been broomed with a straight solution of Latex 560 emulsion (Fig. 11). Only these two test areas appeared to be losing bond in April 1958.

Figure 10. Extensive cracking and loose latex mortar on east end of Lane F after one winter (April 1958).

All these loosened areas were removed and cleaned with pneumatic chisels and sandblasting. It was decided that these areas should be repaired using a latex-cement mortar containing the newer X2130.1 experimental latex emulsion. The tests reported in Table 1 had shown that this latex emulsion was superior to Latex 560 in some properties; in particular, the shear bond strength was about double.

On September 27 and October 6, 1958, the Latex X2130.1-cement mortar was used to replace all the loosened areas. The materials were handled and mixed essentially the same way as in September 1957. Mix data for the three mortar batches involved are given in Table 4 and the deck placement is shown in Figure 12. The deck areas to be replaced were cleared of loose patch material and then washed and soaked with water just before resurfacing.

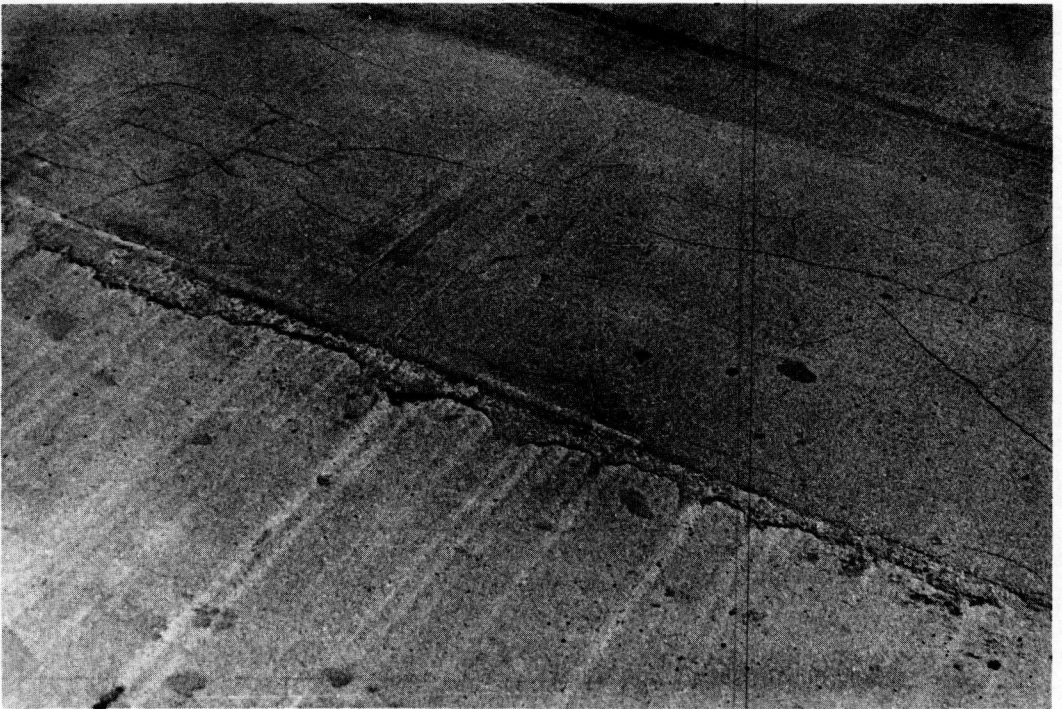
Figure 11. Cracking and loose mortar in west end of Lane D after one winter (April 1958).

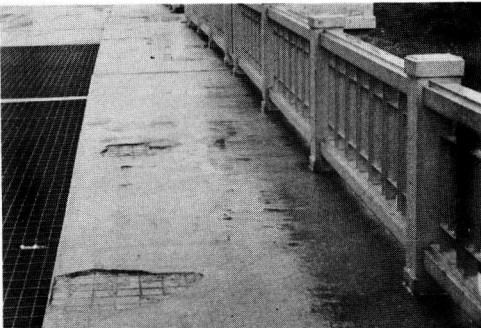
On April 14, 1959, another inspection trip was made to the bridge site. The remaining 1957 sections and those reapplied in 1958 were still bonded to the old bridge deck. A few newly spalled areas were found in the old concrete surface of sidewalk areas J and K, bordering some of the 1957 latex-mortar patches (Fig. 13). However, all the latex mortar areas appeared sound.

Figure 13. Newly spalled areas in north sidewalk, some adjacent to patches.

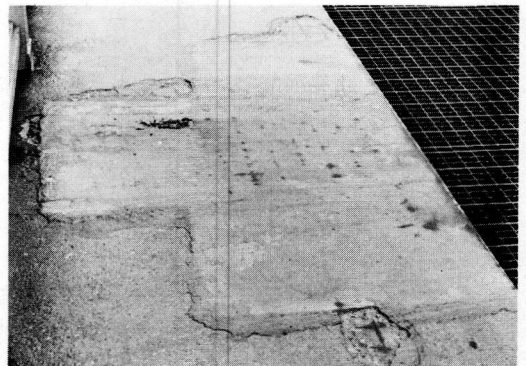
The bridge was examined again on August 7, 1959. The sidewalk spalling in the original concrete around the latex-mortar patches observed in April was spreading even farther (Fig. 14). This breakdown of old concrete over the filled grid sidewalk may gradually loosen the adjacent latex-mortar patches. Surface dampness because of rain during this inspection made the fine crack network in the September 1958 repair work especially clear (Fig. 15), but patches seemed to be bonded to the concrete. General views of the sound latex-mortar resurfaced lanes after two years of exposure are shown in Figure 16.

Figure 14. Further failure around large latex-mortar patch in north sidewalk.

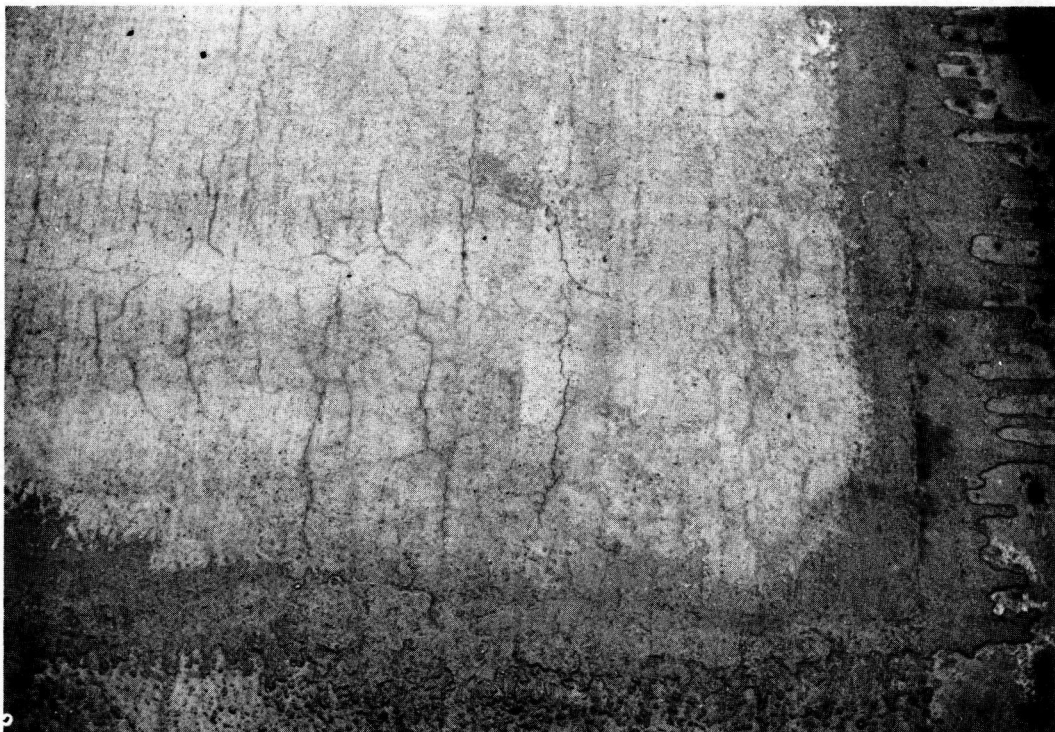
Figure 15. Network of shrinkage cracks in latex-mortar resurfacing on southeast lane, after one winter.

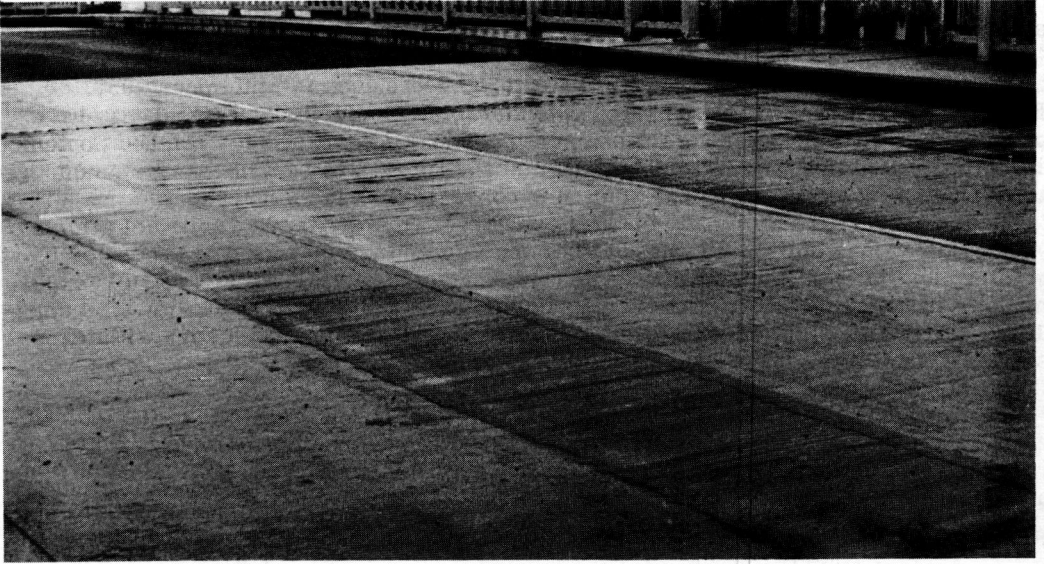
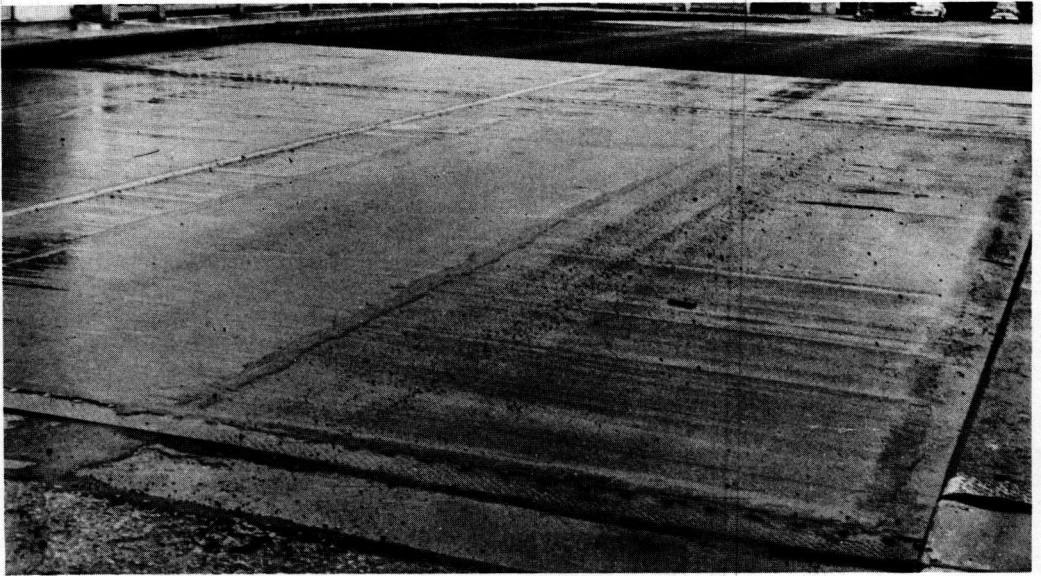
Figure 16. General views of the bridge deck showing over-all sound condition of latex-mortar lanes in August 1959, after two winters; east end (upper) and west end (lower).

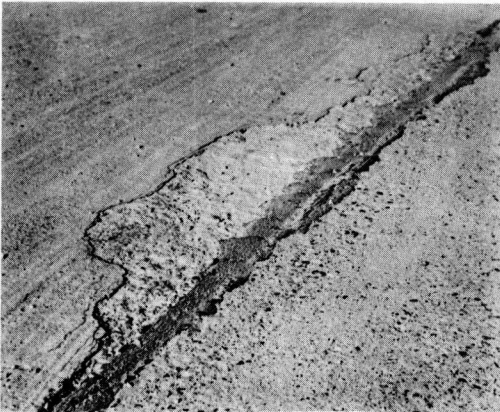
In August and September 1956, a thin bonded resurface was applied to 47,000 sq yd of the aircraft parking apron at Selfridge Air Force Base which is near Mt. Clemens, Mich. Approximately 37,000 sq yd of the project area consisted of 10-in. concrete 14 yr old. The remaining area was 6-in. concrete 27 yr old. The principal defects in the pavement corrected by the resurfacing were surface scaling (Fig. 1), raveling along joints, and surface popouts over unsound particles of aggregate. There was also a considerable amount of random cracking, both transversely and longitudinally.

Figure 1. Scaled and raveled pavement at Selfridge Air Force Base.

Because of surface scale and excessive laitance in many areas it was considered necessary to scarify approximately 80 percent of the pavement surface in order to provide sound, clean concrete for the bonded resurfacing. Scarification was carried out with a fleet of four Tennant machines with heads packed with 4-in. drop forged cutters so arranged as to make a clean cut about 4 in. wide. The debris created by the machines was removed by a combination of means: compressed air and hand push-brooms to clear the immediate working area and a mechanical pickup broom for final disposal.

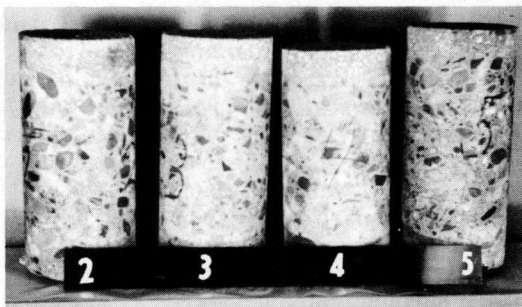
After more than three years of service, the resurfacing at Selfridge Air Force Base is showing good performance. Most of the random cracking of the old pavement has appeared in the resurfacing layer. These cracks are generally close and tight and have not required grouting and sealing.

Figure 6. Cores taken from resurfaced concrete at Selfridge Air Force Base.

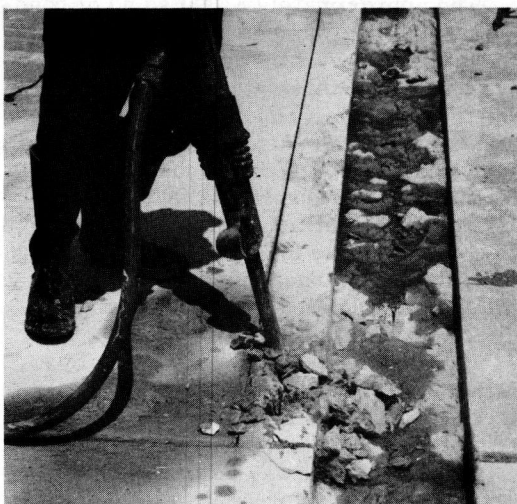
The pavement involved was on an aircraft parking apron which had been strengthened by concrete overlay about a year before the repairs were made. It is not the purpose of this report to state the reason for the spalling. Similar conditions have been observed on other projects where the steel inserts for forming joints were not removed early enough and the concrete next to joints was split horizontally when inserts were pulled out. At Seymour-Johnson, when concrete was sawed preparatory to patching, the sawed face revealed horizontal laminations extending back as

far as 10 in. from the joint. The depth of spalls indicated that the laminations occurred at depths of less than 2 in.

Figure 9. Removing concrete adjacent to joints at Seymour-Johnson Air Force Base.

The defective concrete along joints was removed by use of a diamond blade concrete saw and pneumatic paving breaker. A saw cut was made to a depth of 2 in. parallel to the joint at 6-in. spacing. The 6 in. of concrete between the joint and saw cut was then broken out with pneumatic tools. If the face of the saw cut showed completely sound concrete, the patch was placed at 6-in. width. If the face of the saw cut showed one or more horizontal cracks, another 6-in. section was sawed and removed (Fig. 9).
