# ***Dynamic Full-Scale Tests of Median Barriers***

JOHN L. BEATON AND ROBERT N. FIELD, respectively, Supervising Highway Engineer, and Materials and Research Engineering Associate, Materials and Research Department, California Division of Highways, Sacramento

Full-scale dynamic tests were made of 15 proposed designs of traffic barriers for use in median areas. Of these, two proved to be worthy of trial installations.

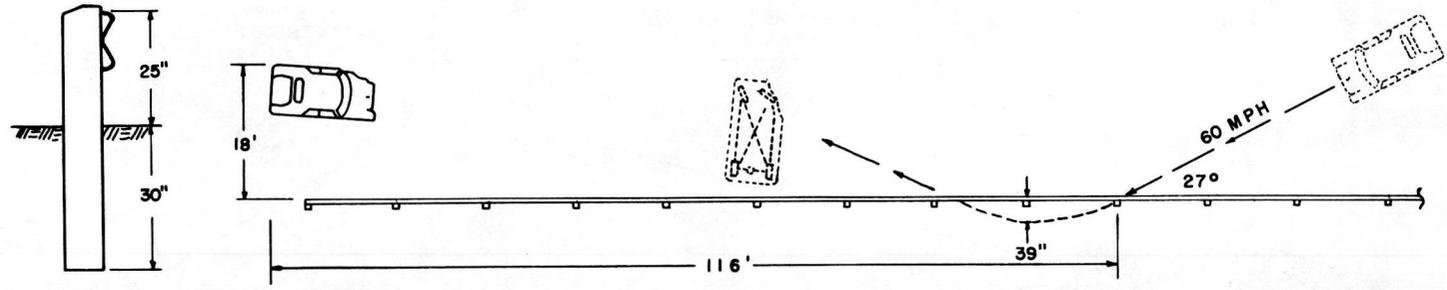
Figure 3. Test data information sheet

Tests No. 1 and 2 (Figs. 3 and 4) were typical highway guardrail installations. In neither of these tests did the car pass over the barrier; however, the collision with the spring-mounted, curved-beam type resulted in the test car rolling along the top of the rail. Indications were that the car could have bounced across as well as coming to rest on the rail. The curved beam (Fig. 4) tended to pocket the car during impact whereas the corrugated beam (Fig. 3) formed a smooth curve and reflected the test car away from the rail. The necessity for good beam strength in metal-beam guardrails was well illustrated by these two tests which coincide with the findings of others (4).

In both of these tests the car rolled over after impact. This was caused by the rail, which was mounted at a 25-in. height (19 in. to center of rail), being forced back and downward under impact. This tended to impart a rolling motion to the car. This same action occurred at all mounting heights of rail, whenever no provision was made to prevent the rail from following the posts downward. At a 30-in. height the car tends to get under the rail forcing it upwards. This minimizes the tendency of the car to roll.

| GUARDRAIL ..... | W Section | DUMMY INJURY ..... | Left shoulder & side injuries. Possible concussion. | TEST NO. .... | 1 |
| BRACKET ..... | None | GUARDRAIL DAMAGE ..... | 3 Sections damaged beyond repair. | DATE ..... | 7-10-58 |
| POST ..... | 8x8 D.F. | POST DAMAGE ..... | 2 Posts damaged beyond repair. | VEHICLE ..... | Chev. 52 Sedan |
| LENGTH OF INSTALLATION... | 212.6' | VEHICLE DAMAGE ..... | Total loss | IMPACT ANGLE..... | 27° |
| GROUND CONDITION ..... | Dry | MAX. DYNAMIC DEFLECTION OF RAIL... | 48" | VEHICLE WEIGHT... | 3980 |

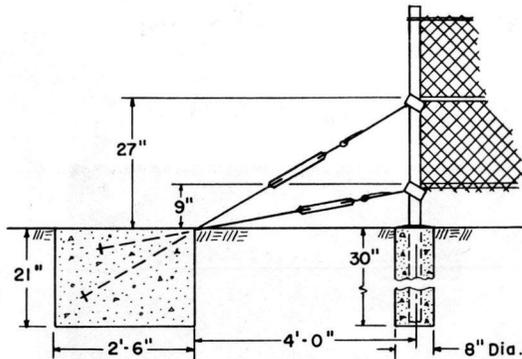
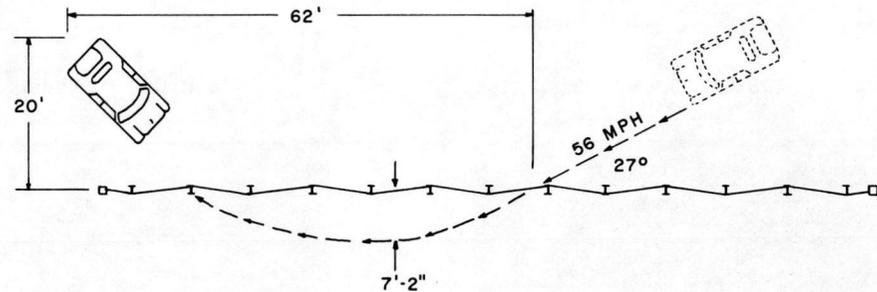
As shown in Figures 14, 16, 17, 18, 19, and 21, several tests were made to determine the proper details for such a system. The combination of 9-gage chain link fabric on 2 1/4-in. by 4.1-lb steel H posts seems to be reasonably well balanced in that during failure it provided sufficient resistance to decelerate both the test car and bus within a reasonable distance, while at the same time it allowed a deceleration rate tolerable to the occupants of the car.

GUARDRAIL ..... Chain Link  
 Fence w/ 3/4" cables 9" & 27" above Pvmt.  
 POST ..... 2 1/4" - 4.1 #  
 H Section Fence Post.  
 POST SPACING ..... 8' O.C.  
 LENGTH OF INSTALLATION... 96'  
 GROUND CONDITION ..... Dry

DUMMY INJURY ..... Possible neck injuries & minor bruises.  
 GUARDRAIL DAMAGE ..... 50' of Fence knocked out. No damage  
 to Cable.  
 POST DAMAGE ..... 7 Posts damaged beyond repair.  
 6 Posts Bent.  
 VEHICLE DAMAGE ..... \$ 600.  
 MAX. DYNAMIC DEFLECTION OF RAIL .. 7' - 2"  
 VEHICLE DECELERATION (PEAK).... Long. 69 G ... Transv. 154 G  
 DUMMY DECELERATION (PEAK).... Long 7 G ... Transv. 9.5 G

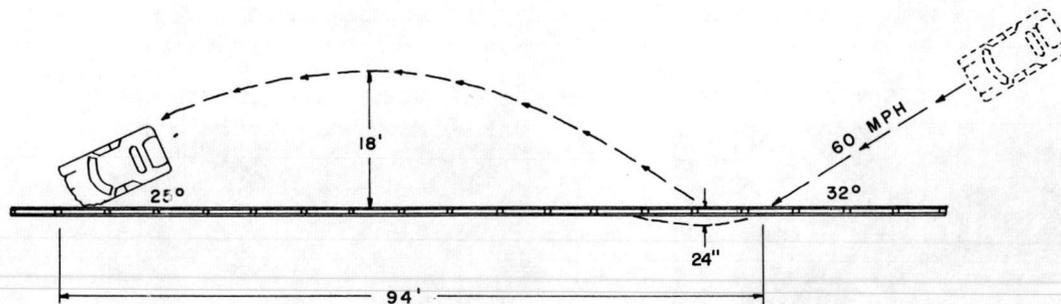
Figure 15. Test data information sheets.

The efficiency of the design used for Test No. 13 (Fig. 15) in lessening the chances of injury-producing impacts apparent in other tests on corrugated-beam guardrail mounted 30 in. above the ground is illustrated by the deceleration patterns shown in Figure 30. Note that the moderately high transverse Gs on the dummy occur when the vehicle is still in contact with the rail. It is apparent that the human body can sustain these moderate transverse Gs, taking the full load against the shoulder and arm, with less chance of critical injuries than the high longitudinal Gs which usually throw the occupant against the steering column and windshield.

GUARDRAIL ..... W Section  
 CHANNEL ..... 6"  $\square$  8.2 #  
 BRACKET ..... 8x8x12 D.F. Block  
 POST ..... 6x8 D.F.  
 POST SPACING ..... 6'-3" O.C.  
 LENGTH OF INSTALLATION ... 125'  
 GROUND CONDITION ..... Dry

DUMMY INJURY ..... Possible left shoulder, arm & side injuries.  
 GUARDRAIL DAMAGE ..... 4 Sections damaged beyond repair.  
 CHANNEL DAMAGE ..... 4 Sections damaged beyond repair.  
 POST DAMAGE ..... 3 Posts damaged beyond repair.  
 VEHICLE DAMAGE ..... \$ 900  
 MAX. DYNAMIC DEFLECTION OF RAIL ... 37"  
 VEHICLE DECELERATION (PEAK) ... Long. 104 G... Transv. 198 G  
 DUMMY DECELERATION (PEAK) ... Long. 16 G... Transv. 18 G

TEST NO. .... 13  
 DATE ..... 12-18-58  
 VEHICLE ..... Chev. 53 Sedan  
 SPEED ..... 60 MPH  
 IMPACT ANGLE .... 32°  
 VEHICLE WEIGHT ... 4000  
 (W/DUMMY & INSTRUMENTATION)

The blocked out metal beam barrier design shown in Figure 24 is the most effective for narrow medians and traffic conditions where deflections allowed by the cable-chain link type could not be tolerated. During the tests this barrier satisfied all three criteria to some degree.

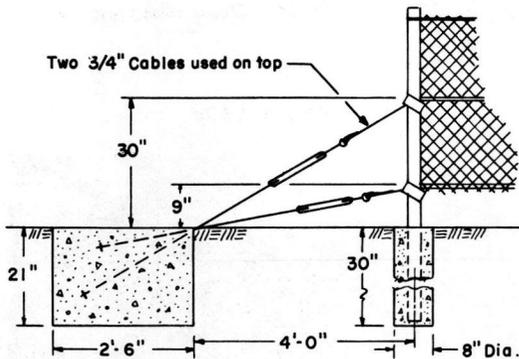
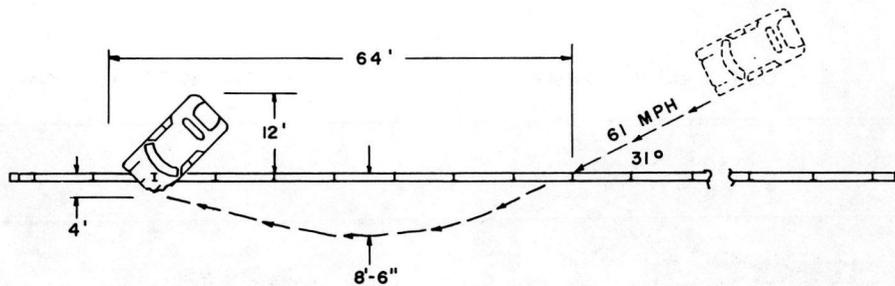
Figure 16. Test data information sheets.

The deflection-time curves (Figs. 32 and 33) indicate the duration of encroachment on the opposing traffic lanes if this barrier is installed on median strips less than 16 ft between edges of pavement.

GUARDRAIL ..... Chain Link  
 Fence w/ 3/4" cables 9" & 30" above Pvmf.  
 POST ..... 2 1/4" - 4.1 #  
 H Section Fence Post.  
 POST SPACING ..... 8' O.C.  
 LENGTH OF INSTALLATION ... 192'  
 GROUND CONDITION ..... Dry

DUMMY INJURY ..... Minor Bruises & possible neck injuries.  
 GUARDRAIL DAMAGE ..... 80' of Fence knocked out. No damage  
 to Cables.  
 POST DAMAGE ..... 11 Posts damaged beyond repair.  
 VEHICLE DAMAGE ..... \$600.  
 MAX. DYNAMIC DEFLECTION OF RAIL ... 8'-6"

TEST NO. .... 14  
 DATE ..... 12-26-58  
 VEHICLE ..... Chev. 53 Sedan  
 SPEED ..... 61 MPH  
 IMPACT ANGLE .... 31 °  
 VEHICLE WEIGHT ... 4000  
 (W/DUMMY & INSTRUMENTATION)

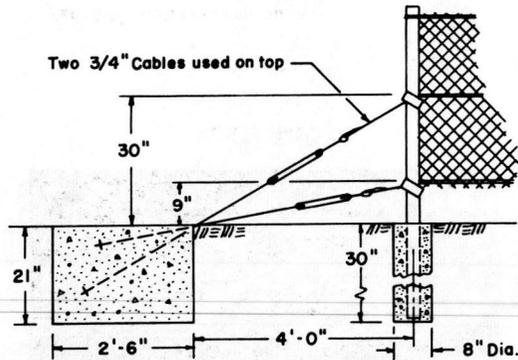
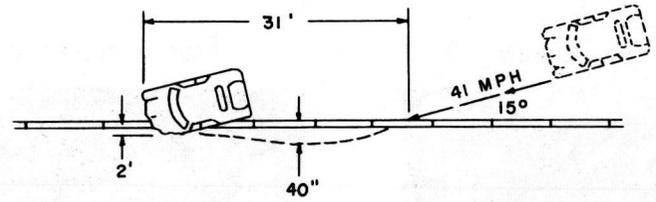
Figure 17. Test data information sheets.

GUARDRAIL ..... 36" Chain Link  
 Fence w/3/4" cables 9" & 30" above pvmt.  
 POST ..... 2 1/4"-4.1 #  
 H Section Fence Post  
 POST SPACING ..... 8' O.C.  
 LENGTH OF INSTALLATION ... 400'  
 GROUND CONDITION ..... Dry

DUMMY INJURY ..... Minor Bruises  
 GUARDRAIL DAMAGE ..... 35' of Fence knocked out. No damage  
 to cables.  
 POST DAMAGE ..... 4 Posts damaged beyond repair.  
 VEHICLE DAMAGE ..... \$ 400.  
 MAX. DYNAMIC DEFLECTION OF RAIL ... 40"  
 VEHICLE DECELERATION (PEAK)... Long. 55 G ... Transv. 22 G  
 DUMMY DECELERATION (PEAK)..... Long. 3 G ... Transv. 2 G

TEST NO ..... 19  
 DATE ..... 3-5-59  
 VEHICLE ..... Chev. 53 Sedan  
 SPEED ..... 41 MPH  
 IMPACT ANGLE ..... 15°  
 VEHICLE WEIGHT.... 3700  
 (W/DUMMY & INSTRUMENTATION)

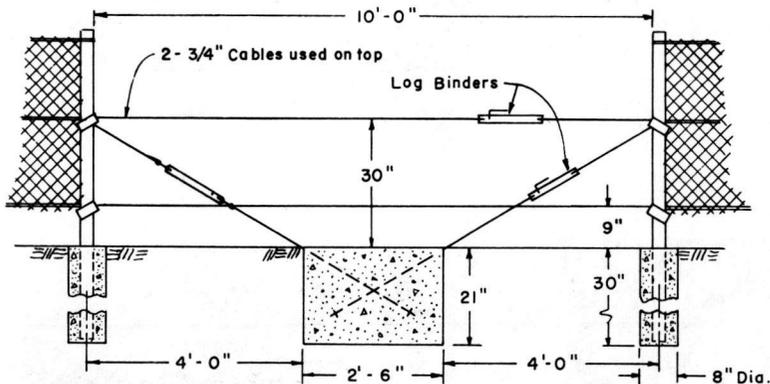
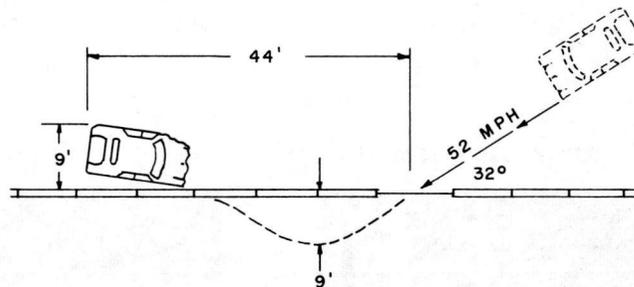
Figure 18. Test data information sheets.

GUARDRAIL ..... 36" Chain Link  
Fence w/ 3/4" cables 9" & 30" above  
pvt. Impact point at center of  
emergency crossover.  
POST ..... 2 1/4"-4.1 #  
H Section Fence Post  
POST SPACING ..... 8' O.C.  
LENGTH OF INSTALLATION ... 400'  
GROUND CONDITION ..... Dry

DUMMY INJURY ..... Severe Chest & Internal Injuries  
GUARDRAIL DAMAGE ..... 24' of Fence knocked out.  
10' of Cable damaged.  
POST DAMAGE ..... 4 Posts damaged beyond repair.  
2 Posts Bent.  
VEHICLE DAMAGE ..... Total Loss  
MAX. DYNAMIC DEFLECTION OF RAIL .. 9'  
VEHICLE DECELERATION (PEAK) .... Long. 53 G ... Transv. 34 G  
DUMMY DECELERATION (PEAK).... Long. NG ... Transv. 6 G

TEST NO. .... 20  
DATE ..... 3-10-59  
VEHICLE ..... Chev. 54 Sedan  
SPEED ..... 52 MPH  
IMPACT ANGLE .... 32°  
VEHICLE WEIGHT ... 3700  
(W/DUMMY & INSTRUMENTATION)

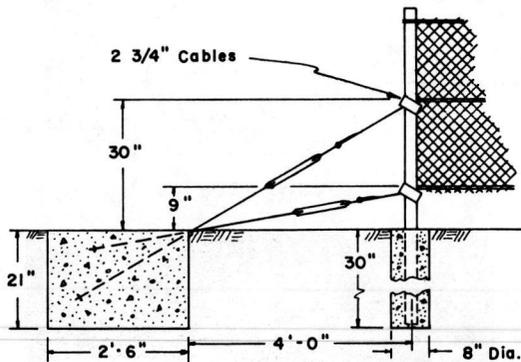
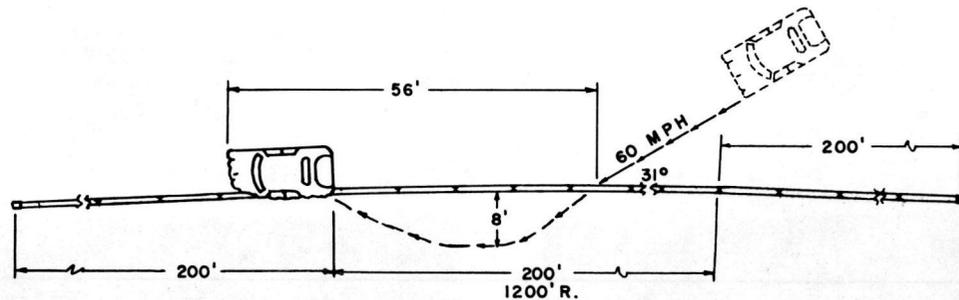
Figure 19. Test data information sheets.

GUARDRAIL ..... 36" Chain Link  
 Fence w/ 2 3/4" cables 9" & 30" above pvmt.  
 POST ..... 2 1/4" - 4.1 #  
 H Section Fence Post.  
 POST SPACING ..... 8' O.C.  
 LENGTH OF INSTALLATION... 600'  
 GROUND CONDITION ..... Wet

DUMMY INJURY ..... Scalp laceration, possible chest injuries.  
 GUARDRAIL DAMAGE ..... 56' of fence knocked out. No damage  
 to cables.  
 POST DAMAGE ..... 12 posts damaged beyond repair.  
 VEHICLE DAMAGE ..... Total loss.  
 MAX. DYNAMIC DEFLECTION OF RAIL ... 8'  
 VEHICLE DECELERATION (PEAK) ... Long. NG ... Transv. NG  
 DUMMY DECELERATION (PEAK) ..... Long. 6G ... Transv. 4G

TEST NO. .... 21  
 DATE ..... 3-20-59  
 VEHICLE ..... Chev. 53 Sedan  
 SPEED ..... 60 MPH  
 IMPACT ANGLE ... 31°  
 VEHICLE WEIGHT... 3850  
 (W/DUMMY & INSTRUMENTATION)

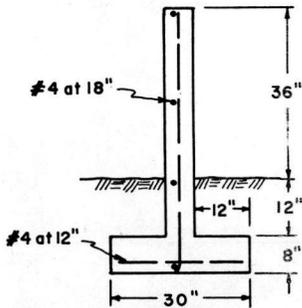
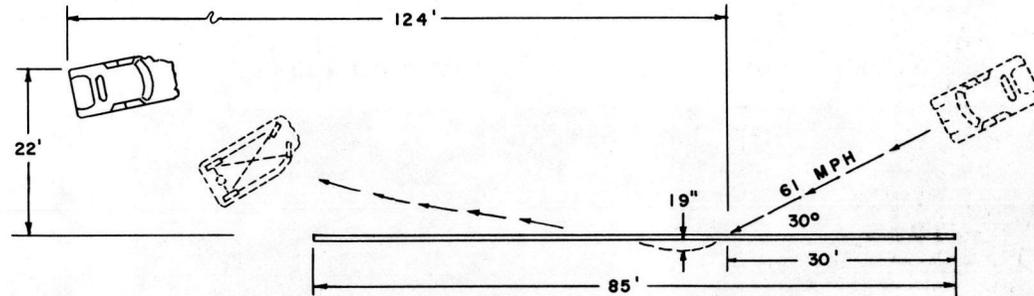
Figure 20. Test data information sheets.

Rigid barriers are represented in this series by only one test (Fig. 20), but this test was supplemented by information gained during dynamic tests of five bridge rails performed and reported in 1955 and two concrete bridge rails tested during this series. As shown by the test data sheet, this design failed during tests.

Indications from the results of Test No. 22 (Fig. 20) are that the design of this rail needs only a slight amount of stiffening to make it serve under heavy collisions. Previous tests on bridge rails indicate that a wall as low as 27 in. in height could be effective as long as it did not fail. The reflective action from a properly designed concrete wall, as indicated by previous tests conducted on bridge rails, shows that the offending vehicle will reflect from the concrete wall with an abrupt change in direction and with high decelerations caused by the extremely rapid reflection of the vehicle from the non-deflecting surface. There is good opportunity, however, for evasive action by following cars in that the reflection angle is normally flat and due to the damaged colliding wheel the car tends to curve back into the rail and come to rest against it. There is even less opportunity of evading stalled traffic ahead after collision than there is with the semi-rigid-type barrier.

The failure of the light concrete wall used in Test No. 22 served to illustrate again the fact that when a rail "lays over" during a heavy col-

GUARDRAIL ..... 36" Conc.  
 Wall, 6" Thick.  
 REINFORCING BAR SPACING... #4 at 12" Vert.  
 #4 at 18" Horiz.  
 LENGTH OF INSTALLATION ... 85'  
 GROUND CONDITION ..... Wet

DUMMY INJURY ..... Concussion, severe shoulder & chest injuries.  
 GUARDRAIL DAMAGE ..... 20' Wall broken  
 VEHICLE DAMAGE ..... Total loss  
 MAX. DYNAMIC DEFLECTION OF RAIL... 22"  
 VEHICLE DECELERATION (PEAK) ... Long. 112G ... Transv. 72G  
 DUMMY DECELERATION (PEAK) ..... Long. 21G ... Transv. 25G

TEST NO. .... 22  
 DATE ..... 3-30-59  
 VEHICLE ..... Chev. 53 Sedan  
 SPEED ..... 61 MPH  
 IMPACT ANGLE .... 30°  
 VEHICLE WEIGHT ... 3850  
 (W/DUMMY & INSTRUMENTATION)

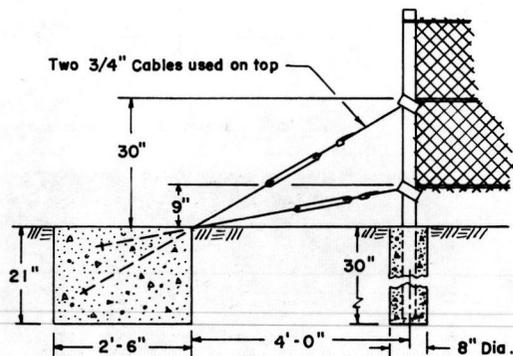
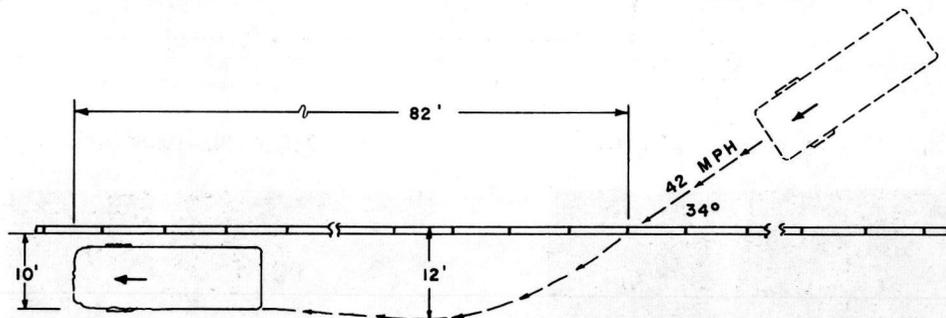
Figure 21. Test data information sheets.

GUARDRAIL ..... 36" Chain Link  
fence w/ 3/4" cables 9" & 30" above pvmt.  
POST ..... 2 1/4" - 4.1#  
H Section Fence Post.  
POST SPACING ..... 8' O.C.  
LENGTH OF INSTALLATION ... 304'  
GROUND CONDITION ..... Dry

DUMMY INJURY ..... Left shoulder injuries.  
GUARDRAIL DAMAGE ..... 90' of fence knocked out. No damage  
to cables.  
POST DAMAGE ..... 23 Posts damaged beyond repair.  
VEHICLE DAMAGE ..... \$ 1200  
MAX. DYNAMIC DEFLECTION OF RAIL ... 12'  
DUMMY DECELERATION (PEAK) .... Long. 2.8G .. Transv. 9.3 G

TEST NO. .... 23  
DATE ..... 4 - 21 - 59  
VEHICLE ..... 1937 - 40 pass. Bus  
SPEED ..... 42 MPH  
IMPACT ANGLE .... 34°  
VEHICLE WEIGHT ... 17,500  
(W/DUMMY & INSTRUMENTATION)

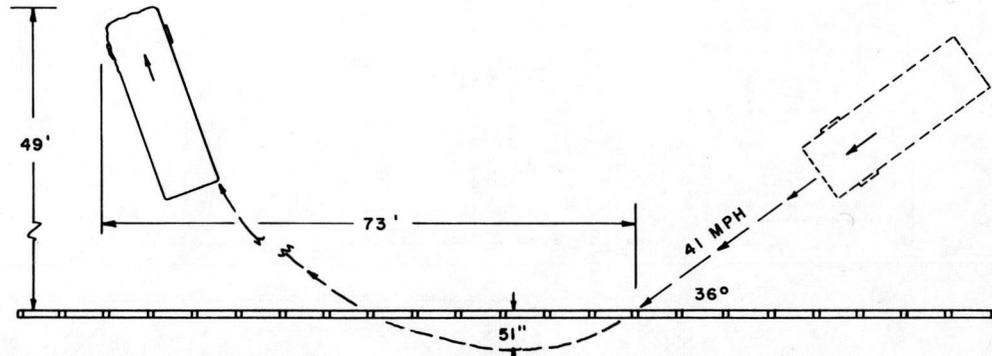
Figure 22. Test data information sheets.

During the study period prior to actual testing, many different designs were considered by the median barrier committee. A selection of designs shown in Figures 3-11, and 13 were selected to best investigate this general classification. These designs were selected for two reasons. The first was that almost all were already in use either in California or in other states or toll road authorities throughout the United States. The other was that the selection represented a good opportunity to investigate both types and spacing of posts as well as types and heights of rails. The results that came from testing this series of designs indicated that a composite design as shown in Figure 24 should be most successful. The two tests (Figs. 15 and 22) confirmed these findings.

GUARDRAIL ..... W Section  
 CHANNEL ..... 6"  $\square$  8.2 #  
 BRACKET ..... 8x8x12 D.F. Block  
 POST ..... 8 x 8 D.F.  
 POST SPACING ..... 6'-3" O.C.  
 LENGTH OF INSTALLATION ... 125'  
 GROUND CONDITION ..... Dry

DUMMY INJURY ..... Critical head, neck & shoulder injuries; severe body bruises.  
 GUARDRAIL DAMAGE ..... 7 Sections damaged beyond repair.  
 CHANNEL DAMAGE ..... 4 Damaged beyond repair.  
 POST DAMAGE ..... 5 Damaged beyond repair.  
 VEHICLE DAMAGE ..... \$ 1,500  
 MAX. DYNAMIC DEFLECTION OF RAIL .. 58"  
 DUMMY DECELERATION (PEAK) .... Long. 6G ... Transv. 25 G

TEST NO. .... 24  
 DATE ..... 4- 30-59  
 VEHICLE ..... 1937-40 pass. Bus.  
 SPEED ..... 41 MPH  
 IMPACT ANGLE ... 36°  
 VEHICLE WEIGHT ... 17,500  
 (W/DUMMY & INSTRUMENTATION)
