An Experiment in Pavement Slab Design

W. E. CHASTAIN, SR., and JOHN E. BURKE, respectively, Engineer of Physical Research and Assistant Engineer of Physical Research, Illinois Division of Highways

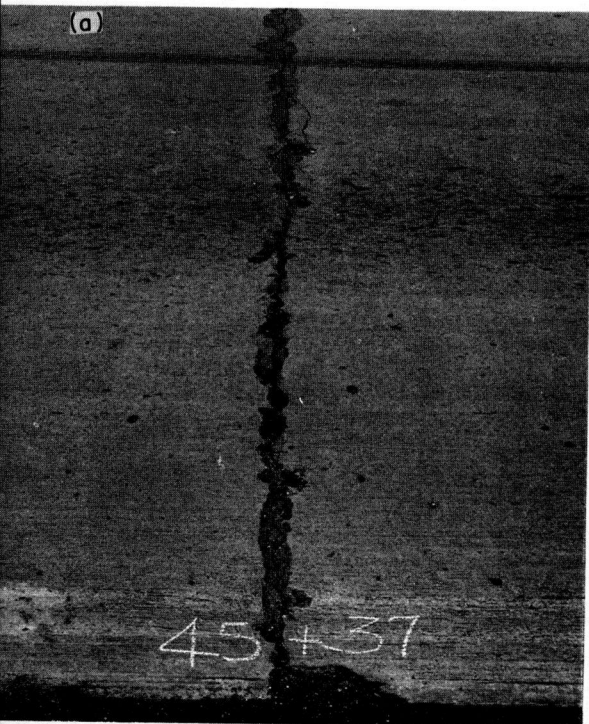
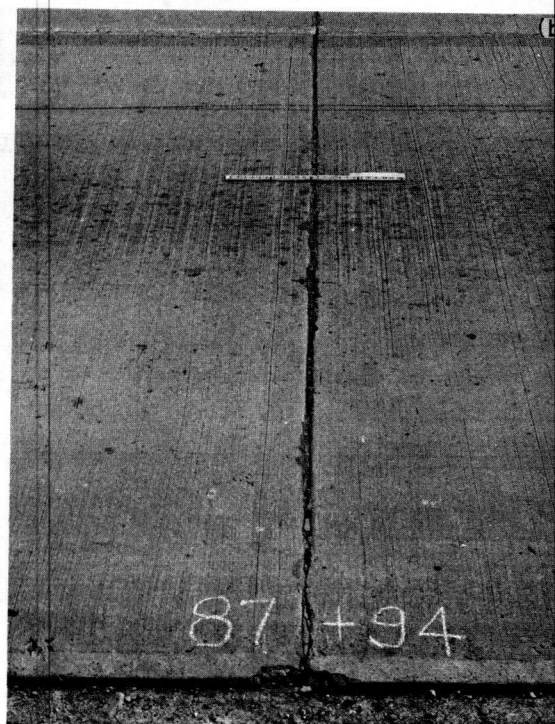
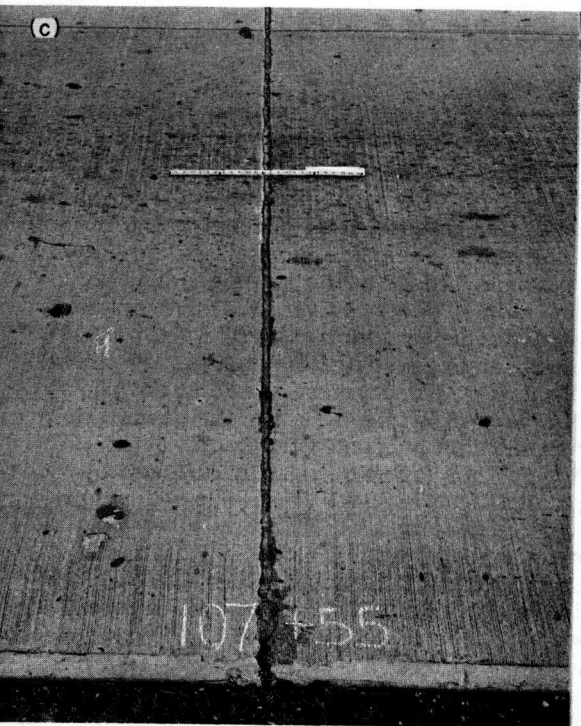
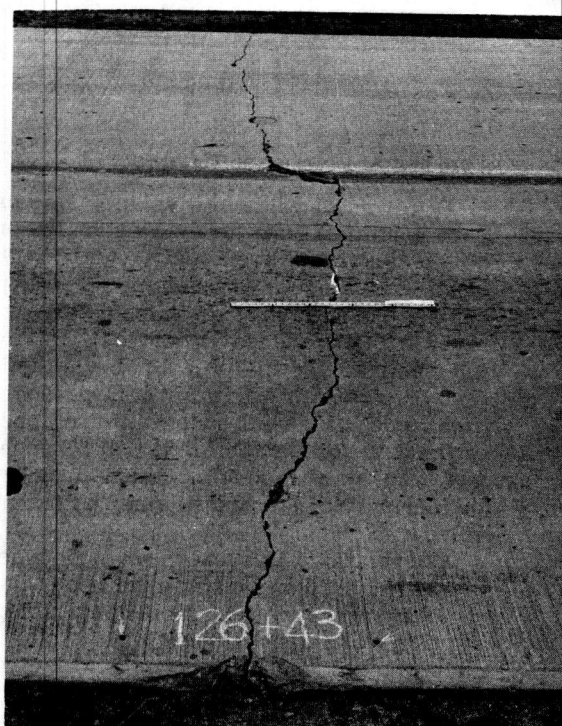
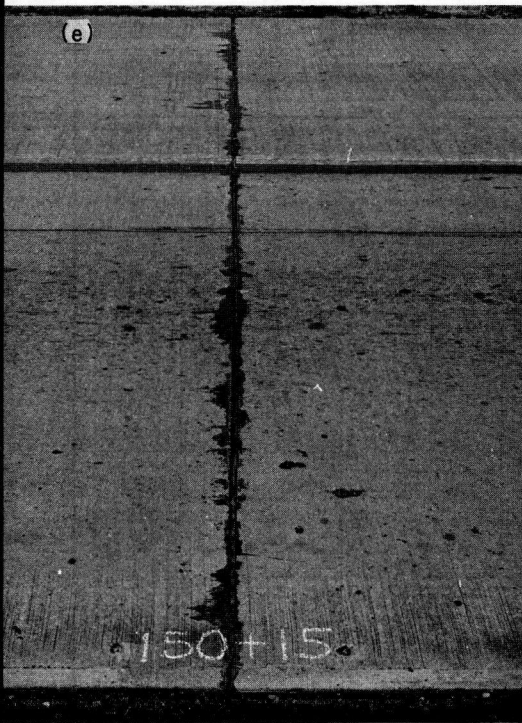
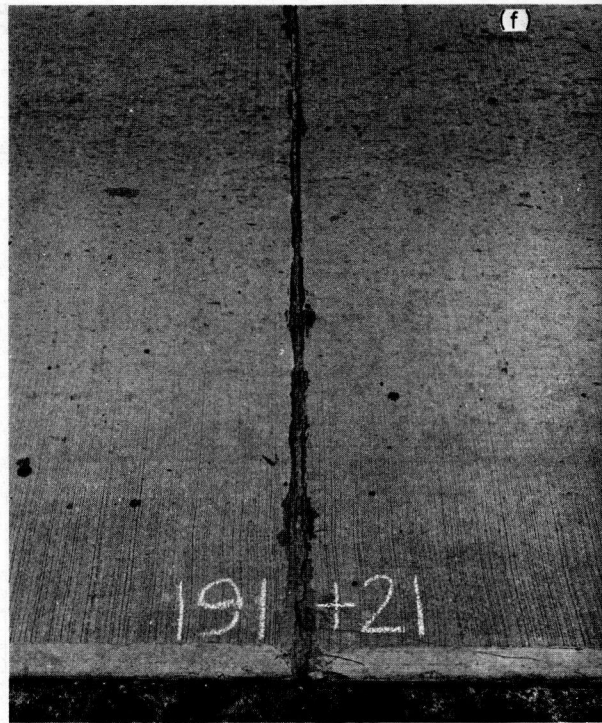
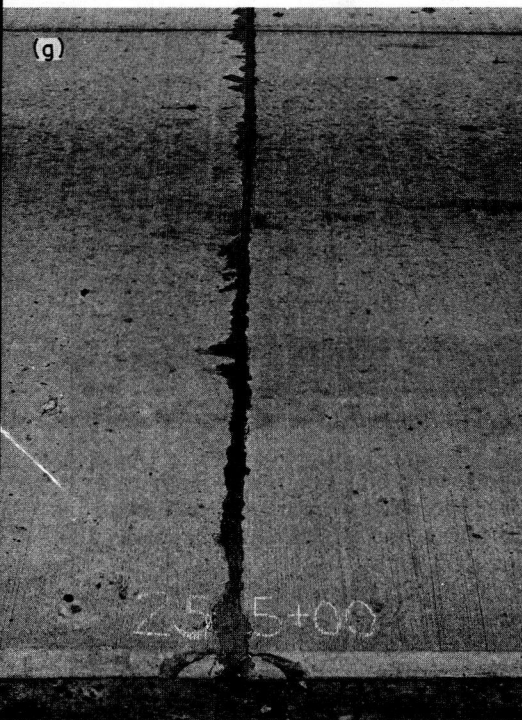
Photographs showing typical conditions at joints and cracks in March 1954 at the end of two winters following construction are presented in Figure 5.

Figure 5. Typical joint and crack conditions two years after construction (March 1954), showing: (a) unedged metal-plate joint, 100-ft spacing, cold-applied sealing compound; (b) edged metal-plate joint, 100-ft spacing, cold-applied sealing compound; (c) dummy-groove joint, 20-ft spacing, cold-applied sealing compound; and (d) crack in nonjointed pavement, no seal applied. Figure 5 (Continued), showing: (e) sawed joint, $\frac{1}{2}$ -in. groove, 100-ft spacing, cold-applied sealing compound; (f) dummy-groove joint, 100-ft spacing, cold-applied sealing compound; and (g) dummy-groove joint, 100-ft spacing, hot-poured sealing compound.

Reference is again made to Figure 5 where photographs of typical joint and crack conditions two years after construction are shown.

Spall.—Spall, as would be expected, has occurred where edging was omitted at the full-depth metal-plate joints. Such spall is widespread but not of great depth or width. Spall is also much in evidence at the cracks in the unjointed pavements. This spall is also widespread and in a few instances quite severe with respect to depth and width. Very little spall has occurred elsewhere.

Condition of Seal.—Of two rubber-asphalt sealing materials which were used, one a hot-poured material and the other a cold-applied material, the hot-poured material showed somewhat better adhesion to the concrete and greater resistance to cracking and removal. Neither material was ever completely effective in cold weather under the conditions of this particular project.

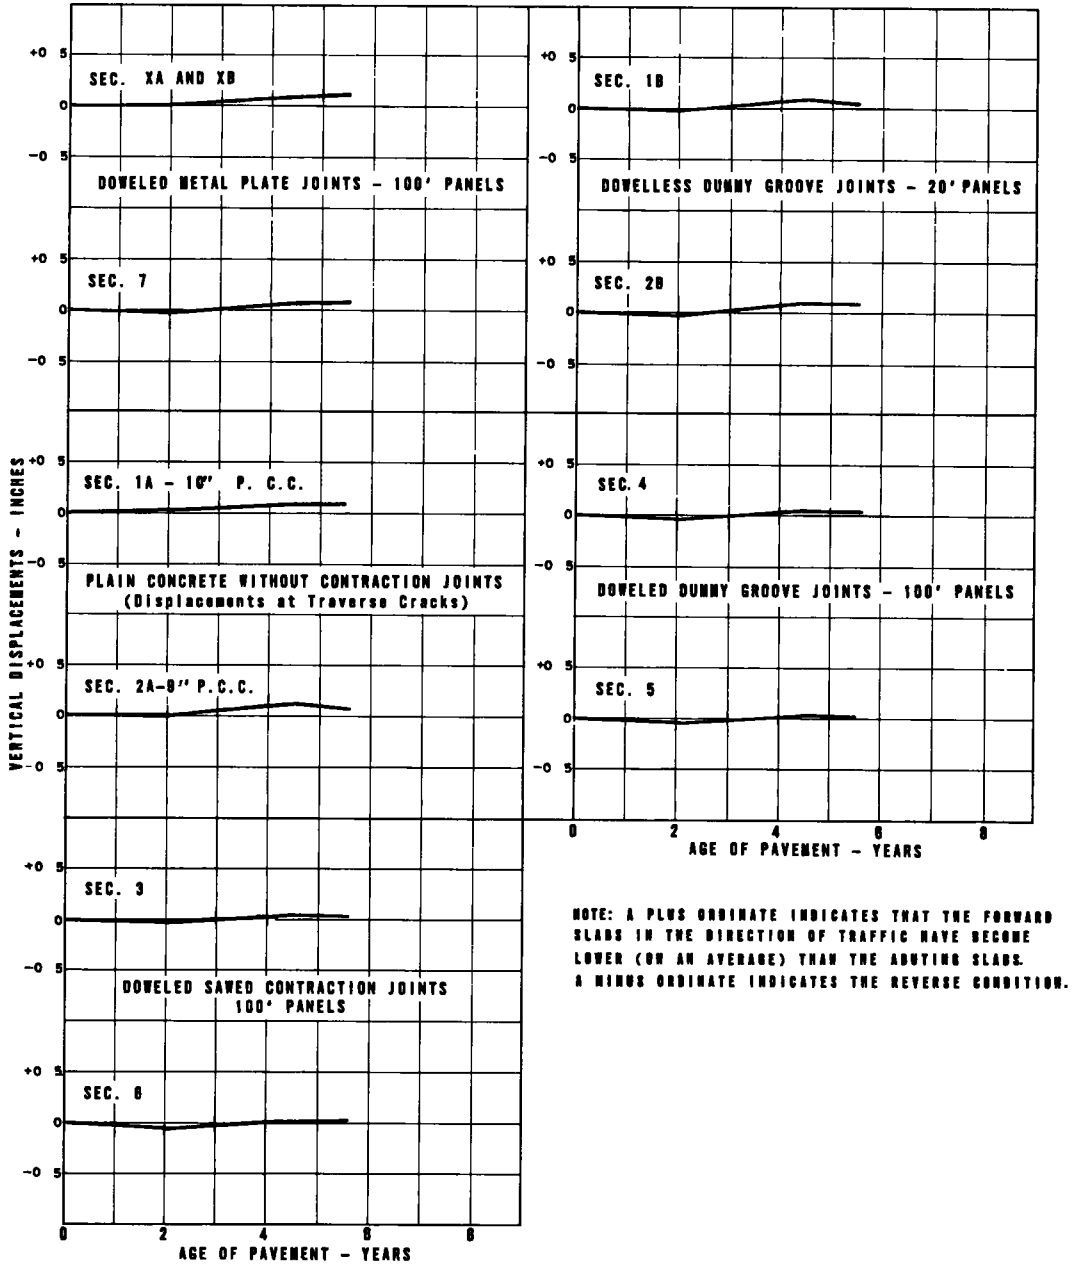
Long-Term Slab Movements.—Long-term slab movements at joints and cracks have occurred in both vertical and horizontal directions. Averages of the vertical displacements measured at joints of the individual test sections during the first five years of pavement life are shown in Figure 6. It will be noted that average displacements are very slight thus far, although there is an apparent tendency toward an increase with age. The forward slabs in the direction of traffic are, on the average, becoming lower than the abutting slabs. No significant differences in the behavior of the individual test sections are apparent.

Figure 6. Vertical displacements of abutting ends of pavement slabs.

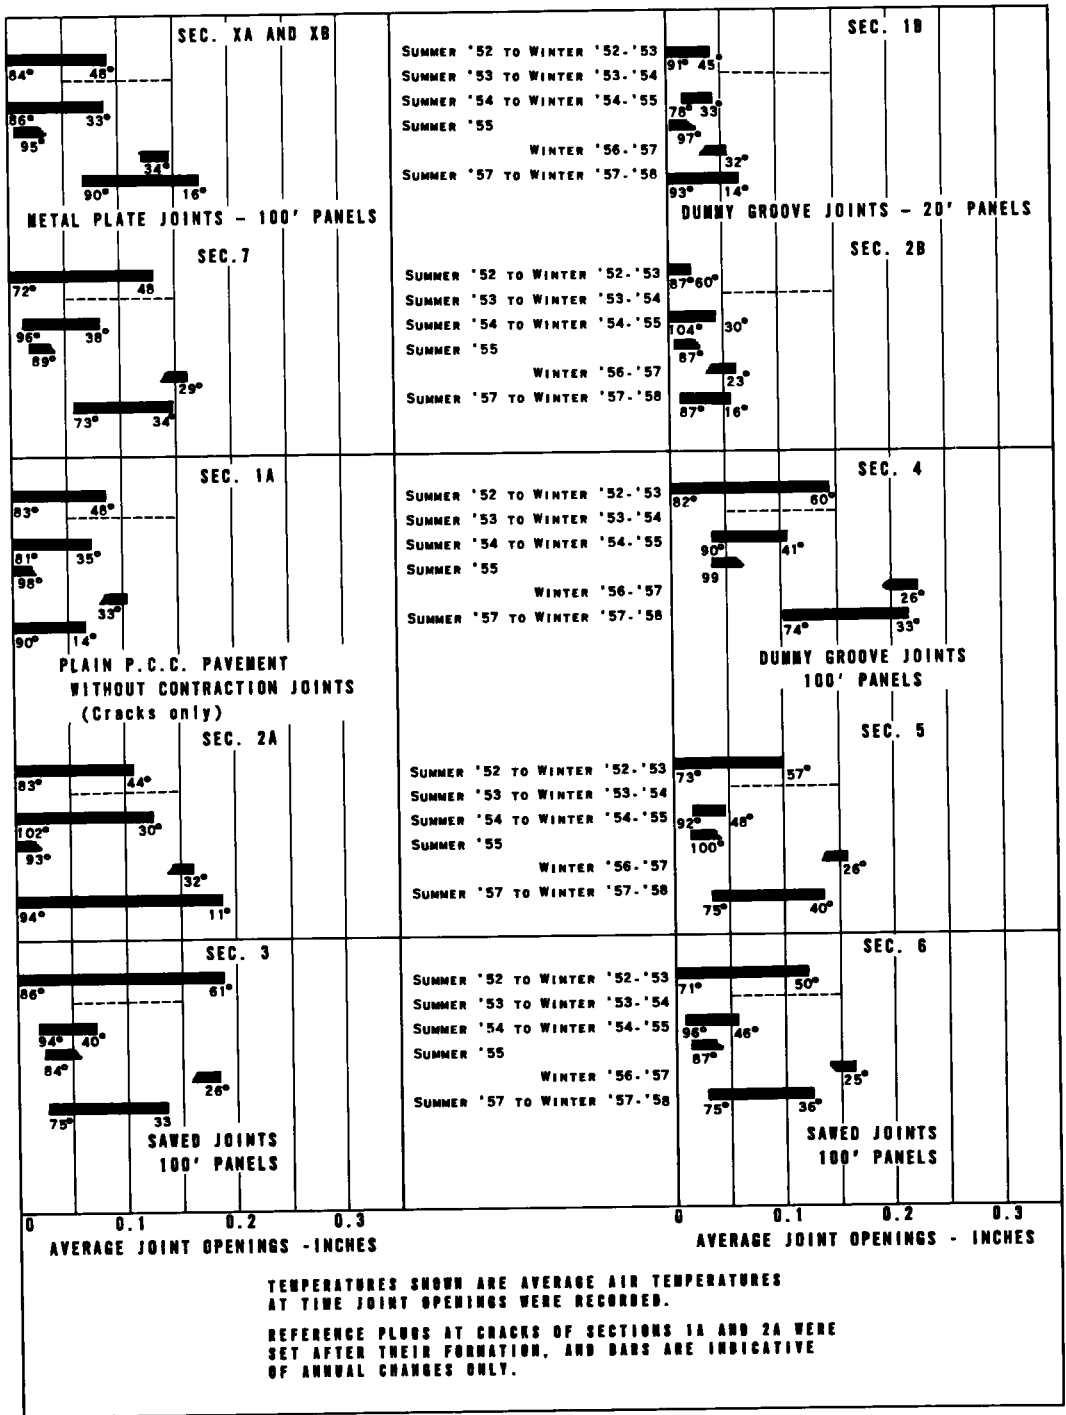
A conventional analysis of horizontal slab movement at joints and cracks is depicted in Figure 7. Although gaps in the field data reduce the value of the analysis, trends that were to be anticipated from the results of similar studies elsewhere are apparent. Opening and closure movements are least for the closely spaced joints (Sections 1B and 2B having 20-ft panels). Joints and cracks of all sections show a tendency to not return to complete closure. Joints spaced at 100-ft intervals maintain greater openings during hot weather than do the joints spaced at 20-ft intervals.

Figure 7. Annual and progressive changes in openings of transverse joints and cracks.
