# Culvert Inlet Failures—A Case History

ROY C. EDGERTON, Research Engineer, Oregon State Highway Department

Bent-up ends have been experienced on three large structural plate culverts installed with the upstream ends square and projecting to the fill toe.

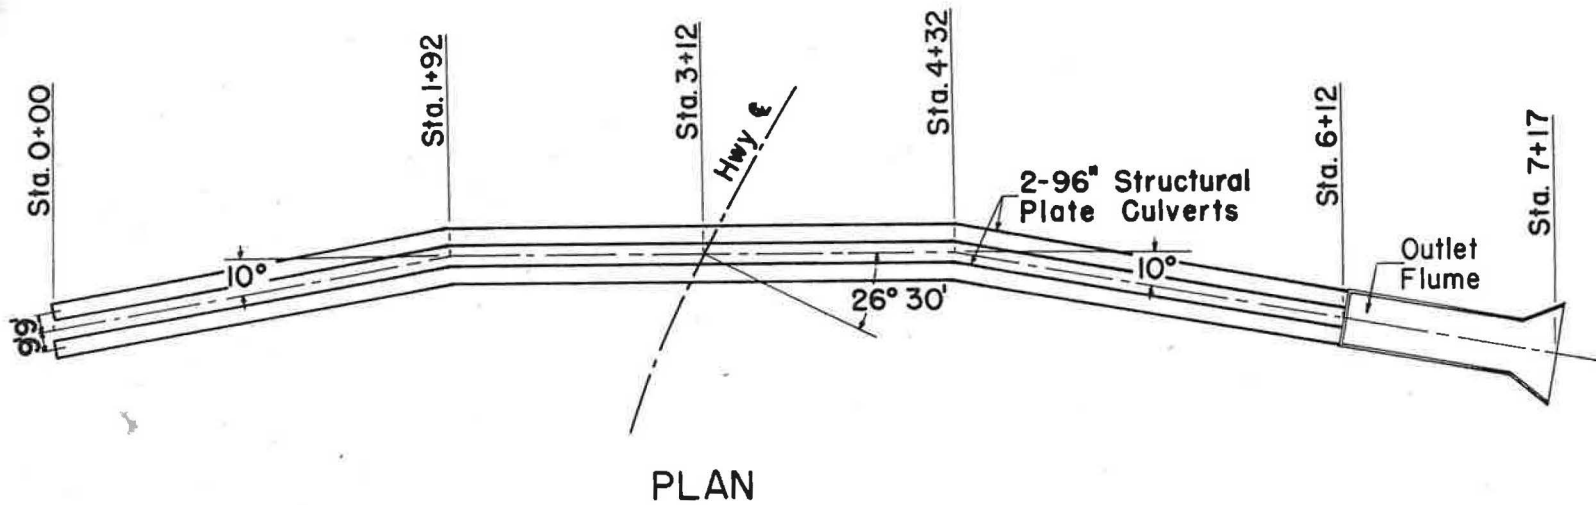
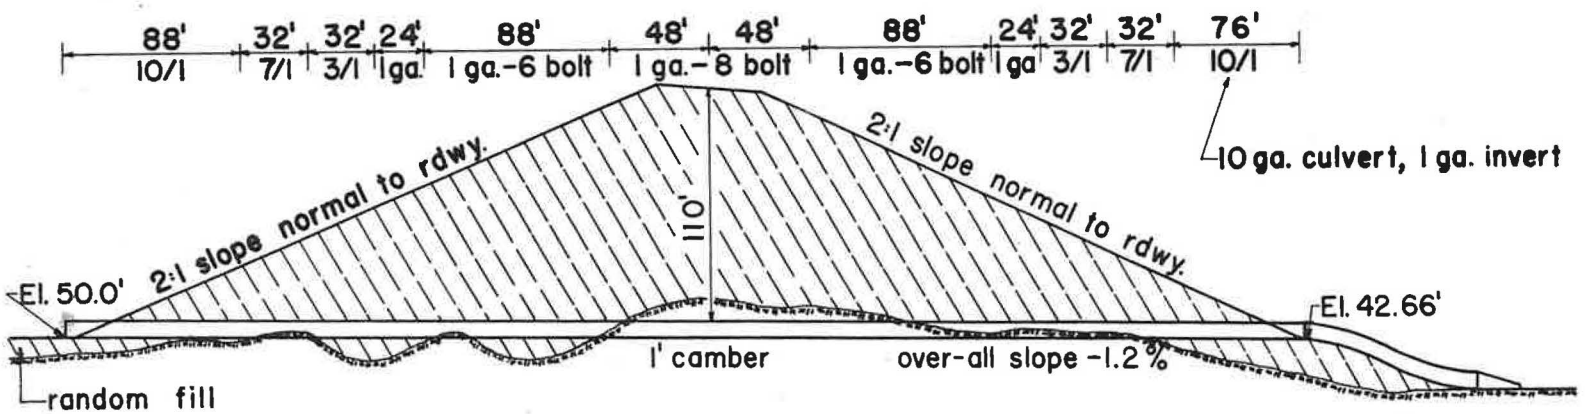
Figure 1. Burnt Hill Creek installation.

Figure 1 shows the Burnt Hill Creek installation in plan and section. The two 96-in. structural plate culverts vary from 1 gage at the center to 10 gage at the ends with 1-gage inverts throughout. The length is 612 ft. The upstream ends are square and extend to the fill toe; the entrances are thus of the projecting type. The culverts outlet into a concrete flume. The culverts were staked according to the plan which called for a 1.2 percent over-all slope with 1-ft camber at the center. From profiles taken in the undisturbed portions of the culverts after failure, it seems probable that at the time of failure the slopes of the inlet sections were steeper than the over-all design slope and supercritical.

The fill slope was 2:1 normal to the centerline. Since the upstream leg of the culverts was skewed about  $30^{\circ}$  with the normal, the actual slope in the direction of the culverts was about 2.3:1. The culvert inverts were placed above the channel bottom and the channel upstream was raised to invert elevation by a random fill. The resulting approach channel was approximately level for about 300 ft upstream from the culverts.

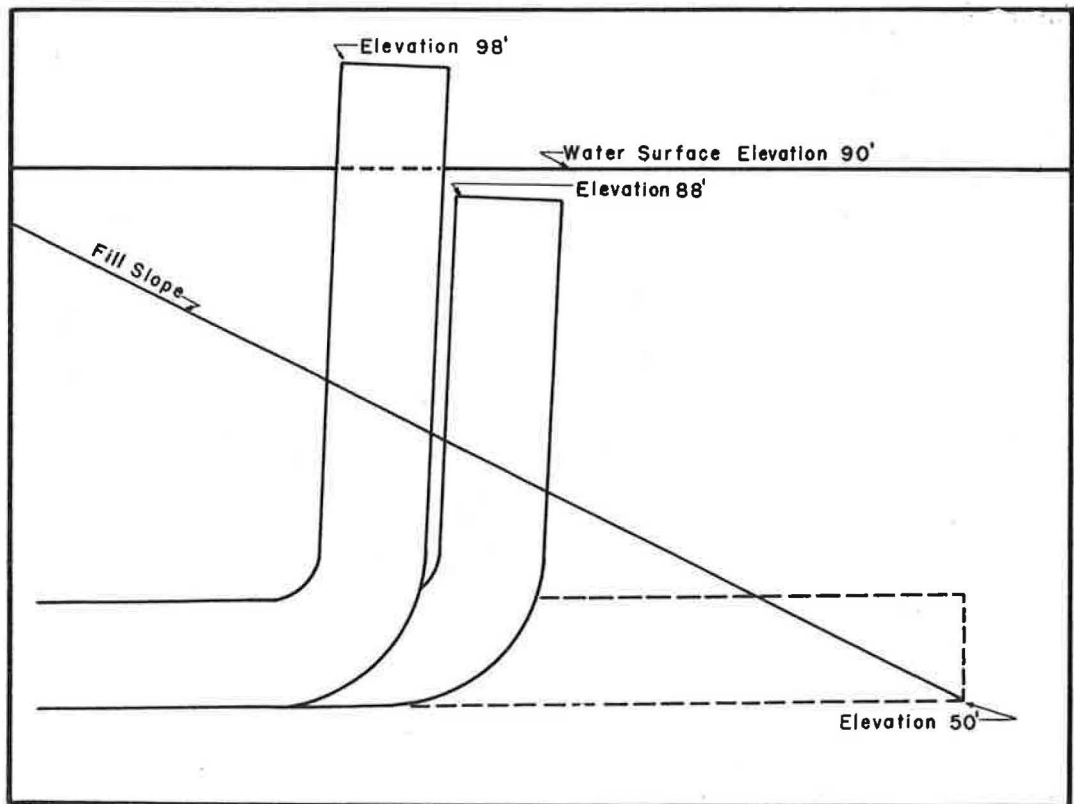
Figure 2. Schematic sketch of Burnt Hill culverts failure.

On the morning of January 9, following an intense storm, the situation shown in Figure 2 was found at the Burnt Hill Creek site. Similar conditions were found at Whiskey Creek. In all cases, the bends were smooth, well formed elbows with straight, undistorted sections of pipe extending upward from the bends.

some 18 ft of pipe. The distances from the centers of the bends to the original upstream ends were about 44 ft for the south culvert and 34 ft for the north culvert.

The known facts point to buoyancy as the cause of the failures. The verification of this would require that the moment applied to a culvert by external forces be compared with the resisting moment of the culvert. This has not been possible since no data on the longitudinal bending properties of structural plate culverts have been found. External moment calculations were made for a 96-in. culvert of the type used at Burnt Hill Creek. A headwater depth of 96 percent of the diameter was used as preliminary calculations indicated that this produced the highest moment of any unsubmerged depth. The assumptions for the moment calculations are shown in Figure 4. A discharge of 340 cfs was used.

The culverts were replaced as originally installed except that the fill slopes in the vicinity of the entrances were steepened to about 0.5:1 with a facing of large rock riprap.

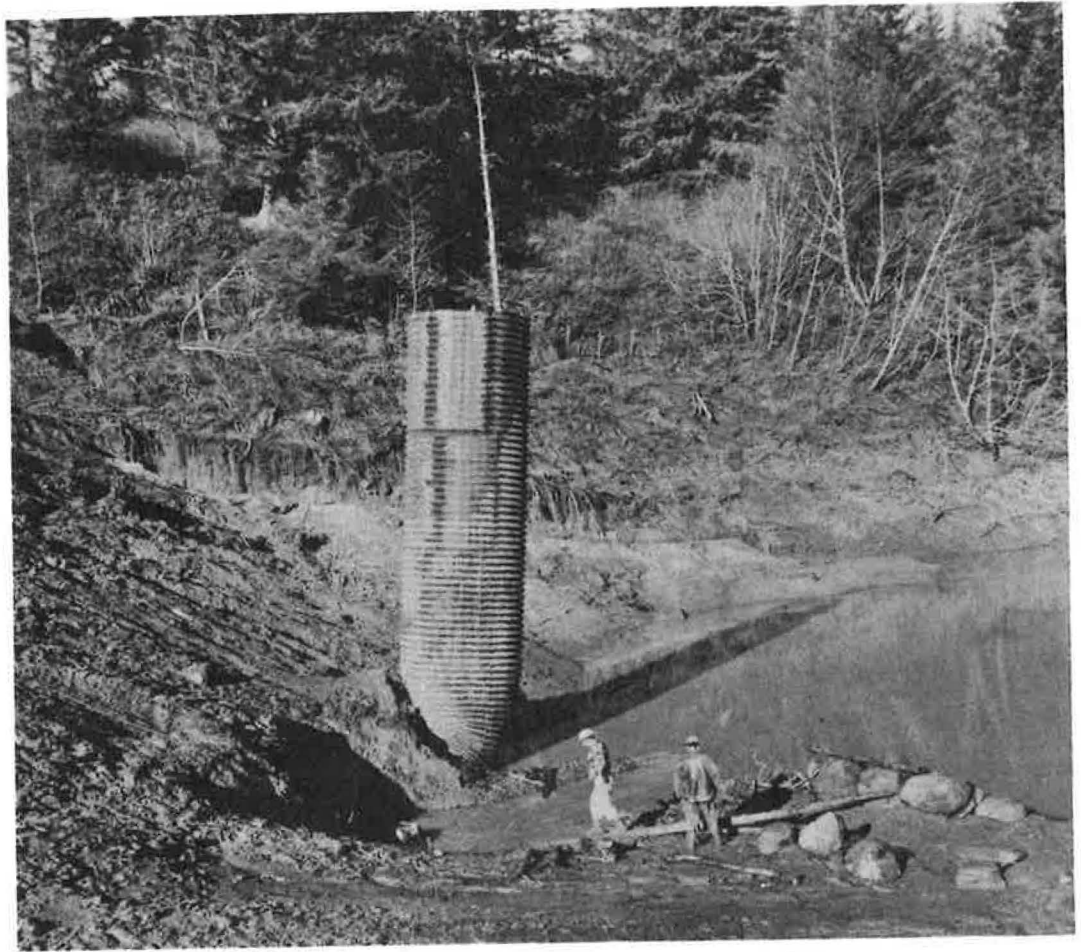
Figure 3. Burnt Hill Creek inlets.

The Whiskey Creek culvert and the south culvert at Burnt Hill Creek were blown off at the bend with ring charges to allow the ponds to drain. Figure 3 shows the Burnt Hill Creek installation after the blast. Although the blasts destroyed or distorted most of the bend area of two culverts, there was an opportunity to examine the north culvert at Burnt Hill Creek before and after disassembly. The corrugations in the 1-gage invert plates that formed the outside of the bend were extended quite uniformly from the original 6 in. to about 6.6 in. The corrugations in the 10-gage plates that formed the inside of the bend vary from 1 to 3 in., apparently depending on the amount and nature of fill material trapped in the folds. The curvature was not uniform, being sharpest at the center of the bend. There was about 25 ft of straight, undistorted pipe extending upward from the bend. The bends in the Burnt Hill Creek culverts occupied

As with photographs in general, Figure 3 was not intended for quantitative interpretation. The skew of the culvert with respect to the fill slope and the level of water in the pond makes this impossible. Figures 1, 2, and 4 were expected to serve the quantitative function. It should be noted that with a 96-in. culvert and an effective fill slope of 2.3:1 the slope line would intersect the top of the culvert about 18 ft from the end of the culvert.

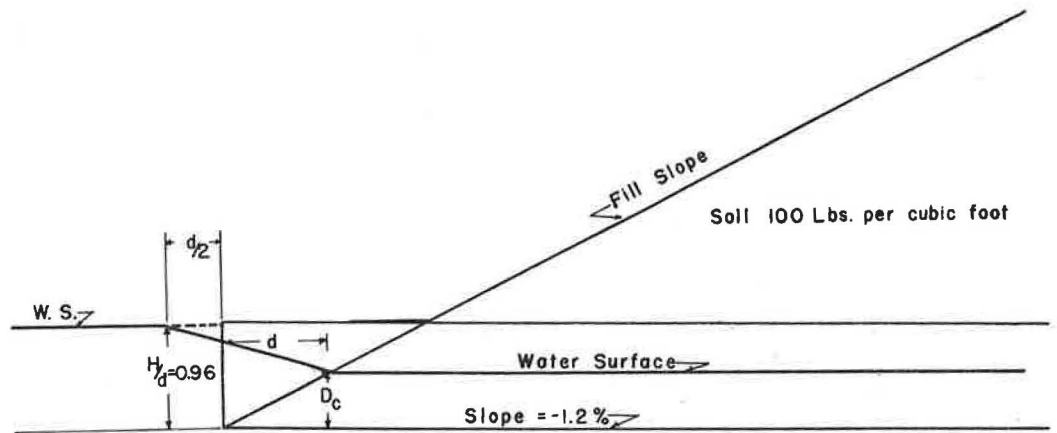
Figure 4. Assumed entrance conditions.

Moments were calculated for fill slopes from 0.5:1 to 2.5:1. The magnitudes and locations of the maximum moments are listed in Table 1. Within this range, the maximum moment more than doubles for each half unit flattening of the slope. This might explain how large structural plate culverts with projecting ends have been used successfully with steep fill slopes. The locations of the maximum moments can be considered to agree with the locations of the bends at Burnt Hill within the accuracy of the basic assumptions.

From calculations based on the assumed conditions, it is felt that the culverts would not have failed had the fill slope existed as shown in Figure 4. It is obvious that the pressure created by the headpond level acts around the culvert's circumference near its entrance and throughout its length by infiltration into the bank, the seepage line decreasing very slowly downstream almost parallel to the gradient line inside the culvert (Fig. 6). The uplift force is, therefore, equal to the weight of the volume of water which would occupy that volume of the culvert between the outside water level and the inside water level. This difference in levels is greater than, but roughly equal to the velocity head of the flow in the culvert  $V^2/2g$ . This uplift force, although appreciable, is not sufficient to lift the culvert, a wedge of the embankment ballast, and simultaneously overcome the culvert's resistance to bending properties.

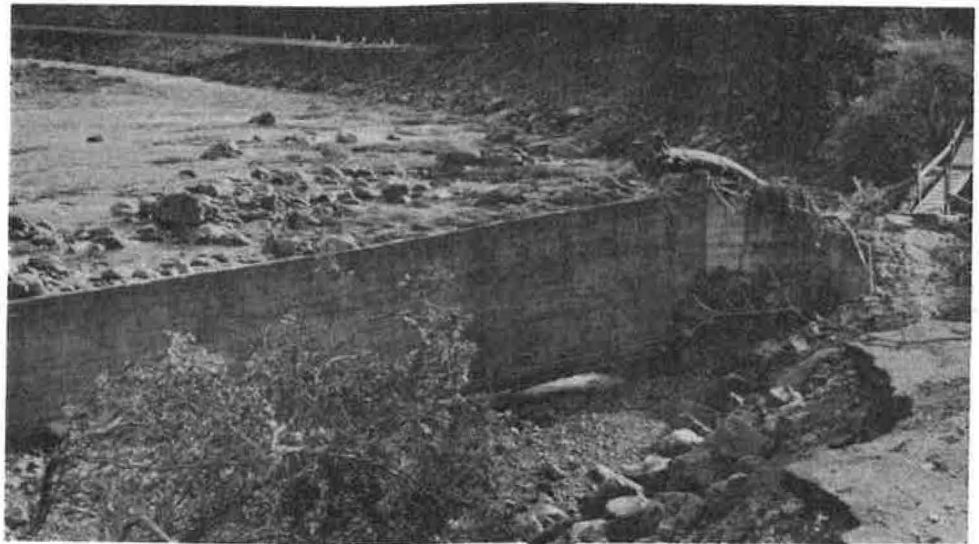
Flotation is not limited to metal pipes. During the flood of December 1955, an 8- by 8- by 48-ft RC box culvert, built in 1926 at the mouth of Cold Canyon along Merced River, jammed with drift and floated out intact, wingwalls included. The structure weighed 90 tons displaced 132 tons and carried an overfill of 34 tons so that net buoyancy was 8 tons less what little water was still inside. Overlapping the highway increased the uplift. It came to rest 15 ft nearer the river and 5 ft downstream (Fig. 5).

Figure 5. Flotation failure of 8x8x48-ft RC box culvert at mouth of Cold Canyon, Merced River, California.

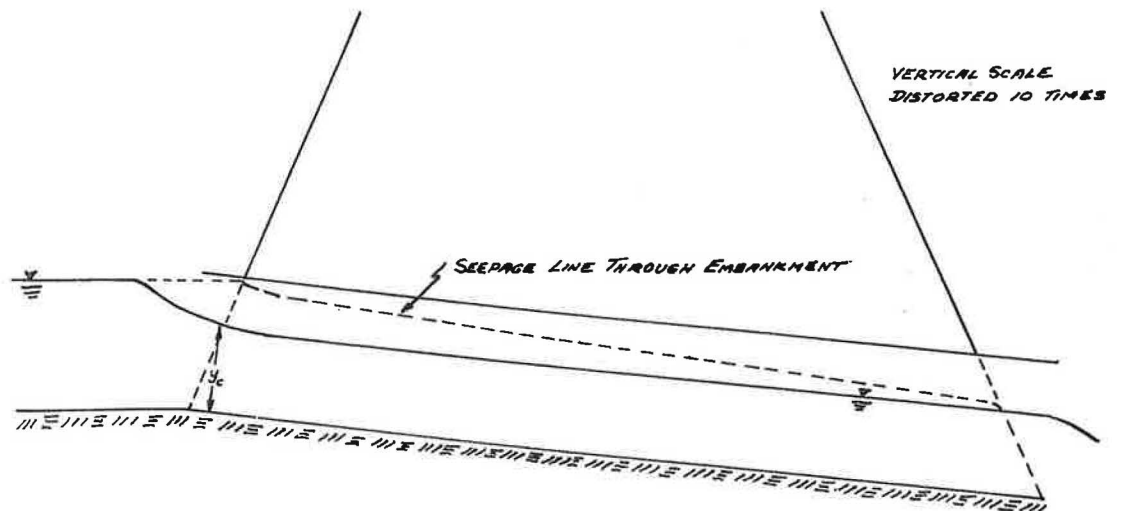
Figure 6.

culvert (at Burnt Hill Creek this length would appear to have been in the order of 25 ft), then the uplift force is sufficient to raise the culvert slightly. Once the pipe has lifted slightly, this phenomenon increases in magnitude. This is due to the fact that the headpond level is forced to rise (in order to discharge into the culvert), while the depth inside the bent section tends to decrease (since the velocity tends to increase with the increased slope); these two effects thereby increasing the difference between the inside and outside water levels.

It is the opinion of the writers that the failure was caused due to the combined facts that the culvert projected too far upstream of the fill slope and that the culvert was laid to too steep a grade.
