Comparative Studies of Combinations of Treated and Untreated Bases and Subbases for Flexible Pavements

CHARLES W. JOHNSON, Materials and Testing Engineer, New Mexico State Highway Department

INSPECTION COMMENTS, F-051-1 (8)

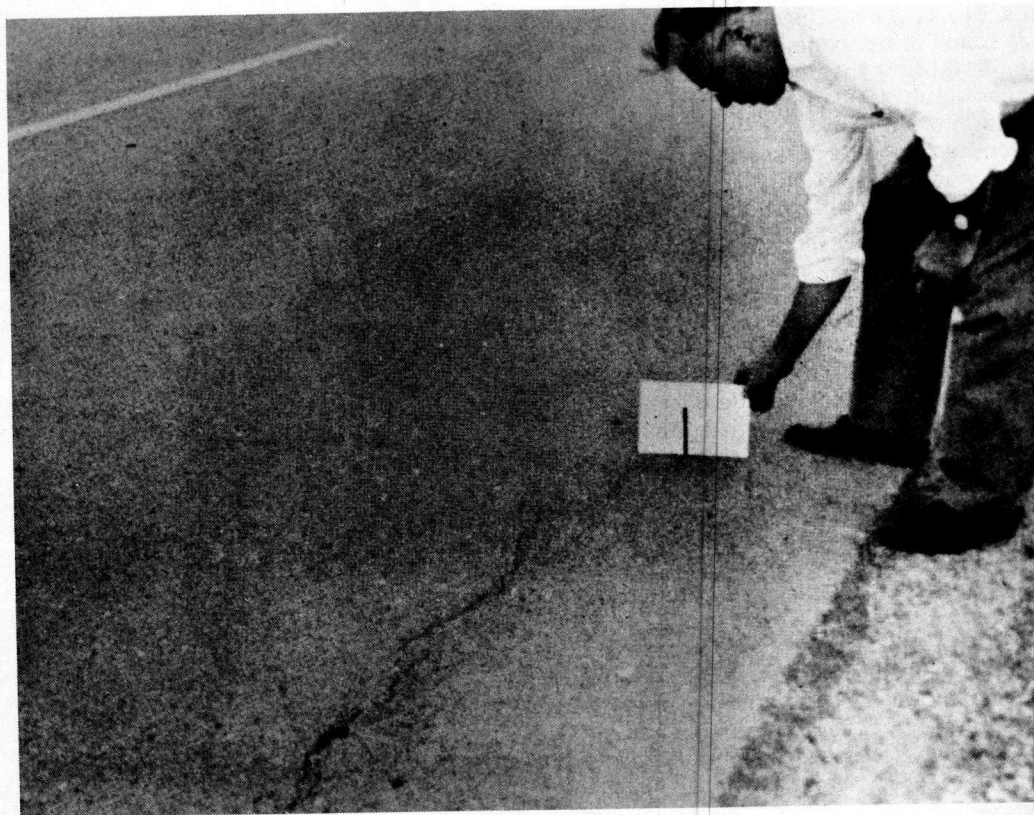
Figure 2. Station 360+00, longitudinal cracking 1 ft in from inner edge of passing lane, eastbound roadway, August 16, 1960.

After one year of heavy traffic, rutting in the surface had developed to a depth of ¼ in. on the Road Forks—East Project, I-010-1 (8) 6. No pronounced differences could be perceived in the upside down or conventional stabilizations. Longitudinal cracks about 1 ft from the paved shoulder are pronounced in the passing lane from station 326+15 to station 600+00, where the base was stabilized with 3 percent cement. From station 600+00 to station 800+00, where the subbase was treated with cement, the longitudinal cracks were located in the paved shoulder about 2 ft away, relative to the other crack position. Longitudinal cracks and rutting appear to be more associated with soil and moisture conditions than with the design of base and subbase courses. The road from

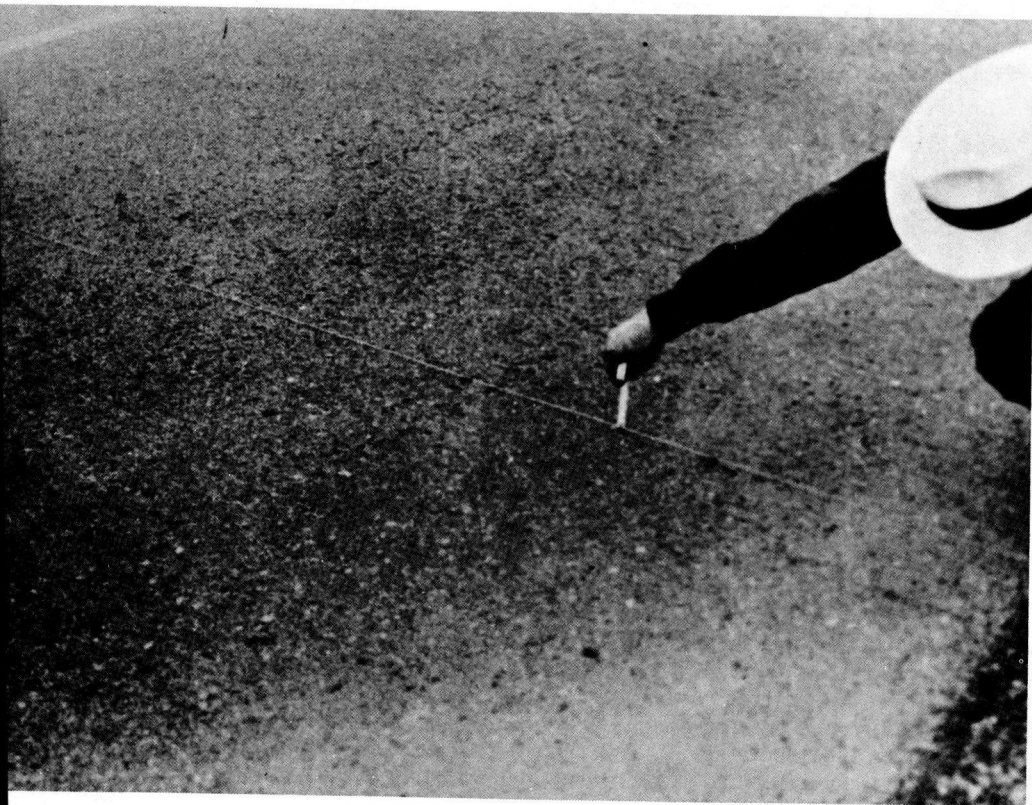
Fig. 3. Station 460+00, $\frac{1}{4}$ -in. rutting in outer wheel path of traffic lane, eastbound roadway, August 16, 1960.

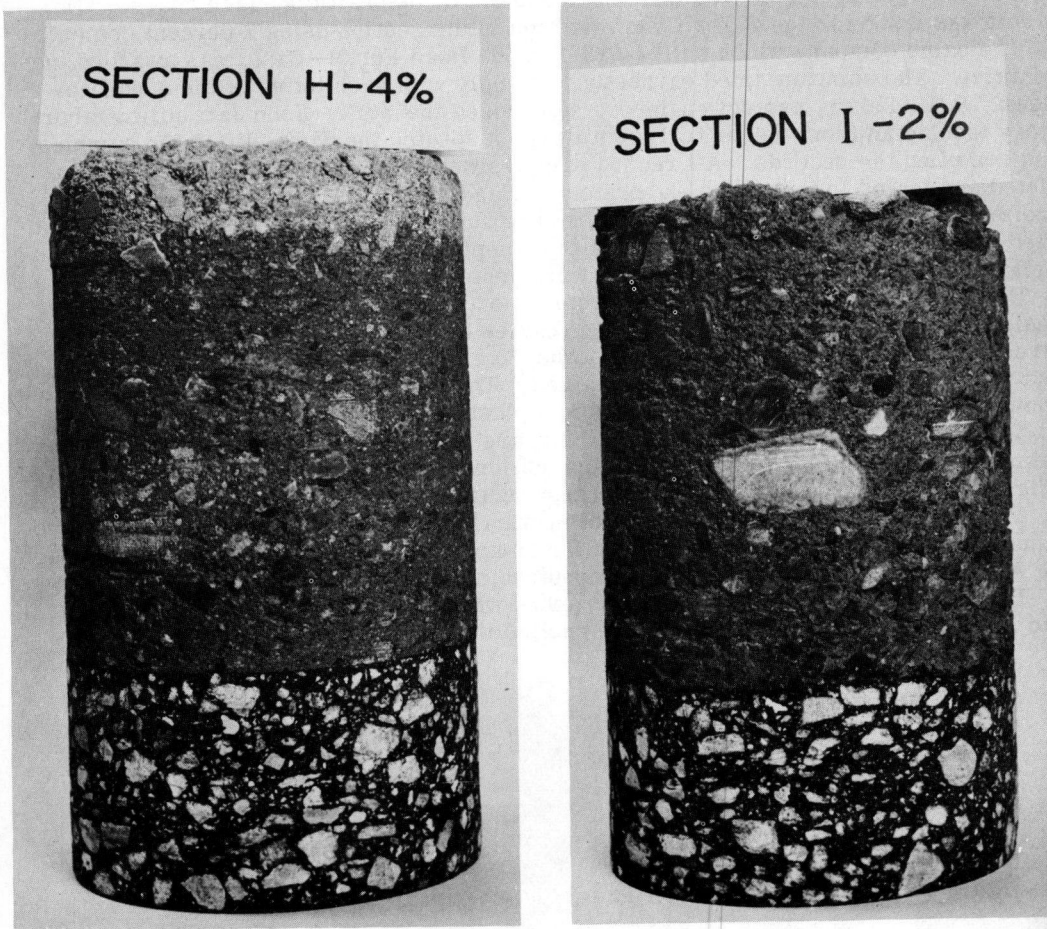
Figure 4. Cores taken from experimental project Sections H and I.

The only surface cracks found were in Sections Hand I, where the base was treated with cement immediately under the mat. Section H was treated with 4 percent cement and Section I was treated with 2 percent cement (Fig. 4). Transverse and pattern cracking were noted in both sections, but none were thought to be damaging as yet. The best indication of what to expect came from a previous survey of regularly-spaced transverse shoulder cracks where the plant mix was laid 1½ in. thick. One hundred and thirty-six transverse cracks were found in Section H, where 4 percent cement was used. One hundred and thirty-seven cracks were found in the shoulder of Section I, where 2 percent cement was used.

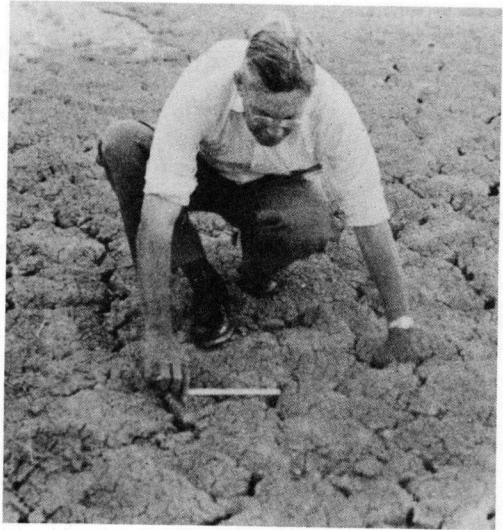
Figure 5. Typical high shrinkage clay soil in bed of dry lake, August 16, 1960.

station 326+15 to station 800+00 traverses a shallow lake with alternately dry and wet cycles (Fig. 5). Summer traffic seemed to have closed up most of the transverse reflective cracking from the cement-treated base. These cracks will no doubt tend to open up during colder weather. Roughness readings (tabulated in the Appendices) were somewhat rougher than the initial readings recorded on F-051-1 (8). Inasmuch as roughness measurements were not taken immediately after construction on I-010-1 (8) it is not known if traffic and weathering contribute to roughness.
