Effect of Pavement Breaker Rolling on Crack Reflectance in Bituminous Overlays

PAUL G. VELZ, Research Engineer, Minnesota Department of Highways, St. Paul

THIS STUDY was conducted on S. P. 6511-10 and S. P. 6512-01 (T. H. 212) located between Bird Island and Stewart. The project was a typical widening and bituminous resurfacing project, in which the bituminous mixtures were placed directly on the old concrete pavement.

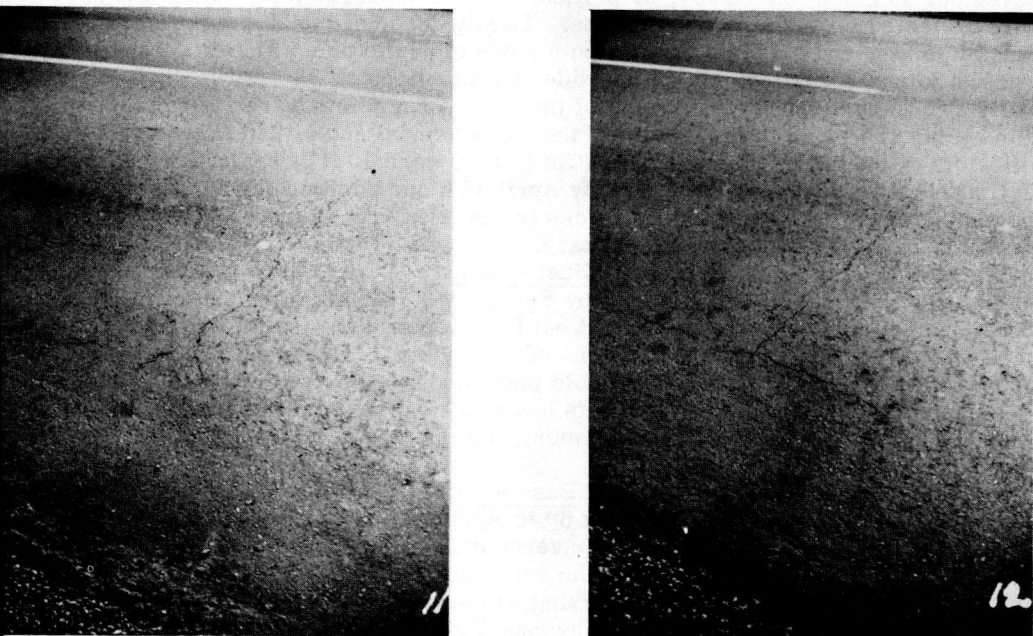
Figure 5. Typical transverse and widening cracks, Sta. 120 to 130.

er 200 ft of longitudinal cracking on centerline. Widening cracks along the edge of the old slab extended up to 5 ft from many of the transverse cracks. Figure 5 shows typical examples of this cracking.

By November 19 two transverse cracks had faulted significantly, 20 percent of the transverse cracks had extended across the widening, and the centerline and widening longitudinal cracks had extended slightly. Cracking progressed so that on February 9, 1960, 57 percent of the cracks extended across the widening. This increased to 66 percent by April 14th. All transverse cracks were over the pavement joints except one which occurred at a construction joint in the bituminous surface in the left lane. However, by April 14 the longitudinal cracking had progressed to the point where there were 446 ft on centerline, 230 ft over the left edge and 134 ft over the right edge of the old pavement. This section has cracked more than any of the other sections studied in detail.
