Crack Control Joints in Bituminous Overlays On Rigid Pavements

JOHN O. WILSON, Engineer of Research and Development, Connecticut State Highway Department

This research study concerns a method of controlling reflection cracks in bituminous concrete overlays over the transverse joints of rigid pavements. The study was undertaken to determine whether sawing and sealing joints would extend the maintenance-free life of the overlay sufficiently to justify the additional cost.

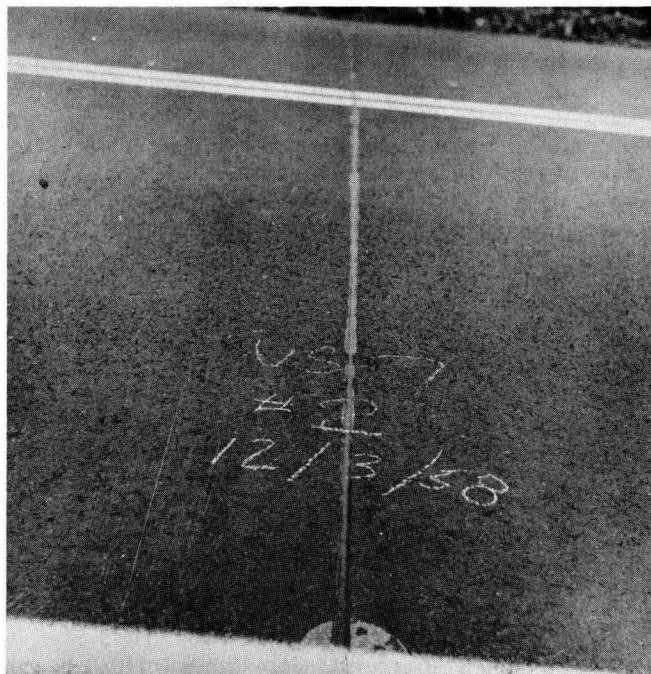
A thorough inspection of the overlay on Project 1, Norwalk, was made prior to sawing, and existing reflection cracks were noted. A further detailed inspection was made on December 16, 1958. Only 7 ft of cracks in addition to those observed prior to sawing were found. It is of interest to note that some cracks observed at the time of sawing showed a tendency to knit together, despite night temperatures at or below freezing. Figures 1 and 2 show controlled and uncontrolled joint cracking on December 3, 1958.

Figure 1. Controlled Joint Crack Project No. 1—Route US 7, Norwalk, December 3, 1958.

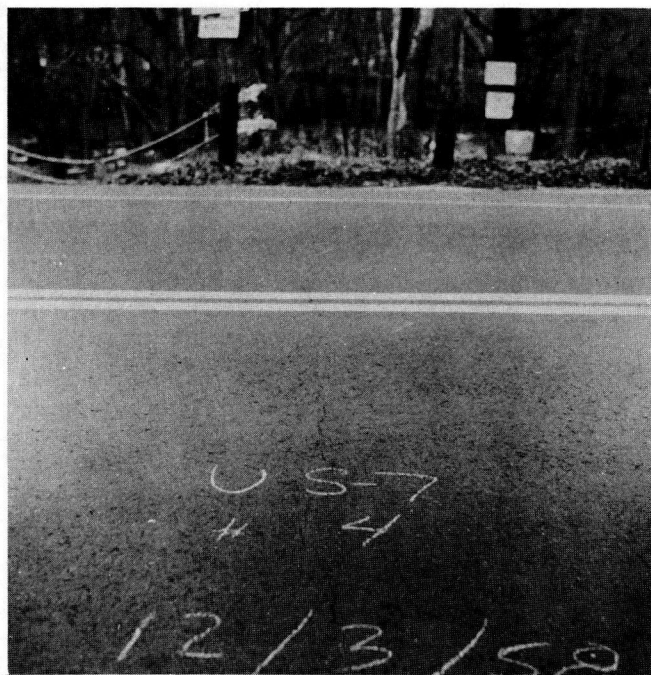
Figure 2. Uncontrolled Joint Crack Project No. 1—Route US 7, Norwalk, December 3, 1958.

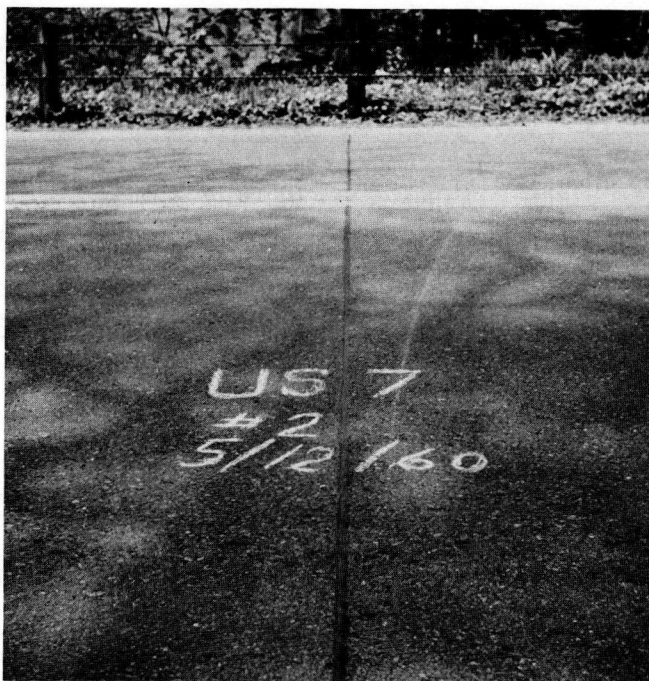
Figure 3. Controlled Joint Crack Project No. 1—Route US 7, Norwalk, May 12, 1960.

The 1959-1960 winter inspections showed such a marked difference in the appearance of the test and control sections that three additional installations were scheduled for 1960 construction. Figures 3 and 4 show the condition in May 1960 of the joints shown earlier. Figures 5 and 6 show the joints in October 1961. The change in numbers reflects the identification now used for inspection of the joints. There is some doubt that Joint 28A is the same joint identified as No. 4 in previous figures.

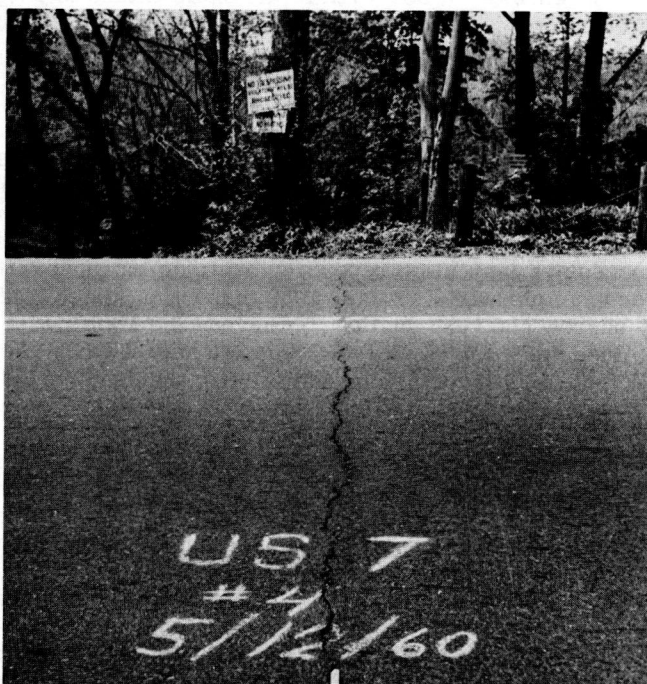
Figure 4. Uncontrolled Joint Crack Project No. 1—Route US 7, Norwalk, May 12, 1960.

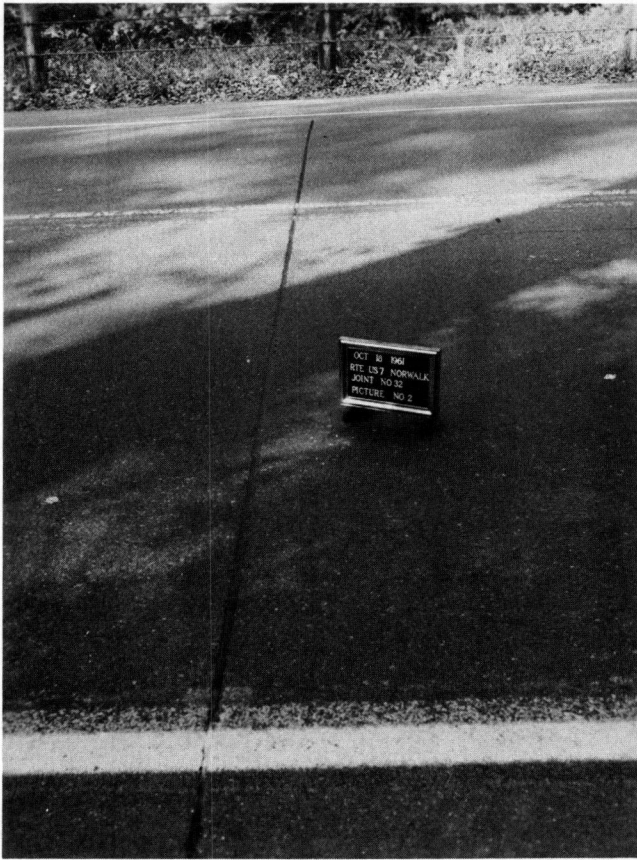
Figure 5. Controlled Joint Crack Project No. 1—Route US 7, Norwalk, October 18, 1961.

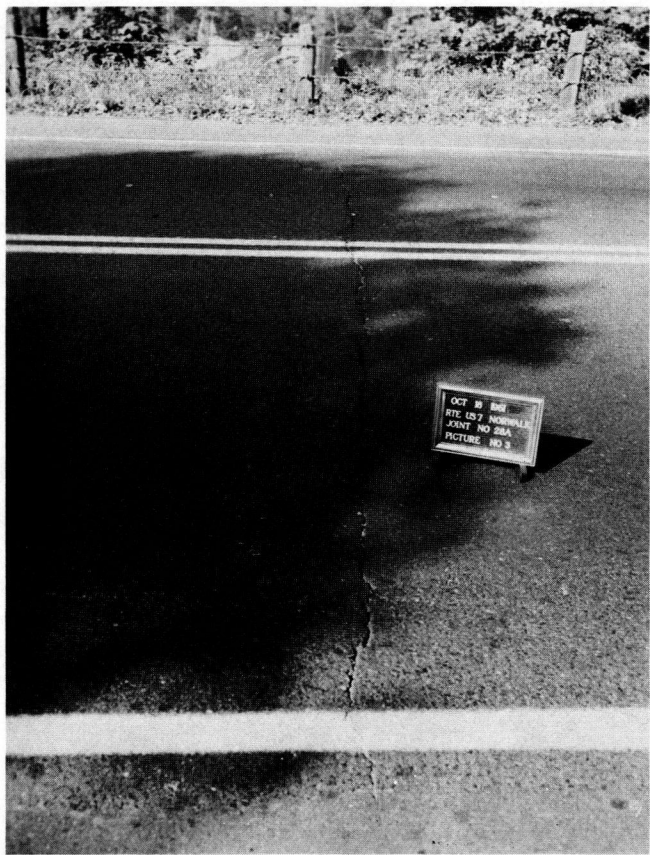
Figure 6. Uncontrolled Joint Crack Project No. 1—Route US 7, Norwalk, October 18, 1961.
