HIGHWAY RESEARCH BOARD

Bulletin 322

*Repair of Concrete Pavements*

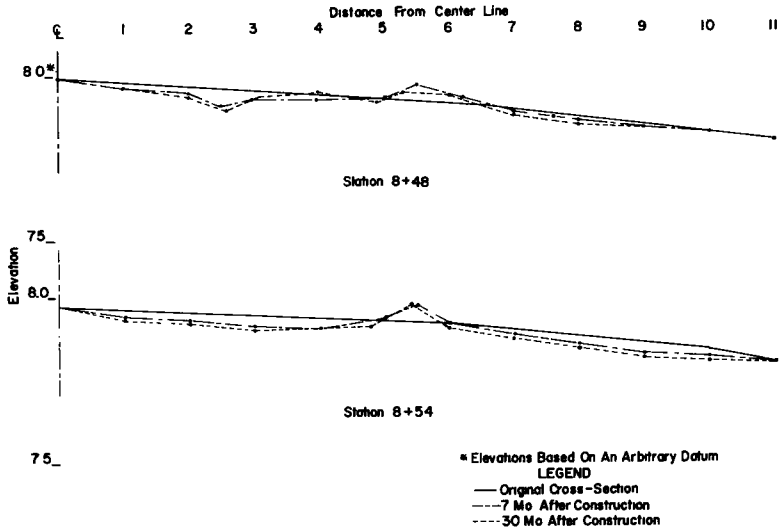
Figure 8. Distortion of Pearce Street section without reinforcement.

Cross-sections were made again after 30 months of service. These cross-sections also indicated that no significant changes could be found in the reinforced section, but that the sections without the fabric continued to distort. Figures 8 and 9 show typical areas where excessive pavement distortion had occurred in the sections without the fabric.

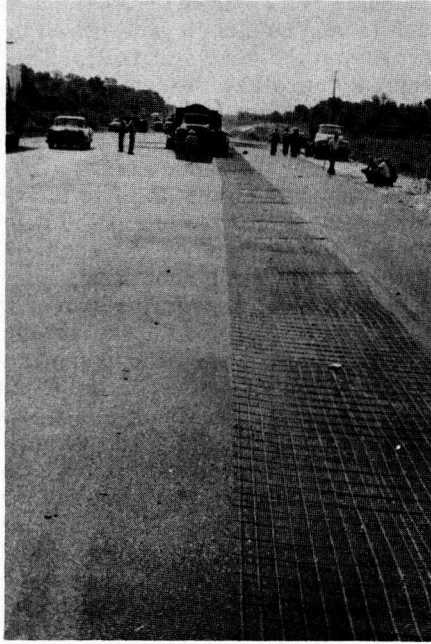
Two rolls were used at a time to reinforce a strip 250 ft long. As the fabric was unrolled, it would not lay flat due to bulges along one edge. Figure 5 shows the bulging of one strip of fabric and Figure 6 shows this same strip after the surface course had been placed over one-half of it and the bulges were removed by crimping. At first the adjoining ends of the 125-ft rolls were lapped with the trailing end of the first roll placed over the leading end of the second roll. The "recoil" tendency of the fabric caused the lapped end to push up through the fresh surface course as can be seen in the center of Figure 6. This was remedied by wiring the lapped ends of the rolls together.

Figure 5. Strip of fabric reinforcement in proper position before placement of surface course; bulging along edge of fabric nearest edge of pavement.

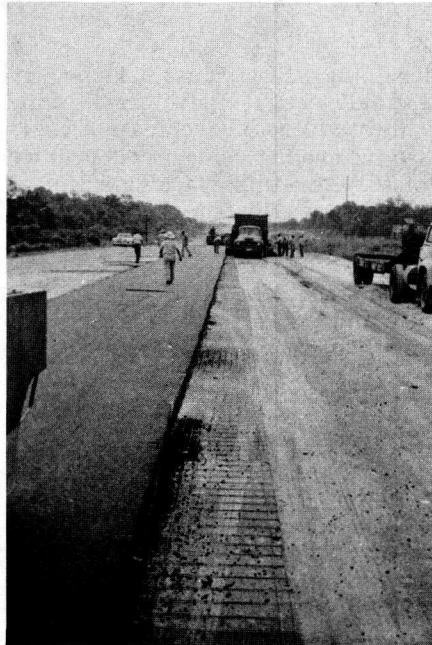
Figure 6. Same strip of fabric (Fig. 5) after surface course has been placed over one-half of it. Practically all bulges have been removed by crimping; evidence of cracking in the fresh surface course seen near exposed fabric in foreground. Note end of strip protruding through the surface course in center of photograph.

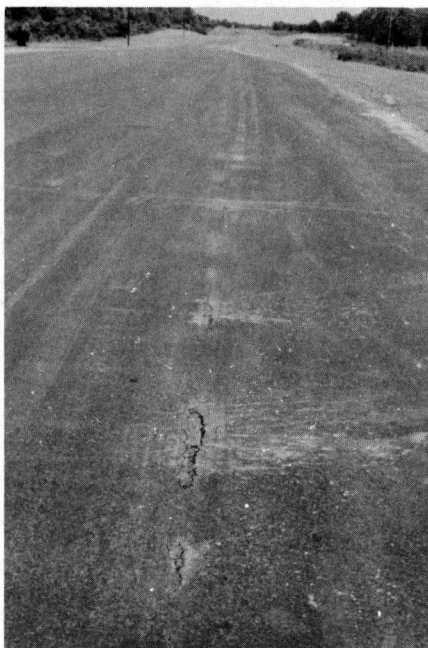
Figure 7. Same area as shown in Figures 5 and 6. A double crack over edge of fabric nearest outside edge of pavement has permitted water and dust to seep in; traffic passing over cracks has splashed water and dust onto surrounding pavement discoloring it.

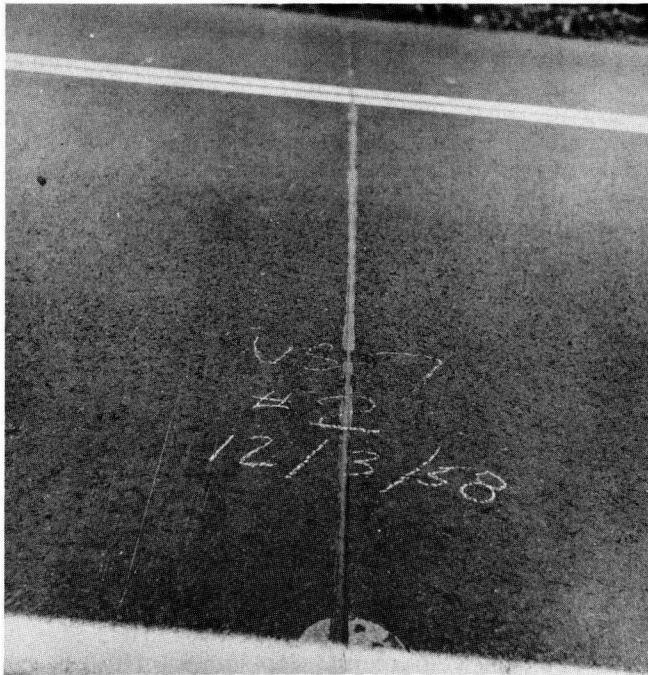
Figure 1. Controlled Joint Crack Project No. 1—Route US 7, Norwalk, December 3, 1958.

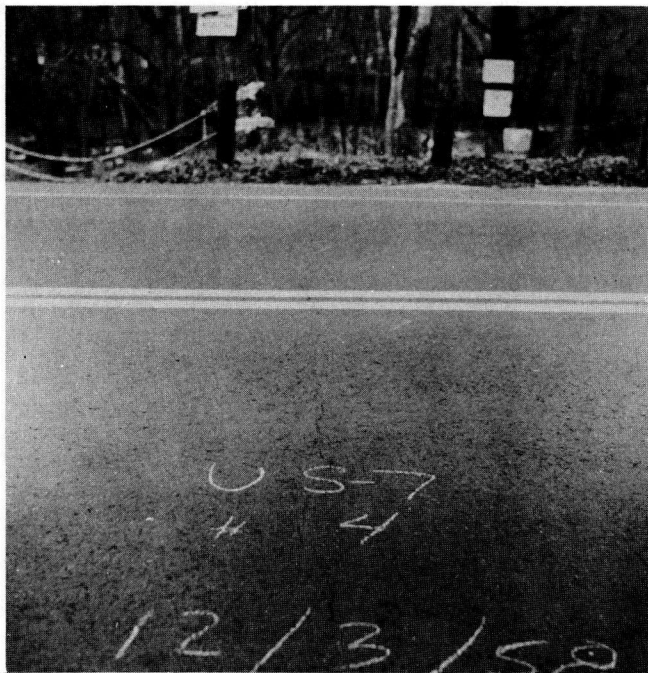
Figure 2. Uncontrolled Joint Crack Project No. 1—Route US 7, Norwalk, December 3, 1958.

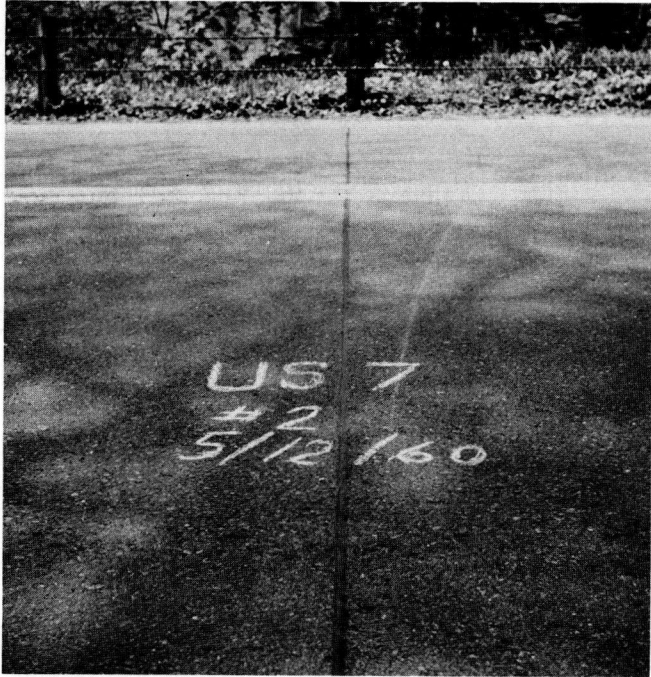
Figure 3. Controlled Joint Crack Project No. 1—Route US 7, Norwalk, May 12, 1960.

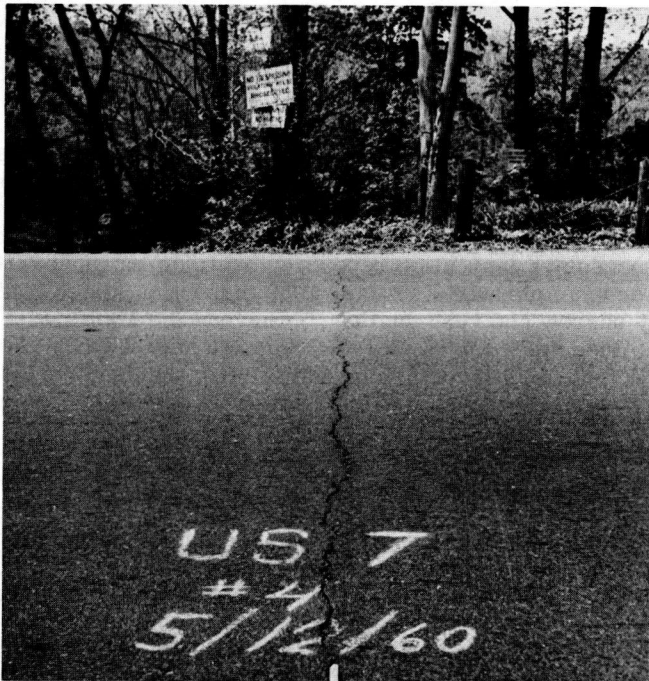
Figure 4. Uncontrolled Joint Crack Project No. 1—Route US 7, Norwalk, May 12, 1960.

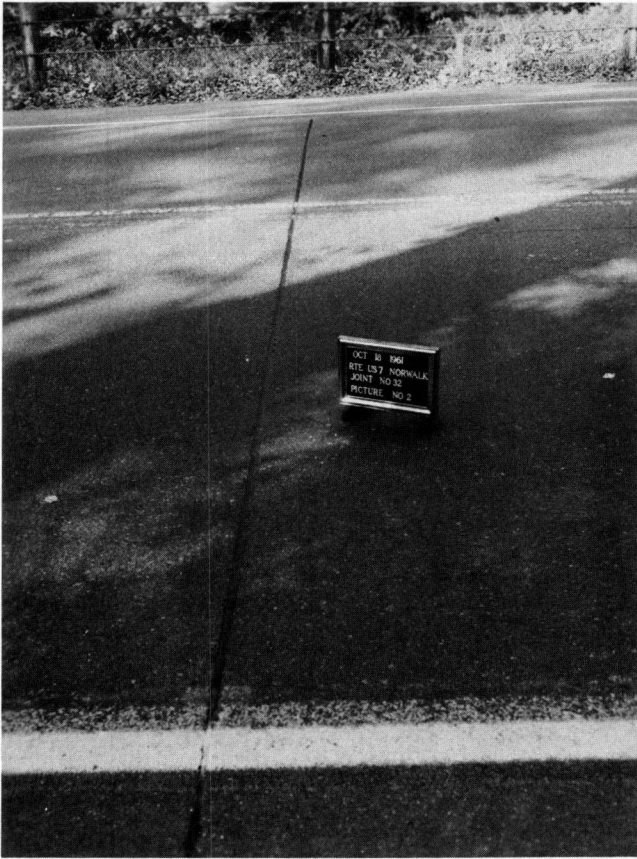
Figure 5. Controlled Joint Crack Project No. 1—Route US 7, Norwalk, October 18, 1961.

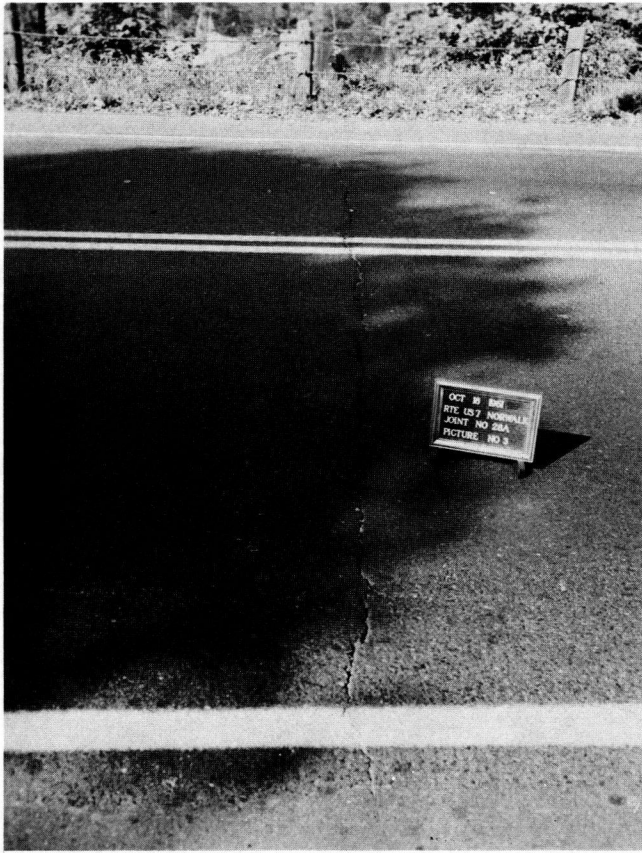
Figure 6. Uncontrolled Joint Crack Project No. 1—Route US 7, Norwalk, October 18, 1961.

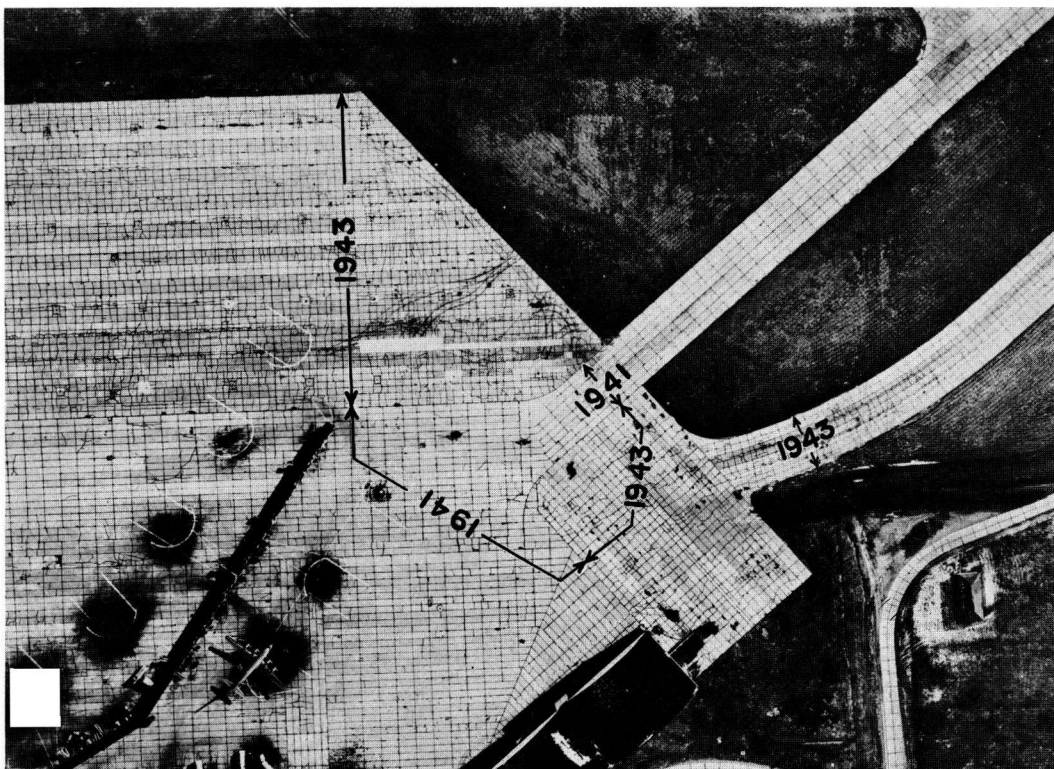
Figure 3.

Figure 3 is an aerial photograph of the same general area taken in November 1950 after four years of service under commercial airline operation. The 1943 construction already shows serious crack development, with transverse cracks in the center of a large percentage of the 25-ft slabs and an unusual pattern cracking developing in certain lanes, with some slabs having already been replaced, as shown by the light colored areas. The 1941 construction, on the other hand, shows very limited development of single transverse cracks subdividing the 25-ft slabs into two slab lengths. A survey

One of the most interesting developments shown in Figure 3 is this pattern cracking developing along the edge of every fourth lane in the 1943 apron. The cause of this incipient cracking was traced to the fact that this section of the apron was poured in alternate 20-ft widths and the concrete mixer was permitted to travel on the recently completed slab while adjacent lanes were being poured. This weakness was also associated with the fact that the paving was done during the fall of the year, under unfavorable weather conditions. The concrete on which the mixer traveled had not been completely cured and its strength was not sufficient to carry the concentrated load of the mixer at the edge of the slab. As a result, these frequently accepted compromises in paving practice contributed more to the deterioration of this badly cracked pavement than any other factors in design or construction.

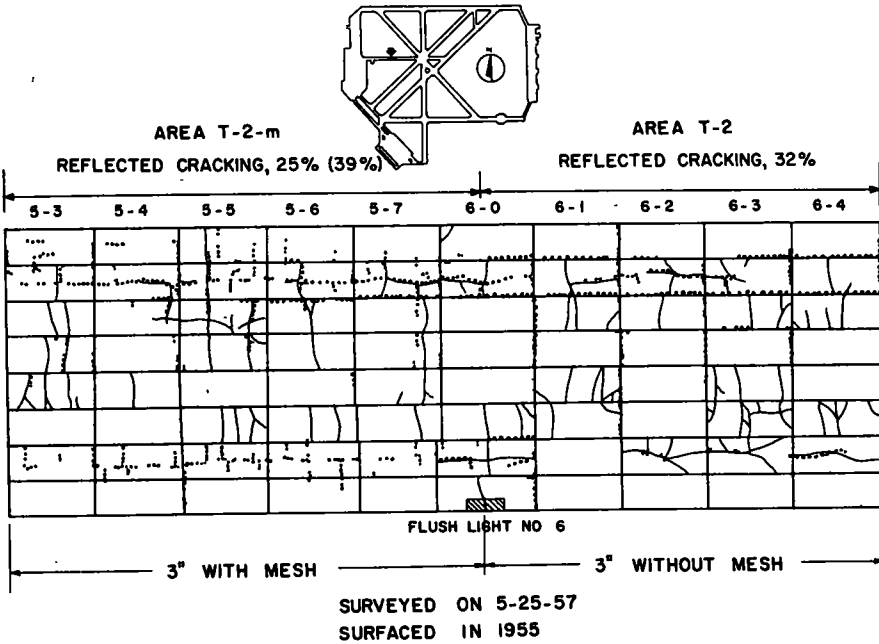
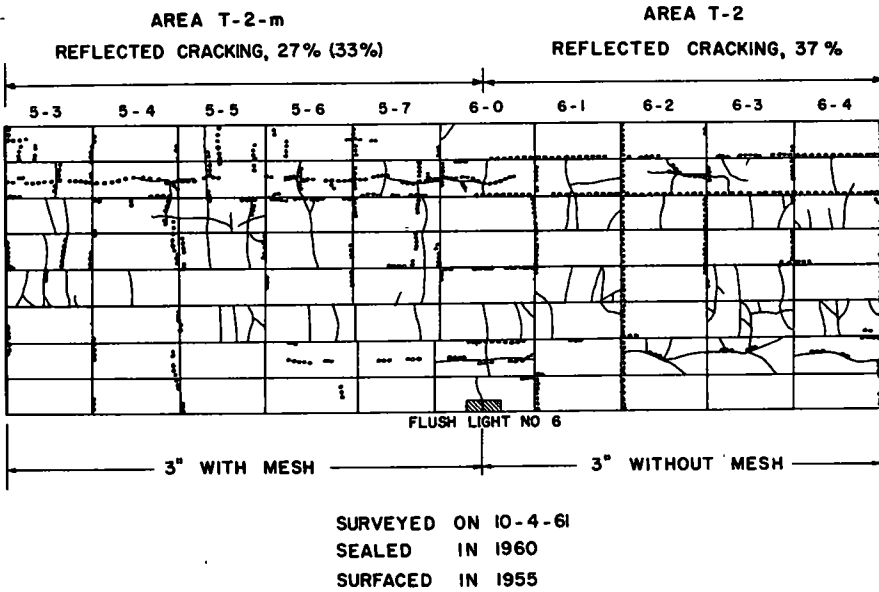
Figure 8.

Test Area 2, shown in Figure 8, is on the central taxiway and gives a comparison of reflected cracking in the 3-in. bituminous surface, with and without welded wire fabric or mesh. Reflected cracking in the area with mesh involves a new type of cracking that makes an accurate quantitative estimate difficult and dependent on a matter of definition. The plan view of the area, at the top of the figure, shows a ladder type of cracking along the center of several lanes where there were no cracks in the underlying concrete pavement. This is related to the fact that the welded wire fabric was ordered in sheets 9 ft 6 in. wide, laid over the longitudinal joint with a 6-in. clearance between sheets at the center of the 10-ft lanes. This might be regarded as a construction defect that could possibly be corrected by providing continuous reinforcement in some manner between the sheets of wire mesh.

Because of discontinuity in the reinforcement, opening of joints or movement of concrete slabs is consequently translated from the joint to the gap between sheets of wire mesh. Similarly, opening of transverse joints in the concrete pavement is spread along the wire mesh by the transverse wires until sufficient movement has accumulated to cause a visible crack, producing the ladder type of cracking pattern. Whether this is reflected cracking or not is a matter of definition. In the percentages reported as reflected cracking, the attempt has been made, uncertain at best, to segregate the cracks reflected directly from the underlying pavement from that cracking transferred to pre-

viously uncracked areas by the wire mesh. The direct reflected cracking is the first percentage shown; the total of both types of cracking is shown in parentheses.

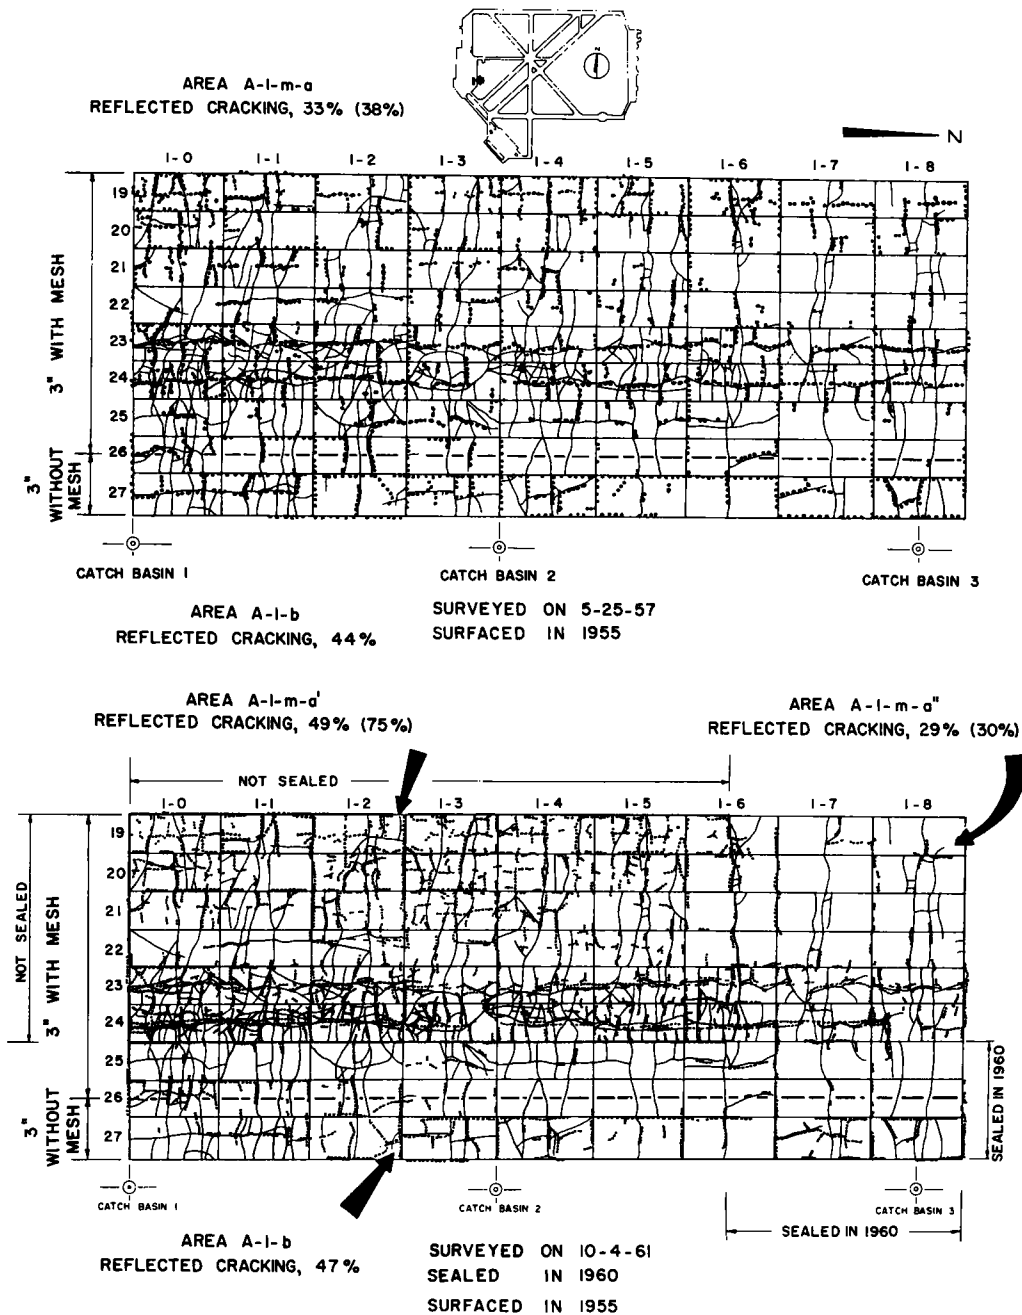
Figure 10.

In the 1957 survey, shown at the top of Figure 10, the unreinforced area showed a reflected cracking of 44 percent; in comparison, the reinforced area had 33 percent direct crack reflection, or (38) percent including the translated cracking. In both cases, there was a measurable differential in favor of the reinforced area. At the bottom of Figure 10, the results of the 1961 survey of the areas sealed in 1960 show the unreinforced area having a reflected cracking of 47 percent, as compared to a direct reflection in the reinforced area of 29 percent, or a total of (30) percent including translated cracking.

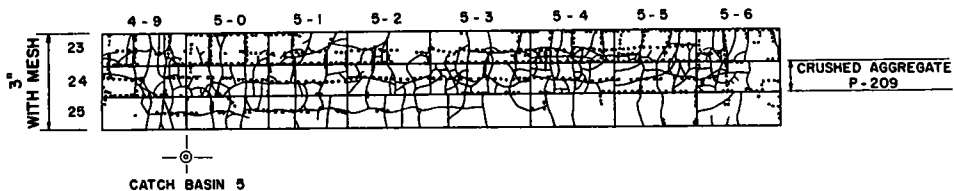
REFLECTED CRACKING  
 LANE 23, 46% (51%)  
 LANE 24, 32% (35%)  
 LANE 25, 14% (17%)

SURVEYED ON 5-25-57  
 SURFACED IN 1955

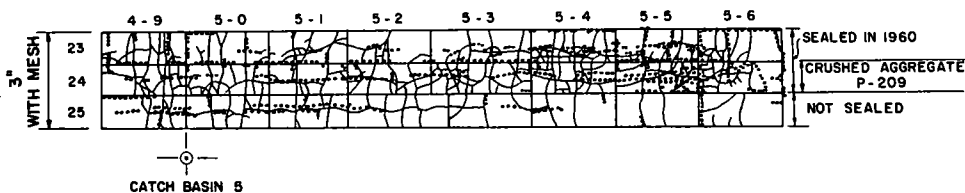
REFLECTED CRACKING  
 LANE 23, 30% (32%)  
 LANE 24, 32% (35%)  
 LANE 25, 19% (22%)

SURVEYED ON 10-4-61  
 SEALED IN 1960  
 SURFACED IN 1955
