# Effectiveness of Granular Bases for Preventing Pumping of Rigid Pavements

CARL E. VOGELGESANG, *Engineer of Special Assignment,  
State Highway Commission of Indiana*

THIS STUDY covers a condition survey in Indiana of 328.5 mi. of rigid pavements constructed with granular bases.

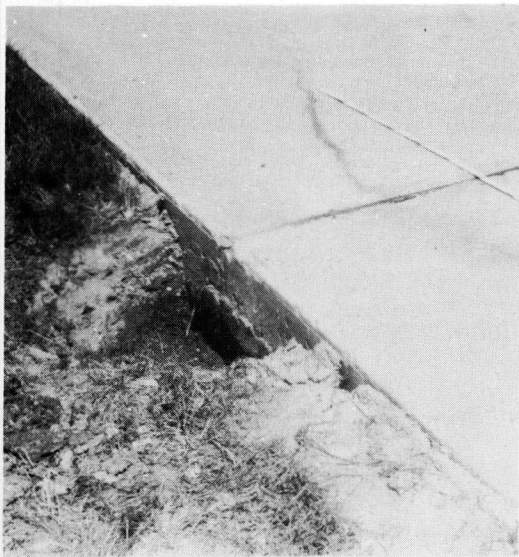
they also occur at midslab locations. Repeated load applications enlarge the blows and often there is a tendency to elongate the channel longitudinally. Observation has shown that when a blow is filled with water, there is a vertical and longitudinal surging action resulting from the passing of a heavy load, which causes the soil particles around its perimeter to be ejected through the surface hole, thus enlarging the hole. Blows of this nature are classified as first stage and are placed in Category 6. Figures 1 and 2 show advanced first stage blows.

Figure 1. Edge-blows (first-stage) and restraint cracks on Indiana 67 at Station 858+75 of project F-130(7), east of Red Key. Water seepage in this area is from plugged underdrain constructed along the edge of the old pavement. Excavation of blow at joint shows bottom edge spall.

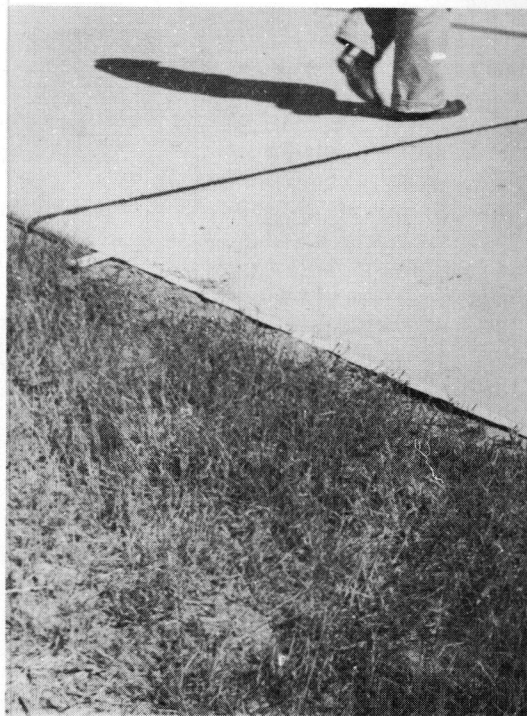
In the early stages, blows are often, although not always, found as single holes. They are also found in series, as shown in Figure 3. Generally when the blows occur in this manner, they are associated with a low shoulder-edge along the pavement, which was caused by a vehicle or vehicles running off the surface in wet weather and leaving the vertical face of the pavement exposed for a depth of 1 to 3 or more in. for some distance.

Figure 3. Series of edge-blows  $5\frac{1}{2}$  ft. long ahead of joint (in direction of traffic) on US 30 at Station 641+28 of Project F-792(7) Part B, west of Columbia City.

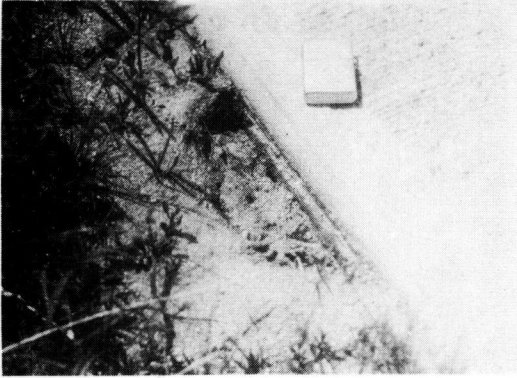
Figure 4. Closeup showing granular material in edge-blow (second-stage) along south edge of eastbound lane of US 40 at Station 270+00 of Project 13 D2, east of Lewisville. Note the typical elliptical or half-moon shape.

second stage. Figure 4 shows a second-stage blow, while Figure 5 shows the material which has been ejected from a blow.

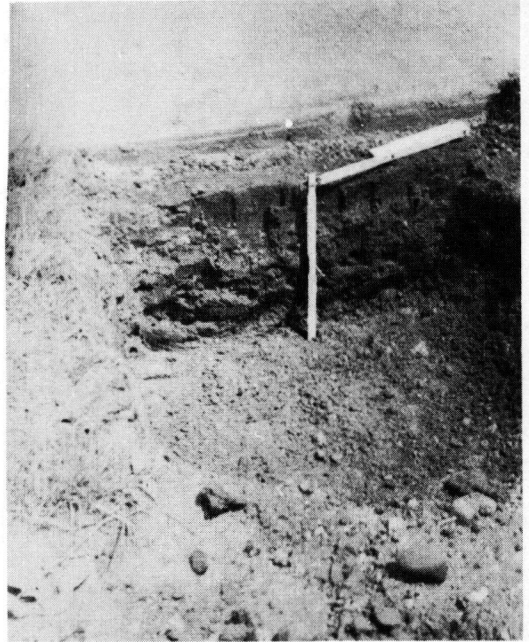
Numerous excavations made where this condition exists substantiate the above statements (see Fig. 6, 7, and 8).

Figure 6. Beginning of investigation at an edge-blow (second-stage) near Station 260+33 of Project 13 D2 on US 40. At this stage a hole has been opened to the top of the subgrade treatment course leaving the vertical granular wall filling the edge-blow cavity and a clay dam in place. Note the top of the granular wall along the pavement edge and the dry condition of the granular material in the bottom of the hole.

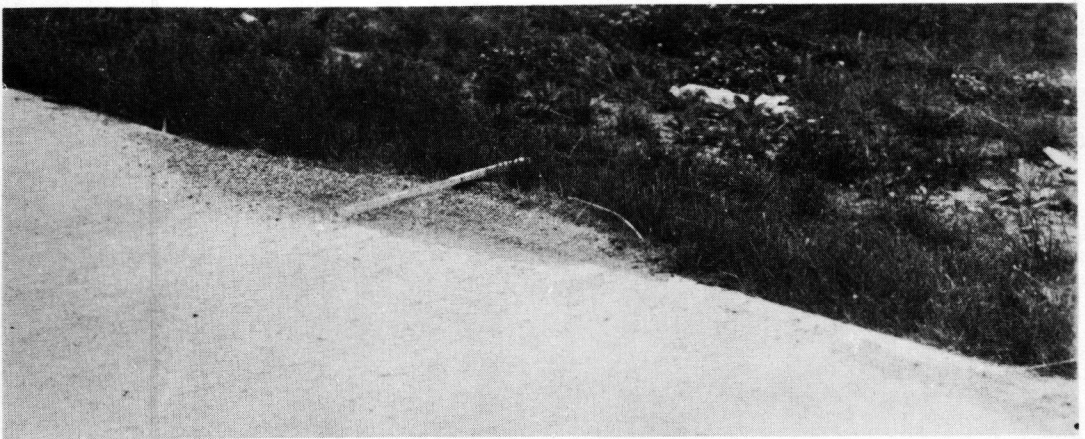
Figure 5. Granular material deposited on surface from edge-blows along south edge of eastbound lane at Station 260+33 of Project 13 D2 on US 40 east of Lewisville. Deposit covered an area approximately 3 by  $1\frac{1}{2}$  ft. and weighed 14.3 lbs.

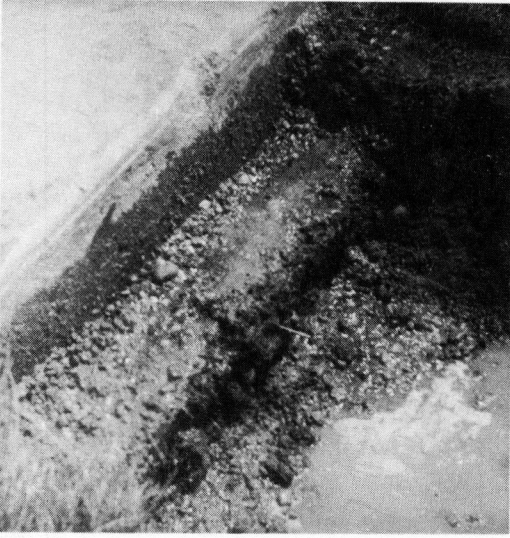
Figure 7. A continuation of the investigation at Station 260+33. At this stage part of the clay dam and granular wall filling the cavity has been removed allowing the water to drain from under the pavement. Note opening under pavement edge where water flowing from beneath the pavement has broken the wall of granular material.

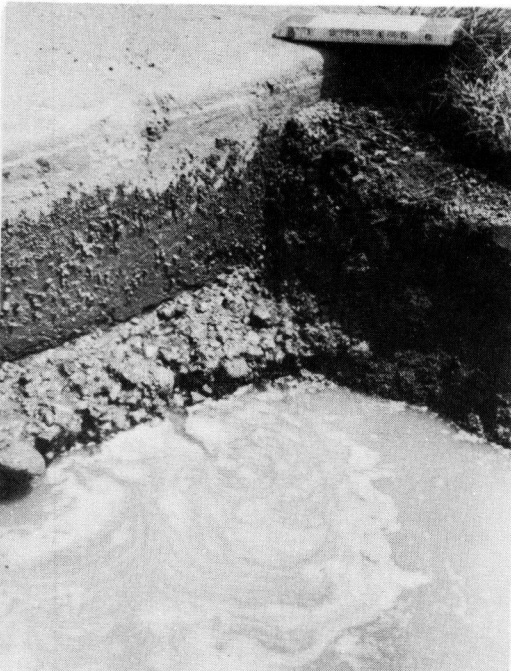
Figure 8. Final stage of the investigation at Station 260+33. Note the cavities under the pavement edge and the continuation of the granular material along the edge of pavement beyond the limits of the excavation.

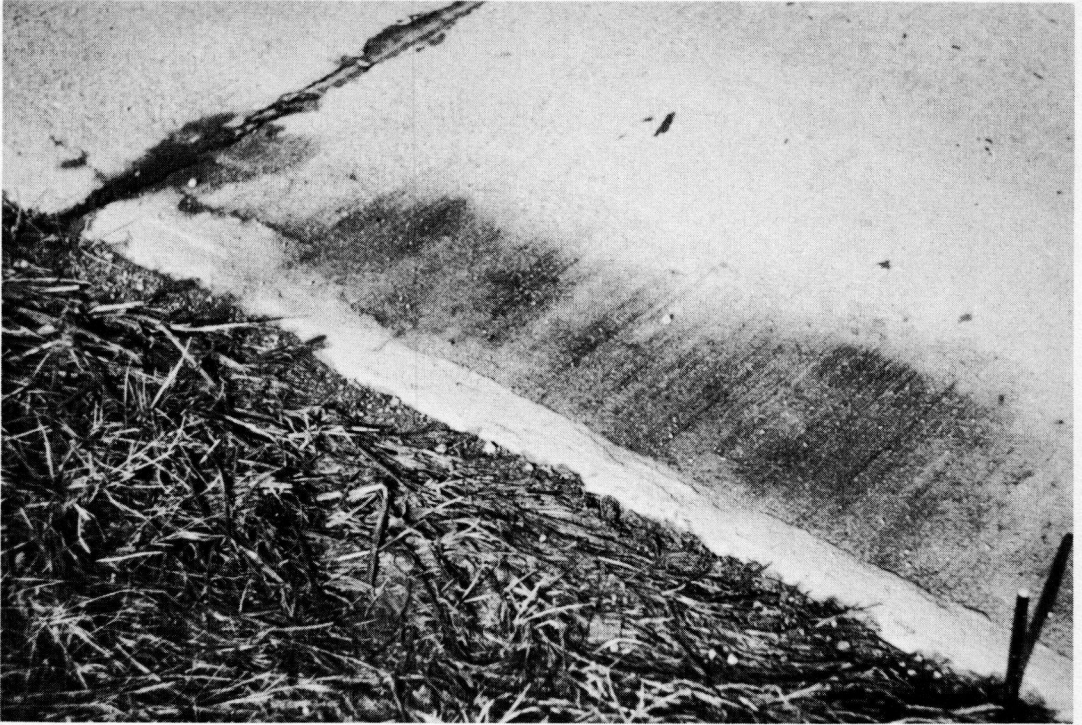
Figure B. Edge condition near Station 260+33 on Project 13 D2 18 months after an edge-blow was excavated and backfilled. Replacement and compaction of shoulder material have removed conditions causing the edge-blow illustrated in Figures 6, 7 and 8.
