HIGHWAY RESEARCH BOARD
Bulletin 52

***Performance of
Concrete Pavement on
Granular Subbase***

THIS STUDY covers a condition survey in Indiana of 328.5 mi. of rigid pavements constructed with granular bases.

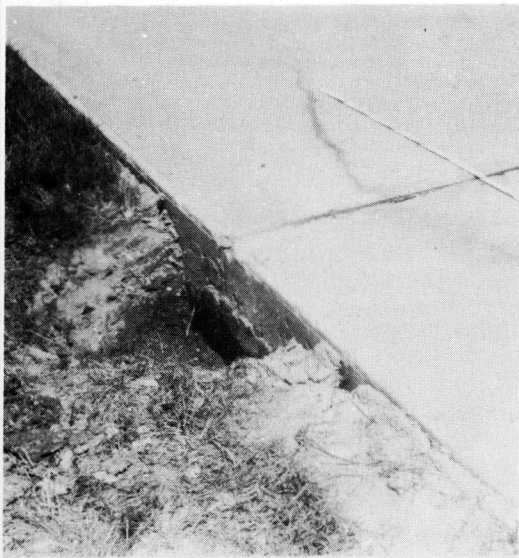
Figure 1. Edge-blows (first-stage) and restraint cracks on Indiana 67 at Station 858+75 of project F-130(7), east of Red Key. Water seepage in this area is from plugged underdrain constructed along the edge of the old pavement. Excavation of blow at joint shows bottom edge spall.

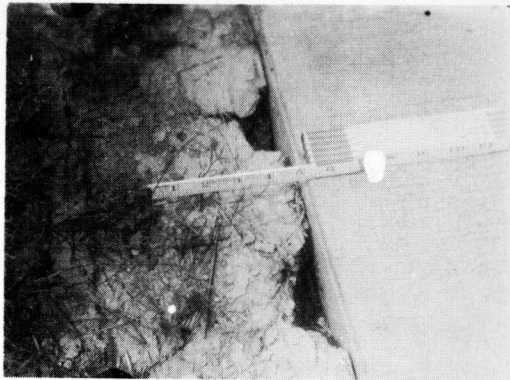
Figure 2. Edge-blows (first-stage, midpanel) on Indiana 67, at Station 1025+60 of Project F-130 (7), east of Red Key.

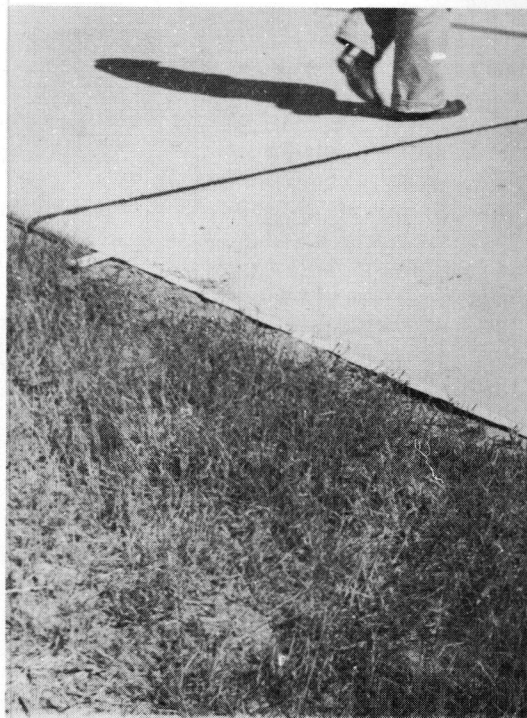
In the early stages, blows are often, although not always, found as single holes. They are also found in series, as shown in Figure 3. Generally when the blows occur in this manner, they are associated with a low shoulder-edge along the pavement, which was caused by a vehicle or vehicles running off the surface in wet weather and leaving the vertical face of the pavement exposed for a depth of 1 to 3 or more in. for some distance.

Figure 3. Series of edge-blows $5\frac{1}{2}$ ft. long ahead of joint (in direction of traffic) on US 30 at Station 641+28 of Project F-792(7) Part B, west of Columbia City.

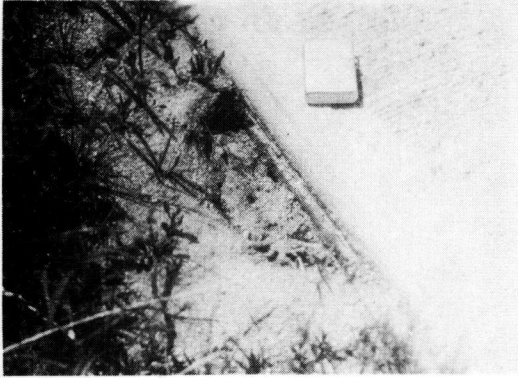
Figure 4. Closeup showing granular material in edge-blow (second-stage) along south edge of eastbound lane of US 40 at Station 270+00 of Project 13 D2, east of Lewisville. Note the typical elliptical or half-moon shape.

second stage. Figure 4 shows a second-stage blow, while Figure 5 shows the material which has been ejected from a blow.

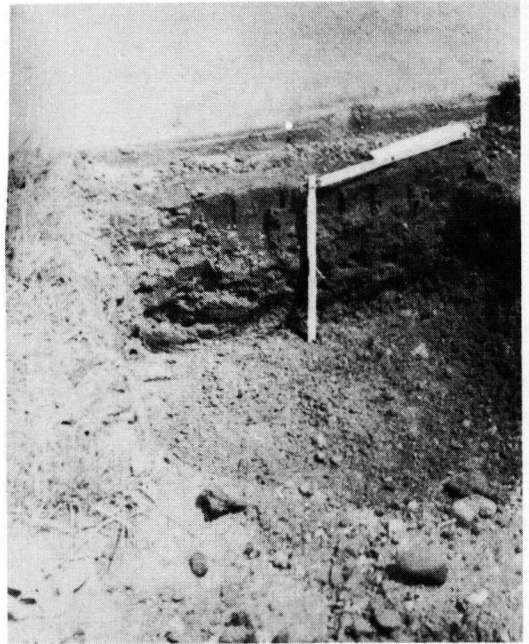
Figure 6. Beginning of investigation at an edge-blow (second-stage) near Station 260+33 of Project 13 D2 on US 40. At this stage a hole has been opened to the top of the subgrade treatment course leaving the vertical granular wall filling the edge-blow cavity and a clay dam in place. Note the top of the granular wall along the pavement edge and the dry condition of the granular material in the bottom of the hole.

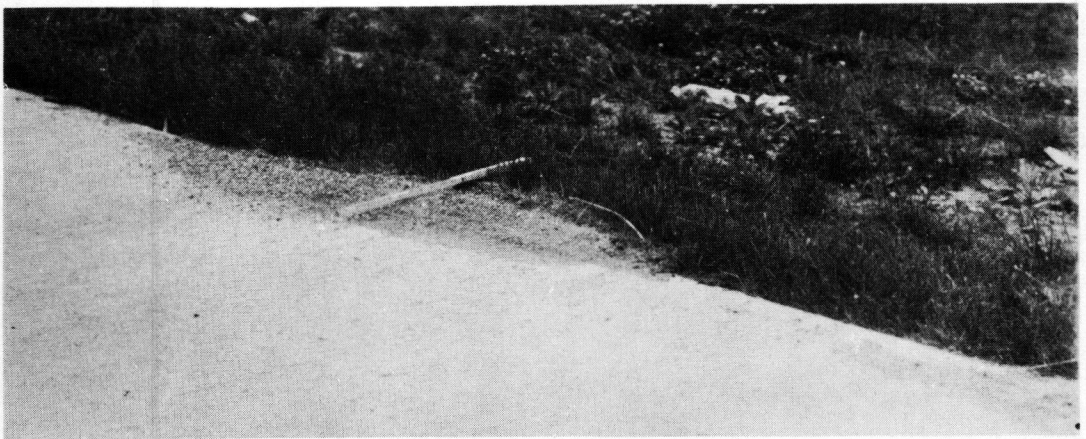
Figure 5. Granular material deposited on surface from edge-blows along south edge of eastbound lane at Station 260+33 of Project 13 D2 on US 40 east of Lewisville. Deposit covered an area approximately 3 by $1\frac{1}{2}$ ft. and weighed 14.3 lbs.

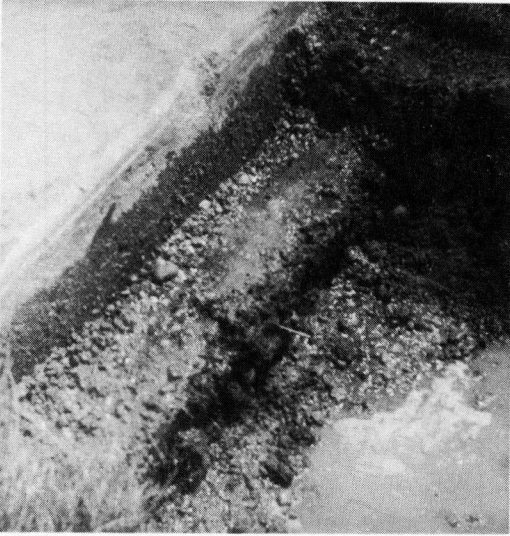
Figure 7. A continuation of the investigation at Station 260+33. At this stage part of the clay dam and granular wall filling the cavity has been removed allowing the water to drain from under the pavement. Note opening under pavement edge where water flowing from beneath the pavement has broken the wall of granular material.

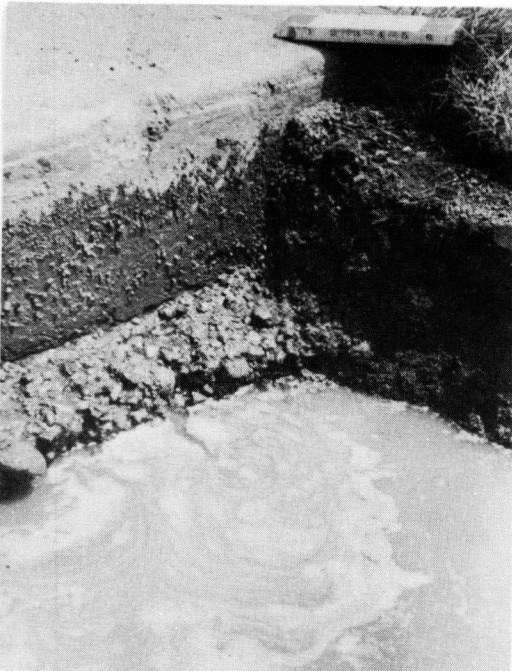
Figure 8. Final stage of the investigation at Station 260+33. Note the cavities under the pavement edge and the continuation of the granular material along the edge of pavement beyond the limits of the excavation.

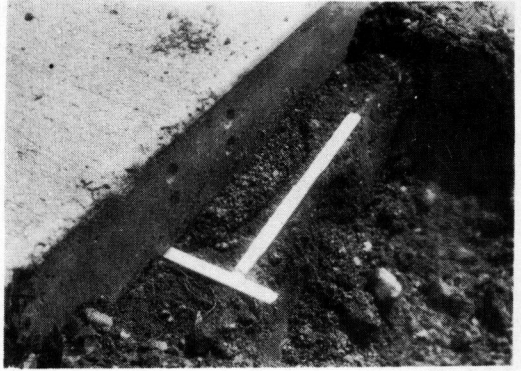
Figure 9 shows a cross section of a second-stage blow about 5 in. below the surface, while Figure 10 shows the condition of the bottom of the blow. These illustrations are typical of many investigated. It should be noted that the cavity is approximately $2\frac{1}{2}$ in. wide at the widest point and is about 10 in. long. The longitudinal dimension on some is as high as 15 in. or more. Figure 10 shows the channel eroded on the surface of the treatment at the pave-

Figure 9. Station 1221+37 of Project F-130(8) on Indiana 67. Granular material in edge-blow at a depth of 5 in. below the surface of the pavement.

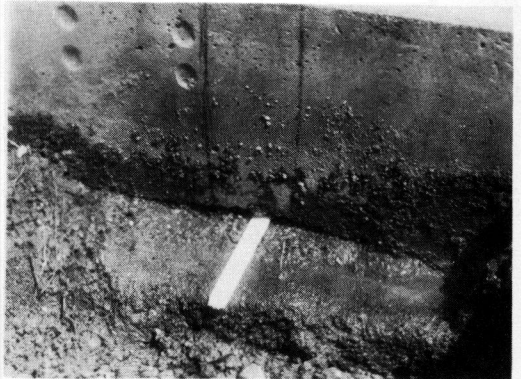
ment edge. The vertical marks on the edge at the top show where the blow opening was located.

Figure 10. Station 1221+37 of Project F-130(8). Rule placed in opening beneath pavement at location of edge-blow. Note free water flowing from under pavement.

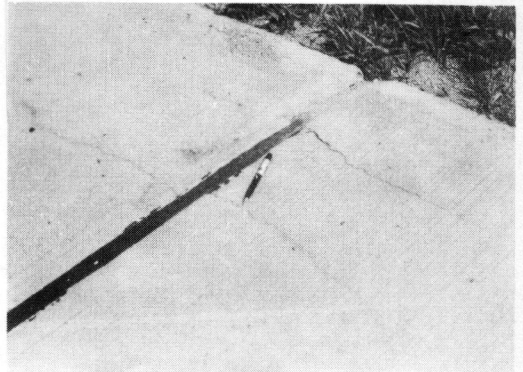
Figure 11. Restraint cracking and edge-blows along south edge of eastbound lane of US 40, east of Lewisville at Station 265+00 of Project 13 D2.

As previously stated, restraint cracks are not included as a primary part of this report. However, since they exist on a number of projects, data were obtained to show the extent of the problem. Restraint cracks are defined as longitudinal cracks occurring at joints, approximately 6 in. to 2½ ft. from the edge of the pavement. They are caused by the infiltration of material into the crack at the edge or under the pavement near the edge during the contraction period of contraction and expansion cycles. The cracks appear or are lengthened when expansion takes place in order to relieve the induced stresses. Figure 11 shows typical restraint cracking.

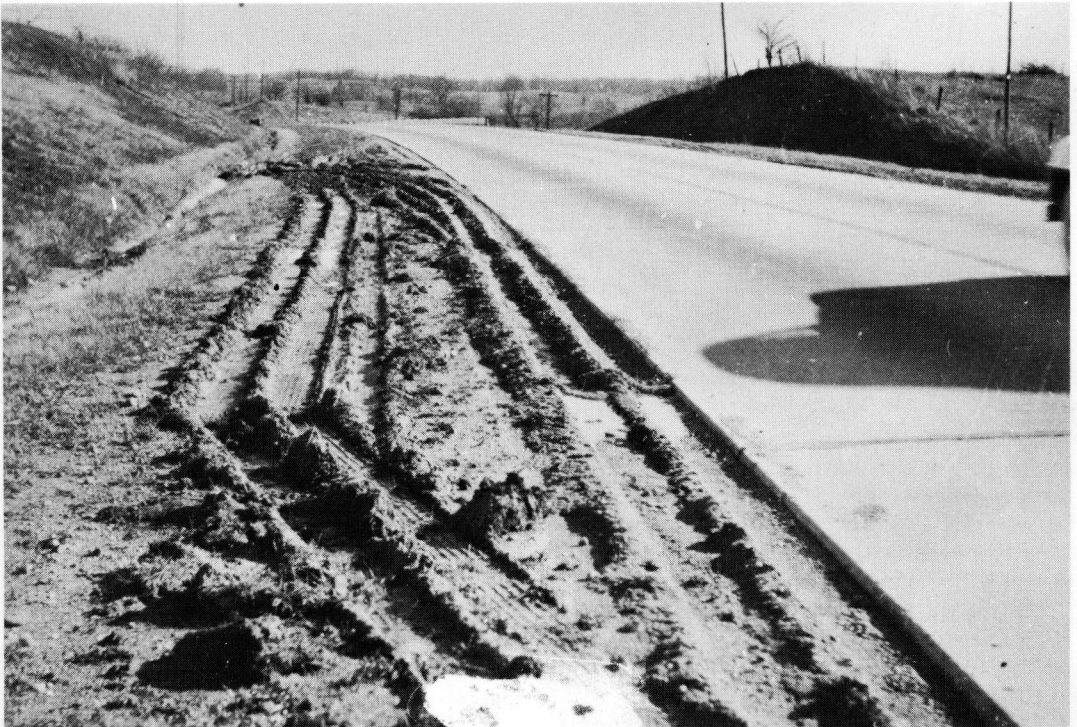
Figure A. Shoulder condition where edge-blows were associated with poor maintenance.

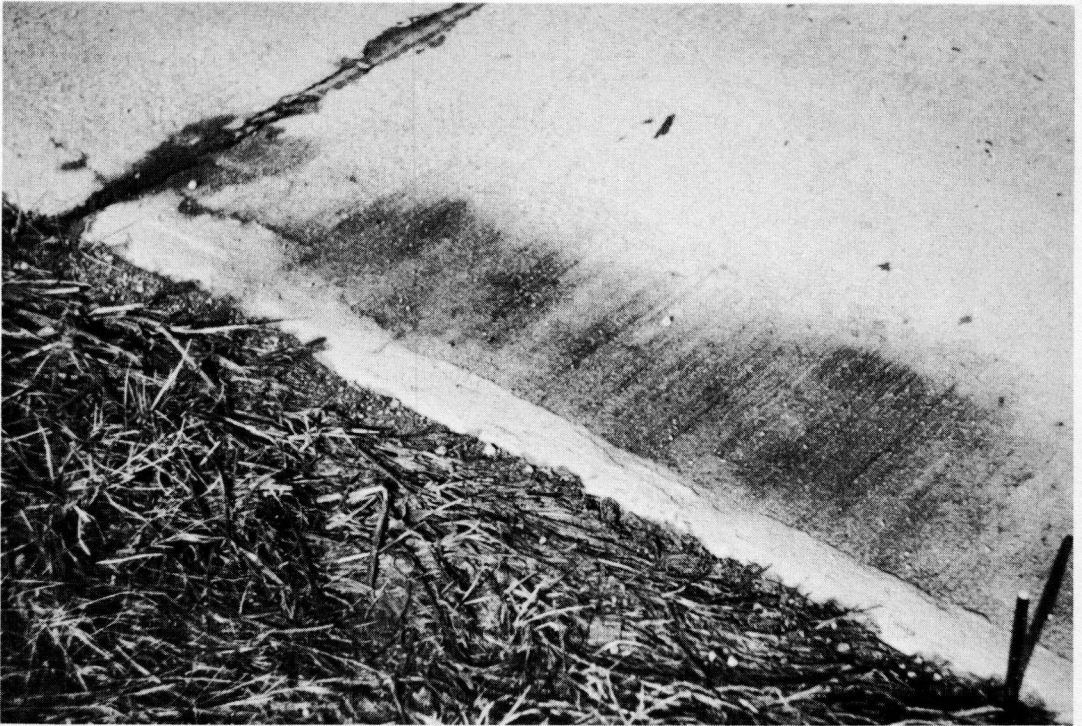
Figure B. Edge condition near Station 260+33 on Project 13 D2 18 months after an edge-blow was excavated and backfilled. Replacement and compaction of shoulder material have removed conditions causing the edge-blow illustrated in Figures 6, 7 and 8.
