**HIGHWAY RESEARCH BOARD**  
**Bulletin 87**

***Concrete Resurfacing of  
Concrete Pavement in Various  
Stages of Deterioration***

**PRESENTED AT THE  
Thirty-Third Annual Meeting  
January 12-15, 1954**

**DEPARTMENT OF MAINTENANCE**

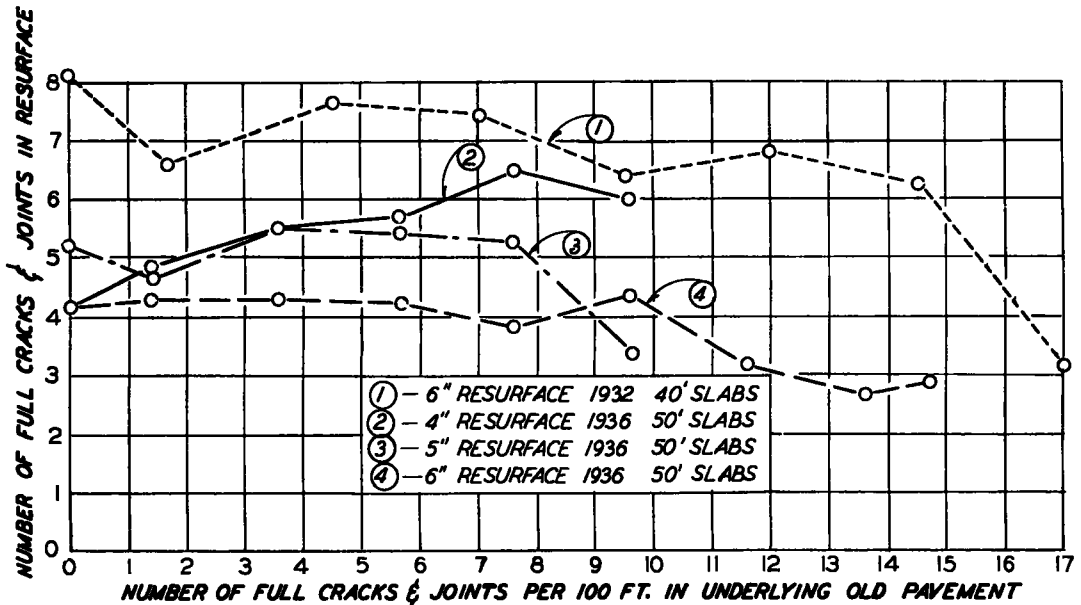
Figure 3. Transverse cracking in resurfaces of various thickness as influenced by transverse cracking in underlying old pavement.

showing consistent influence of the old pavement cracking, but they do show trends which indicate that the transverse cracking in the resurfaces was affected by that in the underlying old pavement. Apparently all of the 1936 resurfaces with expansion joints at 50-foot intervals tended to develop transverse cracking at about the same rate when laid on uncracked old pavement. According to the curves, the 4-inch, 5-inch, and 6-inch resurfaces each show about four or five cracks and joints per 100 feet where laid on sound old pavement. This indicates a tendency for these resurfaces to crack into slabs about 20 to 25 feet long on old pavement that was uncracked when resurfaced in 1936.

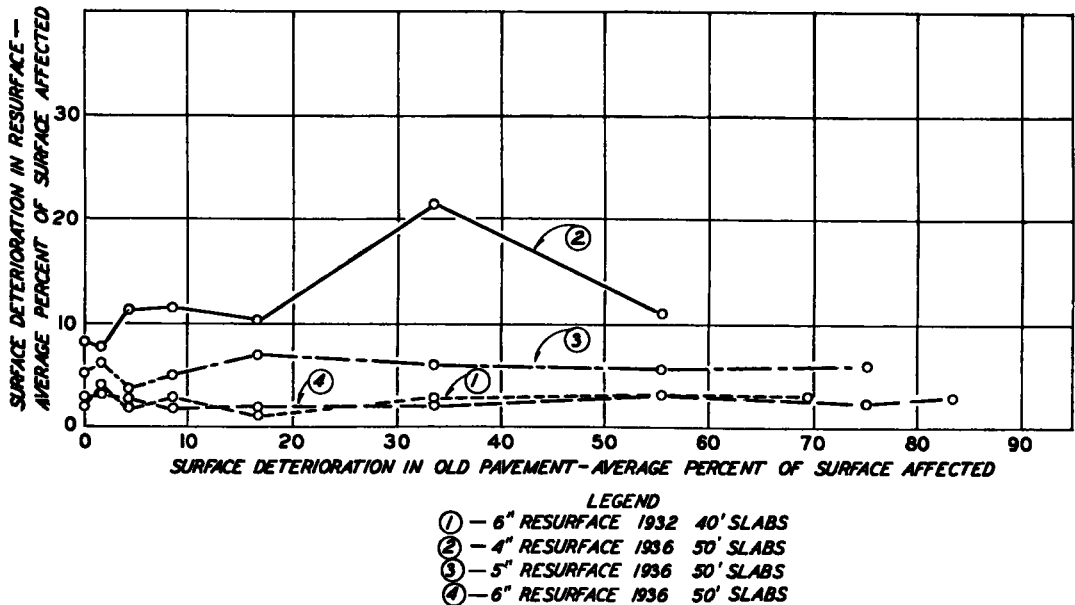
Figure 4. Surface deterioration in resurfaces of various thickness as influenced by surface deterioration in underlying old pavement.

ment increased, but deterioration in the 5-inch and 6-inch resurfaces tended to remain fairly uniform for all degrees of deterioration in the old pavement.

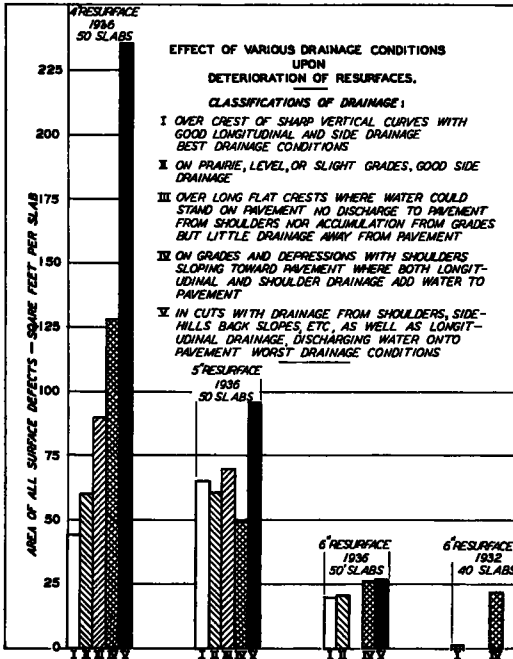
Study of Figure 5 shows that drainage apparently influenced the deterioration in resurfacing of each thickness. In each case, the average deterioration in panels under Classes 4 and 5, those subjected to the most-unsatisfactory drainage conditions, is greater than the deterioration in panels that have been subjected to the better drainage conditions (Classes 1 and 2). The 4-inch resurface appears to have been much more susceptible to the influence of variations in drainage than 5-inch or 6-inch resurface. Four-inch resurface panels under the best drainage conditions (1) showed on the average only 44 sq. ft. of surface deterioration per panel those in locations where drainage was the worst (5) averaged more than five times as much (236 sq. ft. per panel); while panels subjected to intermediate conditions of drainage (2, 3, 4) showed intermediate deterioration which increased in each case (respectively 61, 90, and 128 sq. ft. per panel) as the drainage conditions became worse.

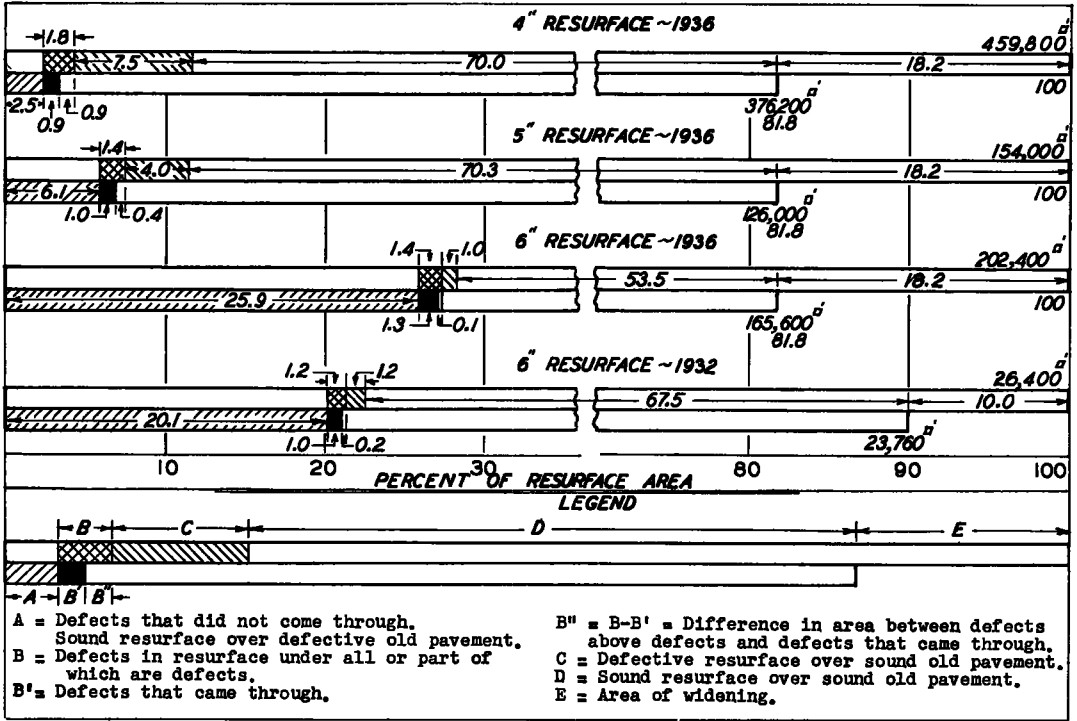
Figure A. Relationships between defective areas in resurfaces and those in the underlying old pavement (areas as percentages of resurface area).
