CORRECTING PAVEMENT PUMPING BY MUD JACKING

Robert E. Frost
Research Engineer, Purdue University

U.S. HIGHWAY NO. 30

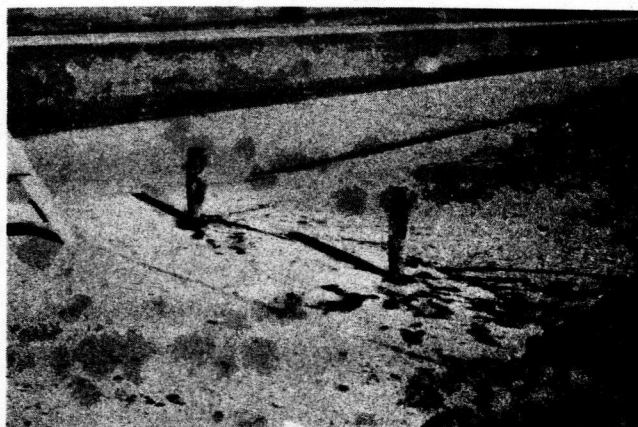
FIGURE 4. THE HOLES WERE PLUGGED TO PREVENT THE SLAB FROM SETTLING AND SQUEEZING OUT THE MIX UPON COMPLETION OF MUD-JACKING.

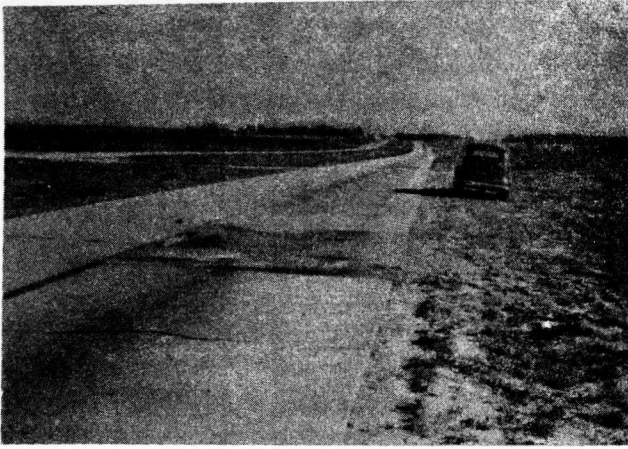
FIGURE 5. PERFORMANCE IN THE WATER-SATURATED SUBGRADE SECTION IN OCTOBER 1944.

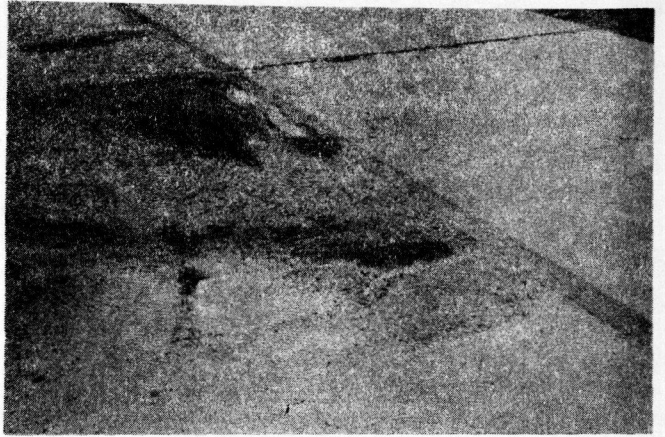
FIGURE 6. CLOSE-UP OF A JOINT IN THE WATER-SATURATED SECTION (OCTOBER, 1944).

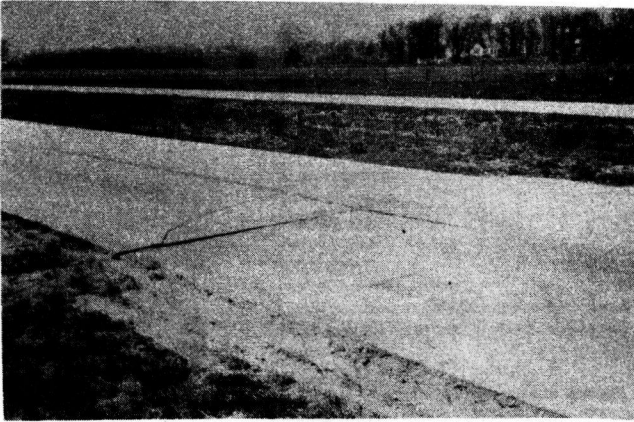
Pumping was found to be severe in the silty-clay drift areas. Figures 7 and 8 are views of the same joint taken in 1943 and 1944 and show the extent of the failure of some of the severely pumping joints on drift soils. One section of this road, constructed on silty-clay drift, contained a total of 50 patched slabs in a distance of 2700 ft. (See Fig. 9).

FIGURE 7. VIEW OF A SEVERELY PUMPING SLAB IN DRIFT SOIL OF THE VALPARAISO MORaine IN NOVEMBER, 1943.

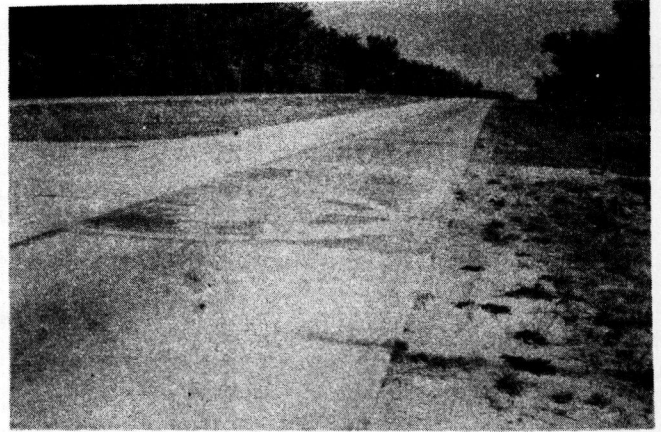
FIGURE 8. VIEW OF THE PATCH ON THE SAME SLAB (FIGURE 7) IN NOVEMBER, 1944. PUMPING IS STILL SEVERE.

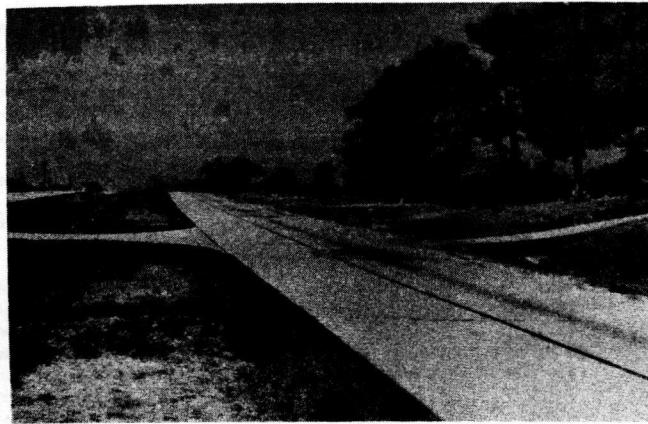
FIGURE 9. A SERIES OF PATCHES AT JOINTS OF SLABS THAT HAVE SETTLED DUE TO PUMPING. ON ONE SUCH SECTION A TOTAL OF 50 PATCHES WAS COUNTED IN 2700 FEET.

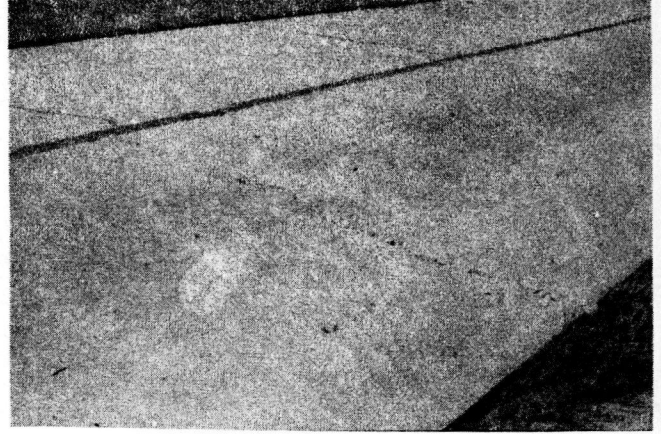
FIGURE 12. ADVANCED STAGES OF CRACKING IN WHICH SPALLING OCCURS CAUSED BY SEVERE SLAB MOVEMENT.

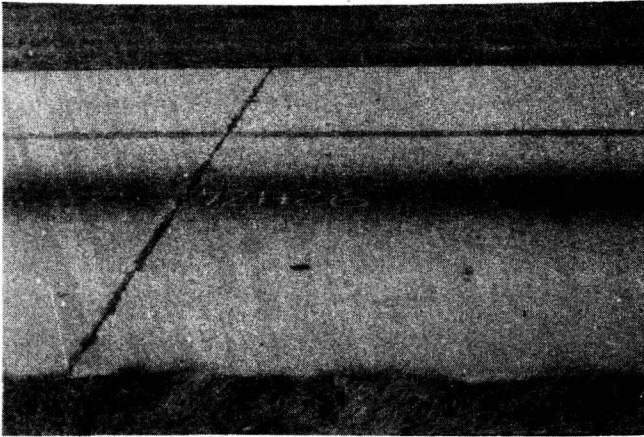
FIGURE 13. SUCCESSFUL MUD JACKING. THIS JOINT TREATED WITH MIX "A" HAD NOT SETTLED OR PUMPED DURING TWO YEARS OF SERVICE.

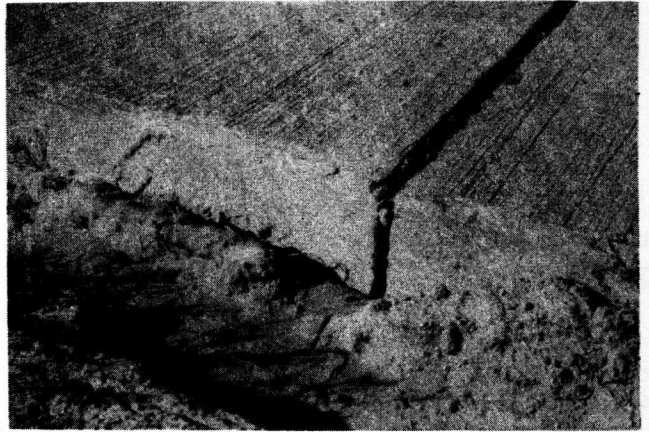
FIGURE 14. SEVERE PUMPING AT AN UNTREATED JOINT IN THE SECTION OF PAVEMENT IN WHICH JOINTS WERE TREATED WITH MIX "A"

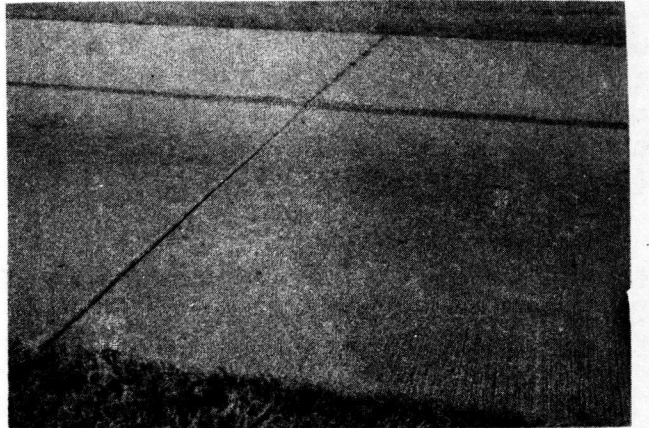
FIGURE 16. AN UNTREATED SLAB (IN THE AREA IN WHICH THE JOINTS WERE TREATED WITH MIX "B") THAT HAD SETTLED $\frac{3}{4}$ OF AN INCH.

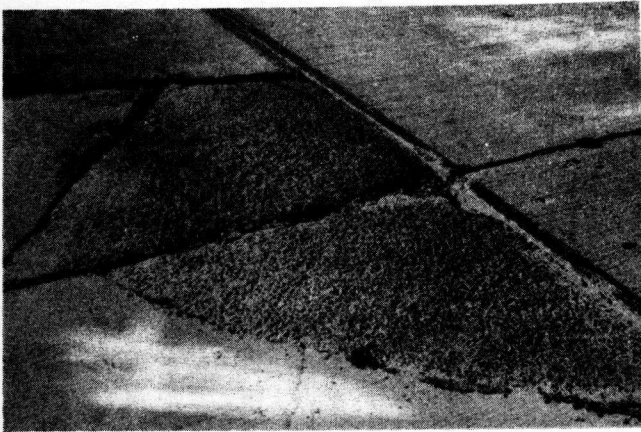
FIGURE 17. THIS SLAB TREATED WITH MIX "B" HAD FAILED DUE TO AN EQUIPMENT FAILURE DURING TREATMENT.

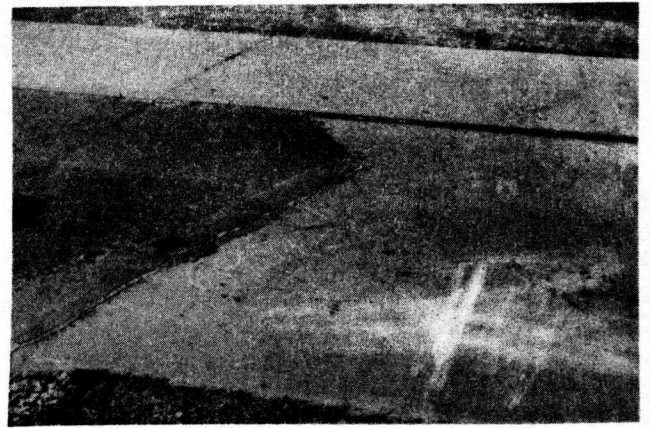
FIGURE 18. THIS IS A VIEW OF THE FIRST CRACK PAST THE JOINT IN FIGURE 17.

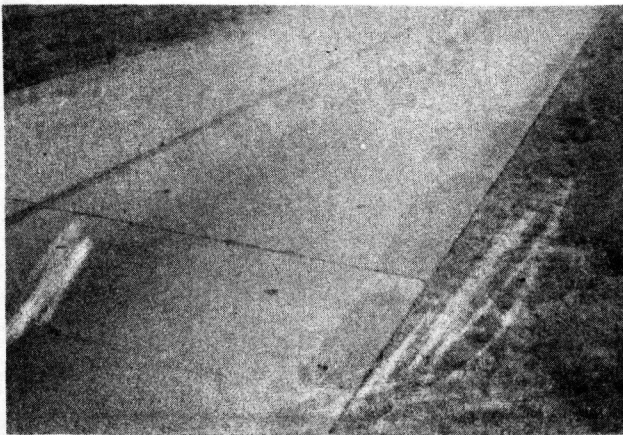
FIGURE 19. THE JOINT AT STATION 662+86 (MIX "C") HAS PERFORMED SATISFACTORILY FOR TWO YEARS.

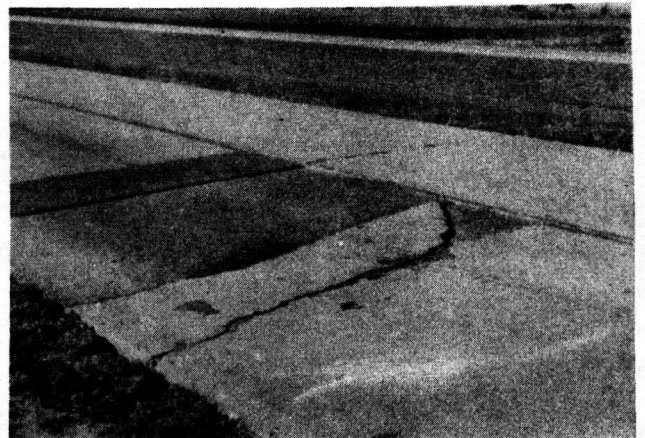
FIGURE 20. THE JOINT AT STATION 662+46 (ADJACENT TO SLAB IN FIG. 19 WAS NOT TREATED AND HAS GIVEN TWO YEARS OF UNSATISFACTORY PERFORMANCE.

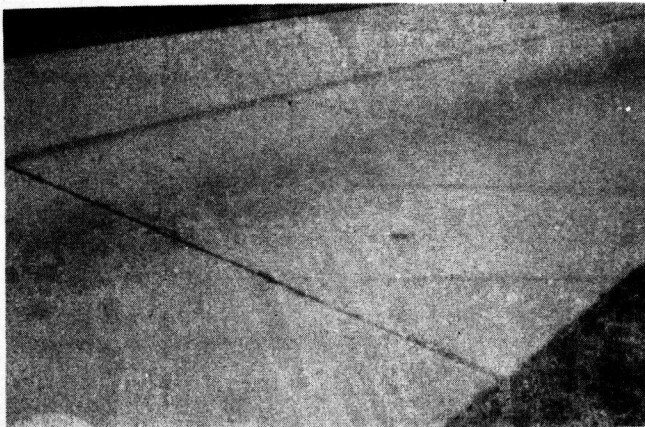
FIGURE 21. ANOTHER SUCCESSFULLY TREATED JOINT (MIX "C").

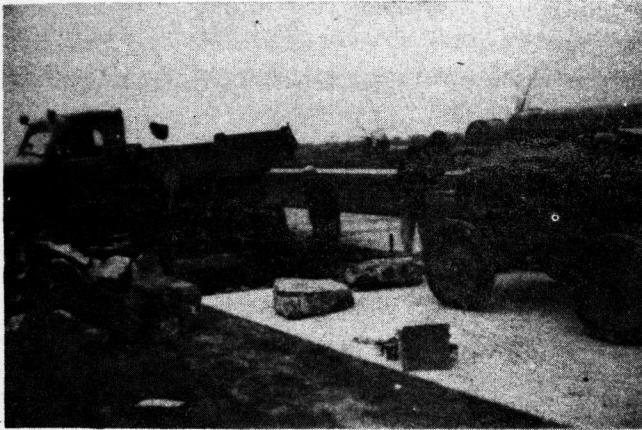
On November 27, 1944, portions of three slabs that had failed and settled considerably were removed and replaced with sand and given a limestone surface. Each of the failed slabs had been patched; some containing two patches. Two of the slabs had been treated by mud jacking (mix B) and one was of the untreated section. The two treated slabs that failed were located in a cut section where the grade was such that drainage was exceptionally poor. Both were rated P-3 (severely pumping) at the time of treatment. A description of each joint and the condition during each performance survey are contained in the Appendix (Record of mud-jacked joints that were patched). Figures 35 and 36 were taken at the time of removal of these slabs. Figure 37(A) is a photo of a sample of mud-jack mix taken from beneath the slab at Sta. 694+86. The mix under this slab was laminated and strings of bituminous material were found in the mix. This is perhaps because of the fact that mixing and treating were done during cold weather and that the hot bituminous material chilled and became stringy when it came in contact with the cold mixing water. Figure 38 contains a series of sketches showing the condition of the subgrade at each location at the time the slabs were removed.

FIGURE 35. REMOVING A SLAB THAT HAD FAILED DUE TO PUMPING.

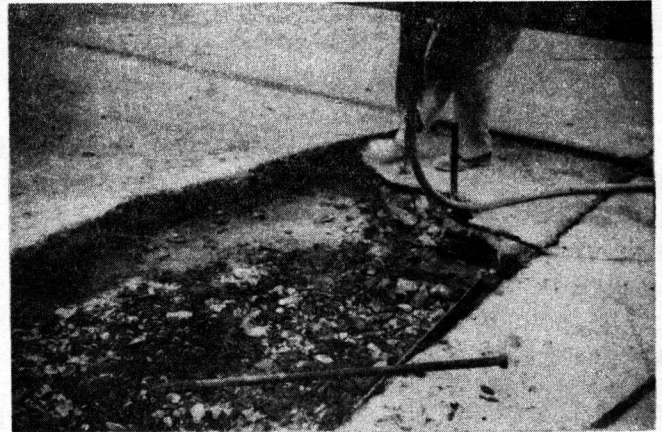
Examination of the mix under the slab at Sta. 695+26 showed the mix to be somewhat disintegrated (cracked) but that it was fairly uniformly mixed and not plastic. The area in which the mix was found seemed to be somewhat drier than the rest of the subgrade. A band of mud about two feet wide was found under the joints and cracks. It appeared that the broken slab sections were rocking on or being supported by the drier area in which mud-jack mix was found. This was true in the other treated section which was removed. A similar muddy condition was found under the untreated slab. The subgrade was dry under the inner portions of the slab and extremely wet under the cracks and at the joint and edge.

FIGURE 36. AN ILLUSTRATION OF THE ZONE OF MUD FOLLOWING THE CRACK.
