INVESTIGATION OF CONCRETE PAVEMENT PUMPING

H. L. Krauser, Construction Engineer
Ohio Department of Highways
Chillicothe, Ohio

This paper describes the investigation of the pumping at transverse joints in concrete pavement slabs on a project 4.39 miles in length on U.S. 52 in Scioto County, Ohio, near the village of Franklin Furnace.

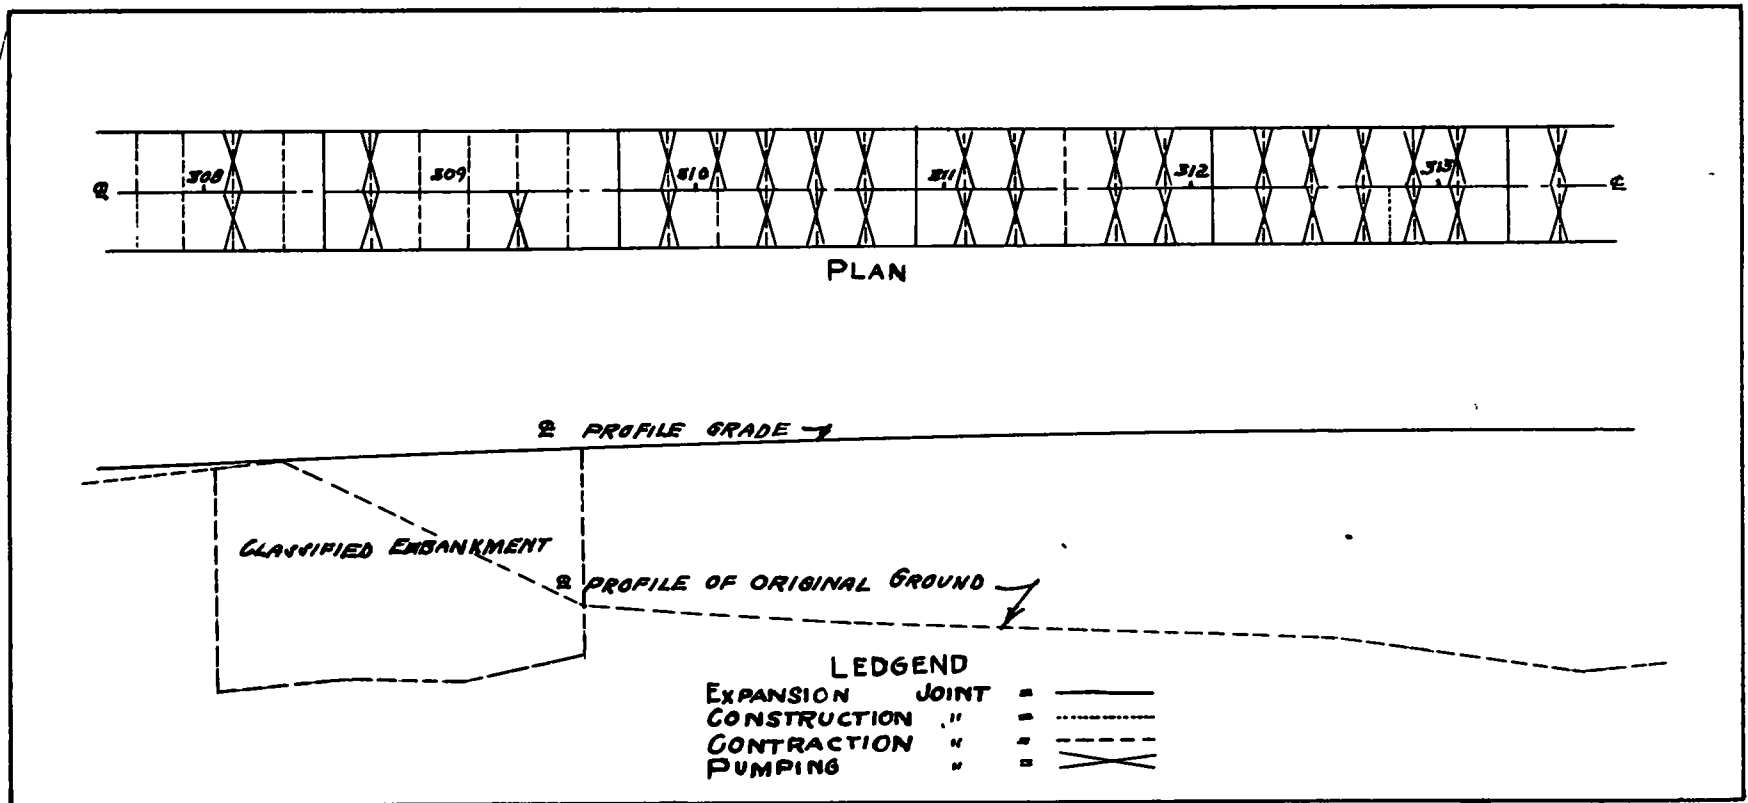
FIG.1. SHOWING METHOD OF PLOTTING TRANSVERSE JOINTS

The investigation was begun by locating all transverse joints on each project. This work was done on March 27 and 28, 1944 after a series of rains made pumping joints easily identifiable. While it might seem that results observed at this time would represent extreme conditions subsequent observations indicate that average conditions prevailed. Each joint was listed as to type and condition and the results plotted. Figure 1 shows a typical section with legend markings.

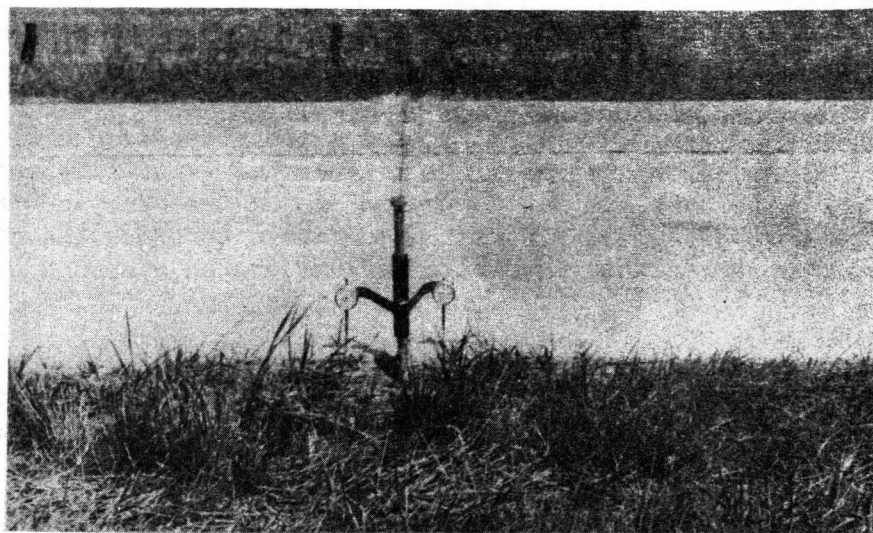
On April 20, 21 and 26, 1944 a series of observations were made to determine the deflection of the pavement slab under traffic. The device used consisted of a metal stake and bracket to which two Ames gauges were attached. The metal stake was driven at such locations that one of the gauges was in contact with each of the pavement slabs adjacent to the transverse joint. At each joint where observations were made the gauges were placed near the pavement edge (See Fig. 3) and near the junction with the center line joint.

FIGURE 3. AMES DIAL GUAGE IN POSITION TO MEASURE SLAB DEFLECTIONS.

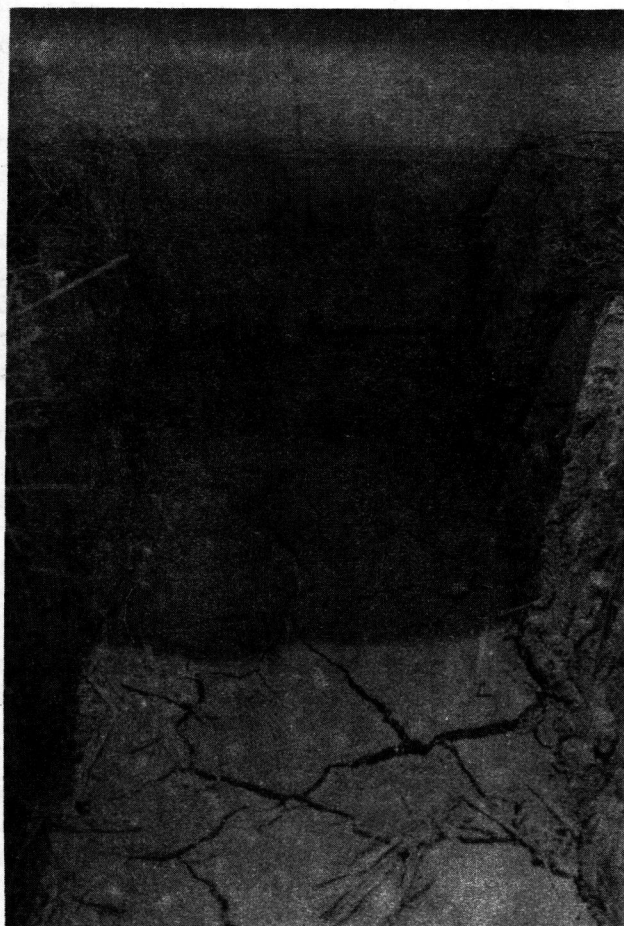
On the left of Sta. 417+68 where a trench was cut through the berm, water was being worked from beneath a contraction joint by traffic one week later. Figure 4 shows this trench. This location is at the transverse joint where the greatest deflection was observed as shown by Table 3.

FIGURE 4. TRENCH CUT THROUGH BERM FROM PAVEMENT EDGE. WATER RAN FROM BENEATH THE PAVEMENT JOINT WHEN TRENCH WAS OPENED.

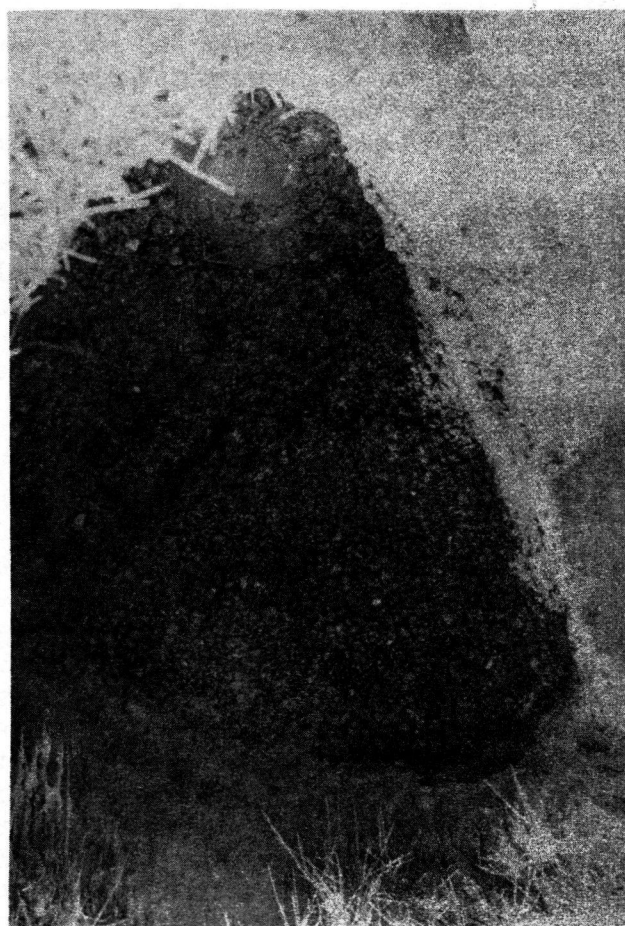
In order to check the functioning of the No. 46 size (3/4 in. to No. 4) porous backfill material that was used over the longitudinal roadway drainage pipe placed adjacent to classified embankment areas, the material was removed at one location down to the top of the pipe and more or less vertical faces of undisturbed material were exposed. Figure 5 shows one such vertical face on the left of Sta. 337+10. At this location it was observed that eight inches of heavily silted aggregate was in place immediately above the top of the pipe. Above this was approximately 20 in. of aggregate with a very small amount of silt. Above this was a layer, approximately 12 in. thick, composed of predominately silty material. The flow line of the ditch has been raised approximately six inches by silt depositing in it during the five month period that has elapsed since the contract work was completed on this project. While the porous backfill is apparently functioning satisfactorily at the present time, it is doubtful whether it will do so indefinitely with the continuance of the depositing of silt.

FIGURE 5. VERTICAL FACE OF #46 POROUS BACKFILL OVER PIPE. NOTE HEAVY SILT CONTENT FOR APPROXIMATELY 8" OVER PIPE.

When using gravel for porous backfill over pipe underdrainage, it is recommended that the size be not larger than No. 6 (3/8 in. to No. 8). Despite the high coefficient of permeability (187.5 ft. per day) that was obtained from tests of the No. 46 porous backfill material taken from immediately above the underdrainage pipe, heavy silting has occurred and will eventually reach a point where the functioning of the system will be greatly impaired if not entirely invalidated. It is further recommended that the open joints of the underdrainage pipe be wrapped with burlap to prevent the finer particles of the porous backfill material from being carried through these joints.
