THE PUMPING OF CONCRETE PAVEMENTS IN NEW JERSEY,  
CORRECTIVE MEASURES EMPLOYED, AND FUTURE DESIGNS

William Van Breeman, Engineer of Special Assignments,  
New Jersey State Highway Department

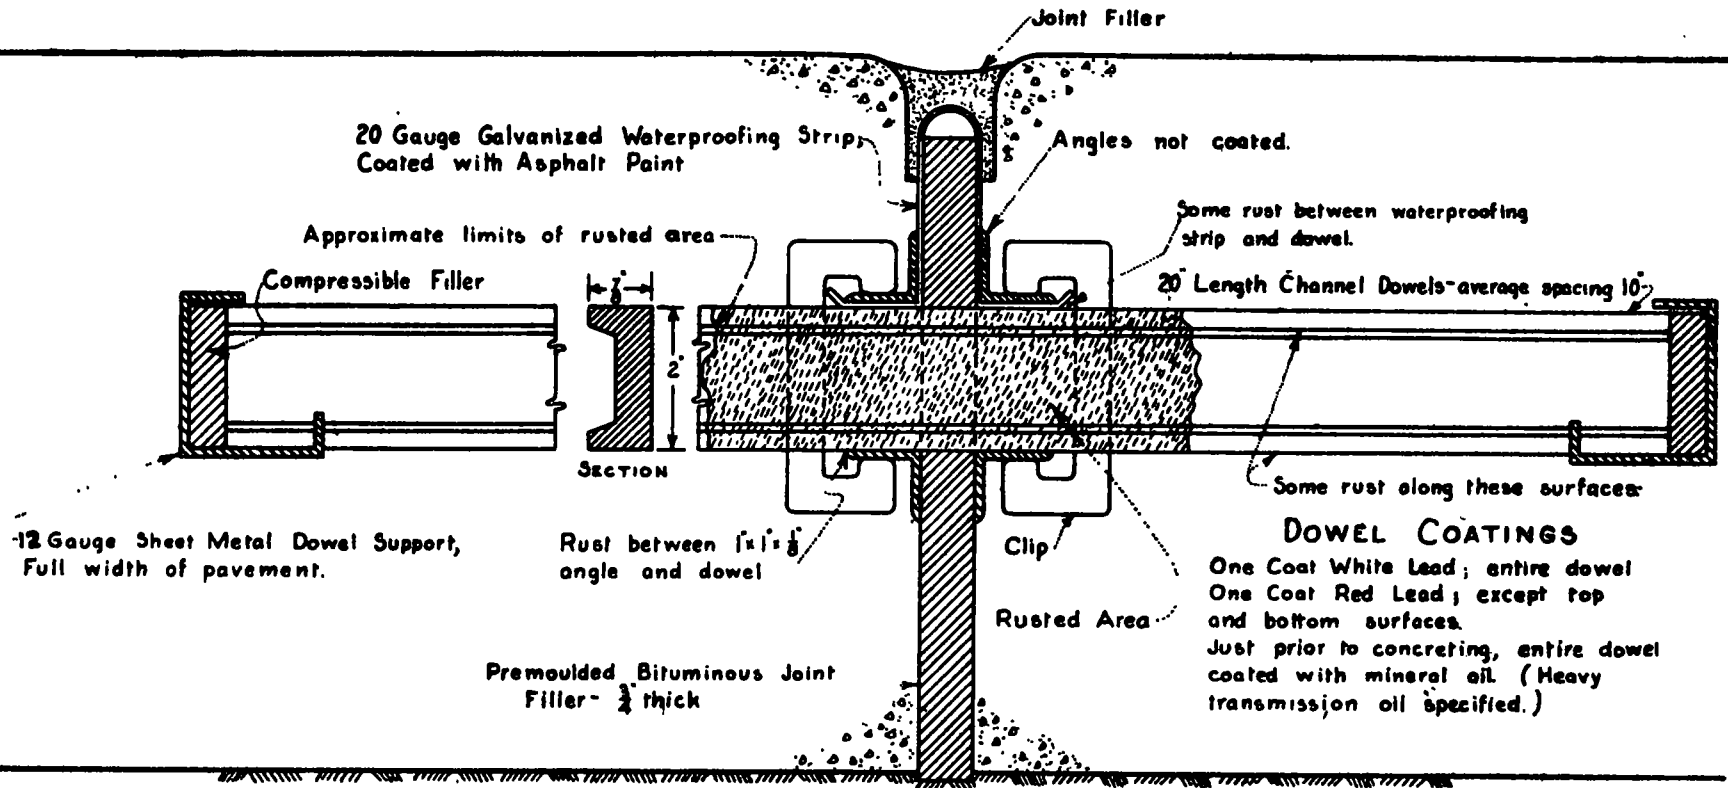
Three of these dowels were entirely withdrawn from the concrete for detailed inspection. Considerable rusting of the dowel surfaces was found, especially for several inches each side of the joint space. (See Figure 1). The remaining 6 in. or so in the vicinity of the ends of the dowels was comparatively free from rust although some rust was found along the entire bottom surface of the channels and along the bottom surface of the top flange. The dowels were surrounded by very dense, well consolidated concrete. The indications are that moisture entered at the joint faces and progressed inwardly for several inches. As the dowels were withdrawn, pieces of concrete at the joint face which evidently adhered to the rusted portions of the dowels were broken out.

In so far as this particular joint is concerned there appears to be no doubt that corrosion of the dowel metal is the primary cause of the resistance to sliding. And there appears to be no reason to doubt that corrosion has similarly affected the rest of the joints in this and many other locations. That corrosion is the primary cause of restraint appears to be substantiated by (a) appreciable rusting and pitting of the dowel surfaces and (b) the fact that as soon as the pulling had advanced to the point where the rusted portion of the dowels had been withdrawn from the concrete the force required to continue sliding was considerably less.

FIGURE 1. SECTION THROUGH CHANNEL-DOWEL JOINT  
SHOWING RUSTED AREAS.  
SCALE:  $\frac{1}{2}'' = 1'$

It appears, therefore, that as the rust forms its tendency to expand imposes a progressively increasing squeezing or gripping action on the dowels which gradually builds up sliding restraint. Apparently sliding of the dowels back and forth in the concrete as normally occurs initially is insufficient to counteract the gripping tendency induced by corrosion.
