THE PUMPING ACTION OF CONCRETE PAVEMENTS

MAINTENANCE OF JOINTS IN CONCRETE PAVEMENTS

THE PUMPING ACTION OF THE SLABS

Special Papers Presented  
for  
The Twenty-fourth Annual Meeting  
(Unassembled)

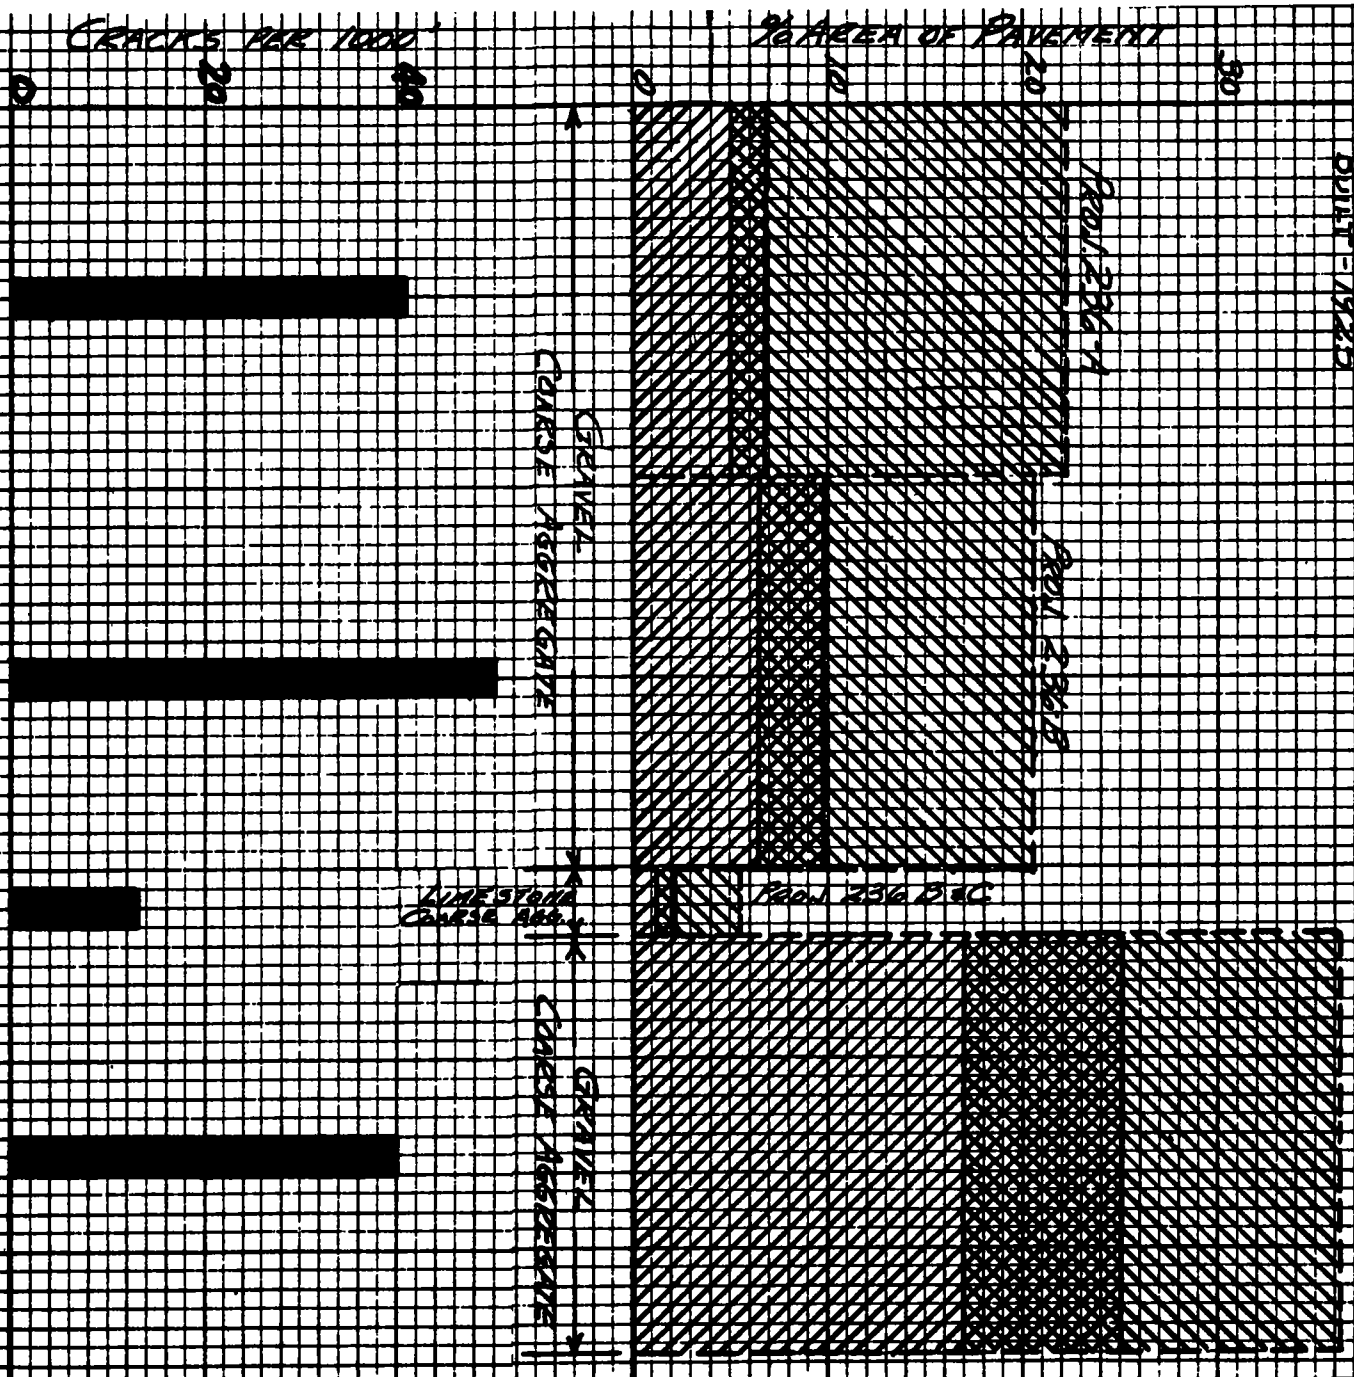
FIGURE 1

- DETECTIVE PAVEMENT  
 - ANTICIPATED FAILURES WITHIN 5 YEARS  
 - CONCRETE REPAIRS WITHIN 5 YEARS

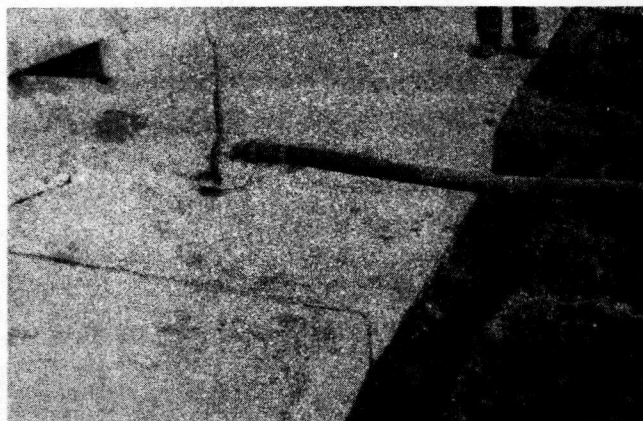
FIGURE 3. SUCCESSFUL MUDJACKING. HERE THE SLAB HAS BEEN RAISED TO GRADE AND A LONG RIBBON OF THE MUD-JACKED MIXTURE IS SEEN EXTRUDED FROM BENEATH THE SLAB.

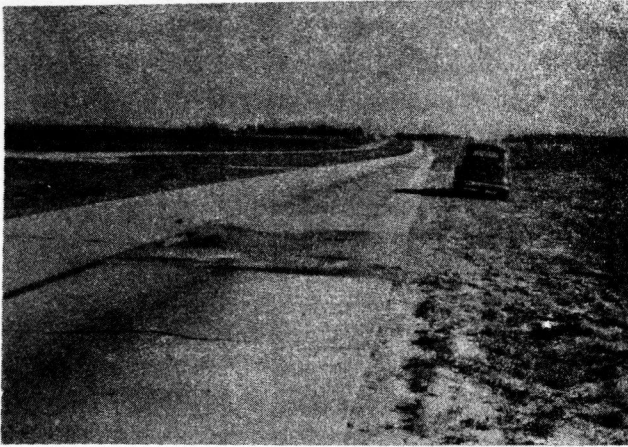
FIGURE 5. PERFORMANCE IN THE WATER-SATURATED SUBGRADE SECTION IN OCTOBER 1944.

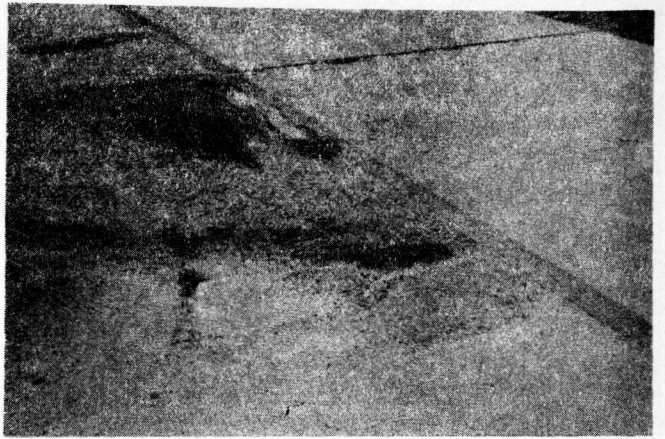
FIGURE 6. CLOSE-UP OF A JOINT IN THE WATER-SATURATED SECTION (OCTOBER, 1944).

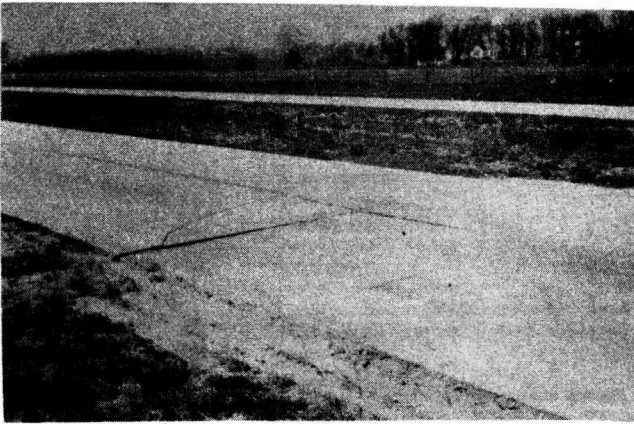
Pumping was found to be severe in the silty-clay drift areas. Figures 7 and 8 are views of the same joint taken in 1943 and 1944 and show the extent of the failure of some of the severely pumping joints on drift soils. One section of this road, constructed on silty-clay drift, contained a total of 50 patched slabs in a distance of 2700 ft. (See Fig. 9).

FIGURE 7. VIEW OF A SEVERELY PUMPING SLAB IN DRIFT SOIL OF THE VALPARAISO MORaine IN NOVEMBER, 1943.

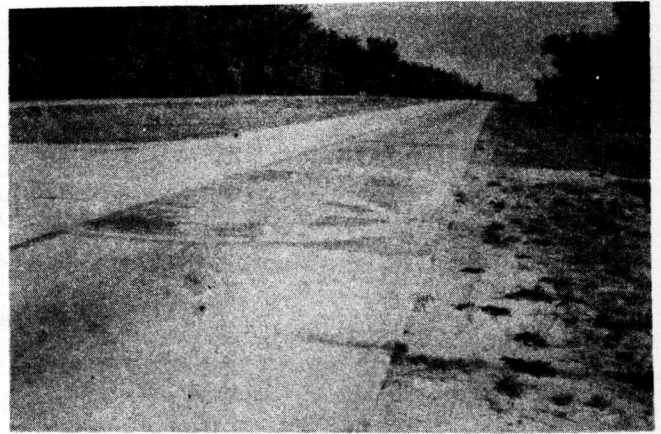
FIGURE 8. VIEW OF THE PATCH ON THE SAME SLAB (FIGURE 7) IN NOVEMBER, 1944. PUMPING IS STILL SEVERE.

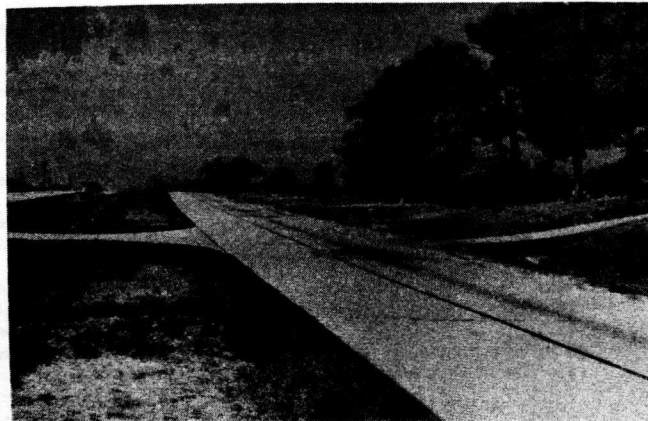
FIGURE 9. A SERIES OF PATCHES AT JOINTS OF SLABS THAT HAVE SETTLED DUE TO PUMPING. ON ONE SUCH SECTION A TOTAL OF 50 PATCHES WAS COUNTED IN 2700 FEET.

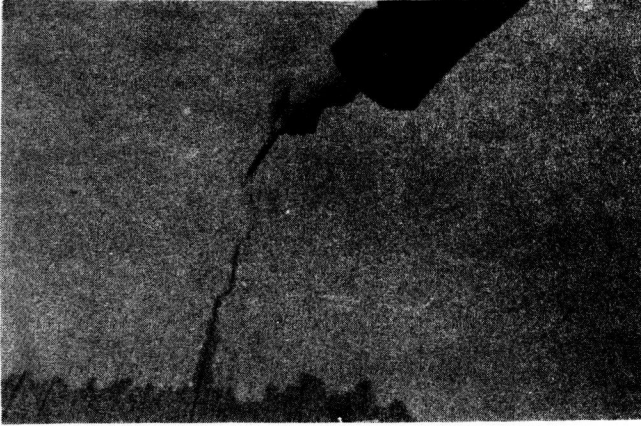
FIGURE 11. FIRST STAGES OF CRACKING DUE TO SLAB PUMPING.

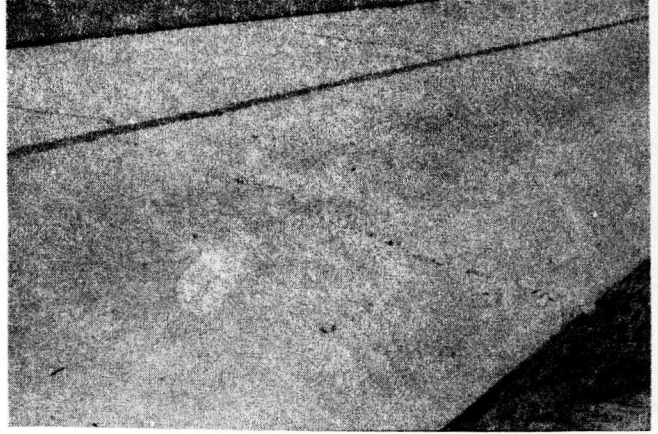
FIGURE 12. ADVANCED STAGES OF CRACKING IN WHICH SPALLING OCCURS CAUSED BY SEVERE SLAB MOVEMENT.

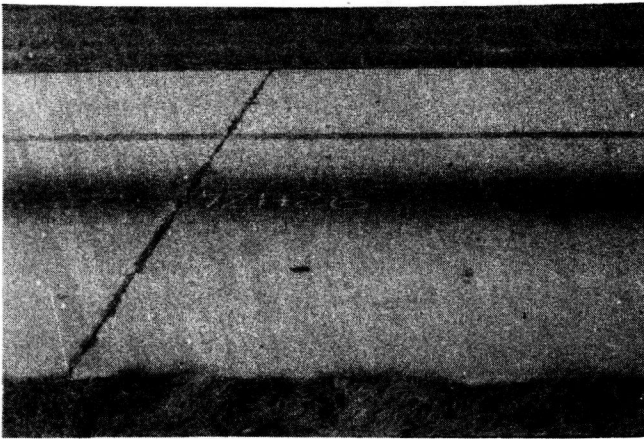
FIGURE 13. SUCCESSFUL MUD JACKING. THIS JOINT TREATED WITH MIX "A" HAD NOT SETTLED OR PUMPED DURING TWO YEARS OF SERVICE.

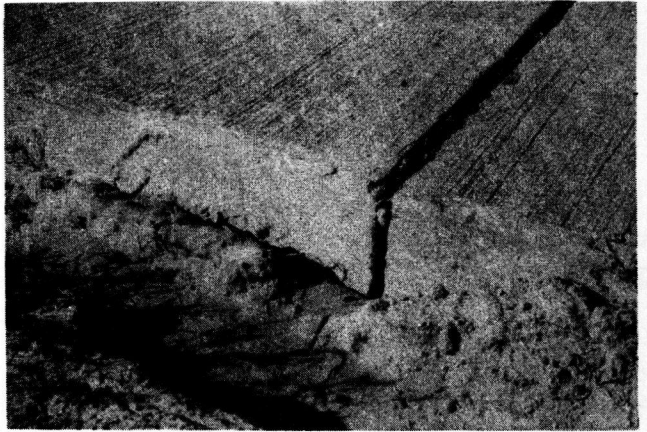
FIGURE 14. SEVERE PUMPING AT AN UNTREATED JOINT IN THE SECTION OF PAVEMENT IN WHICH JOINTS WERE TREATED WITH MIX "A"

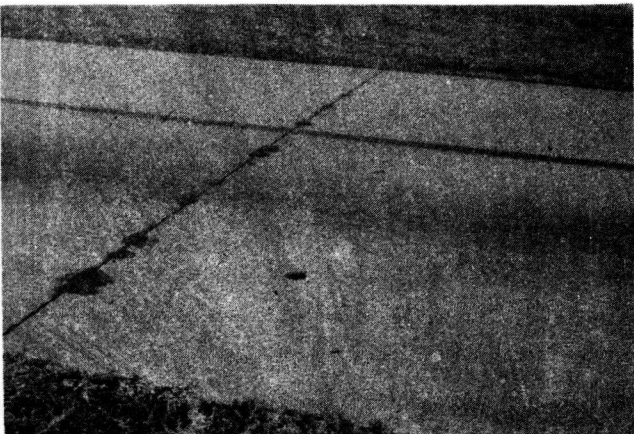
FIGURE 15. A SLAB TREATED WITH MIX "B" THAT HAS GIVEN TWO YEARS OF GOOD SERVICE.

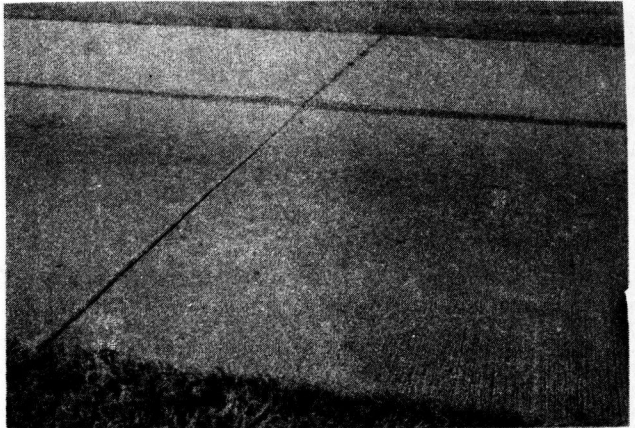
FIGURE 16. AN UNTREATED SLAB (IN THE AREA IN WHICH THE JOINTS WERE TREATED WITH MIX "B") THAT HAD SETTLED  $\frac{3}{4}$  OF AN INCH.

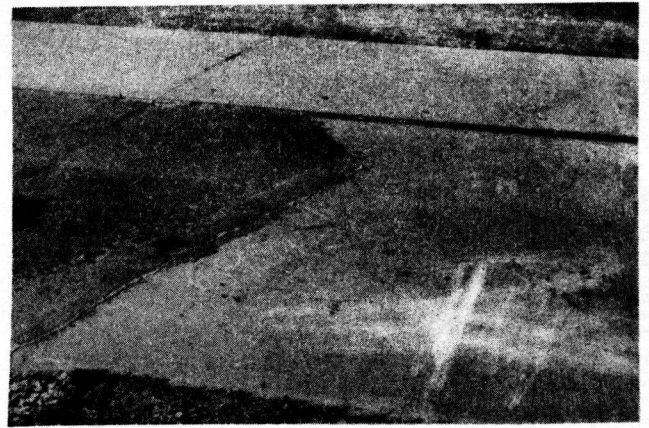
FIGURE 18. THIS IS A VIEW OF THE FIRST CRACK PAST THE JOINT IN FIGURE 17.

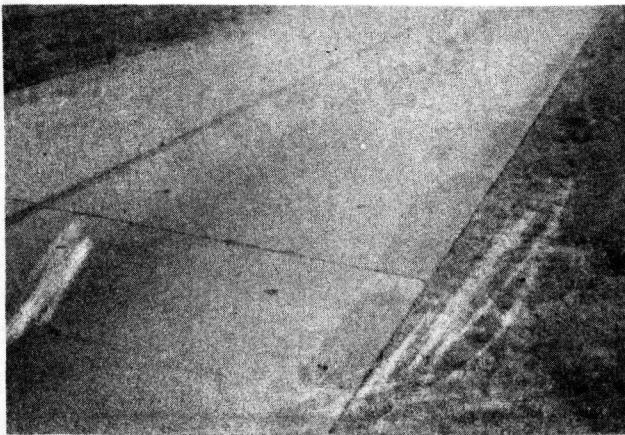
FIGURE 19. THE JOINT AT STATION 662+86 (MIX "C") HAS PERFORMED SATISFACTORILY FOR TWO YEARS.

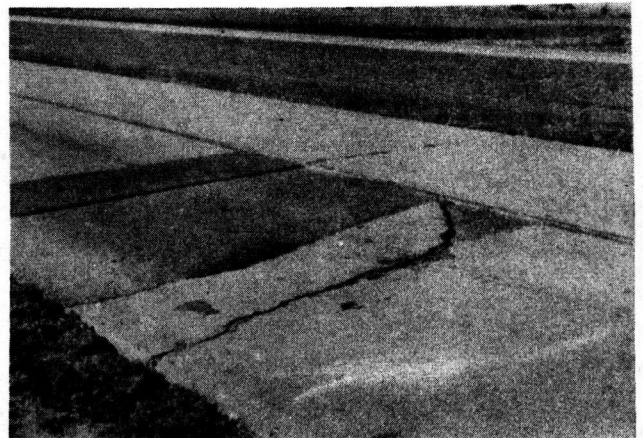
FIGURE 20. THE JOINT AT STATION 662+46 (ADJACENT TO SLAB IN FIG. 19 WAS NOT TREATED AND HAS GIVEN TWO YEARS OF UNSATISFACTORY PERFORMANCE.

This slab was not treated. A zone of soupy mud was found directly under the cracks and the joint. The remainder of the subgrade-pavement contact area was fairly dry. The drain at this joint had also clogged to the tile.

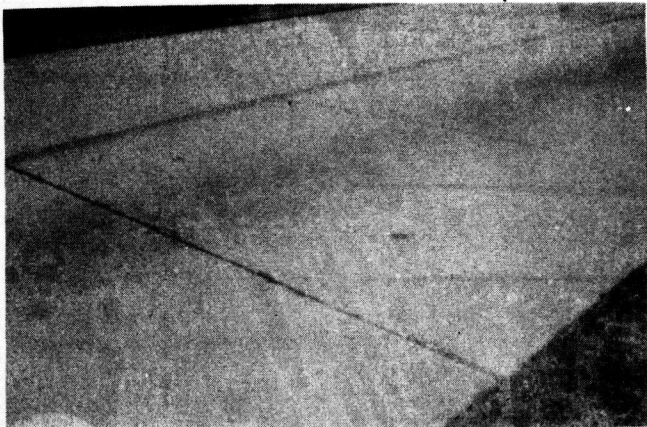
FIGURE 21. ANOTHER SUCCESSFULLY TREATED JOINT (MIX "C").

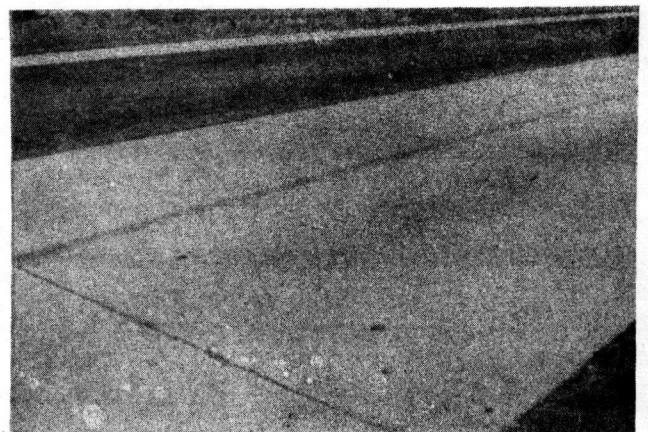
FIGURE 22. THIS JOINT, TREATED WITH MIX "D", PERFORMED SATISFACTORILY DURING TWO YEARS OF SERVICE.

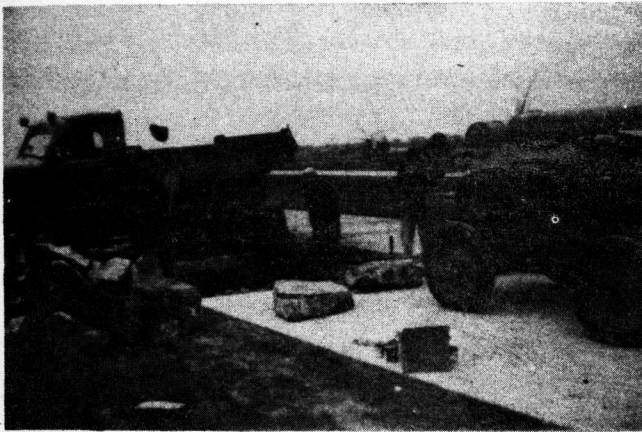
FIGURE 35. REMOVING A SLAB THAT HAD FAILED DUE TO PUMPING.

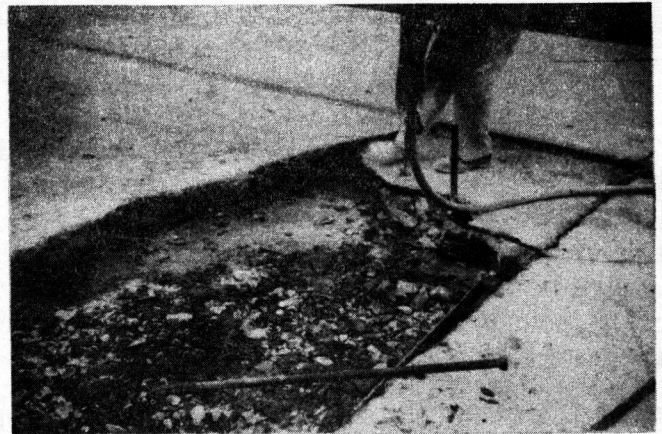
FIGURE 36. AN ILLUSTRATION OF THE ZONE OF MUD FOLLOWING THE CRACK.

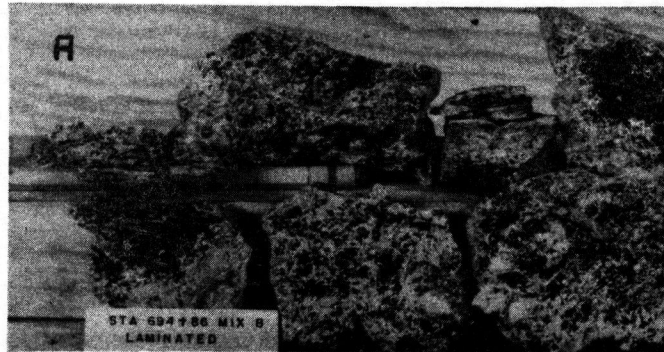
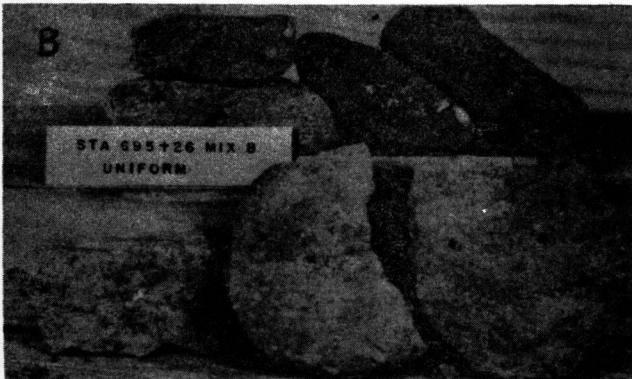
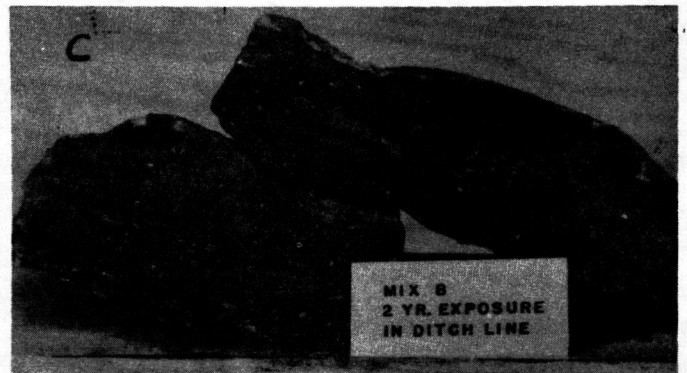
FIGURE 37. PHOTOGRAPHS OF THREE SAMPLES OF MUD-JACK MIX. THE SAMPLES IN PICTURES A AND B WERE TAKEN FROM BENEATH THE PAVEMENT OF TWO TREATED SLABS, AFTER TWO YEARS OF SERVICE. THE SAMPLE IN PICTURE C WAS EXPOSED TO WEATHERING FOR TWO YEARS IN THE DITCH LINE. COMPARE THE TEXTURE OF SAMPLE A WITH THAT OF SAMPLES B AND C. STATION 694+86 WAS TREATED WITH MIX B DURING COLD WEATHER AND THE CHILLING OF THE BITUMINOUS MATERIAL RESULTED IN A NON-UNIFORM MIX. NOTE THE LAMINATIONS IN SOME OF THE SAMPLES IN PICTURE A.

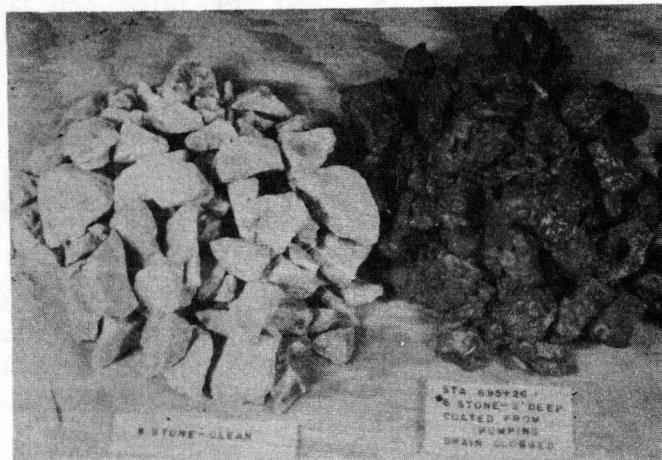
FIGURE 39. COMPARISON BETWEEN CLEAN STONE AND STONE COATED WITH MUD SLURRY FROM A PUMPING JOINT. THIS STONE WAS REMOVED FROM A DRAIN THAT HAD CLOGGED.

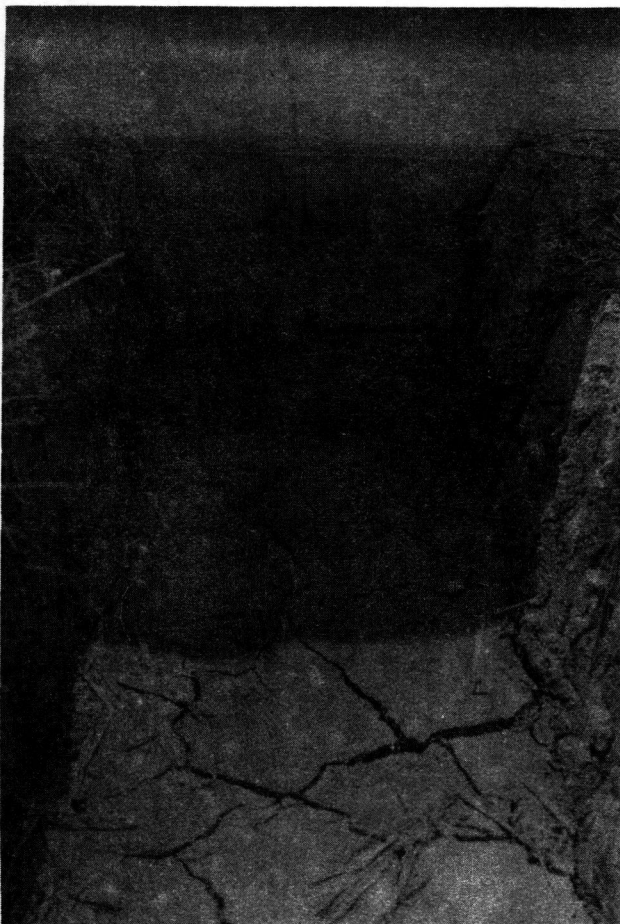
FIGURE 4. TRENCH CUT THROUGH BERM FROM PAVEMENT EDGE. WATER RAN FROM BENEATH THE PAVEMENT JOINT WHEN TRENCH WAS OPENED.

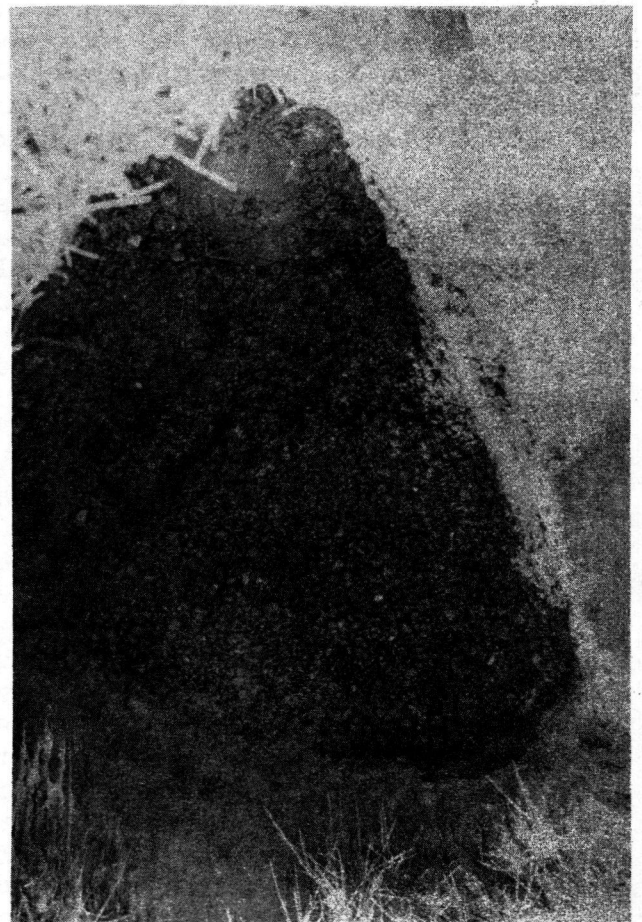
FIGURE 5. VERTICAL FACE OF #46 POROUS BACKFILL OVER PIPE. NOTE HEAVY SILT CONTENT FOR APPROXIMATELY 8" OVER PIPE.

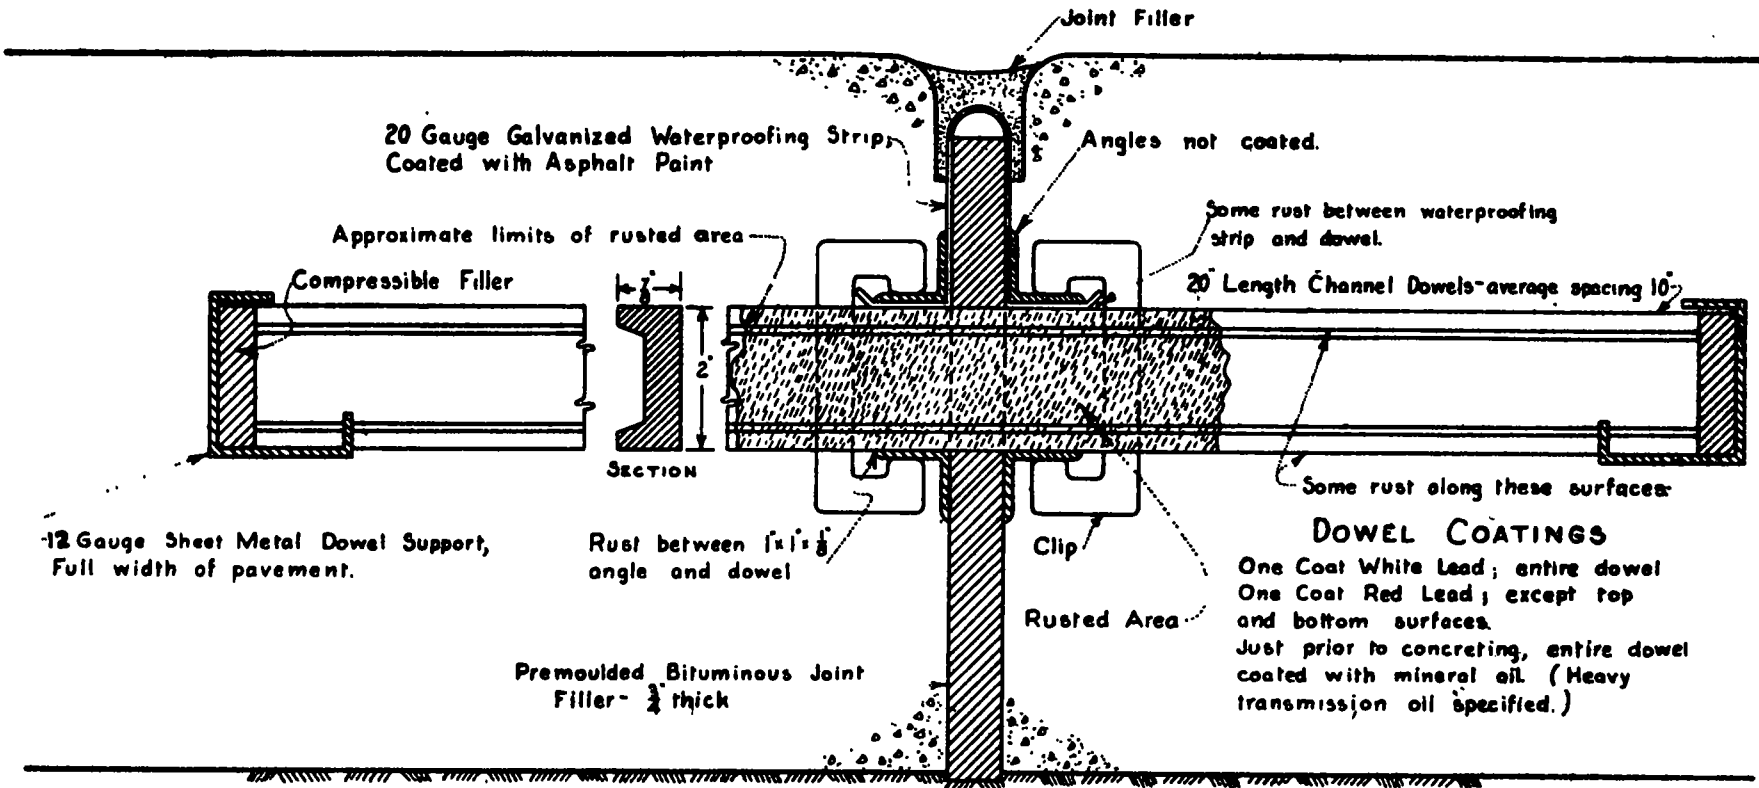
1. When steel corrodes the volume of the products of corrosion is several times the volume of the metal destroyed.

**FIGURE 1. SECTION THROUGH CHANNEL-DOWEL JOINT SHOWING RUSTED AREAS.**  
 SCALE: 1/2" = 1'

2. If corrosion occurs in a state of confinement the products of corrosion exert a considerable expansive effort which, under certain conditions, may be as much as 2000 lbs., per sq. in.

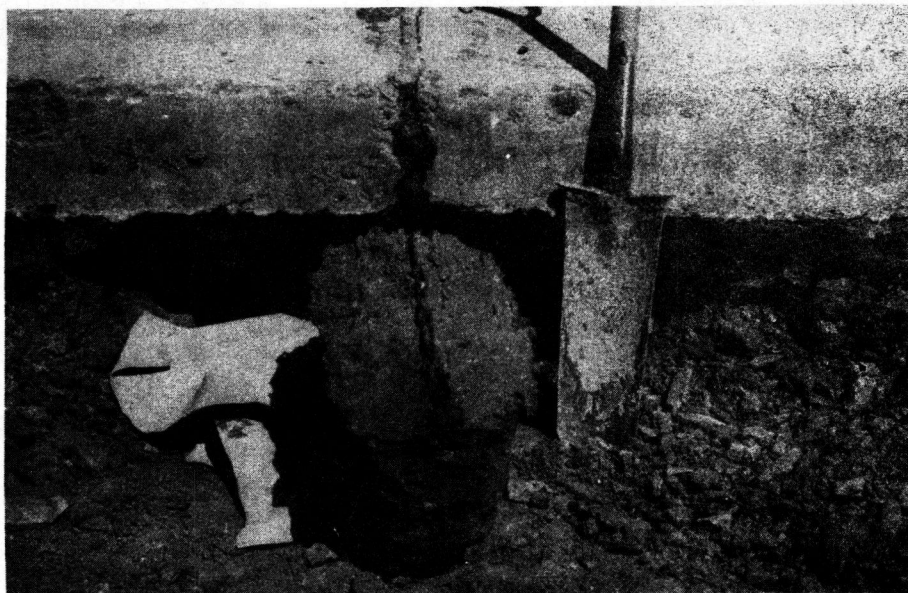
FIGURE 2. UNDISTURBED COLUMN OF SOIL REMOVED FROM UNDER A PUMPING EXPANSION JOINT. NOTE THAT A SOFT MUD HAD FORMED ONLY UNDER THE FAR SIDE OF THE JOINT IN THE DIRECTION OF TRAFFIC.

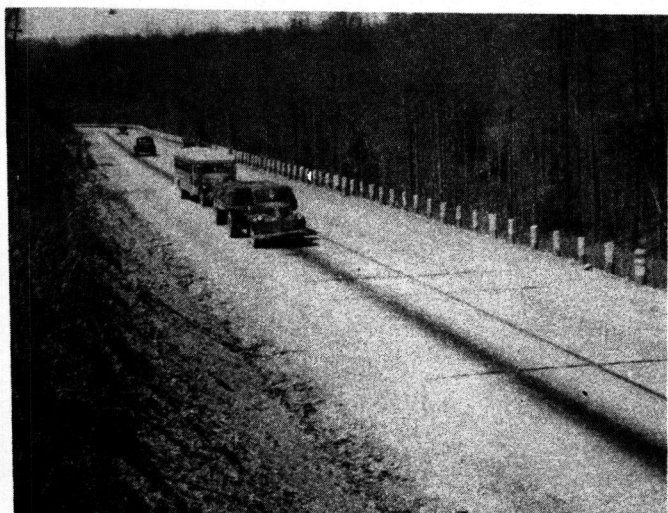
FIGURE 3. NOTE THE DIFFERENCE IN THE OIL STREAKS RESULTING FROM DIFFERENCE IN UP-HILL AND DOWNHILL SPEEDS AND TRACTIVE RESISTANCE OF VEHICLES ON A LONG GRADE. FAP 486 A (2) STA. 380 COFFEE COUNTY (4-6-44)

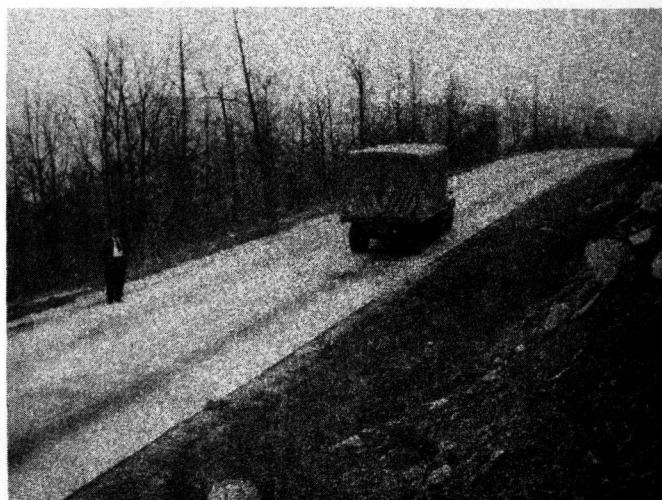
FIGURE 4. ANOTHER EXAMPLE SHOWING THE DIFFERENCE IN THE OIL STREAKS IN THE UP-HILL AND DOWNHILL LANES DUE TO SPEED OF TRAFFIC ON A LONG 6% GRADE. NOTE THE PUMPING AND DAMAGE TO PAVEMENT IN THE UPHILL TRAFFIC LANE. FAP 269 B MARION COUNTY (3-22-44)
