# The Peace River Highway Bridge— A Failure in Soft Shales

R. M. HARDY, Research Professor of Civil Engineering, University of Alberta,  
Edmonton

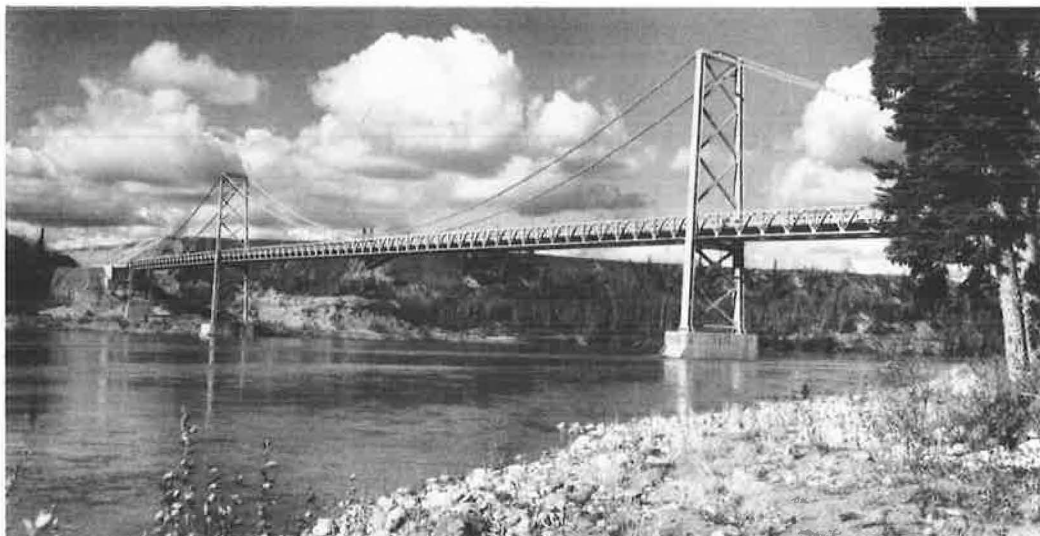
Figure 1. The Peace River highway bridge as originally constructed.

Figure 1 shows the bridge as originally built, looking towards the north bank on which the slide subsequently developed. It was built in 1942 incidental to the construction of the Alaska Highway, now called the Northwest Highway System in Canada, and was designed by the United States Public Roads Administration. It was a suspension bridge with a total length of 2,130 ft, made up of a main span of 930 ft, suspended side spans of 465 ft, and 135-ft simple trusses spanning from the cable bents to the anchor blocks at each end. At the north end the tower and cable bent were carried on spread footings on shale, and the anchor block was also based on shale.

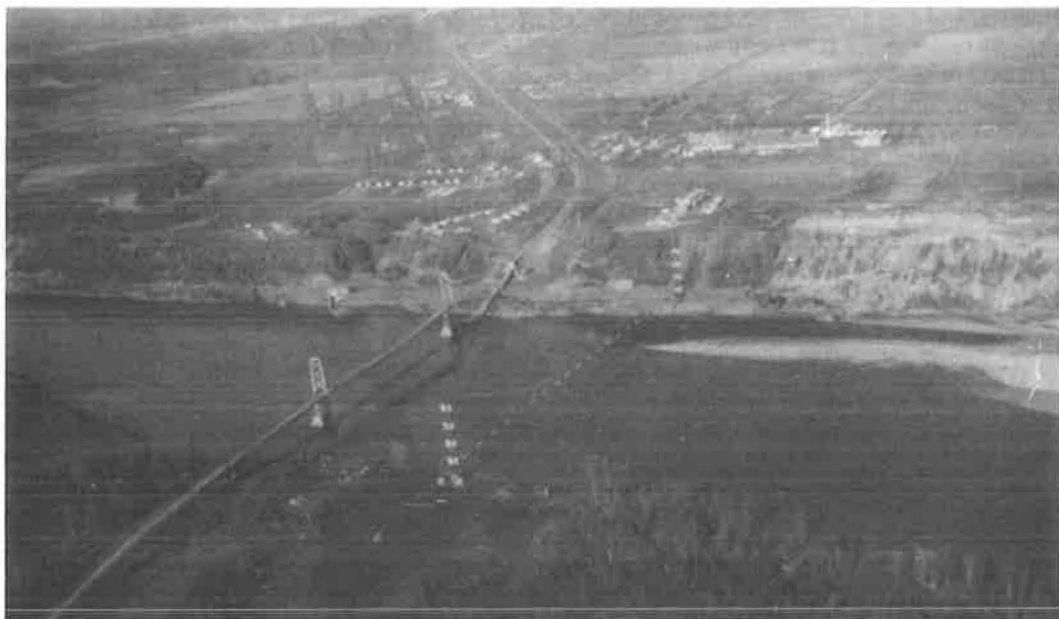
Figure 2. Gas processing plant and pipeline suspension bridge in relation to highway bridge.

The locations of the natural gas scrubbing plant pumphouse and pipeline suspension bridge in relation to the highway bridge are shown in Figure 2.

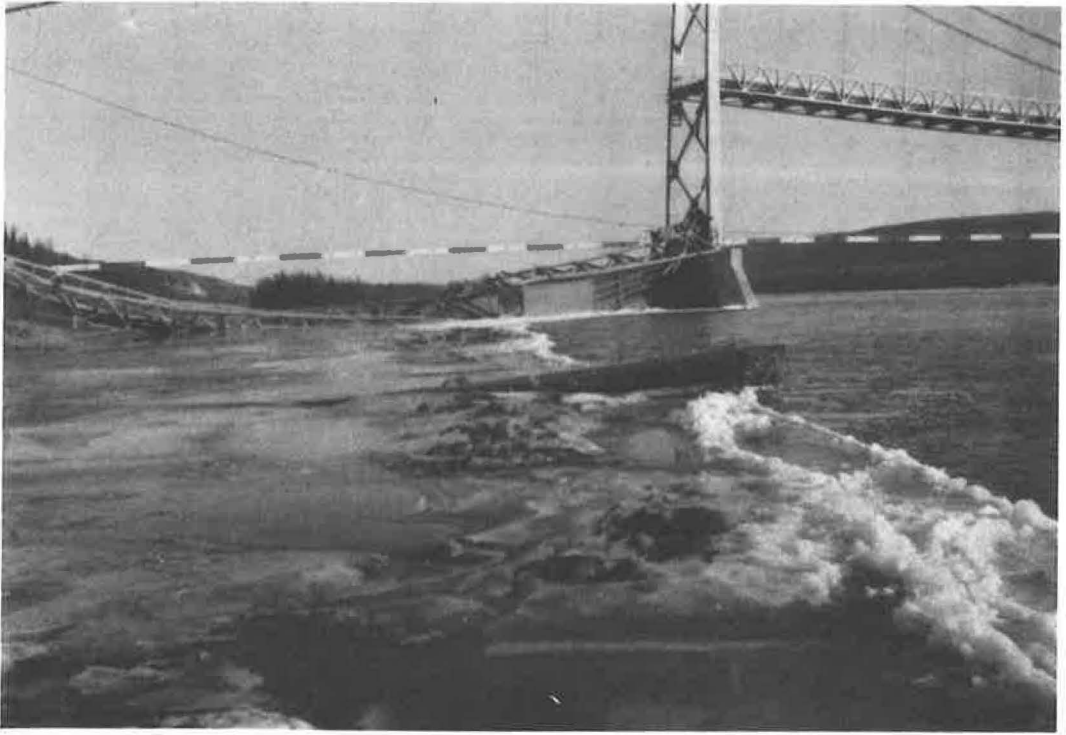
Figure 3. Toe of slide projecting above river surface.

It was evident following the collapse that the bank instability was not confined to the area immediately around the north anchor block. It was clear that a major bank movement had developed. The slide extended a distance of about 470 ft east of the highway bridge, and about 625 ft west to within a few feet of the water intake structure. It was thus about 1,100 ft long and was centered about 75 ft west of the bridge centerline. The extent of the slide above the river level was clearly defined by a sheared face at the top and cracks at the ends. The toe of the slide appeared above the water surface at a distance of about 120 ft from the shoreline.

The extent of the bridge collapse is shown in Figures 3, 4, 5 and 6. The toe of the slide is shown in Figure 3 projecting above the water surface in the river. The extent of the slide which developed in the bank is indicated in Figures 6 and 7.

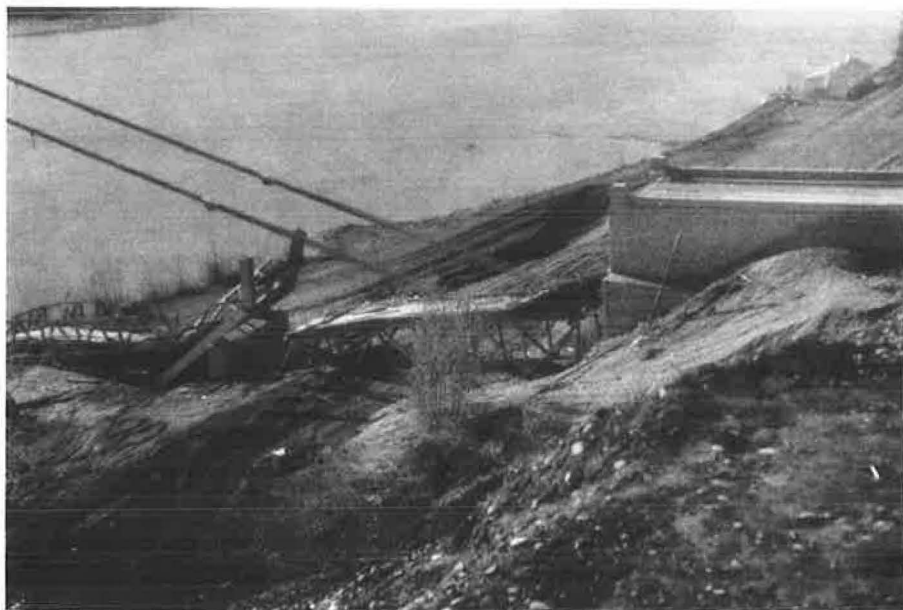
In view of this, officials of the Northwest Highway System made a complete check of their 1952 survey during the period October 3-8, 1957. This showed a possible 1.08-ft shift southward and a definite 3-in. shift westward of the top of the north cable bent. Observations on the north anchor block showed a tilting, as well as shifting toward the south, with a possible movement of 1.6 ft horizontally in the interval 1954 to early October 1957. It is likely that most of this movement occurred during the late summer of 1957, because with this magnitude of total creep noticeable defects in the approach road immediately north of the anchor block would be inevitable. Such in fact were evident between early September and early October 1957. A total settlement estimated at 18 in. in the approach road was observed for a distance of about 18 ft north of the anchor block during this period, cracks were observed in the soil on either side of the anchor block, and surface runoff disappeared behind the anchor.

The cause of the bridge collapse was without question the instability of the bank. The weight of soil within the mass which moved far exceeds the forces acting on the bridge anchor block. It was not a structural failure of the bridge in any sense. The anchor block and cable bent foundation merely rode the slide. However, it appears that deteri-

Figure 4. Slide area, showing movement of anchor block.

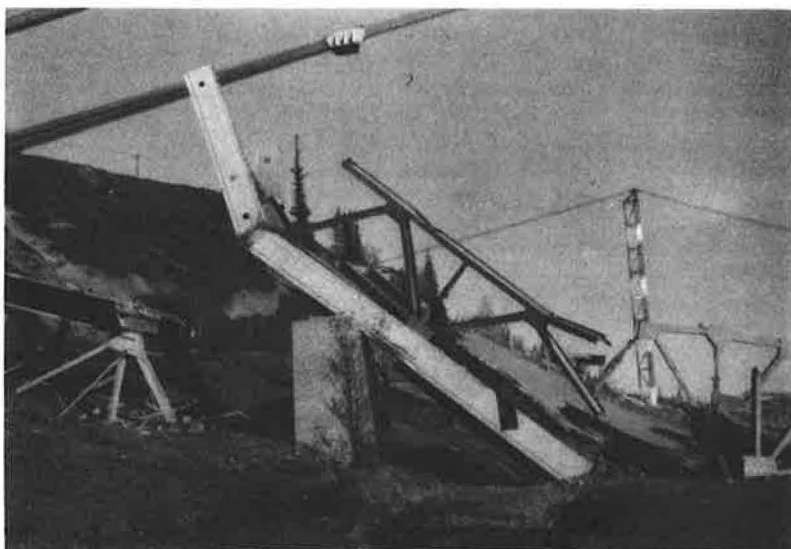
Figure 5. Collapsed cable bent.

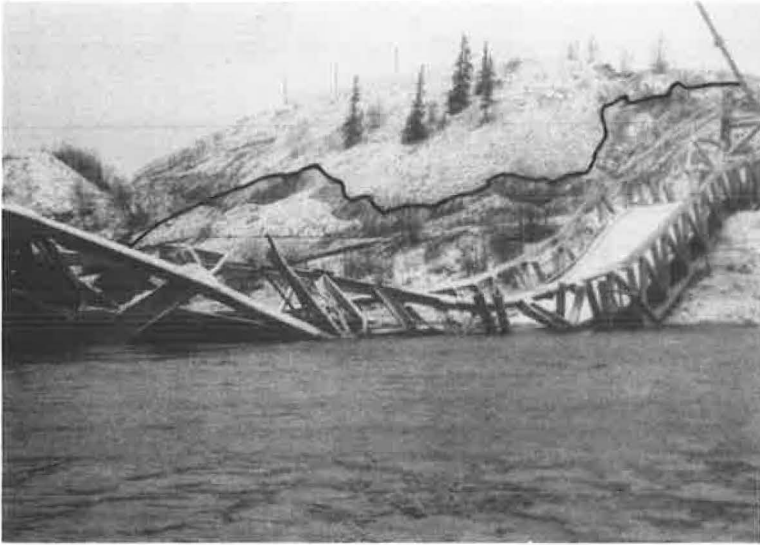
Figure 6. Slide escarpment to west of highway bridge.

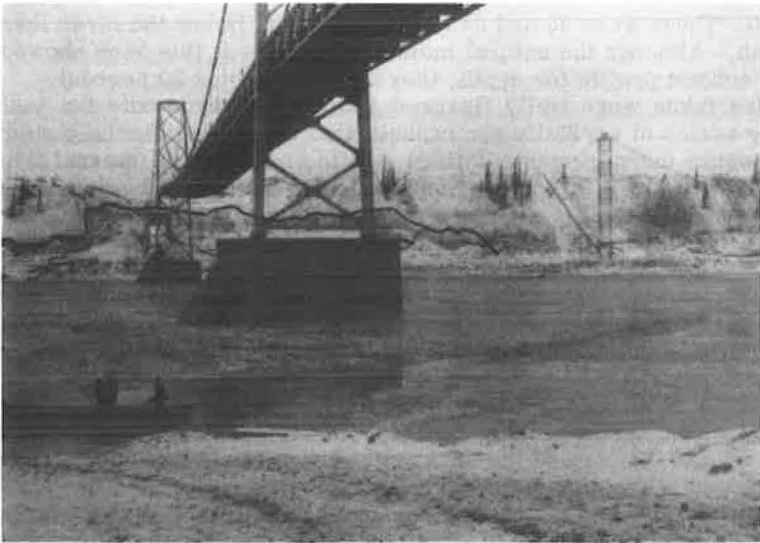
Figure 7. Slide escarpment to east of highway bridge.
