# HIGHWAY RESEARCH RECORD

Number 17

## *Stability of Rock Slopes*

5 Reports

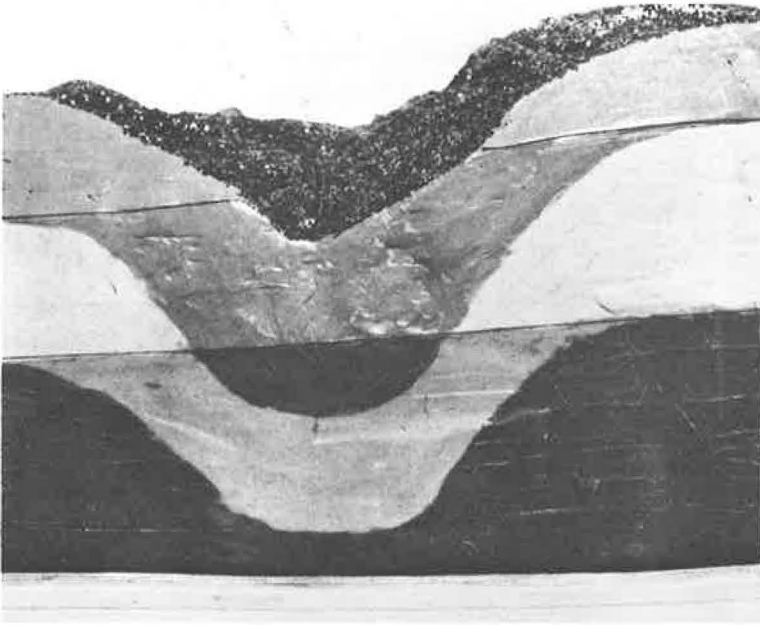
Figure 3. Front view, model of cut through ravine.

Another variable may be added to this last model and the crest of the ridge may be creased with an old ravine in which weathering has progressed to some depth. Figure 3 shows a replica of a design that fails to consider the effect of weathering and the change in materials with change in topography. The soil and weathered rock zones descend with the side slopes of the ravine and encroach into the slope zones established for the cut on the basis of conditions on the ridge crests on either side of the ravine. Such a design which develops 1 to 1 and even  $\frac{1}{4}$  to 1 slopes on soil is going to be a nuisance if not a disaster to the traveler and the maintenance man. Therefore, the slope should be matched to the material.

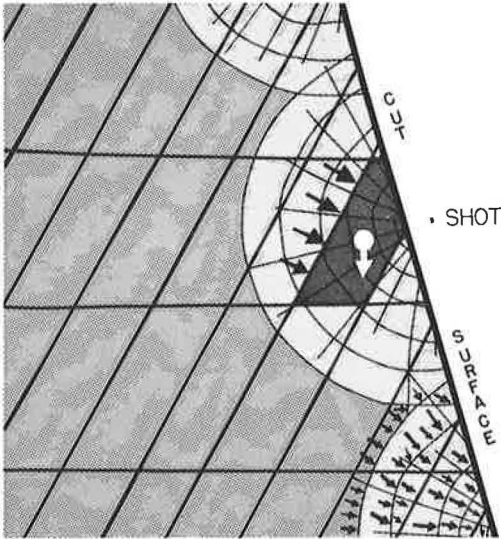
Figure 6. Potentially unstable rock segments.

Figure 6 shows the same conditions but the site is on the left wall of the cut; therefore, the segments appear to lean into the cut. The apparent forces are shown by arrows against the side of a segment that is supported by a small triangular segment at the cut surface. As long as the cut-side segments remain in place, the rock mass is stable; but if those segments move or fall out, then the landward segments will topple and rockfall will result.

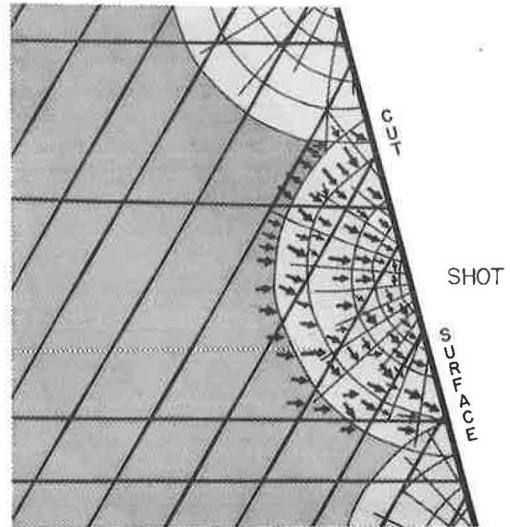
Figure 7. Segments shattered by blasting.

Figure 7 is a modification of Figure 6 and shows the effects of blasting put off at a point labeled "shot" located within the cut area. The original segments have been shattered into odd-shaped fragments within the blast areas by radial and circumferential cracks until the original segments no longer exist and new segments with new conditions of stability or instability occupy the sites of the original segments. The motion of these

fragmental segments as they move sooner or later into the cut is shown by the black arrows. Examination of the original segments, heavily outlined, shows that slope-side buttress segments are now shattered and ready to fall out. The pressure arrows of the landward, unstable fragments will soon force the fractured segments over the slope to be followed by others as rockfalls that will continue for a long time.

On the other side of the cut, the joints dip into the slope, as shown in Figure 7. In such a situation the common methods of blasting will leave a jagged surface partially on the overhanging joints (the underside of the segments) and partially across the joints; that is, through the segments. The stability of the fractured segments remaining adjacent to the left slope surface depends on where the cut slope passes through the fragment and how much of the next roadward fragment remains as a buttress. The rock segment is a high, slabby piece of rock with a narrow base which does not underlie the center of gravity of the segment and is unstable. Most assuredly, a large number of the fractured segments are going to come falling down on the roadbed as rockfalls unless something is done to hold them in place, catch them, or cut the slope in such a way that such shapes are not formed. It would seem wise to presplit the left slope.

Presplitting of cut slopes will reduce the disturbance of the slope-forming materials and reduce the quantity of rockfalls which will, in turn, decrease the maintenance costs. The reduction in rockfalls will also decrease the quantity of scaling required during construction and tend to offset the small cost of drilling and shooting to presplit the rock. It is believed that some positive measures must be taken to reduce the shattering of the slope rock which is one of the major causes of rockfalls. Preservation of the rock segments in their preconstruction condition permits design assumptions to be made and plans prepared without fear that construction procedures will invalidate them.

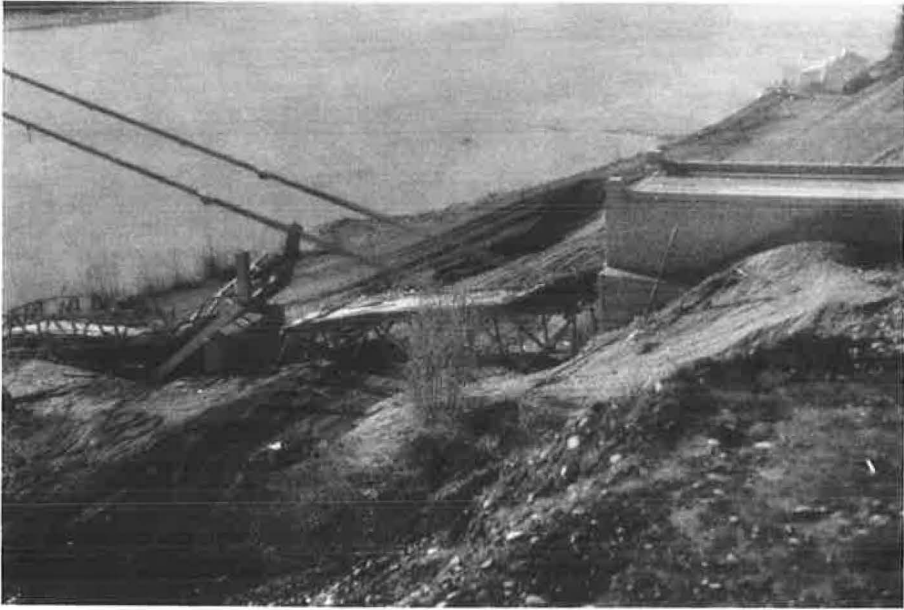
Figure 4. Slide area, showing movement of anchor block.

The cause of the bridge collapse was without question the instability of the bank. The weight of soil within the mass which moved far exceeds the forces acting on the bridge anchor block. It was not a structural failure of the bridge in any sense. The anchor block and cable bent foundation merely rode the slide. However, it appears that deteri-

oration of the stability conditions in the bank commenced soon after completion of the bridge and they continued to deteriorate for a period of years.
