Continuously-Reinforced Concrete Pavements in Pennsylvania—A Six-Year Progress Report

R. K. SHAFFER, and C. D. JENSEN, respectively, Research Coordinator and Director of Research, Materials Bureau, Pennsylvania Department of Highways

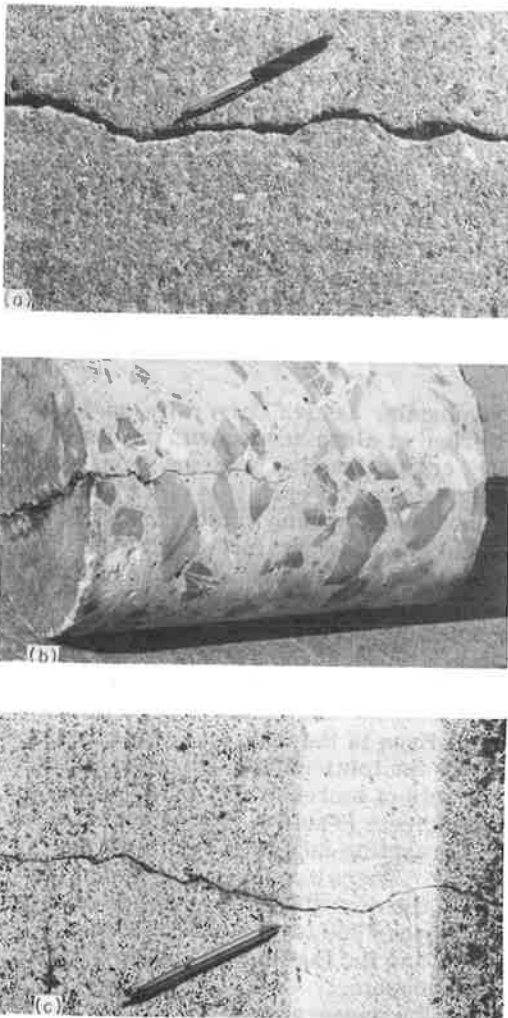
There has been some concern in this State over the appearance of the cracks on the York pavement, particularly the wide, irregularly spalled openings at the surface. The Materials Bureau has always felt these were only superficial and confirmed this opinion by removing a core over a typical crack. Immediately below the surface, the crack assumed hairlike proportions, and as it progressed toward the center of the core, or pavement slab, it became almost indiscernible. The true appearance of the crack, unspalled and void of traffic wear can be observed along the pavement edge. These conditions are shown in Figure 3. It is not felt that moisture of any appreciable amount can penetrate this opening.

Figure 3. Typical crack on York pavement: (a) spalled appearance at surface, (b) core removed directly over crack, (c) appearance of crack at edge of pavement.

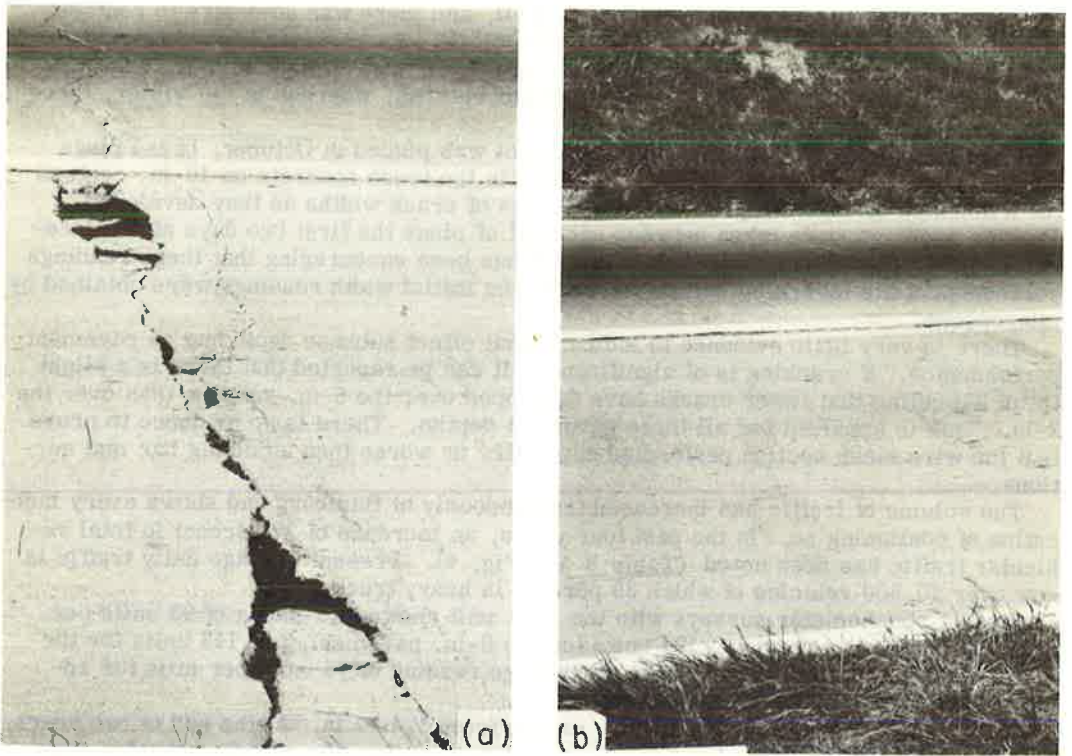
Shortly following the completion of the Hamburg project, generally within three months, it became evident that a number of cracks were becoming unusually wide; some of them measuring $\frac{1}{4}$ to $\frac{1}{2}$ in. at the surface (Fig. 5). An investigation conducted in the spring of 1958, when sufficient pavement was removed at the edge of the roadway to expose the steel, revealed in three instances that there was no overlap of reinforcing steel at all. At two locations, the wide cracks were not at overlaps. The average lap of steel in the remaining ten areas was $7\frac{1}{2}$ in., ranging from 3 to 11 in. The specifications covering this project did not require the bar mats to be tied. It is apparent that this requirement should have been specified and certainly should be written into future contracts involving continuously-reinforced pavements.

Of 13 such areas repaired, only one patch was not successful. After four years, these repairs (Fig. 5) are performing adequately, and although new cracks have formed in the longer patches, they are of a pattern typical of a normal continuous pavement. The

Figure 5. Hamburg pavement: (a) appearance of typical wide crack, (b) patched area after 4 year's service.

After determining the cause of the cracking, arrangements were made to repair the defective areas. It was essential that the work be performed carefully. To insure this, detailed construction specifications were written. The concrete pavement repairs consisted of removal of the existing pavement, restoration of the continuity of the longitudinal reinforcing steel, and replacement of the pavement with high-early strength cement concrete.

In repairing the steel, No. 5 deformed steel bars of the same quality as the existing steel were required for splicing and were of sufficient length to provide an 18-in. overlap at both ends. The steel was welded at the center of the lap with a $\frac{1}{2}$ -in. bead, on one side only, for a length of 5 in. No. 3 transverse bars were placed and tied to the longitudinal bars in accordance with the pattern of the original bar mats.

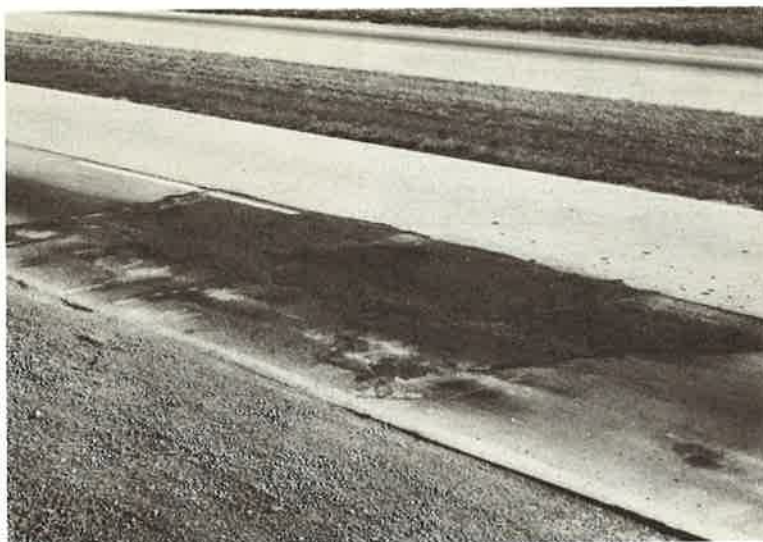
As if the crack failures were not sufficient trouble for the maintenance department, signs of major distress began appearing in the eastbound 7-in. lanes in 1959. More large cracks developed in several locations and these areas deteriorated progressively until large portions of the concrete, comprising as much as 200 sq ft, were broken, disintegrated, and were noticeably below original grade. The broken concrete constituted a hazard to traffic and had to be patched repeatedly with bituminous material. A typical area is shown in Figure 6. In addition to this type of failure, longitudinal cracking was encountered in several locations, primarily near these distressed areas and always within 6 to 8 in. of the center longitudinal joint. Pumping was evident along the edge of the outside traffic lane.

The investigation, conducted in connection with the repaving, paralleled the earlier findings: The average overlap of steel was $10\frac{1}{2}$ in., the average depth was $3\frac{1}{4}$ in.

Figure 6. Failure in 7-in. pavement, Hamburg.

The overlap of steel ranged from 8 to 13 in. , and the range in depth was from $2\frac{3}{4}$ to $3\frac{3}{4}$ in. , measured from the top of the steel. Many of the steel bars were broken in the areas where pavement damage was the worst. There is no doubt that the overlap (12 in.) of steel on this project was inadequate and that the large transverse cracks and subsequent breaking of concrete between two such parallel cracks were probably the beginning of many of the failures. The majority of these areas occurred at an overlap. The quality of the concrete removed appeared to be sound and revealed an excellent distribution of aggregates.

It was apparent that these failures were becoming worse. In the spring of 1960, the laboratory recommended that the 7-in. eastbound lanes be replaced. Bureau of Public Roads concurrence was secured, considering the major research aspect of the joint venture. A contract was awarded in September 1960 for the replacement of 5,340 sq yd of concrete with standard reinforced pavement, 10 in. in depth. Work commenced on October 19, 1960, when the contractor began breaking the concrete in the eastbound lane between stations 188 + 96 and 188 + 97.5, a distance of approximately 2,000 lineal feet.

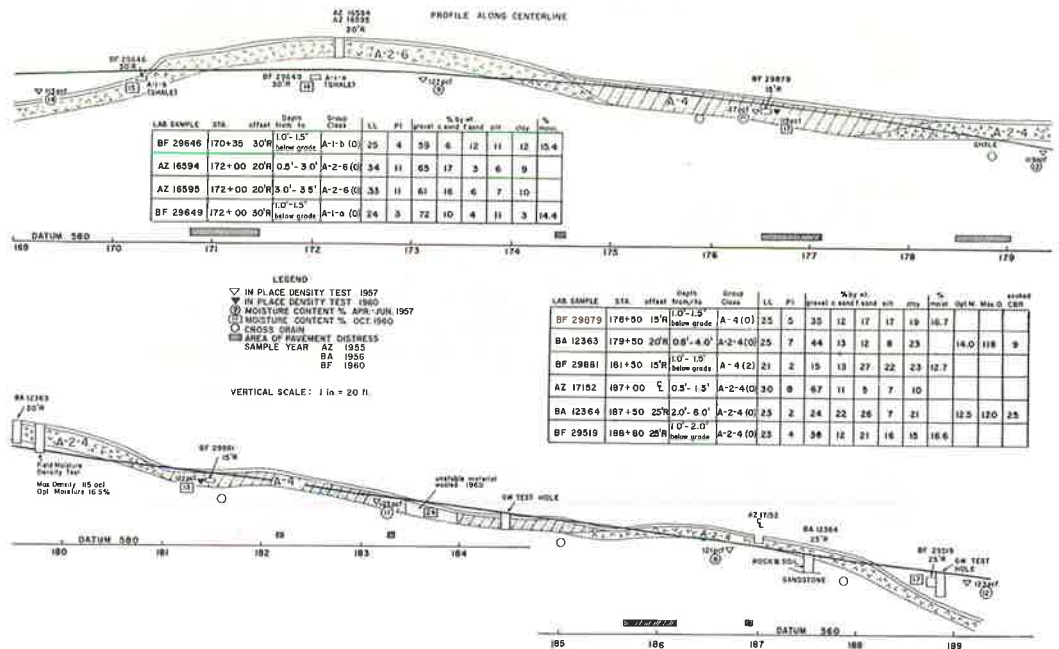
1. Five soil gradations each for the subbase and subgrade with moisture content determinations (Fig. 7; Table 7).
2. Two sand cone density checks of the subgrade (Table 6).
3. Two holes drilled for ground water level.

Figure 7. Soil survey, Hamburg project, stations 169 to 189.

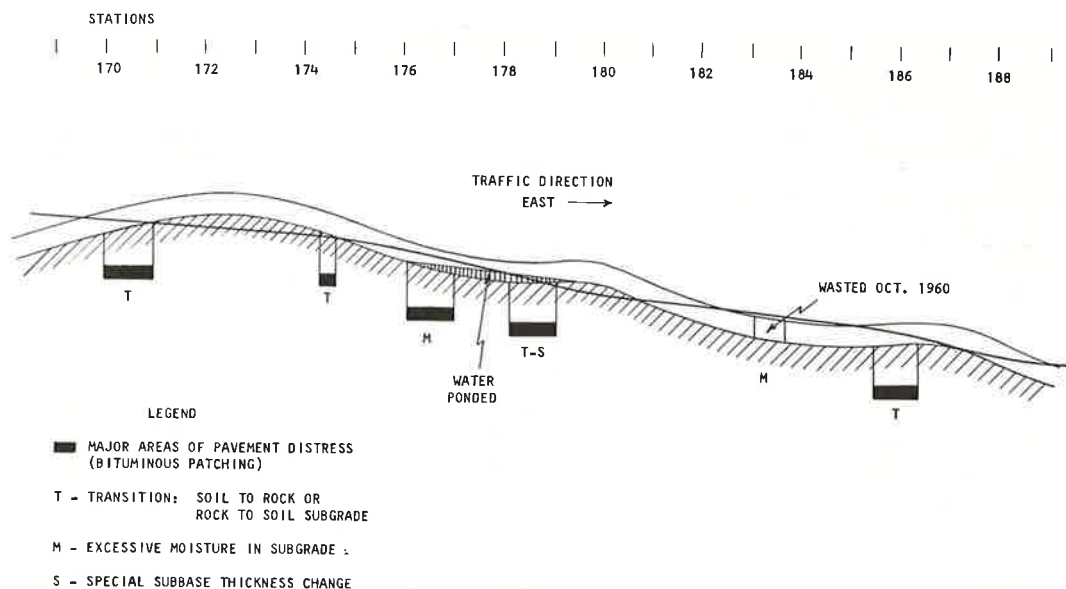
Figure 9. Failed section showing major areas of pavement distress.

The grade line skirts along the original ground line making deeper cuts through three knobs (station 171 + 00 to 174 + 00, 178 + 50 to 181 + 00, and 186 + 00 to 188 + 00) into rock. This causes a non-uniformity of bearing of the subgrade as shown in Figure 9. The transition of soil to rock in the western flank of each knob is an area of pavement distress. At the transition of rock to soil coming out of a 7-ft cut at station 174 + 50, pavement failure was also present. At station 178 + 50 to 179 + 00, the abrupt change in the subgrade is also in the area of the thickness change of the subbase, possibly further aggravating the non-uniform bearing condition.

In between the three knobs are two pockets of the natural soil derived from the Martinsburg formation below. Where this soil overburden is at its greatest depth below grade (stations 176 + 50 to 177 + 20 and 183 + 50 to 184 + 00) and where surface rolling would have the least effect at depth, unstable conditions exist in the subgrade. This is caused by excessive moisture with a resulting softening of the subgrade.

Compaction control was adequate and the type of subgrade was not poor, but the nonuniformity of the subgrade bearing was too great for the bridging action of the 7-in. pavement. This condition, aggravated by the overlap problem plus repeated application of heavy axle loads, was undoubtedly the cause of failure. If the grade line had either been lower or higher with a more uniform subgrade present, and drainage had functioned properly, it is believed that a well-constructed roadway of 7-in. continuously-reinforced pavement would not have failed at this location.
