Maryland's Two Continuously-Reinforced Concrete Pavements—A Progress Report

ALLAN LEE, Chief, Research Section, Maryland State Roads Commission

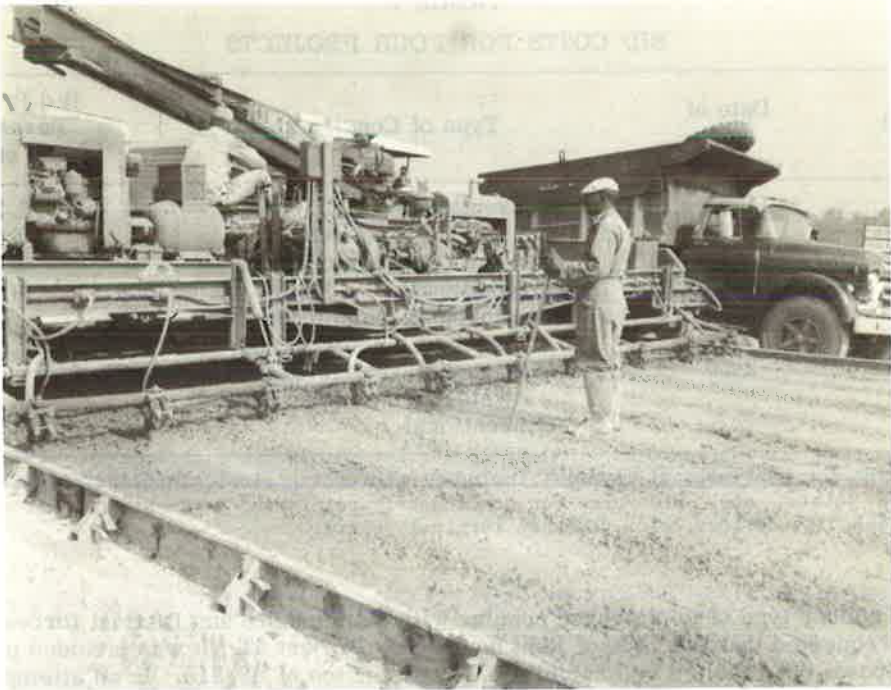
Figure 7. Pavement construction showing internal vibration of concrete.

1. It is extremely important to vibrate both lifts of a continuously-reinforced pavement and to use two pavers when two lift construction procedure is followed.
2. Although it has not been used, preplacing the steel in very long lengths and completely randomizing splice locations would be a preferred type of construction. With this method of construction, the concrete would be placed in one lift and would be thoroughly vibrated for its entire depth.

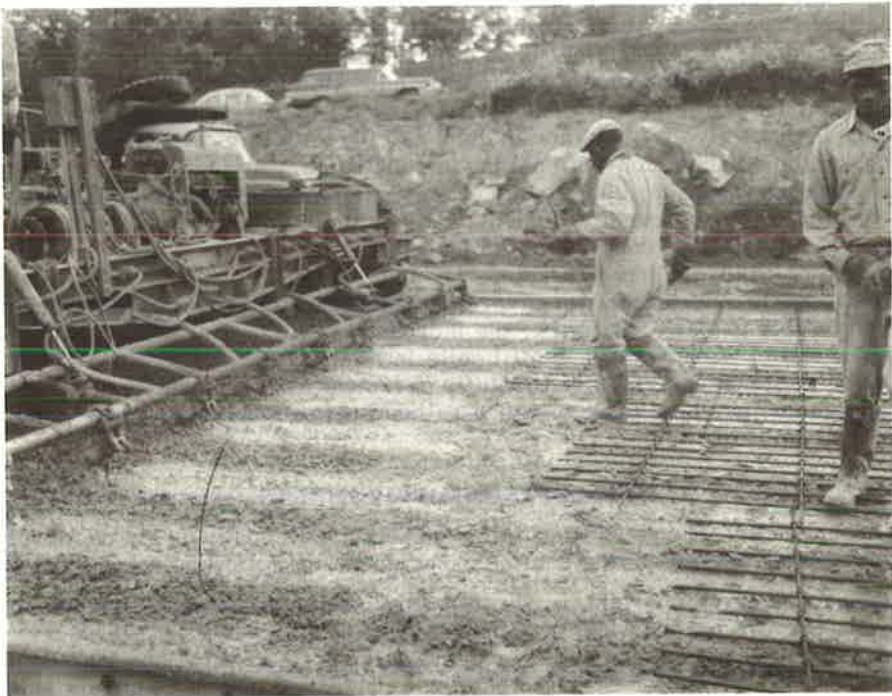
Figure 8. Pavement construction showing internal vibration of concrete, and staggered ends of bar mats.

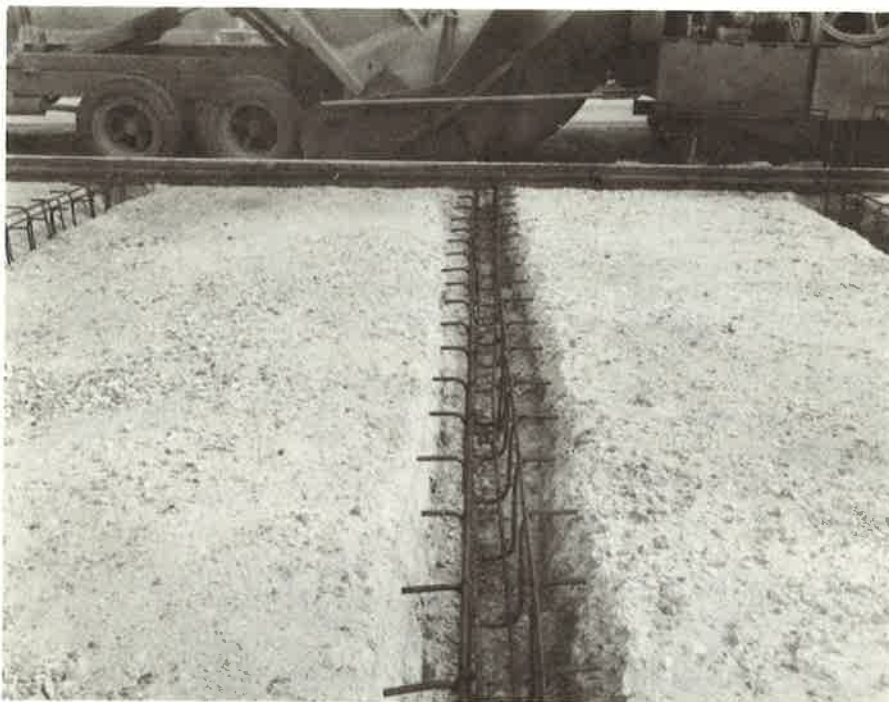
The lugs were 12 by 12 in., directly beneath the roadway slab, and cast integrally with it. The first lug is 10 ft from the end of the continuously-reinforced section, and there is a clear distance of 10 ft between lugs. Three lugs as described were provided for each anchorage, and they were reinforced with No. 5 stirrup-type bars.

Figure 9. Details of reinforcing steel cage in end restraint lugs.

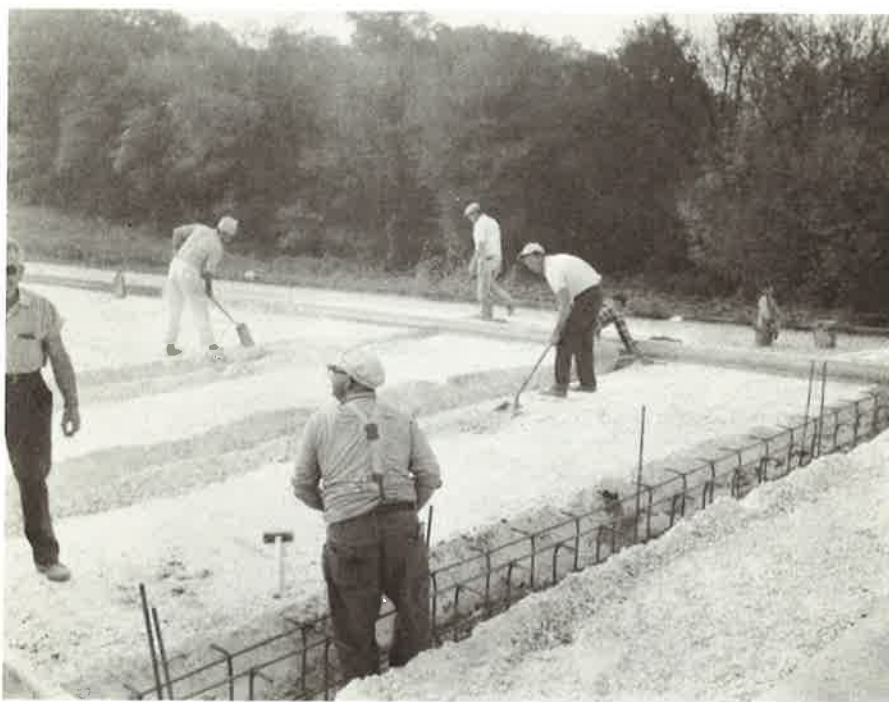
Figure 10. Placing reinforcing steel and trimming subbase at end restraint lugs.

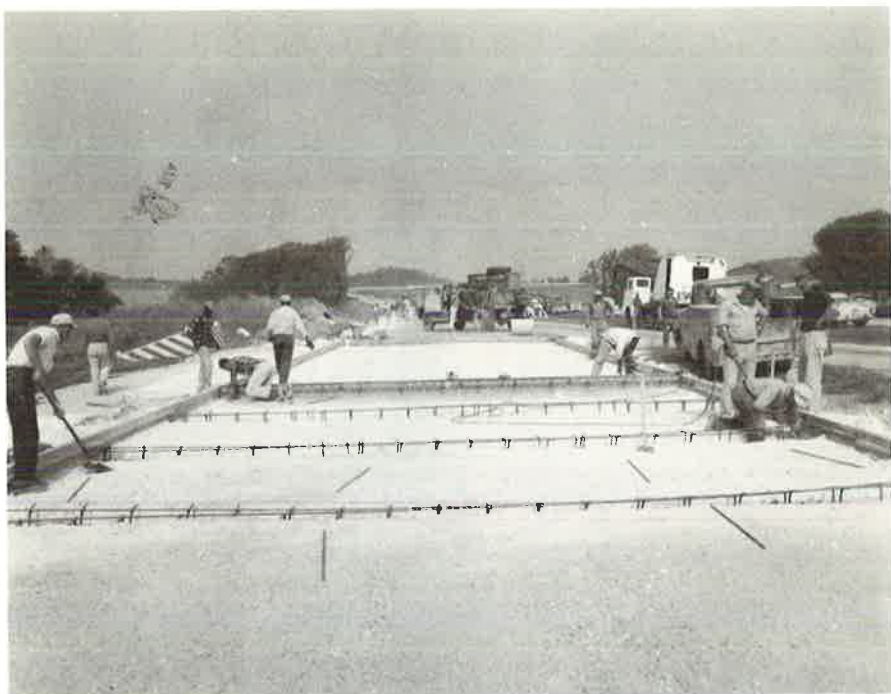
Figure 11. Trimming subbase at end restraint lugs.

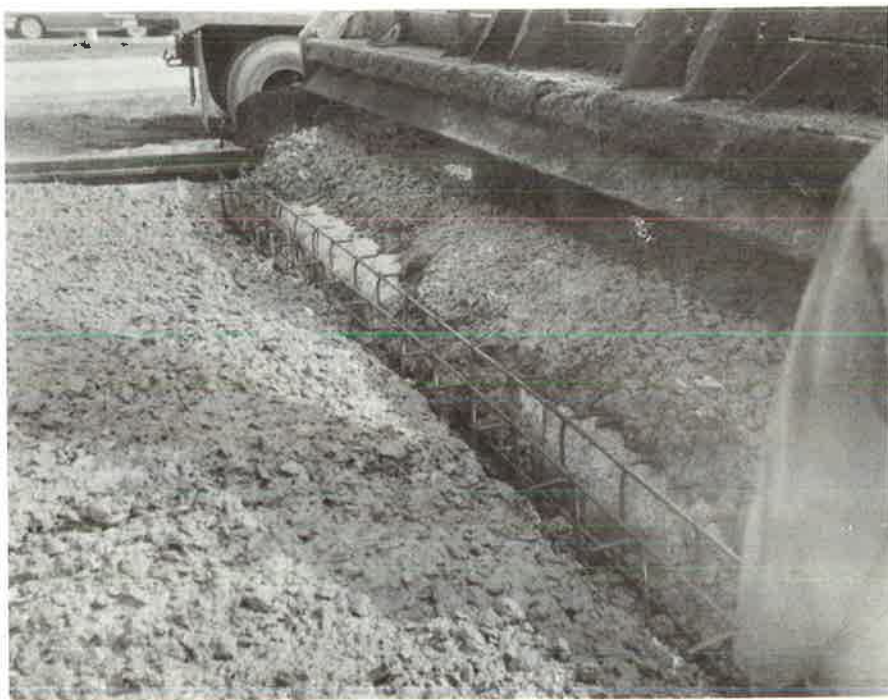
Figure 12. Concrete pouring in vicinity of end restraint lug.
