# Corrosion Performance of Aluminum Culvert

THOMAS A. LOWE and A. H. KOEPF

This paper discusses corrosion characteristics of aluminum and how these characteristics might be affected by burial in soil. The influence of various types of soil on aluminum are discussed in the light of experience gained through monitored culvert installations including a compendium of field performance with aluminum culvert and an appraisal of the over-all performance of the product.

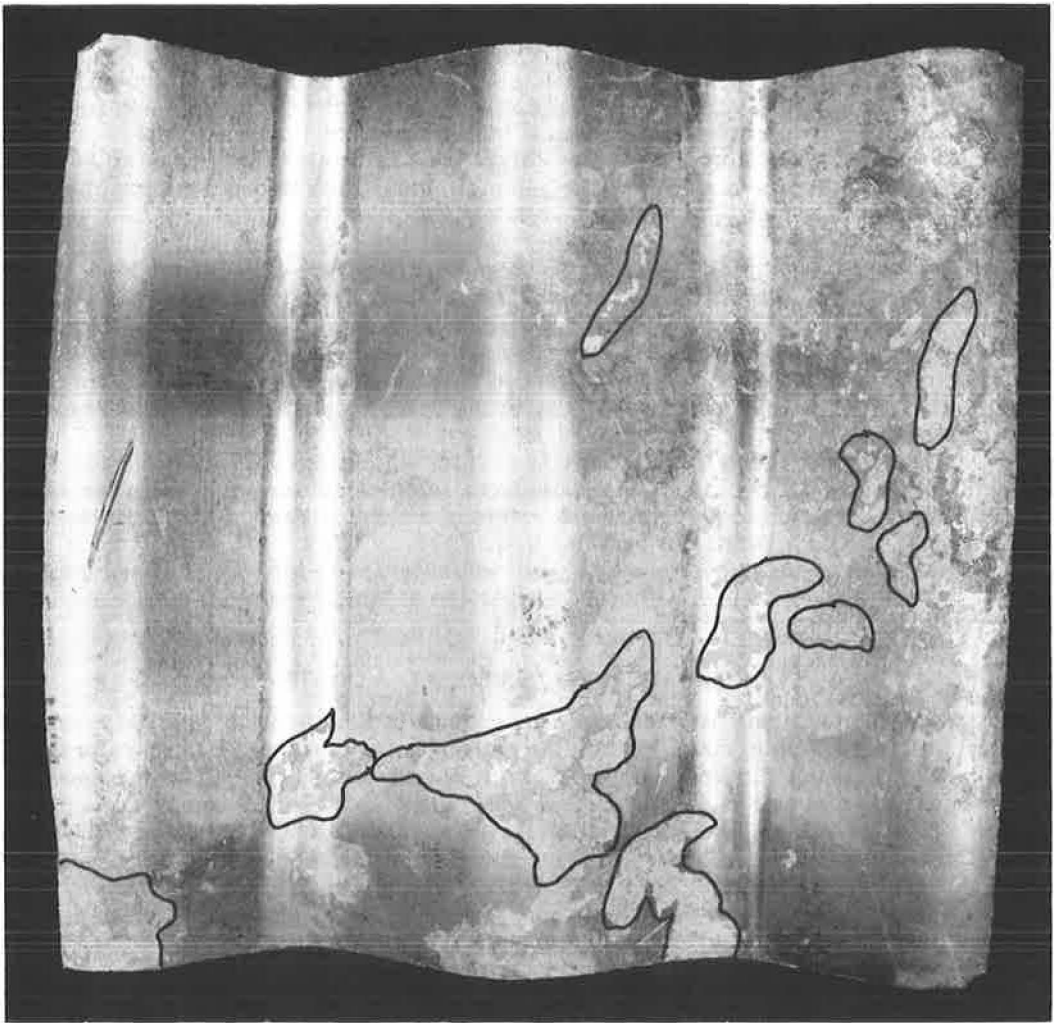
Figure 2. Random superficial attack of aluminum culvert at Royal City, Wash., after 1 yr, no etch, 5/6 X.

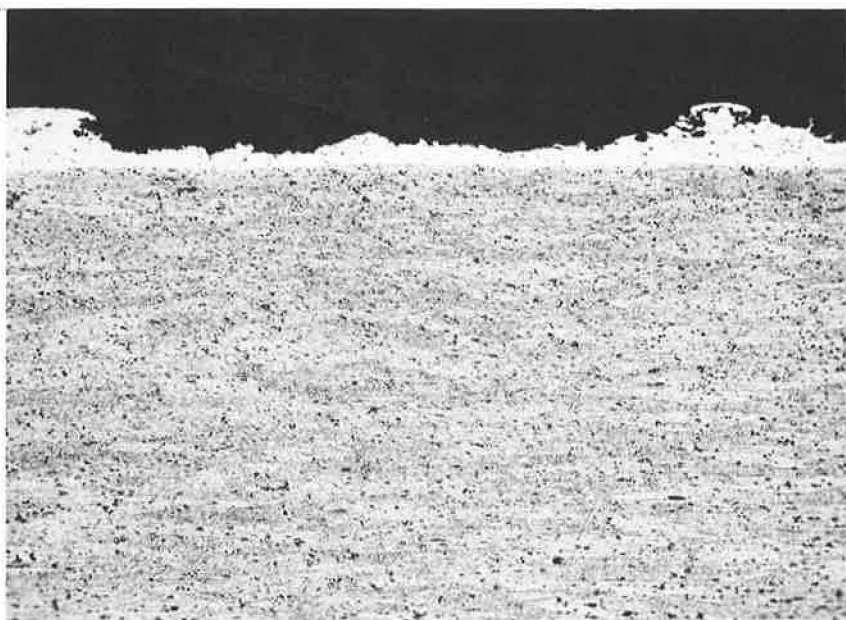
Figure 3. Random attack of aluminum culvert at Royal City, Wash., after 1 yr, caustic fluoride etch, 100X.

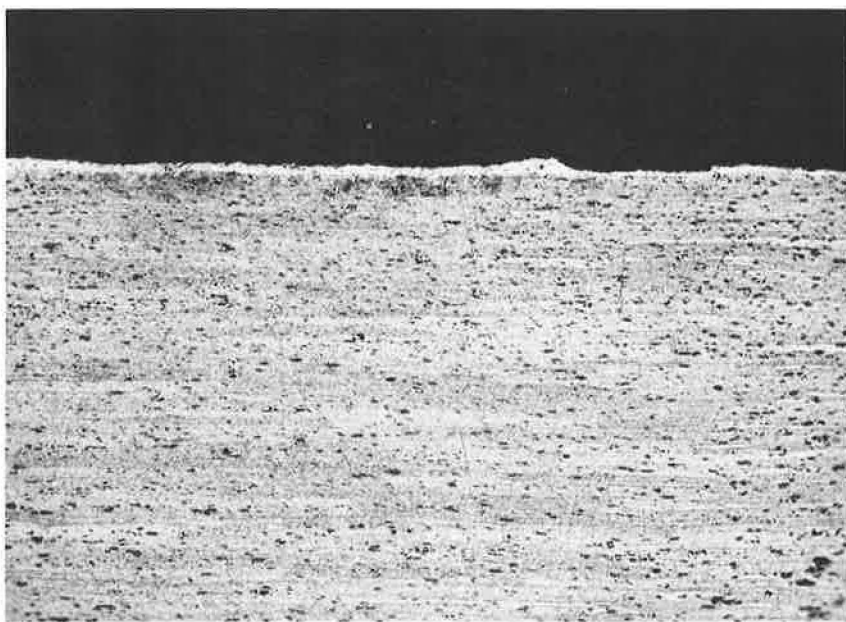
Figure 4. Random attack of aluminum culvert at Royal City, Wash., after 1 yr, caustic fluoride etch, 100X.

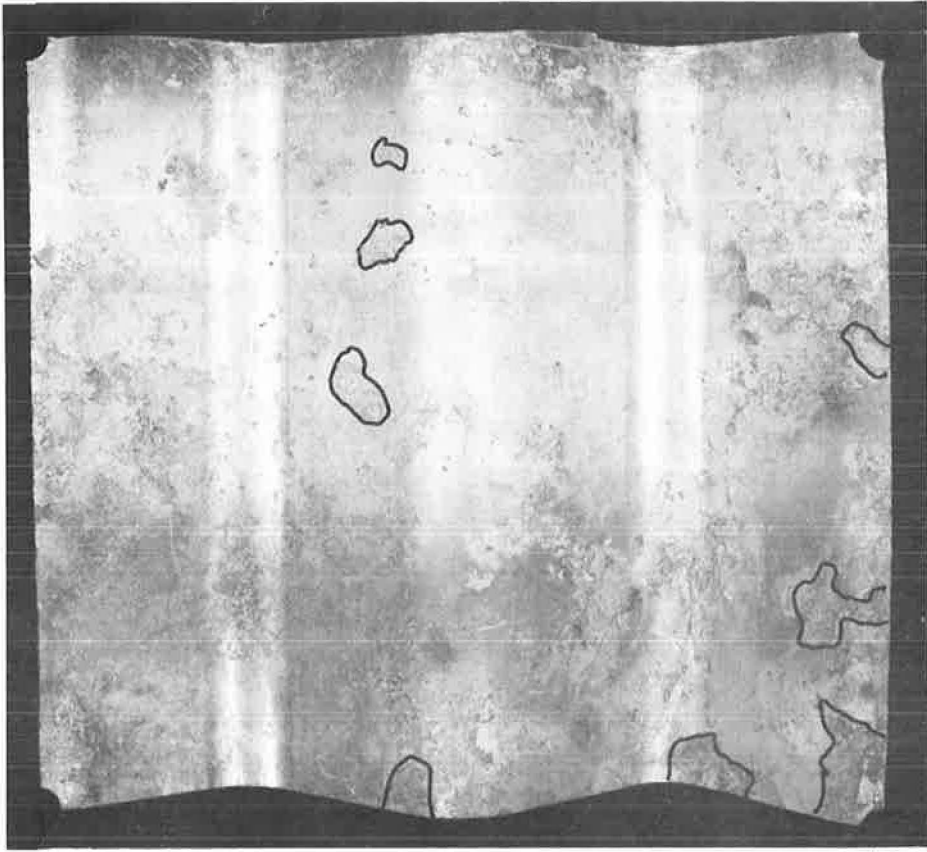
A study of the data indicates that the performance of aluminum is relatively consistent throughout each soil group. Within the entire listing of Great Soil groups in Table 3 (more than 95 percent of the geography of the United States) there is no evidence of general corrosion attack on aluminum. The pH range of 4.0 to 9.0 removes the prospect of chemical attack on the oxide film. Typical of the attack observed on aluminum culvert in certain cases is the sample from Royal City, Wash. This installation has been inspected at the end of 0.5-, 1-, 2- and 3.1-yr exposure. Random superficial attack was noted on this culvert at the end of 0.5 yr that was similar to that seen after 1 yr (Figs. 2, 3 and 4). Subsequent inspections and sampling indicated that the attack had not progressed to any measurable degree (Figs. 5, 6 and 7).

Figure 5. Random superficial attack of aluminum culvert at Royal City, Wash., after 3.1 yr, no etch, 5/6 X.

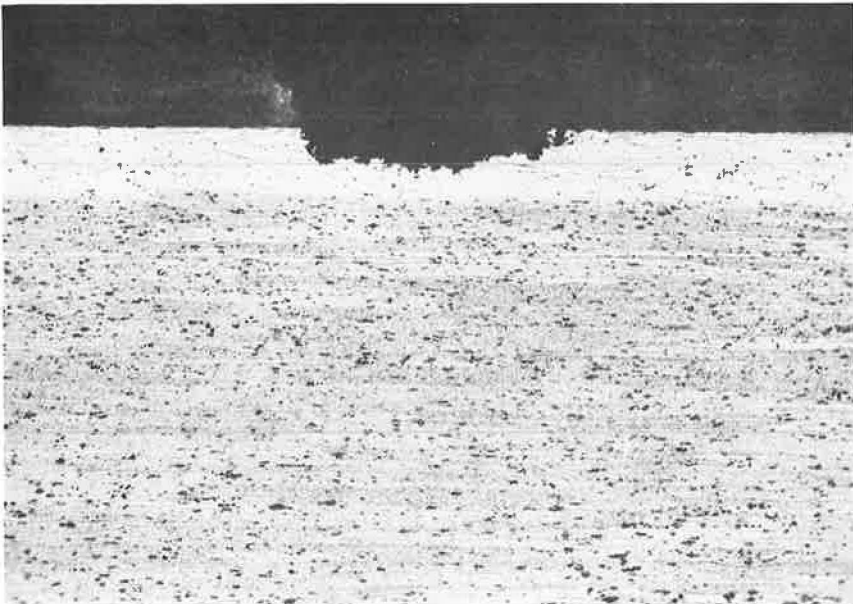
Figure 6. Random attack of aluminum culvert at Royal City, Wash., after 3.1 yr, caustic fluoride etch, 100X. Depicted here is the unaffected condition of most of the surface and the nature and extent of pitting which appear as small dark spots on the surface.

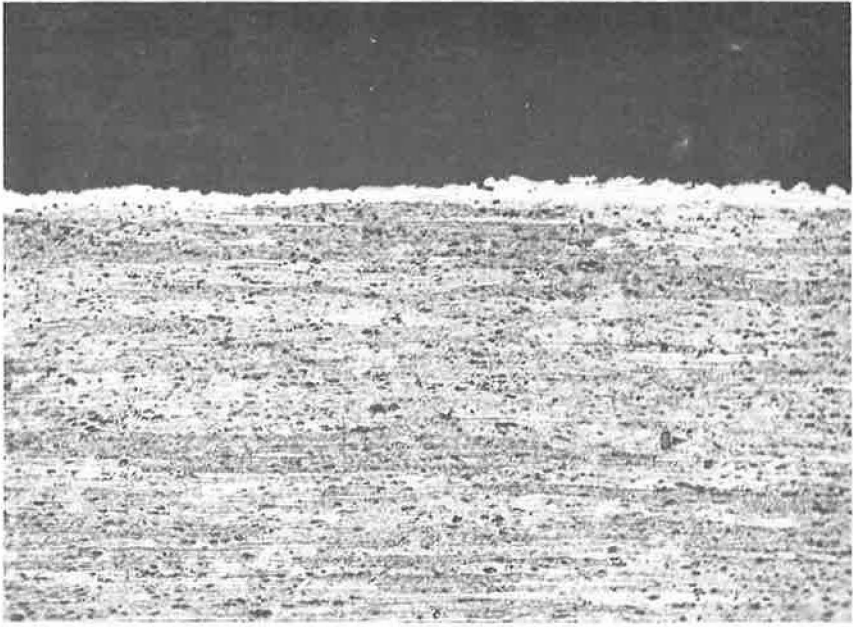
Figure 7. Random attack of aluminum culvert at Royal City, Wash., after 3.1 yr, caustic fluoride etch, 100X. The area showing maximum depth of attack has some clad alloy remaining on the surface.

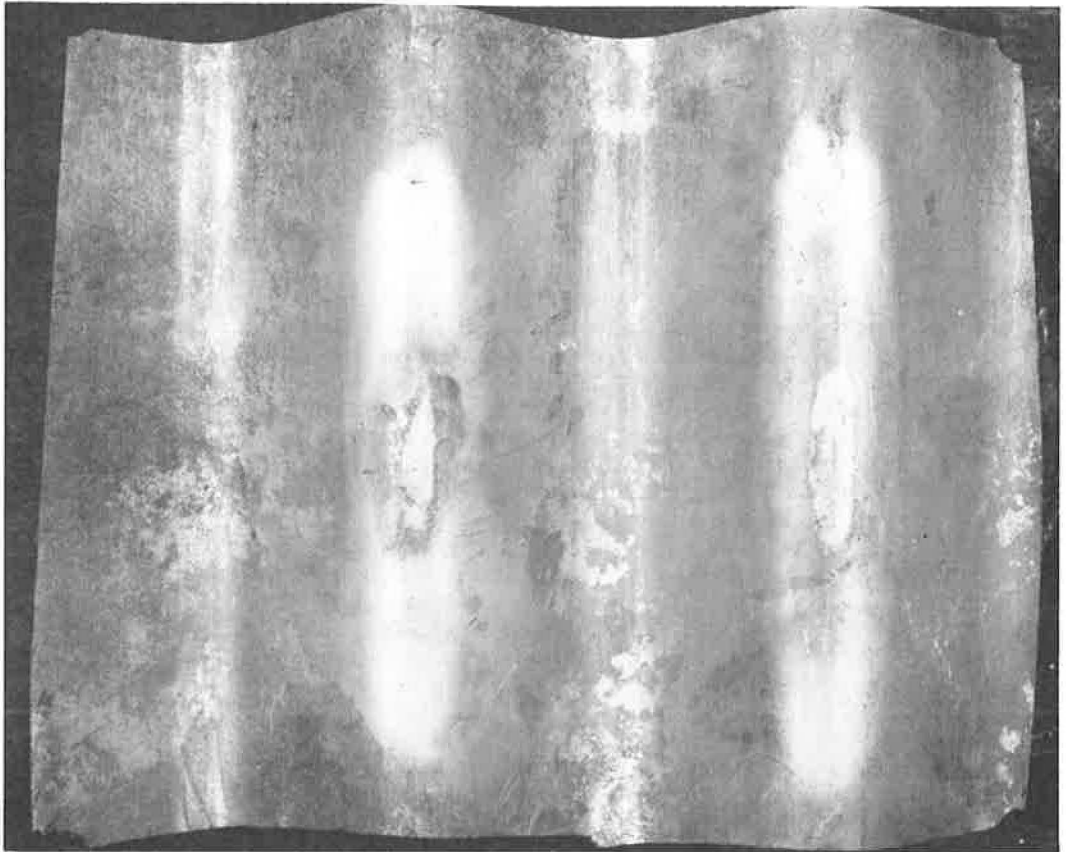
Figure 8. Aluminum culvert, Concord, Calif., after 3.5 yr, no etch, 5/6 X. Coloration in the corrugation valley was caused by chromic-phosphoric acid cleaning solution.

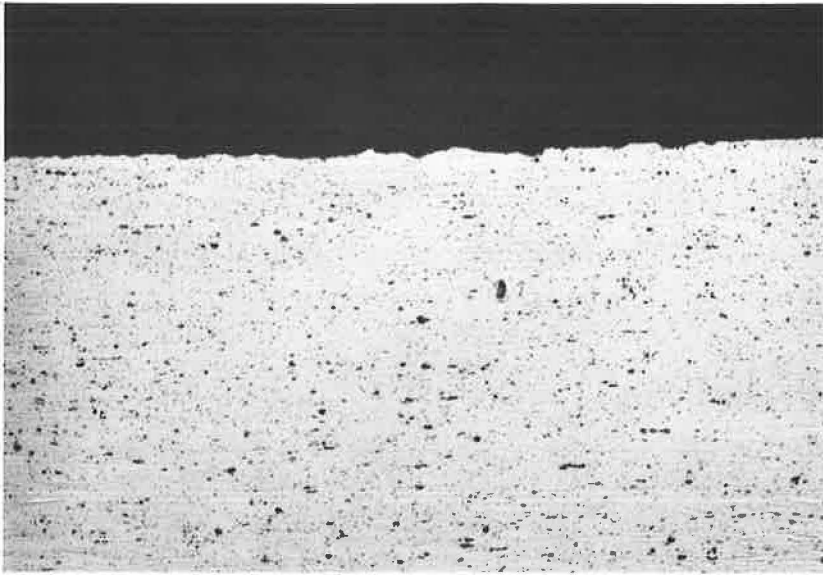
Alluvial soils do not seem to follow any consistent pattern with respect to their chemical activity. The increase in fines in such soils, however, tends to reduce their resistivity. In areas of less rainfall, these soils may become alkaline as in Concord, Calif. The low resistivity mildly alkaline soil there has caused no significant attack. Differential coloration in the two corrugation valleys (Fig. 8) was caused by the chromic-phosphoric acid cleaning solution. A section through the lacy patterns of etching noted on that sample shows the attack to be superficial (Fig. 9).

Figure 9. Aluminum culvert, Concord, Calif., after 3.5 yr, no etch, 100X. Chemical attack was superficial on the soil-side surface.

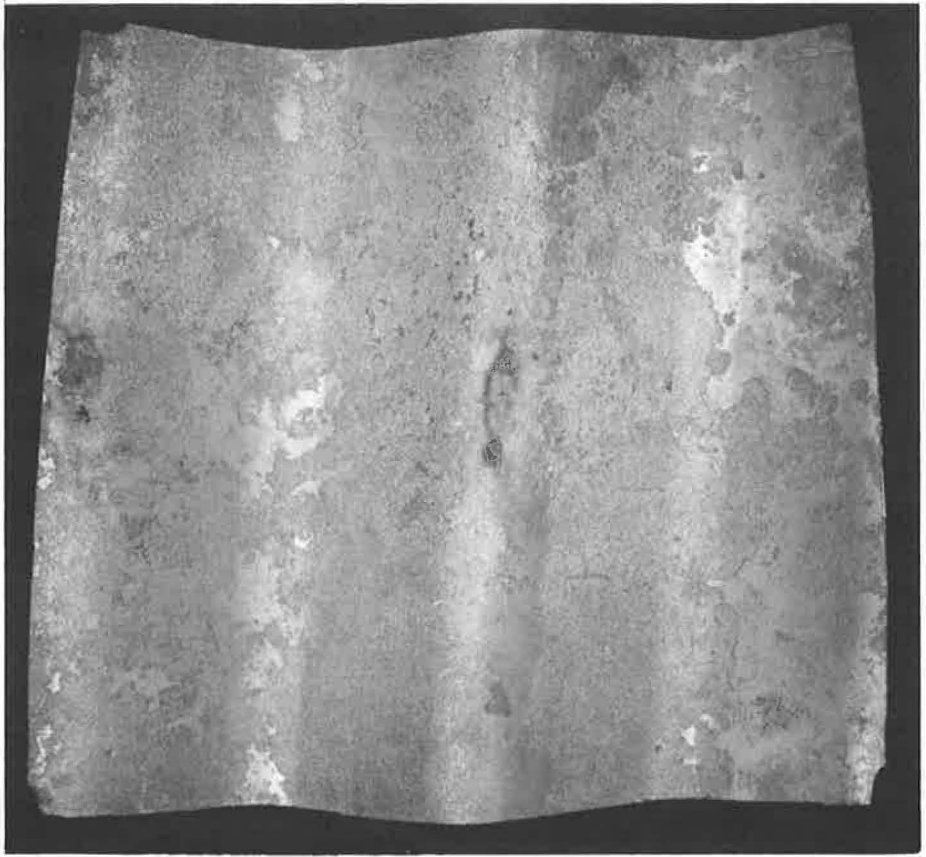
Figure 10. Aluminum culvert, Gramercy, La., after 3.5 yr in clay muck, no etch, 5/6 X. Areas which have not been attacked can be distinguished from those on which the cladding has been etched.

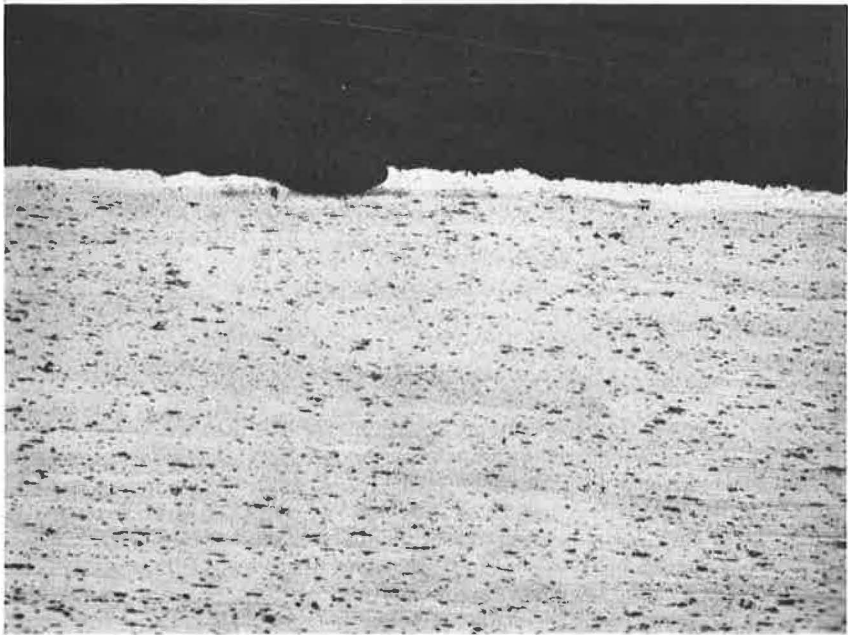
Figure 11. Aluminum culvert, Gramercy, La. Soil-side section represents typical condition of etched surfaces on sample, caustic fluoride etch, 100X.

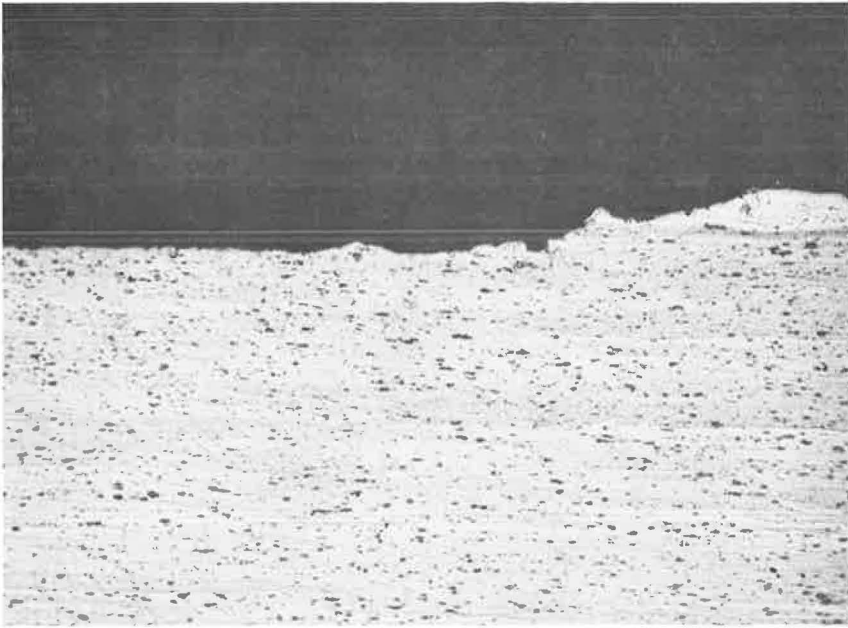
Figure 12. Aluminum culvert, Gramercy, La. Areas of deepest attack typified by this soil-side section occurred on the corrugation crest, caustic fluoride etch, 100X.

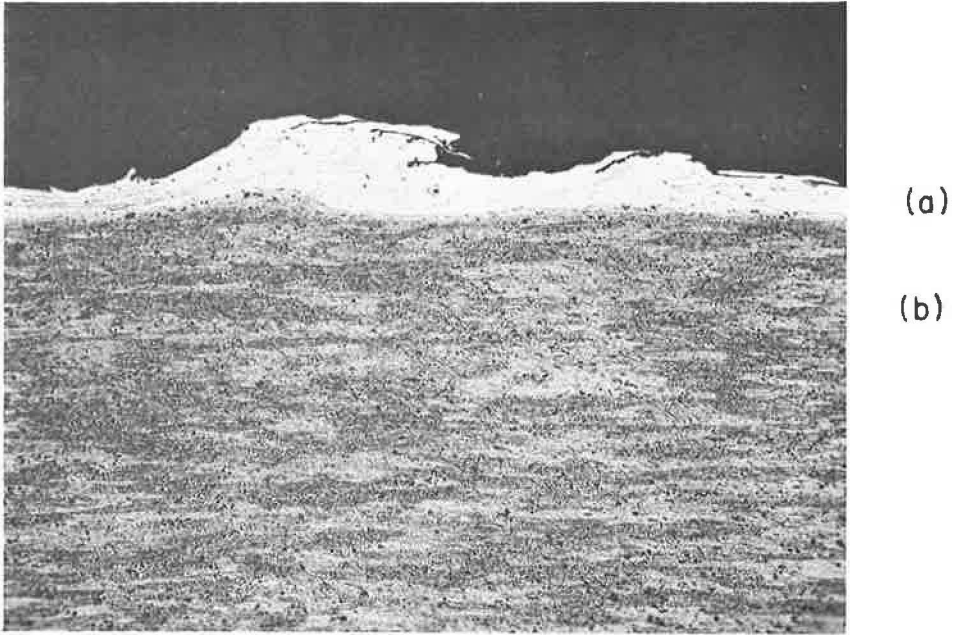
Figure 13. Aluminum culvert, Granite Falls, Wash: (a) clad alloy, (b) core alloy, caustic fluoride etch, 100X. This section from the invert shows distortion of the cladding layer that occurs as a result of the peening action of particles carried by the runoff.

Thus, from the preliminary program, it appears that hydraulic design of aluminum culvert might well be limited to sustained velocities below 10 fps where a heavy rock-laden bed load is anticipated. Where the bed load is sandy, higher velocity limits are possible.

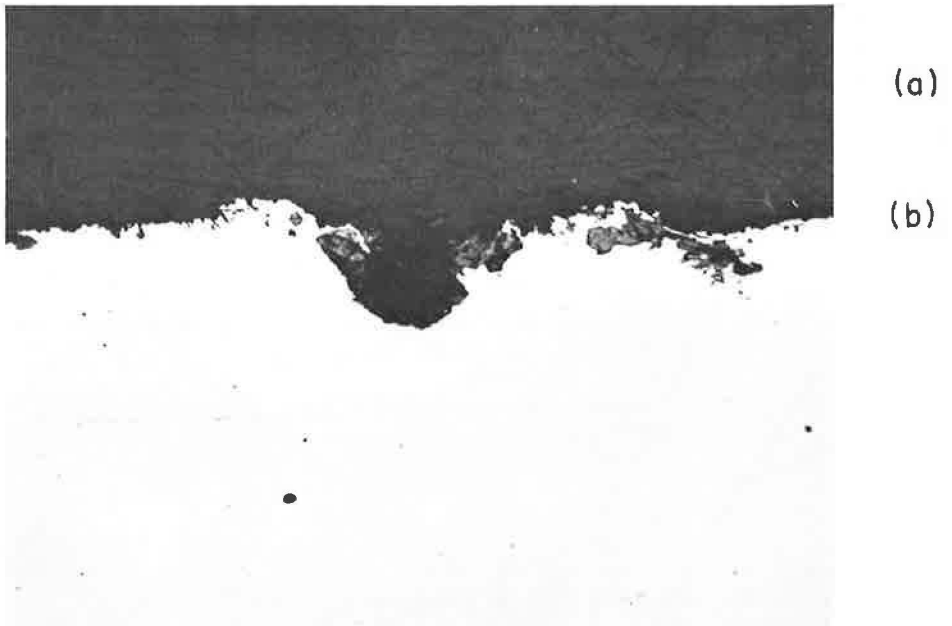
Figure 14. Galvanized steel culvert, Granite Falls, Wash: (a) bakelite mounting, (b) steel core, no etch, 100X. This section from the invert shows that the zinc coating has been removed from the galvanized steel invert and pitting of the underlying steel has started.

iron oxide. To date, typical performance of the steel at this site is shown in the photomicrograph (Fig. 14). One culvert in which velocity is 13 fps shows definite signs of metal removal due to wear energy. An experimental installation where water velocity was 25 to 30 fps provided destructive energy of such force that neither corrugated metal (aluminum or steel) nor concrete could resist rapid wear that caused thinning and destruction of the inverts by tearing.
