Moving Load Test on Experimental Prestressed Concrete Highway Slab

JOHN R. SMITH and RICHARD K. LIGHTHOLDER

Department of Civil Engineering, University of Pittsburgh

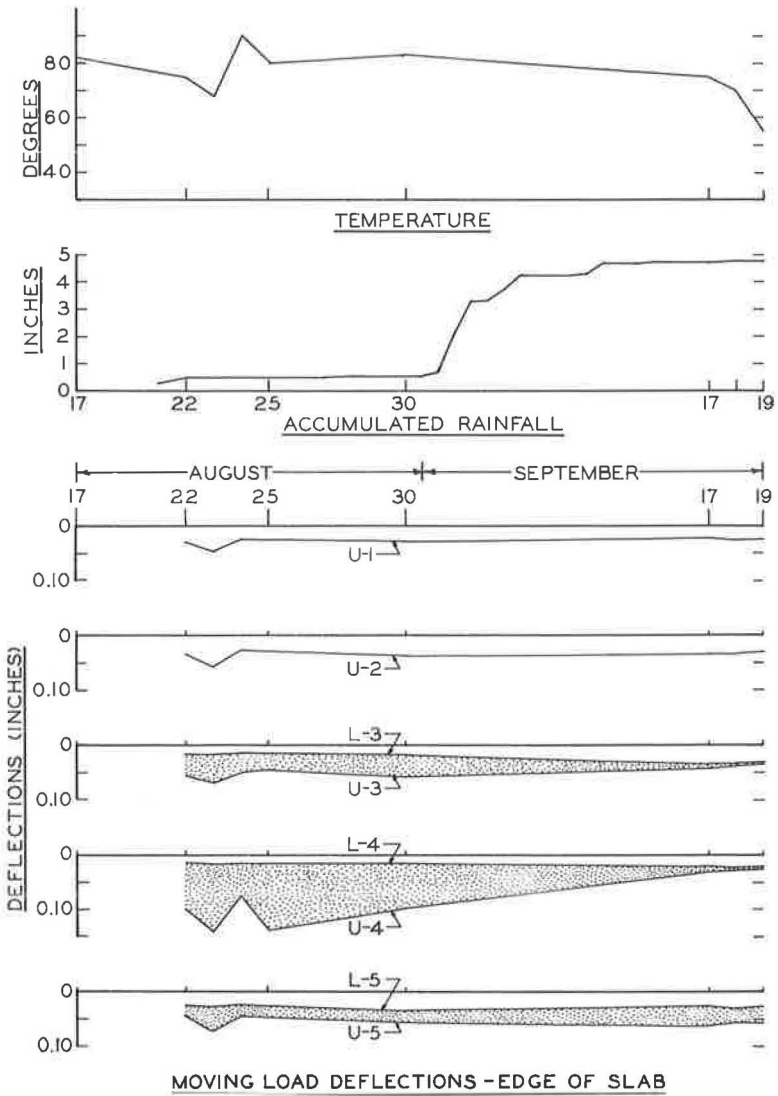
Figure 7. Pretest data for deflectometers.

Three thousand repetitions were applied to the slab while the vehicle and the instrumentation were being adjusted. During this time, the deflectometers indicated a separation between the sleeper slab and the main slab. This amounted to about 0.123 in. on the west side of the joint and 0.043 in. on the east side. It was decided to bring the main slab in contact with the sleeper slab on the west side of the joint by grouting the separation.

The pretest data for the deflectometers are shown in Figure 7. The separation between the two slabs is illustrated by the shaded area between U-3, L-3; U-4, L-4; and U-5, L-5. The readings for September 17 show the effect of the grouting operation. The relative movement between the main slab and the sleeper slab is negligible. The temperature and rainfall data shown at the top of the graph are of importance only to indicate the weather conditions which preceded the tests.

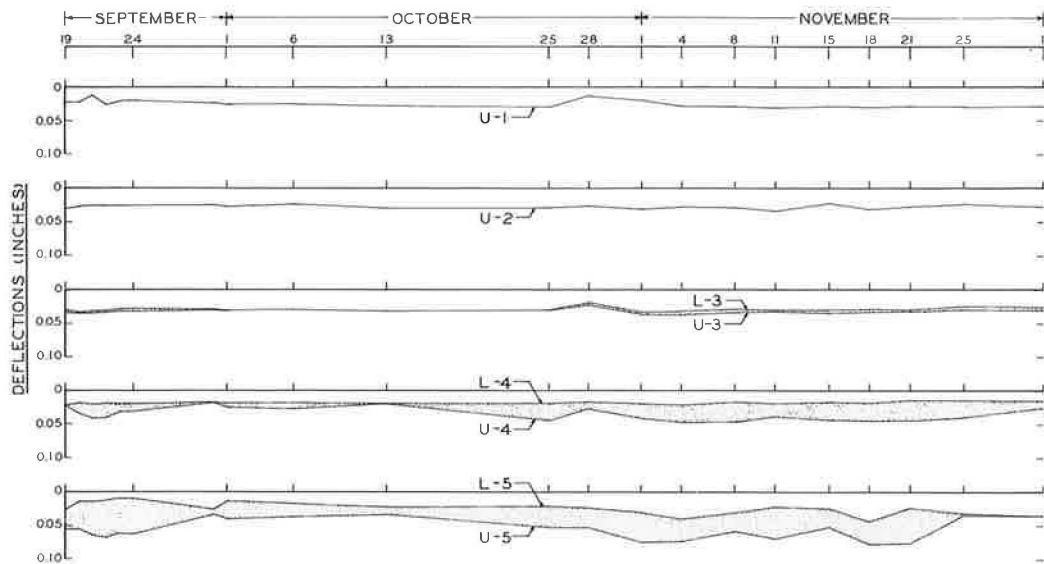
The graphs in Figure 11 are a plot of the maximum peaks on the oscillographs. In a few cases these readings were supplemented with values obtained from the maximum reading deflectometers. In all but a couple of cases the two instruments agreed reasonably well with each other. It can be seen that the deflections of the slab at U-1, U-2, U-3, and L-3 were relatively consistent and amounted to about 0.030 in.

At points U-4, L-4, U-5, and L-5, the effect of the loss of subgrade support can be seen. The shaded area is representative of the separation between the main slab and the sleeper slab. The live load deflection of the sleeper slab averaged about 0.02 in. at L-4 and varied from 0.02 to 0.04 in. at L-5. The deflection of the main slab varied from 0.02 to 0.04 in. at U-4 and from 0.03 to 0.074 in. at U-5. The last readings, taken on December 1, 1962, indicated that the separation was becoming less as pumping reduced the support under the east ramp.

Figure 11. Moving load deflections—edge of slab.

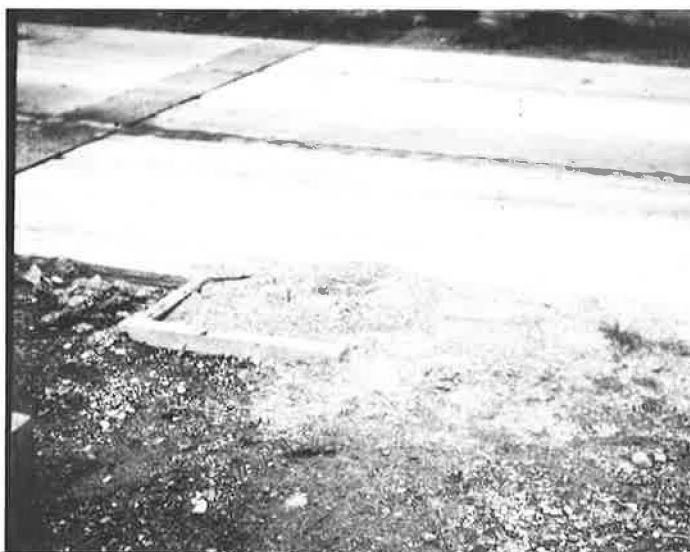
Figure 12. Pumping at U-5, L-5—Oct. 30, 1962.

The first evidence of pumping was witnessed about 7 P.M. September 27, and it continued until about 10 A.M. the following morning. Two cubic feet of well-graded sand was pumped out at U-5, L-5. On October 30 about 1.5 cu ft of sand was pumped at U-5, L-5 (Fig. 12). In both cases there was no evidence of pumping at any other location.

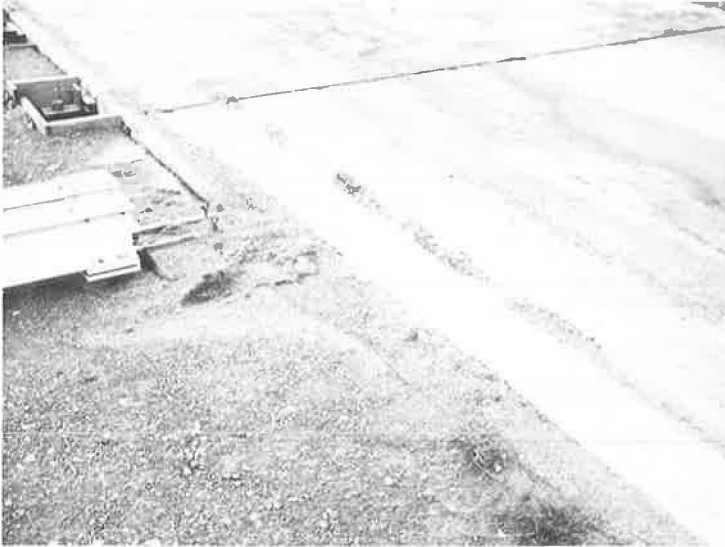
Figure 13. Pumping at U-5, L-5—Nov. 10, 1962.

On November 9 and 10 there was heavy pumping at the edge of the slab from the U-5, L-5 position to the bottom of the east ramp (Figs. 13 and 14). There was a substantial amount of fines pumped into the U-4, L-4 position and a somewhat lesser amount at U-3, L-3. The only other evidence of pumping was a slight trace of fine sand under the counter hose about 5 ft east of the west ramp.

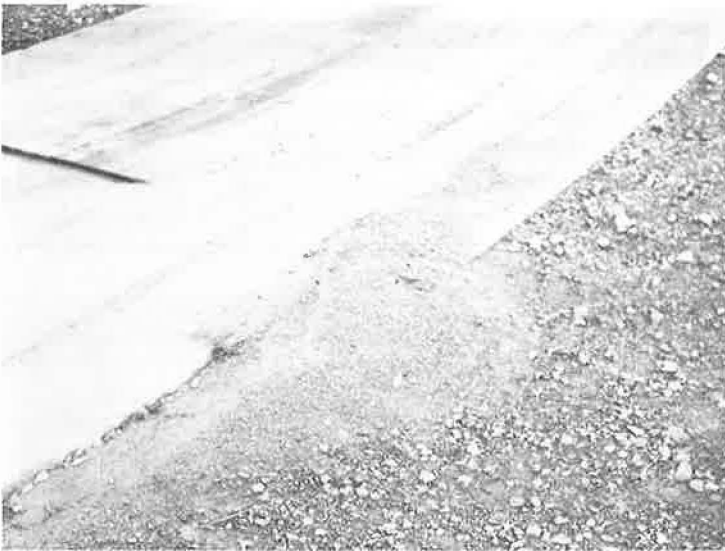
Figure 14. Pumping at bottom of east ramp—Nov. 10, 1962.

The principal cause of pumping was poor subbase drainage. Moisture tests indicated that the moisture content of the base material was about 24 percent. Rain had little effect on these readings. Water appeared to collect in the sand layer and during the early storms was forced in and out of the separation between the pavement and the sleeper slab. Much of the water and sand was forced out of the separation into the hole along the edge of the slab at deflectometers U-5, L-5. As the volume of sand under the slab was reduced, the pumping extended along the edge of the slab—first to the bottom of the east ramp and then back to the U-4, L-4 position at the rubber joint.

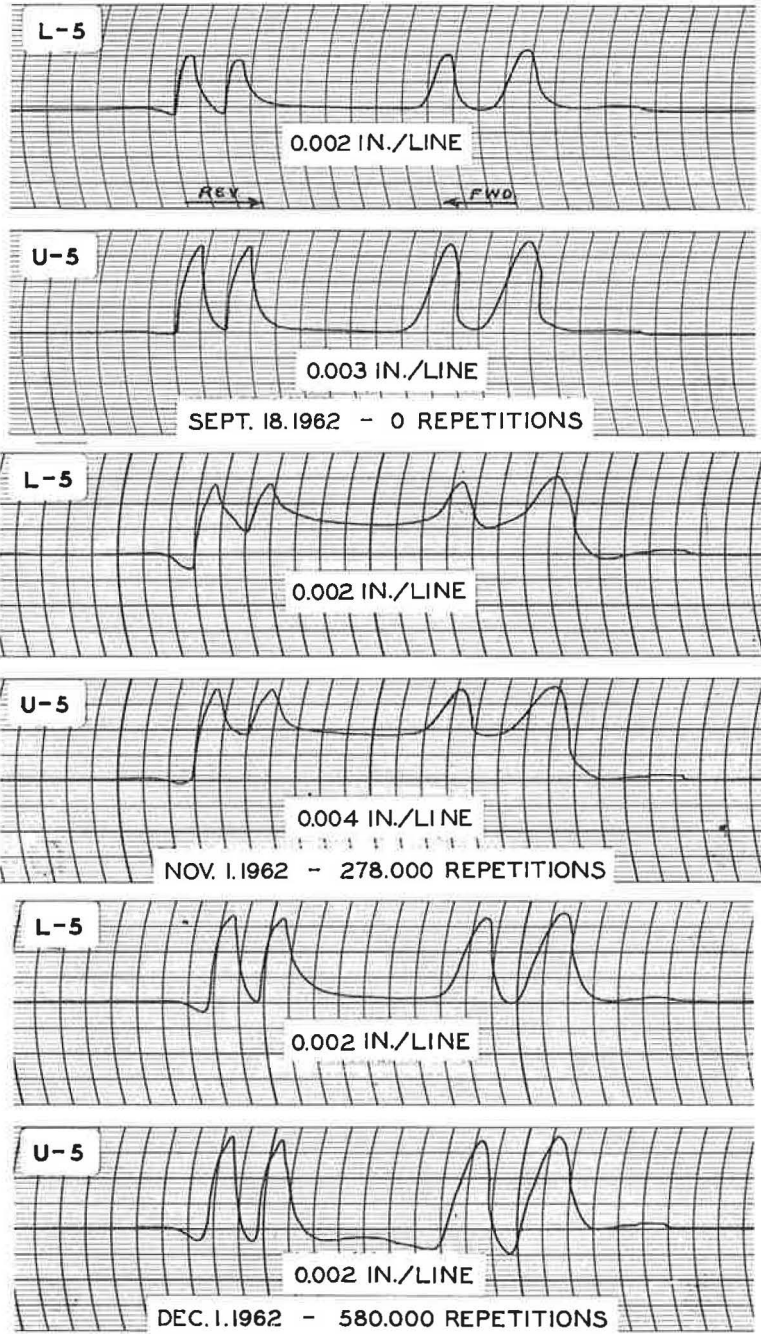
Figure 15. Oscillographs at U-5 and L-5.

The oscillograph charts shown in Figure 15 graphically illustrate what had occurred at U-5, L-5 due to the pumping action. The September 18, 1962 chart shows the deflections as the vehicle passes over the points and ascends the ramp, then reverses itself and returns across the point to the main slab. While the vehicle was up on the ramp, the deflections at U-5, L-5 returned to zero.

The November 1, 1962 chart was taken after 278,000 repetitions and a considerable amount of pumping. Here the slab appeared to be acting as a supported cantilever that maintained a reaction on the sleeper slab while the vehicle was on the ramp.

On December 1, 1962, after 580,000 repetitions and additional pumping, the slab appeared to have settled to the subgrade again because the deflections had nearly returned to zero while the vehicle was on the ramp. Figure 16 tends to reinforce this line of reasoning. The graph shows the change in elevation of the points shown in Figure 6, after 580,000 repetitions. The sketch in the lower left of the figure shows the relative location of the wheels and the points. The change in elevation between stations 1 and 7 is relatively consistent. Line A at the loaded edge of the slab has moved downward about 0.25 in. while line D on the opposite edge shows little change in elevation. Station 7 marks the west edge of the sleeper slab. Stations 8 and 9 are on the west and east sides of the rubber joint, respectively, and station 10 is at the east edge of the sleeper slab.

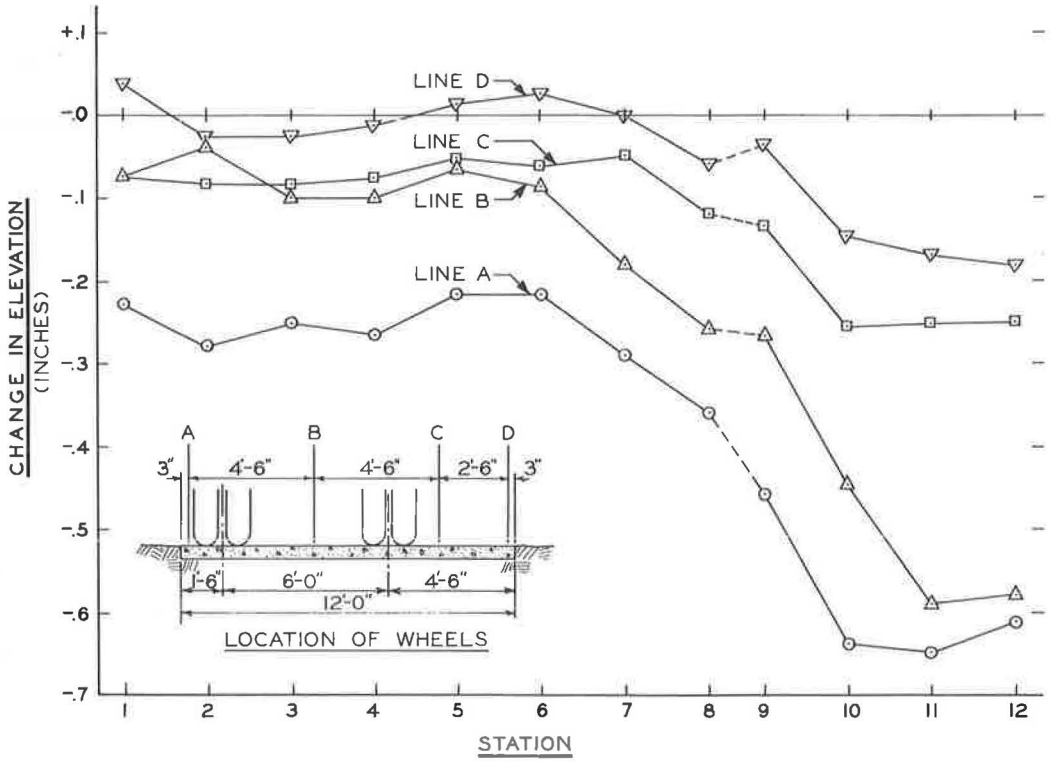
Figure 16. Change in elevation, 580,000 repetitions.

The pavement at the east edge of the sleeper slab has settled about 0.64 in. on line A and about 0.14 in. on line D. The pavement between the sleeper slab and the bottom of the ramp has settled about 0.65 in. on line A and 0.18 in. on line D.

The downward movement east of the joint was considerably greater. The loaded edge of the slab subsided about 0.65 in. This was caused by the excessive pumping in this area.

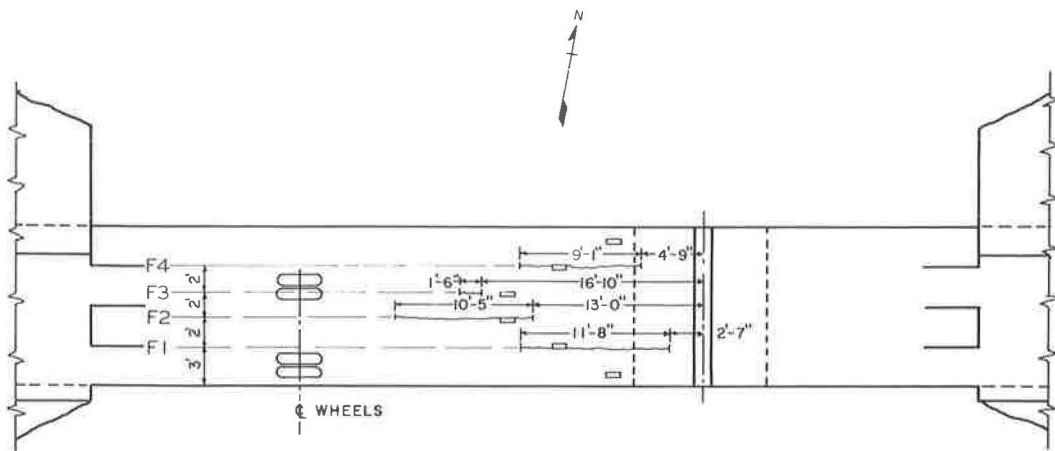
Longitudinal cracks were first discovered on August 22, 1962 during the initial compaction runs. These cracks are shown in Figure 22 and represent the condition that existed at the beginning of the test. They are located over the prestressing tendons. The relative position of the wheels is shown in the figure.

Figure 22. Longitudinal cracks, Aug. 22, 1962.

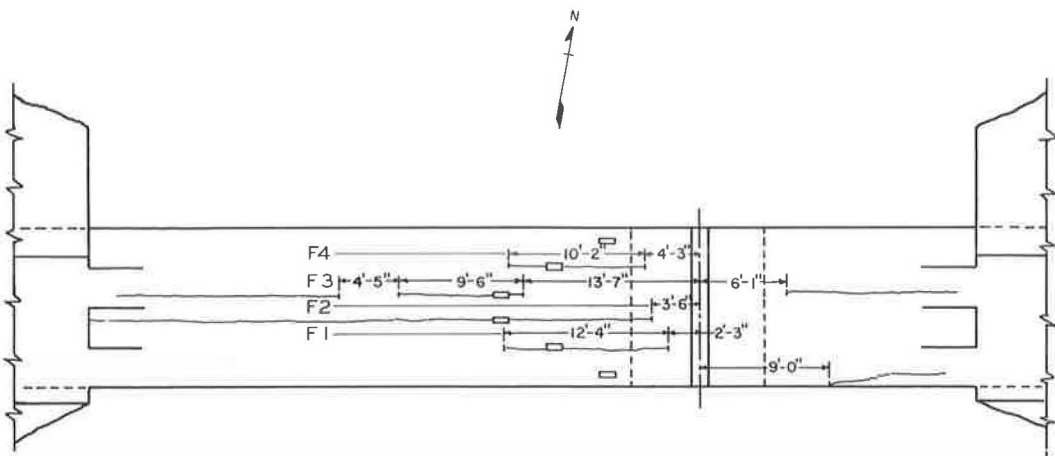
A record of the final cracks, after 580,000 repetitions, was made on December 2, 1962. These are shown in Figure 23. West of the joint the cracks at F-1 and F-4 increased in length only a few inches. Fifty thousand repetitions of the load caused an

Figure 23. Longitudinal cracks, Dec. 2, 1962.

extension of the crack F-2 from the west ramp to within 5 ft of the rubber joint. At the same time, a crack 8 ft long was found extending from the west ramp in line with F-3. Three hundred fifty thousand repetitions brought these two cracks on line F-3 within 7 ft of each other.

The cracks east of the joint developed during the rain on November 9 at 350,000 repetitions. When they were originally discovered, the crack along F-4 was within 8.5 ft of the expansion joint, and the crack at the edge of the pavement was 12.75 ft from the joint.

An examination of the test site in the summer of 1963 revealed that the crack at F-3 had extended the entire length of the slab to a point 3.5 ft west of the expansion joint. All the other cracks remained essentially the same as they were at the end of the tests.

While this test indicates the fine performance of the pavement under relatively extreme conditions, it is felt that further testing under normal highway conditions is necessary. It is recommended that a test pavement of this type be incorporated as a part of the construction of an actual highway. Particular attention should be given to the design and drainage of the subgrade, the placing of the slab on the sleeper slab, and the reduction or elimination of the longitudinal cracks by redistributing the prestressing strands, and, if practicable, the inclusion of transverse reinforcement.

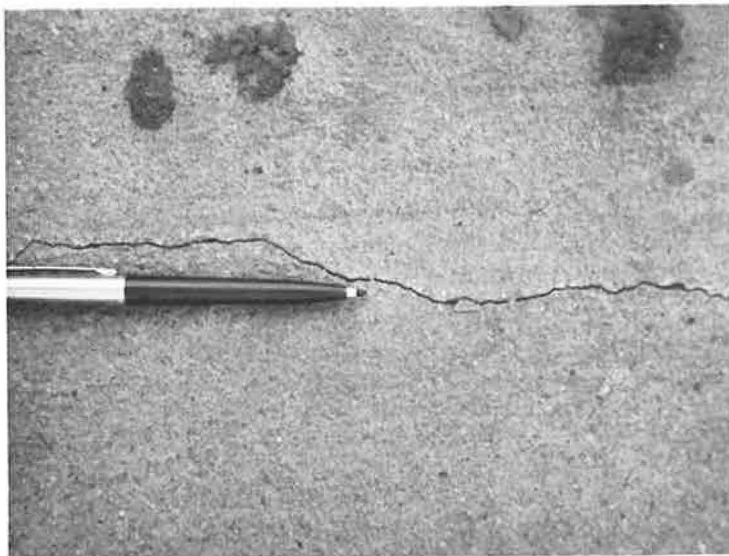
Figure 24. Longitudinal crack at F-2.

A close-up of the crack at F-2 is shown in Figure 24. The picture was taken at what appears to be the widest crack in the test section. At this point it was 0.043 in. wide.
