Evaluation of Welded-Wire Fabric in Bituminous Concrete Resurfacing

W. EMMITT CHASTAIN, SR., and R. H. MITCHELL

Respectively, Engineer of Research and Development and Research Engineer, Illinois Division of Highways

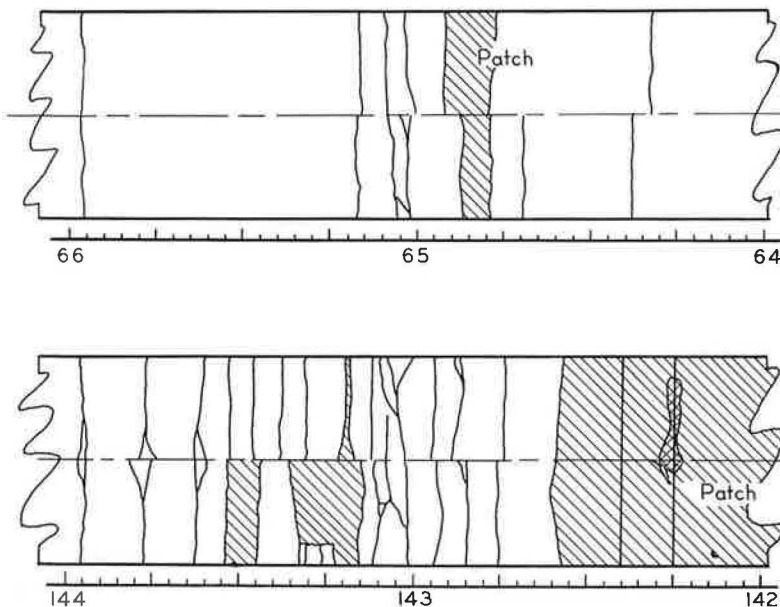
The original improvement was constructed in 1925, with the then-current practice of light cut-and-fill sections. The pavement, placed directly on the silty loam soils, was constructed of plain concrete 18 ft wide and to a 9- by 6- by 9-in. cross-section. No transverse joints were used except for construction stops. Steel bars, $\frac{3}{4}$ in. in diameter, were installed at each pavement edge. A full-depth metal plate was used to form a center longitudinal joint, with the adjoining slabs being tied by deformed steel bars. The pavement underwent extensive portland cement concrete patching and maintenance repair in the 1940's. At the time of resurfacing, it had numerous wide transverse cracks accompanied with serious spalling and faulting. Intermittent areas of scaling had occurred throughout the entire length, and many of the old patches were severely raveled.

Figure 2. Typical condition of old concrete pavement.

A comprehensive condition survey of the existing pavement was made before resurfacing. A representative field survey sheet typical of the condition of the old concrete pavement is shown in Figure 2.

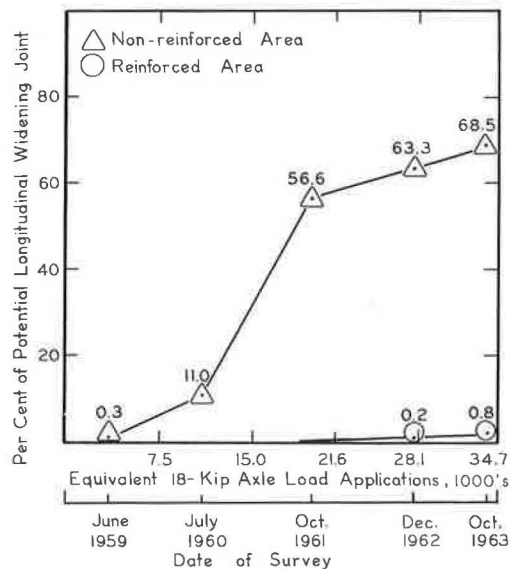
The survey data on longitudinal reflection cracking over the longitudinal widening joints were summarized and analyzed for the two sections with fabric and for the two sections without fabric reinforcement. The progression of longitudinal reflection cracking over the widening joint for both the reinforced and nonreinforced sections is shown graphically in Figure 5.

Reflection cracking over the longitudinal widening joint in the areas containing the welded-wire fabric was not apparent until the fourth survey in 1962, at which time 0.2 percent of the total possible length had reflected. In 1963, after 5 yr of service, the reflected amount was still less than 1 percent. Reflection cracking over the widening joint in areas outside the fabric reinforcement, recorded in 1959 after 1 yr of service, amounted to 0.3 percent of the total possible length. In 1960, the recorded value was approximately 10 percent. This cracking distress progressed to 57 percent in the third year of service, to 63 percent in the fourth year, and to nearly 70 percent by the fifth year, 1963. During these years, single-axle loads accumulated at the rate of about 7,500/yr. All widths of fabric reinforcement appear to be about equally effective in controlling cracking over the widening joint.

Figure 5. Progression of longitudinal reflection cracking over widening joint.

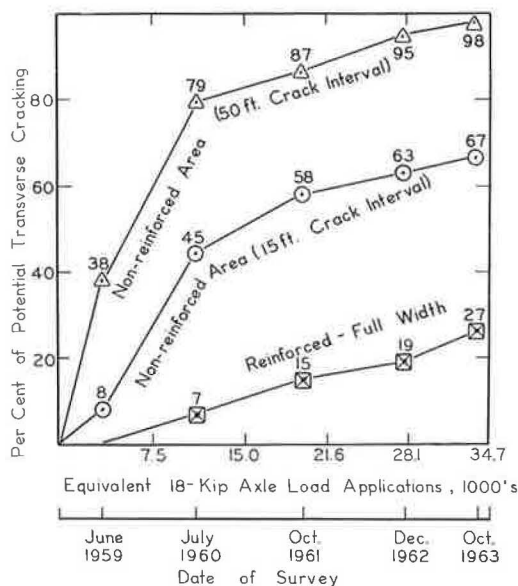
The analysis of transverse reflection cracking was limited to the two sections of pavement of initial long and short average joint and crack interval when no reinforcement was used, and to the reinforced sections having near-full-lane-width (10½ ft) fabric. The non-reinforced section of shorter joint and crack interval and the fabric-reinforced section initially had about the same average interval of 13 ft. The other nonreinforced section initially had an average joint and crack interval of about 50 ft. It did not seem appropriate to include in this analysis the sections in which the shorter widths of fabric covered the original transverse joints and cracks only partially. The progression of transverse reflection cracks, expressed as a percentage of the original number of transverse joints and cracks, with time and the accumulation of 18-kip equivalent axle loads is shown in Figure 6. From this figure, it is apparent that the welded-wire fabric has been beneficial in reducing the growth of transverse reflection cracking up to the fifth year of service, with the percentage reflected being about one-fourth that in the 50-ft crack-interval section, and less than one-half the value of the 13-ft crack-interval control section.

Figure 6. Progression of transverse reflection cracking.

dition of the two areas of pavement because these two areas differ greatly in the average length of uncracked sections, which was 47 ft in the originally longer crack-interval section, 20 ft in the control section, and 70 ft in the continuous full-lane reinforced sections after 5 yr of service.
