# Earthquake Damage to Highways in the Valdez District, Alaska

RALPH R. MIGLIACCIO, Geologist, Pacific Materials Laboratory, Inc.,  
Bloomington, California

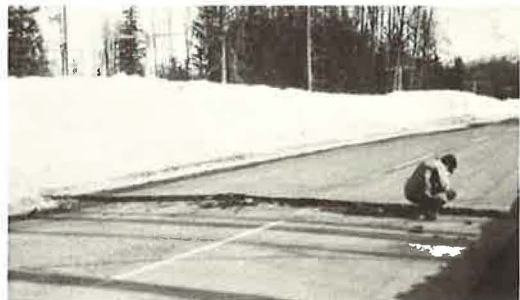
Figure 4. Crack approx. 5 in. wide and 6 ft deep in Richardson Highway near Mile 3, showing vertical displacement.

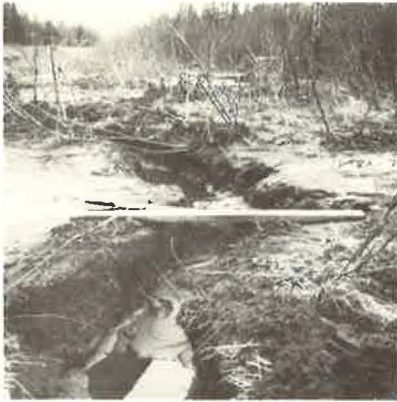
Figure 5. Ground crack adjacent to Richardson Highway near Mile 3; note fine sand ejected during quake.

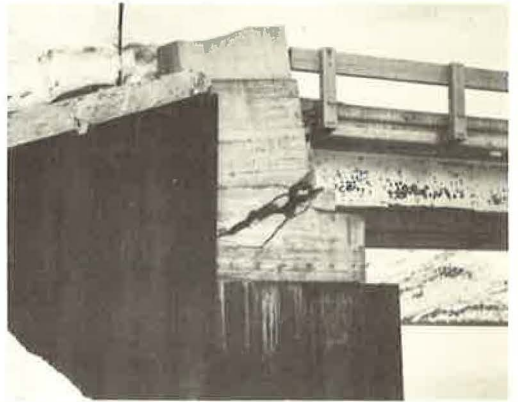
Figure 6. Abutment of Valdez Glacier Stream bridge.

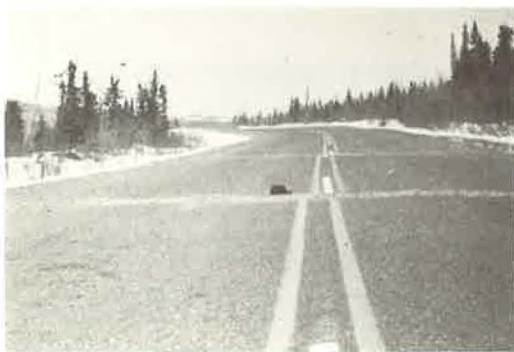
Figure 9. Cracks in Richardson Highway near Mile 73, showing horizontal offset of centerline.

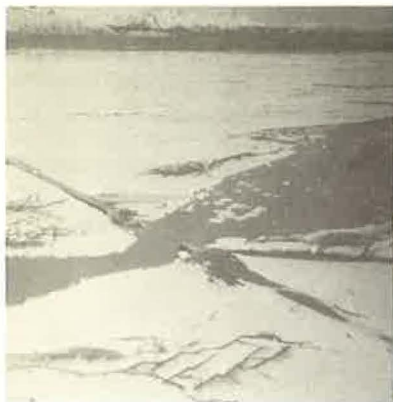
Figure 10. Aerial view of 35 Mile bridge on Copper River Highway with four spans totally destroyed; note ground breakage and evidence of sand ejection.

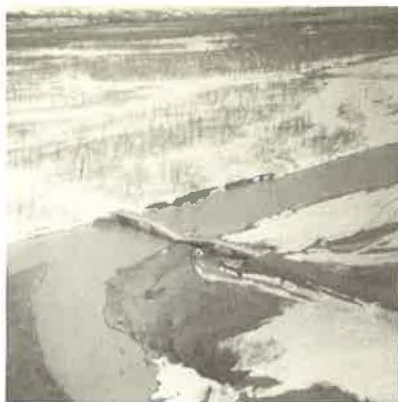
Figure 11. Aerial view of 37.2 Mile bridge, Copper River Highway, showing evidence of vertical movement on right-hand abutment, and ground cracks on right.

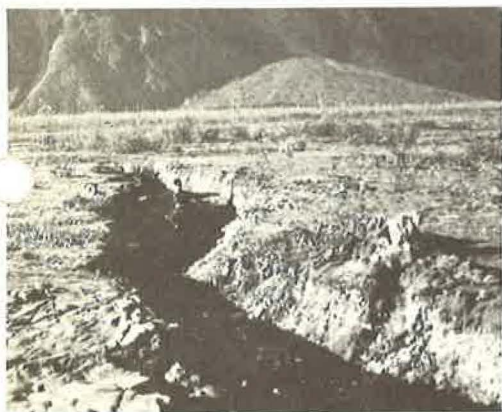
Figure 12. Crack near Mile 63, Copper River Highway, approximately 10 ft wide, 5 ft deep and 300 ft long; note fine sand ejected during quake.

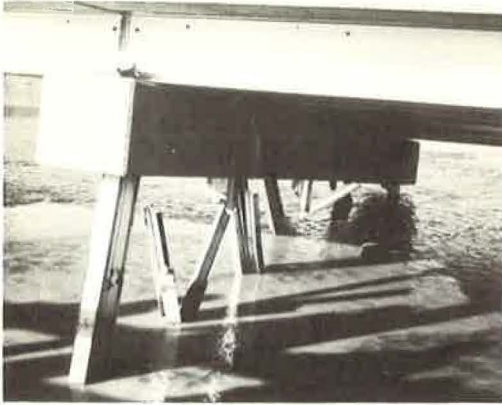
Figure 13. Fractured rail piling with random breaks beneath Scott Glacier Stream bridge, Copper River Highway.

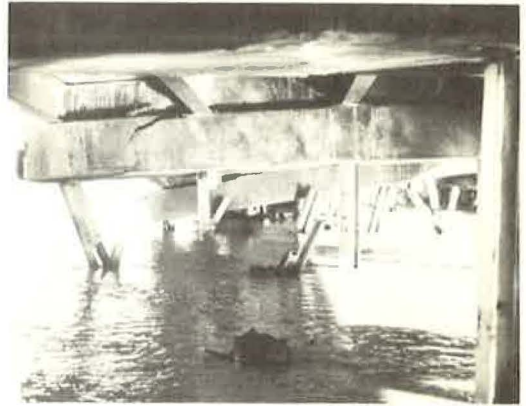
Figure 14. Fractured rail piling beneath Scott Glacier Stream bridge, Copper River Highway.

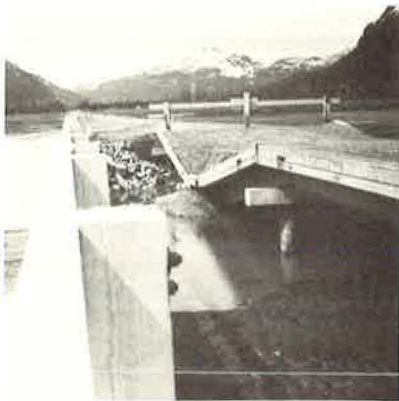
Figure 15. Loss of entire bent supported by timber piling; one of Scott Glacier Stream bridges.

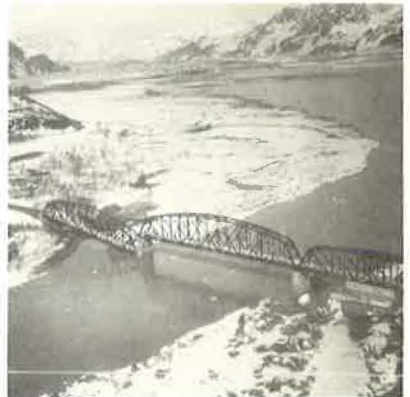
Figure 16. Aerial view of Million Dollar Bridge.

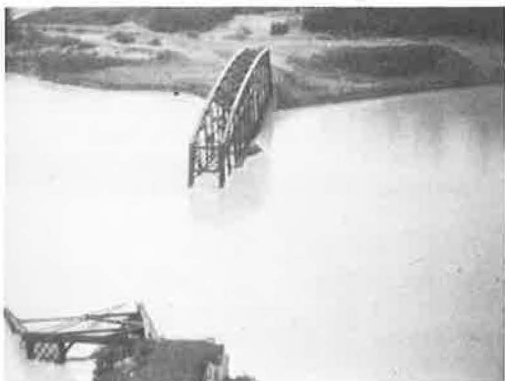
Figure 17. Steel truss bridge at Mile 28, Copper River Highway, with center pier missing; span tipped over as a result of movement of river ice.
