# A 10-Year Report on Performance of Bonded Concrete Resurfacings

ROY W. GILLETTE, Manager, Personnel Training, Portland Cement Association

Approximately 15 small and large bonded concrete overlay projects constructed over the past 10 years on both highway and airfield pavements are described. Because techniques of constructing these projects have been amply covered previously, only performance of the overlays under ordinary usage is considered.

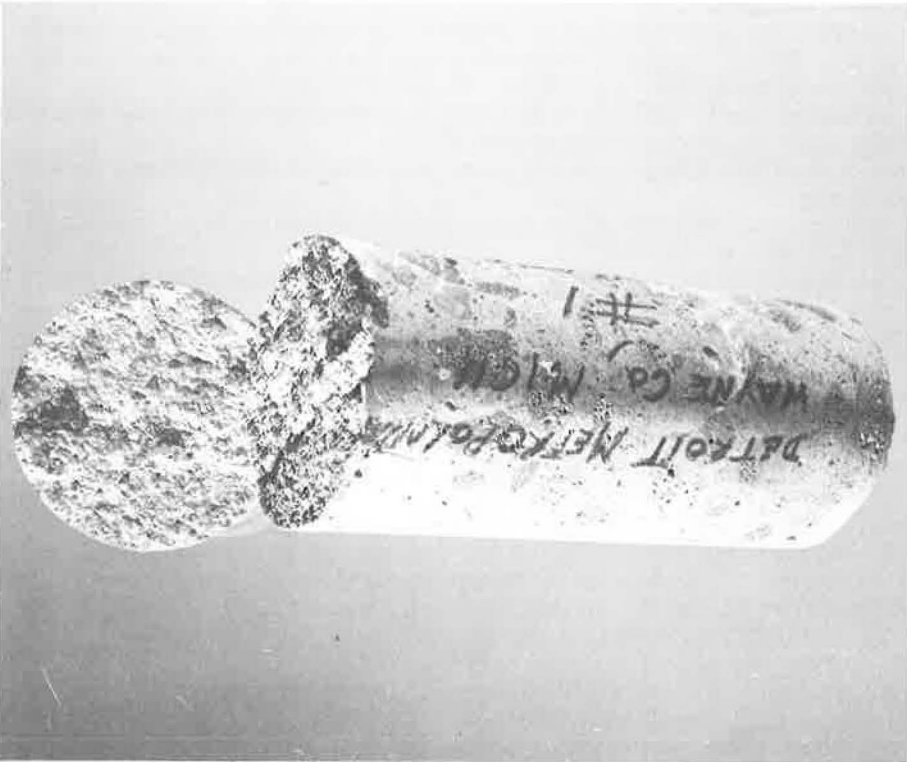
Figure 3. Core showing break in base pavement at Detroit.

The entire area was surveyed and cored in the summer of 1964 and is in excellent condition (Fig. 3). There are some small unbonded areas and some small spalls along transverse joints due to construction difficulties with a paper joint insert. Several cracks are evident due to misplacement of joints in the resurfacing which do not match the joints in the base pavement.

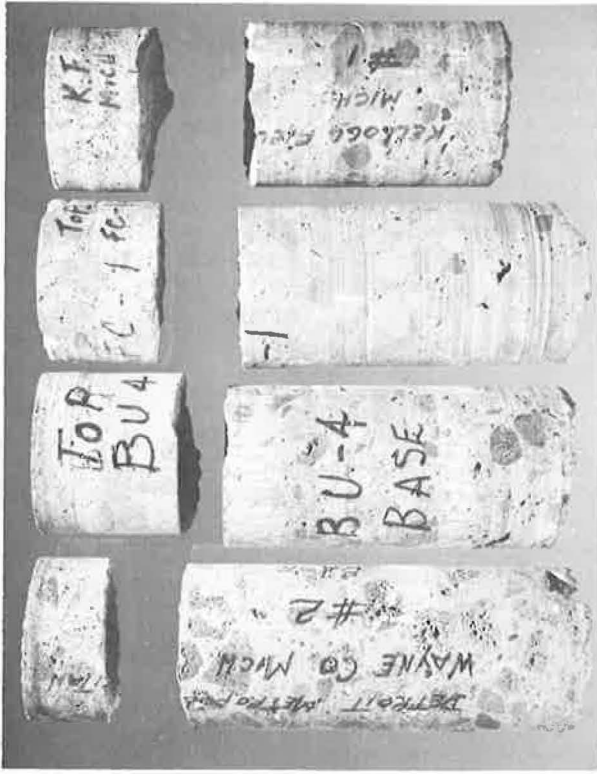
Figure 4. Cores showing breaks in base pavements at (l. to r.) Detroit Metropolitan Airport; Bunker Hill Air Force Base, Ind.; Fort Campbell, Ky.; and Kellogg Field, Mich.

3. An adequate bond strength can be obtained, using the techniques outlined by Westall (3, 4). When such bond is obtained, shear tests cause a break in the base pavement in practically every core tested (Fig. 4);

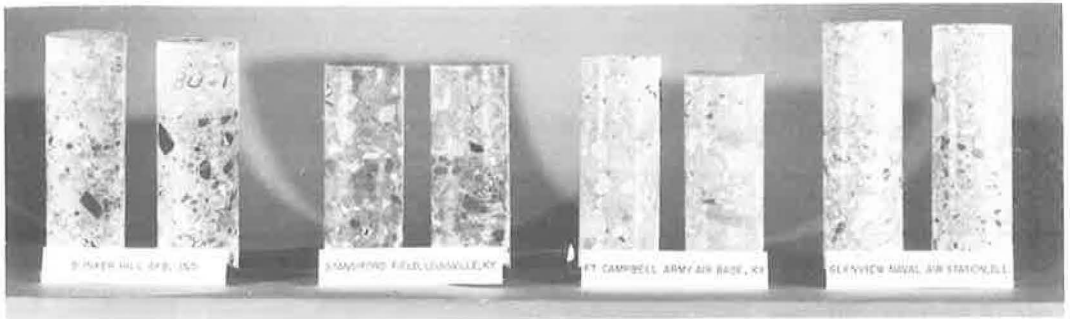
This was the first major project constructed at a civil airport and was one of the thickest resurfacings constructed using the acid etch, bonding grout technique. The resurfacing was 4 in. in thickness and consisted of 8,300 sq yd at the end of a primary runway. The 4-in. resurfacing was placed on a 6-in. resurfacing constructed in 1944 on an old 9-6-6-9-in. concrete base pavement (Fig. 5). This 4-in. resurfacing was

Figure 5. Four-inch cores taken at Bunker Hill Air Force Base, Ind.; Standiford Field, Louisville, Ky.; Fort Campbell Army Air Base, Ky.; and Glenview Naval Air Station, Ill.

In 1964, both 4- and 2-in. cores (Fig. 5) were removed from this project and all showed an excellent bond between the surface and the base pavement. A walking survey of this area at this time showed additional reflective cracks and one area of spalled concrete near a drop inlet along the edge of the apron. The overall area is in excellent condition.

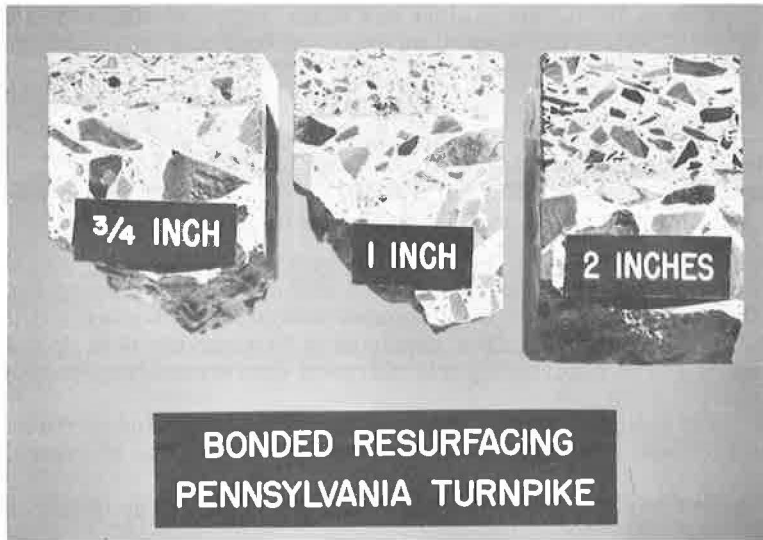
Figure 6. Pavement sections cut from Pennsylvania Turnpike.

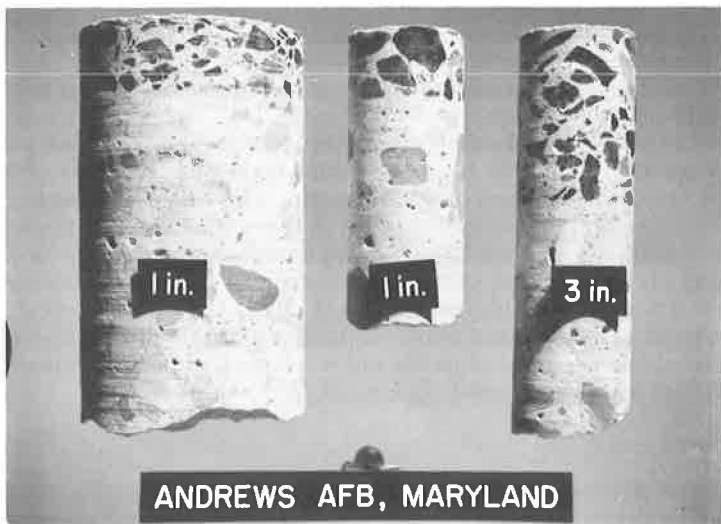
A survey and cores taken in the summer of 1964 showed the pavement to be in excellent condition with all cores showing excellent bond (Fig. 7). The same condition of small bond loss along joints was found with a few small spaces having been patched. This project also utilized sandblasting for surface preparation instead of scarification.

Figure 7. Cores from Andrews Air Force Base, Md.

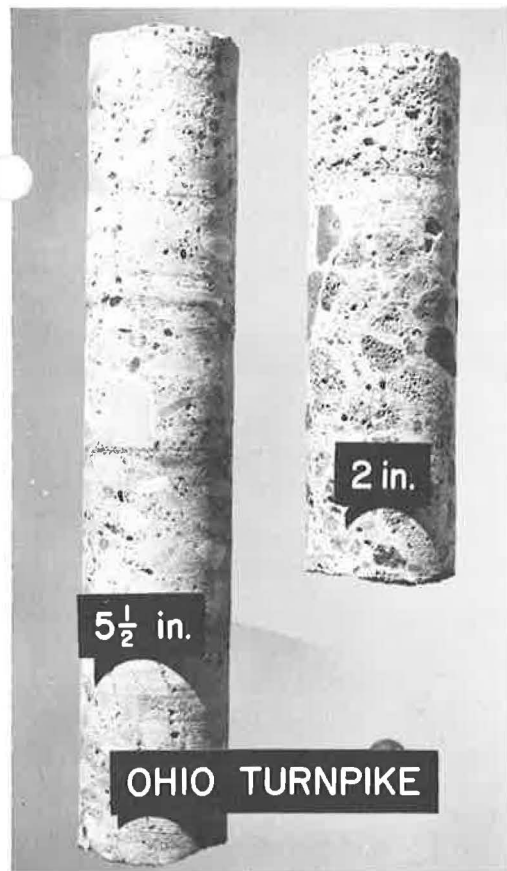
Figure 8. Cores from Raccoon Creek Bridge resurfacing and from patch on Tinkers Creek Bridge on Ohio Turnpike.

ment made this impossible. However, a series of 2-in. cores was taken, so as to miss the steel, and all showed an excellent bond (Fig. 8). These cores were taken in the right-hand lane on the eastbound section of the bridge at approximately milepost 97.9. After 9 years the resurfacing is in excellent condition with no evidence of scaling, cracking or distress of any kind.

Tinkers Creek.—This bridge deck was patched approximately 1½ years ago using the aforementioned bonding techniques. The patching was necessary to replace concrete which had spalled above the steel in the deck. Several 2-in. cores were taken between steel bars and all showed an excellent bond (Fig. 8). The patches are in excellent condition and none sounded loose.
