# Nondestructive Tests for Detecting Discontinuities In Aluminum Alloy Arc Welds

F. C. PANIAN, J. A. PATSEY and G. F. SAGER, Aluminum Company of America, Alcoa Research Laboratories, New Kensington, Pa.

This paper describes an investigation conducted to evaluate radiographic and ultrasonic procedures for detecting 14 types of discontinuity in TIG or MIG arc welds in 2219-T87 aluminum alloy plate, and to determine the effects of these discontinuities on the static strength of the welded joints. The discontinuities studied were microporosity, linear porosity, scattered porosity, oxide inclusions, tungsten inclusions, lack of interpass fusion, lack of root fusion, lack of side fusion, incomplete root penetration, crater cracks, longitudinal cracks, craters, underbead folds and weld bead overlaps. The welds were examined metallographically to aid in establishing or confirming the types of discontinuity present.

This investigation represents a portion of the work done on NASA Research Contract No. NAS 8-5132 on the Arc Welding of 2219 Alloy.

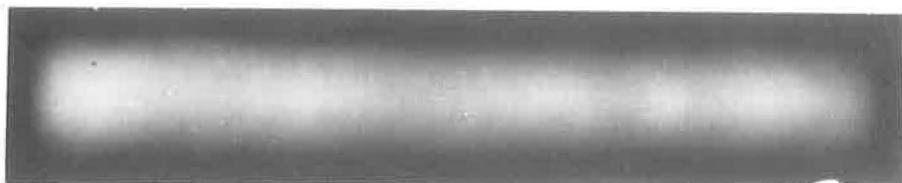
Figure 1 illustrates radiographs of a relatively sound weld, incomplete root penetration, linear and scattered porosity and lack of interpass fusion. The relatively sound weld contains some microporosity not discernible in the radiograph. Incomplete root penetration appears as a sharp line extending horizontally along the midportion of the weld bead. The linear porosity appears as an irregular scattering of faint spots along the centerline of the weld bead. The majority of the spots are in the right-hand third of the weld, but there are several just to the left of the center. Lack of interpass fusion appears as a discontinuous line of varying width and density extending along the centerline of the weld bead.

S278454 - RELATIVELY SOUND TIG WELD

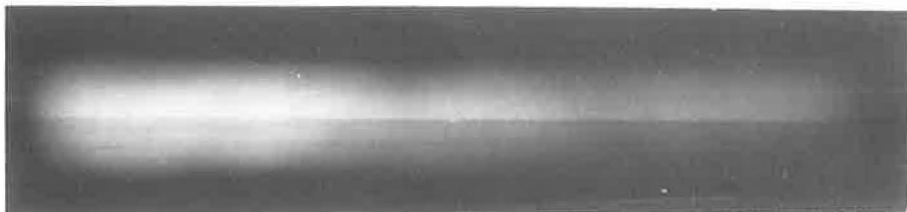
S278488 - MIG WELD WITH INCOMPLETE ROOT PENETRATION

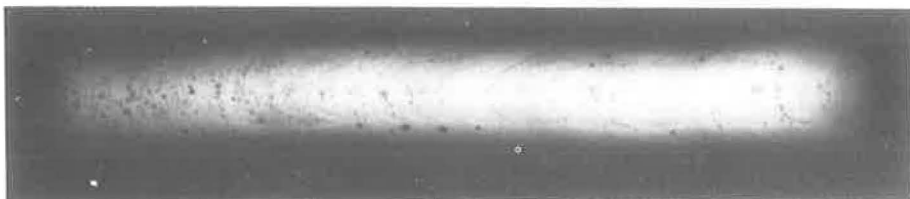
S278496 - MIG WELD WITH SCATTERED POROSITY

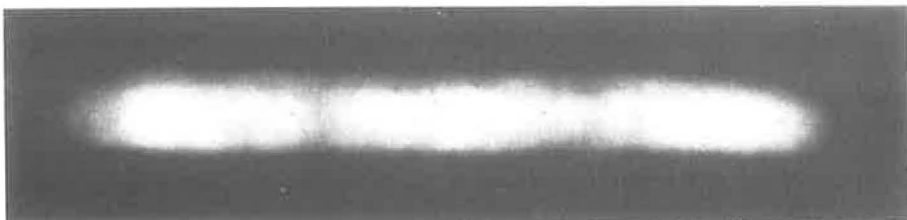
S278493 - MIG WELD WITH LACK OF INTERPASS FUSION

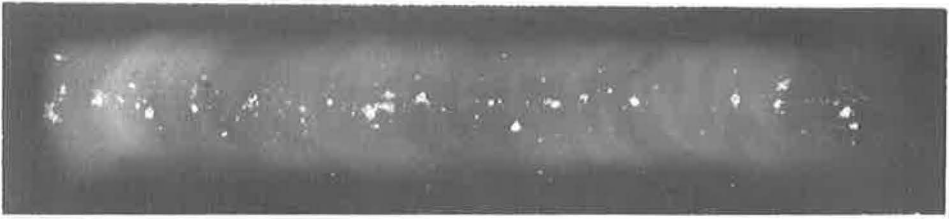
Figure 2 illustrates radiographs of welds containing tungsten inclusions, oxide inclusions and craters. Light patches associated with the high density tungsten inclusions stand out very sharply. The oxide inclusions require closer scrutiny and appear as small spots of porosity near the right-hand end of the weld bead. The craters appear as rounded zones with relatively dark centers.

S278456 - TIG WELD WITH TUNGSTEN INCLUSIONS

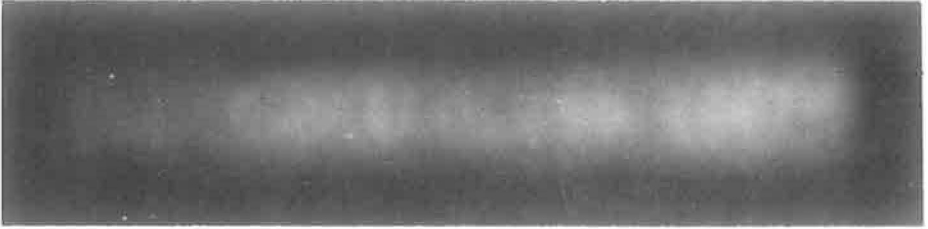
S278515 - RELATIVELY SOUND MIG WELD

The radiographs in Figure 3 include a relatively sound weld containing some micro-porosity not discernible in the radiograph and welds with incomplete root penetration, linear porosity, lack of interpass fusion and lack of root fusion. The line of incomplete root penetration is broader and more diffuse than that in Figure 1. The lack of interpass fusion is evident as a few dark spots along a very faint, diffuse and discontinuous horizontal line through the mid-portion of the weld. The conspicuous dark spots in the bottom radiograph indicate voids of significant size along unfused portions of the weld root.

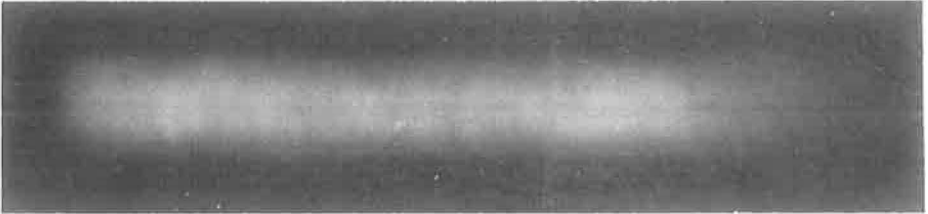
S278504 - MIG WELD WITH INCOMPLETE ROOT PENETRATION

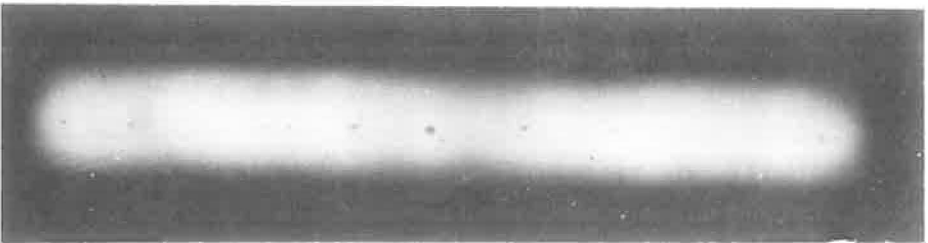
S278501 - MIG WELD WITH LINEAR POROSITY

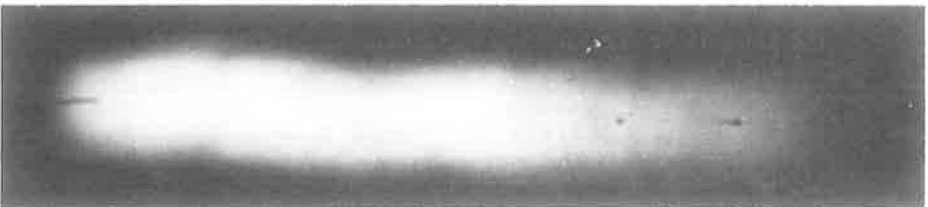
S278516 - MIG WELD WITH LACK OF INTERPASS FUSION

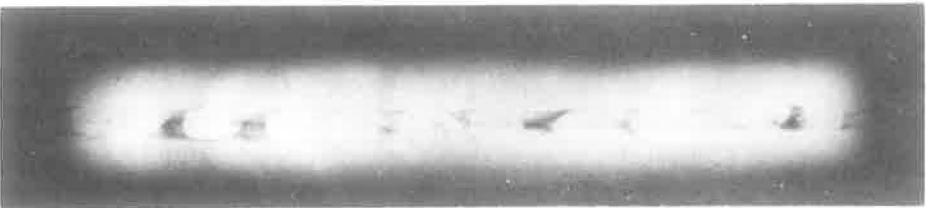
S278511 - MIG WELD WITH LACK OF ROOT FUSION

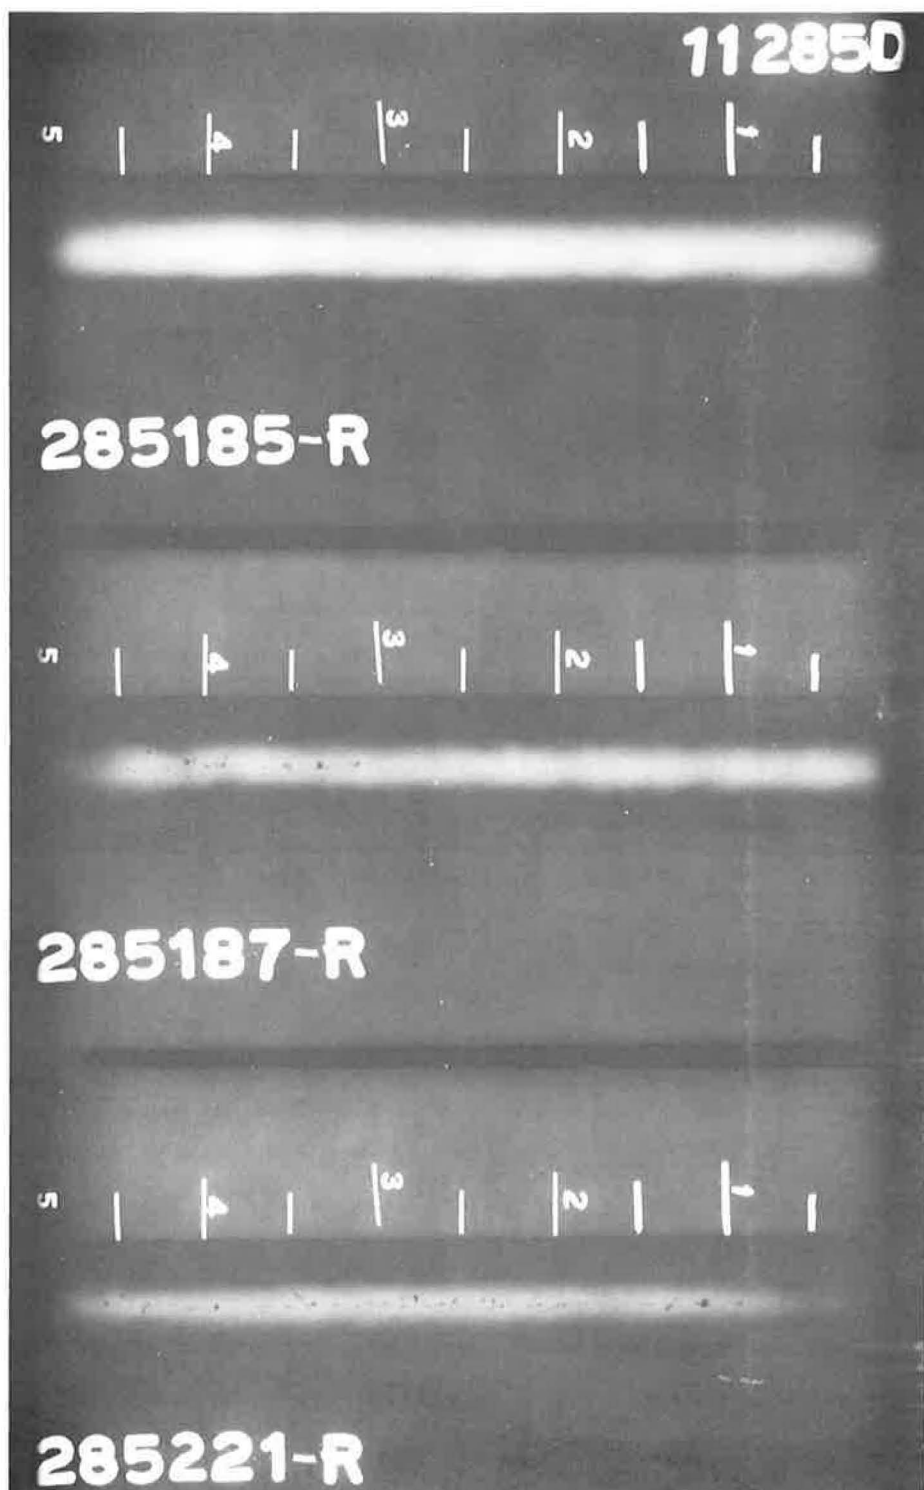
Figure 4. Radiographs of square butt welds in  $\frac{1}{2}$ -in. 2219-T87 plate representing various degrees of penetration: S285185-R, complete with interpenetration of weld bead roots; S285187-R, moderately incomplete; and S285221-R, markedly incomplete.

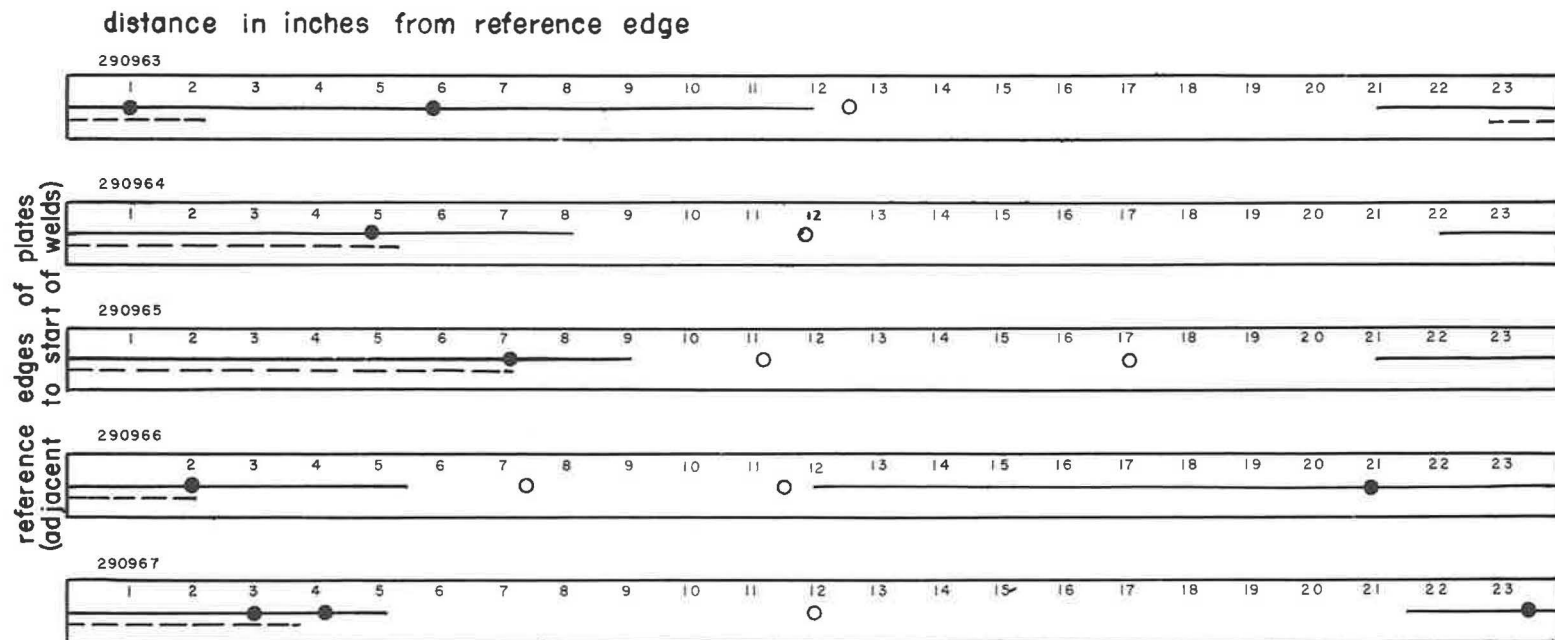
- continuous ultrasonic indication in weld presumably incomplete penetration
- radiographic evidence of incomplete penetration
- location of metallographic section showing complete penetration
- location of metallographic section showing incomplete penetration

Figure 6. Results obtained from the ultrasonic, radiographic and metallographic tests for incomplete penetration.

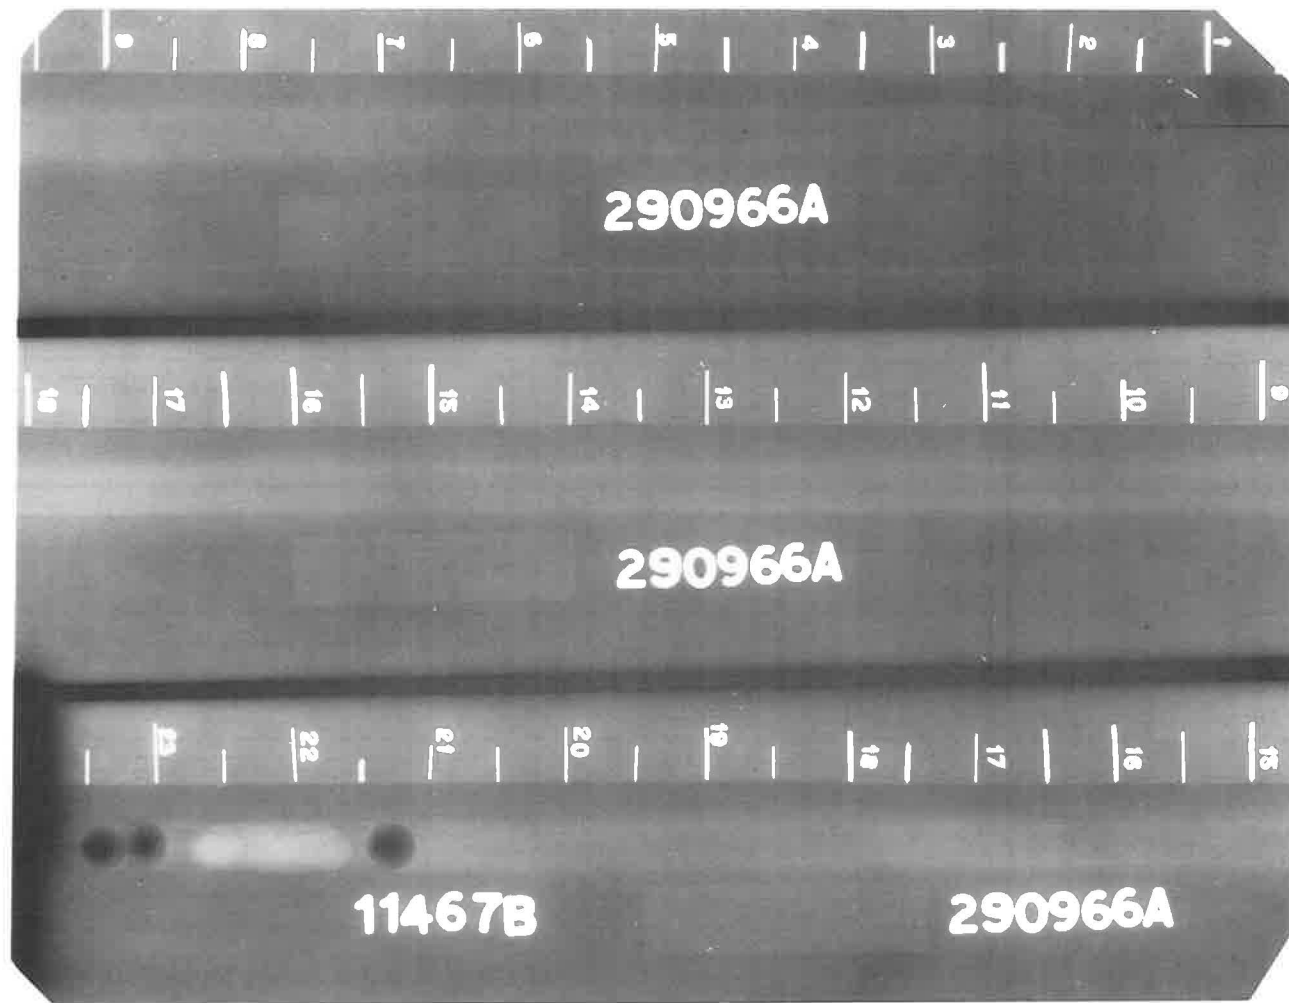
Figure 7. Radiograph of weld in panel S290966 after scarfing (about two-thirds original size). Weld starts about  $1\frac{1}{4}$  in. from "reference" end of plate (upper right); incomplete penetration is evident for a distance of about three-fourths in. at beginning of weld; circular indentations (dark spots) may be associated with weld setup or attachment of equipment.

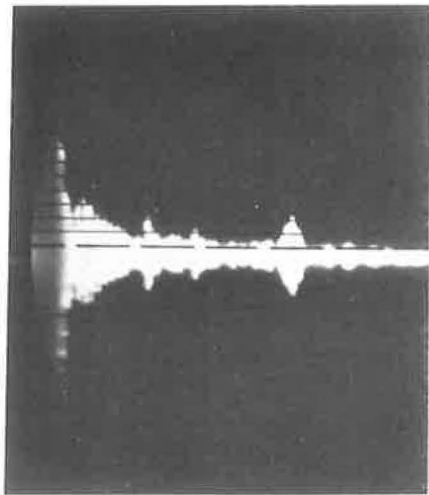
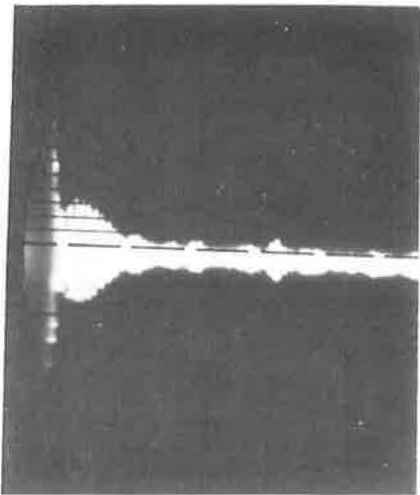
relatively sound and some microporosity

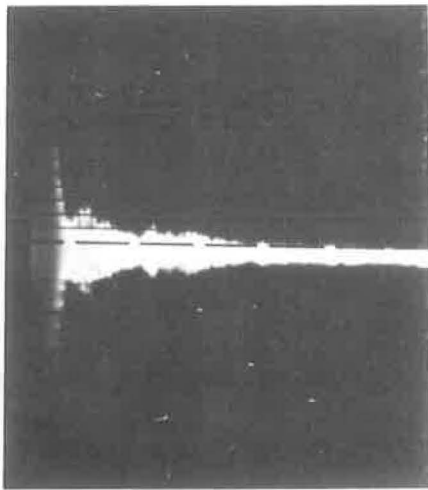
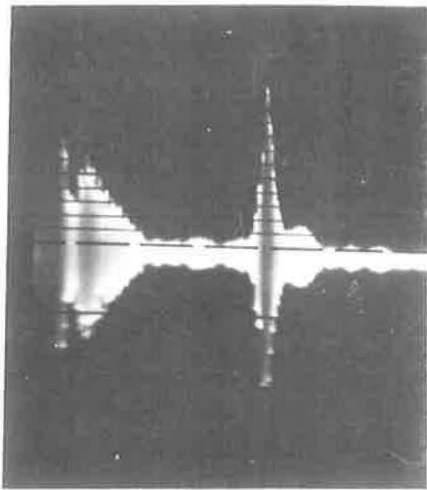
craters

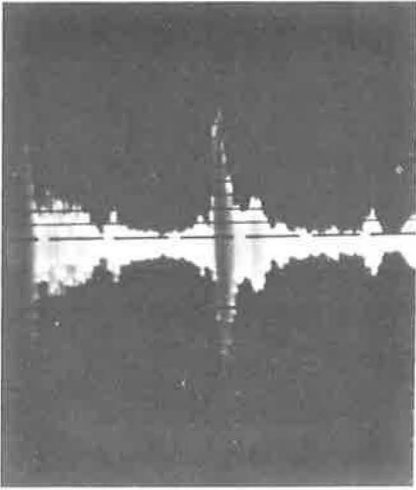
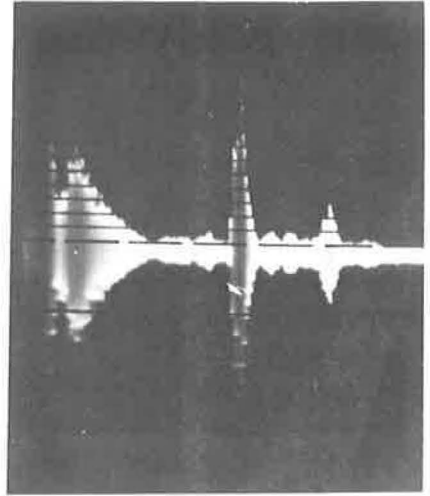
lack of interpass fusion

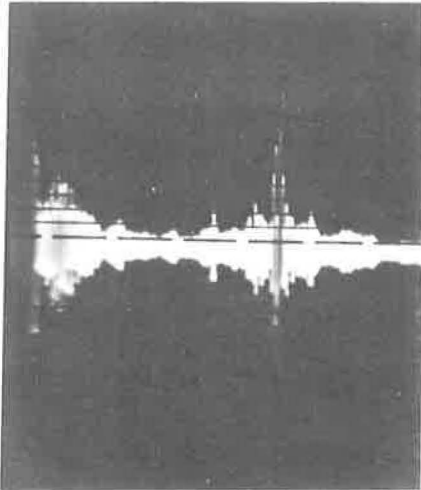
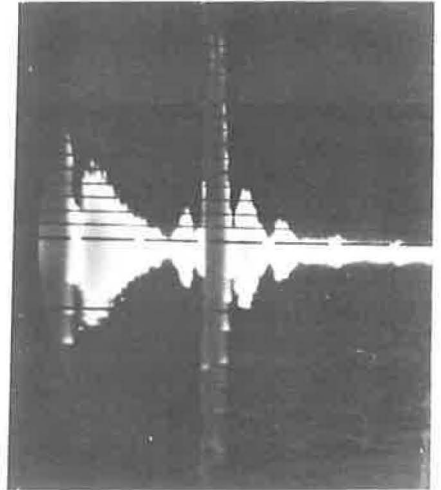
lack of root fusion

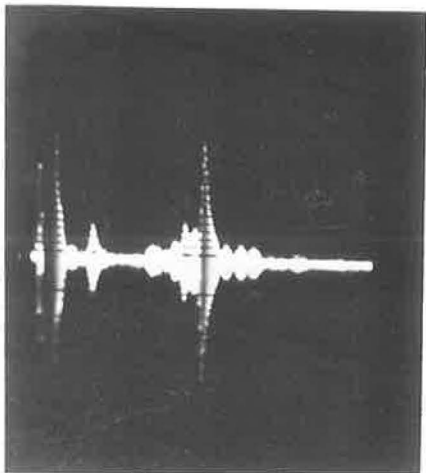
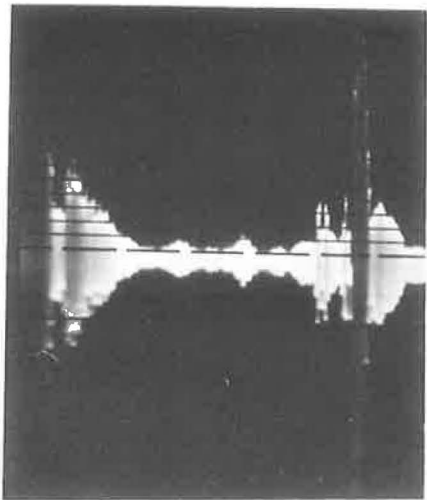
lack of side fusion

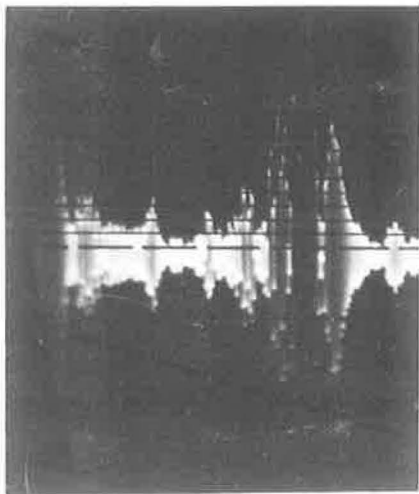
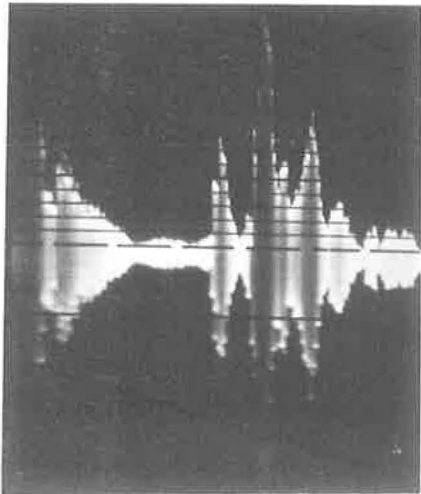
incomplete root penetration

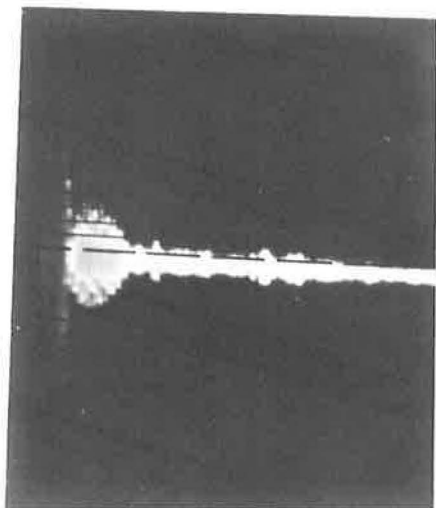
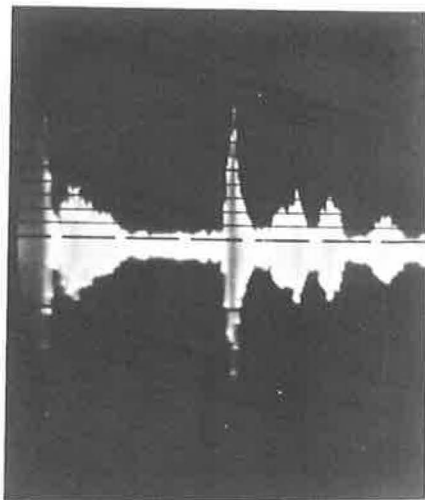
scattered porosity

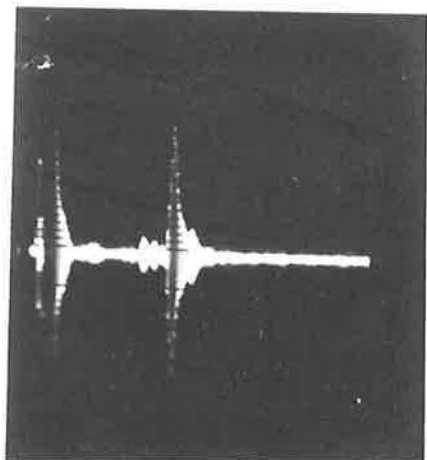
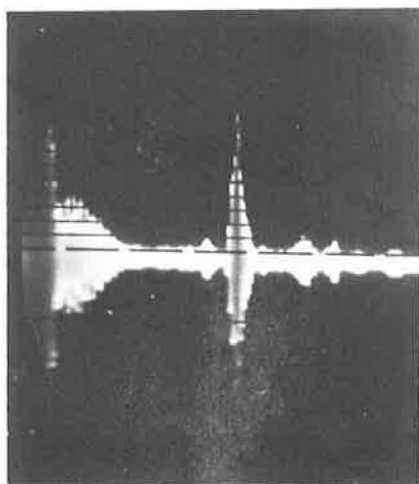
oxide inclusions

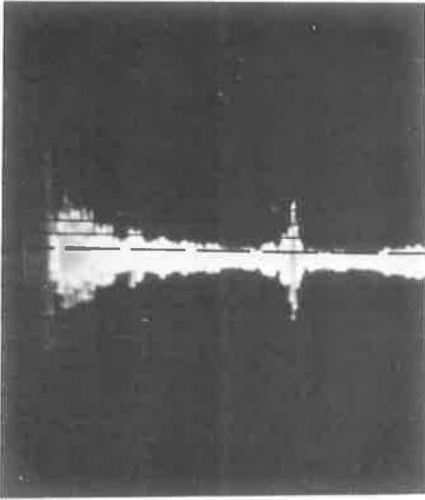
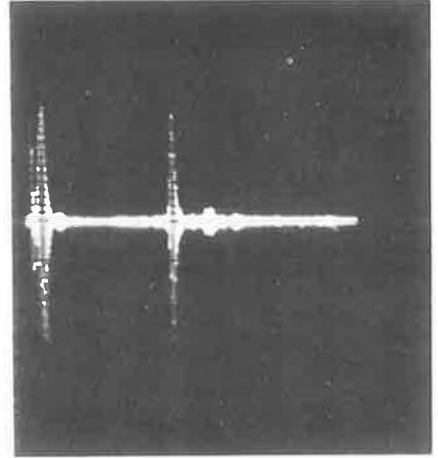
linear porosity

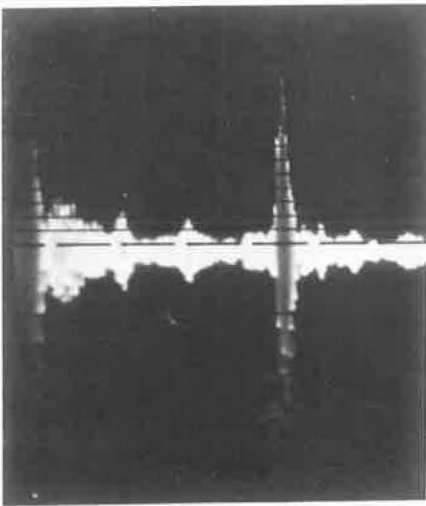
tungsten inclusions

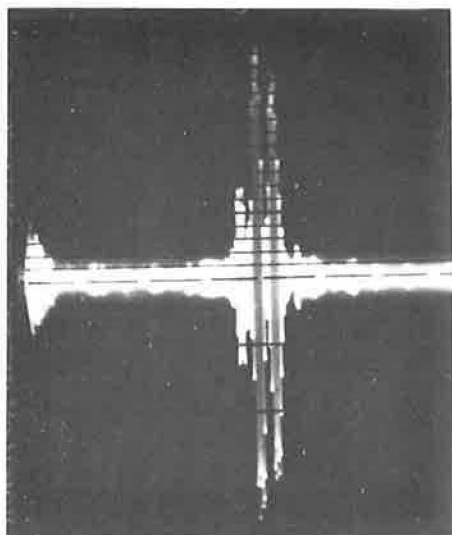
A- indication from incomplete penetration  
S- 285221

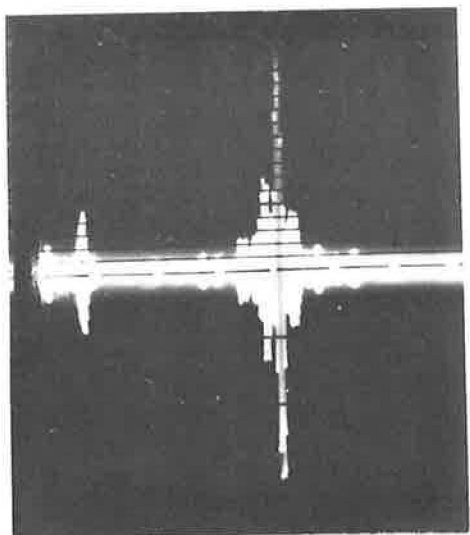
B-indication from incomplete penetration  
S- 285187

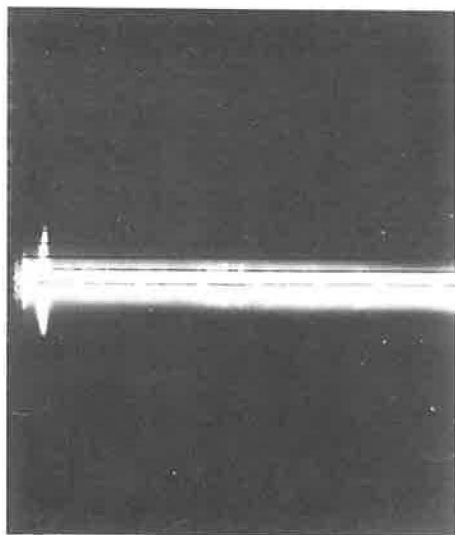
C- screen presentation from complete  
penetration S-285185

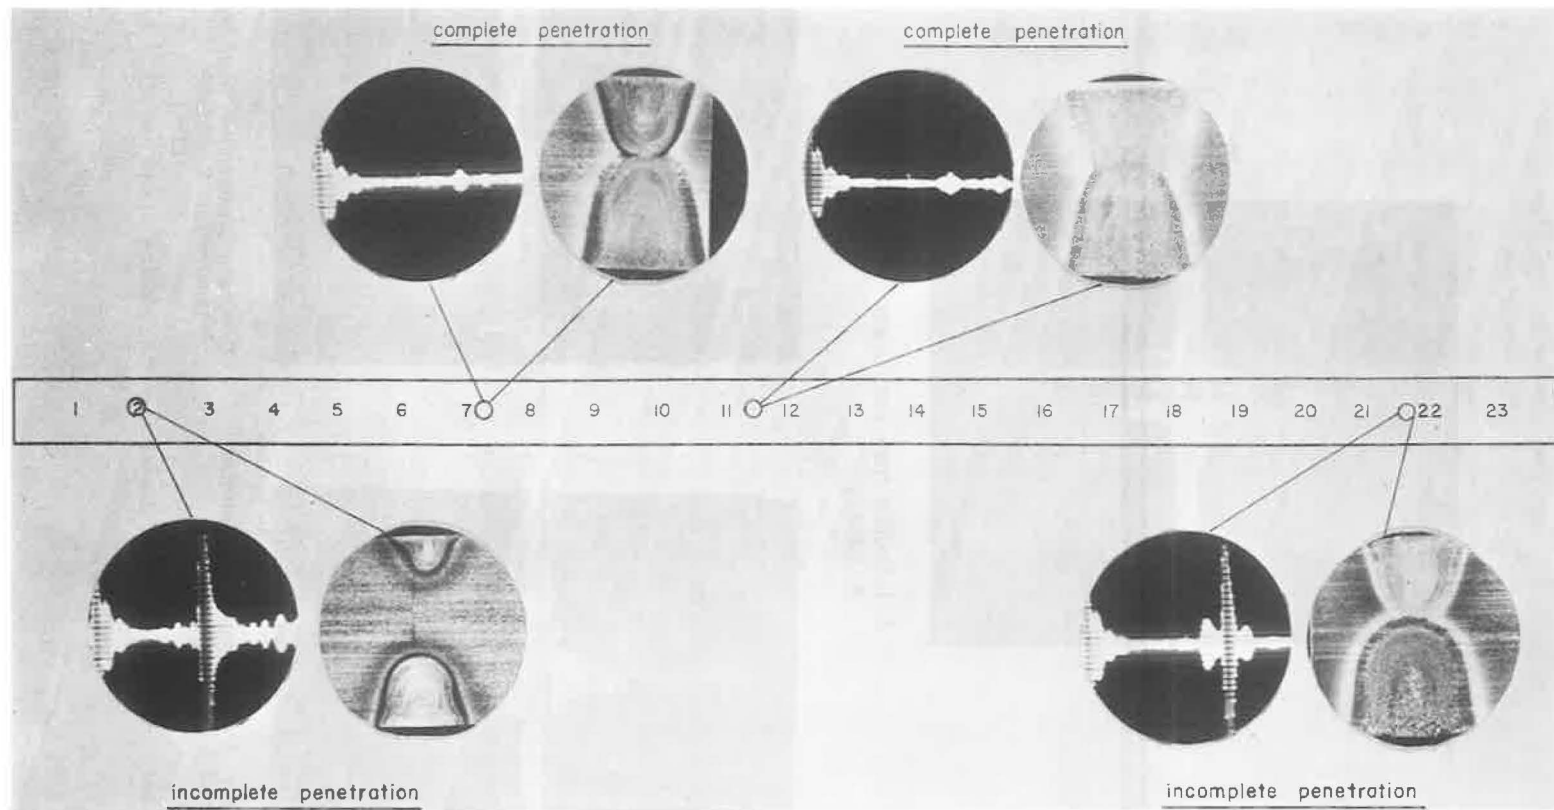
Figure 17. Reflectograms and macrographs from corresponding locations in weldment numbered 290966.

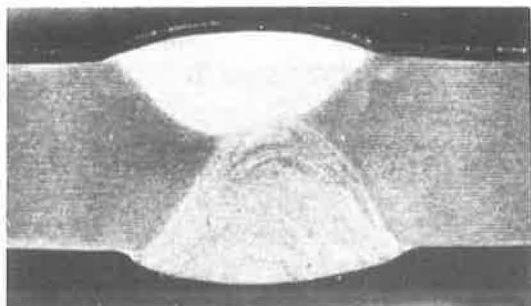
**S278454 - RELATIVELY SOUND WELD**  
(Etch 10% NaOH)

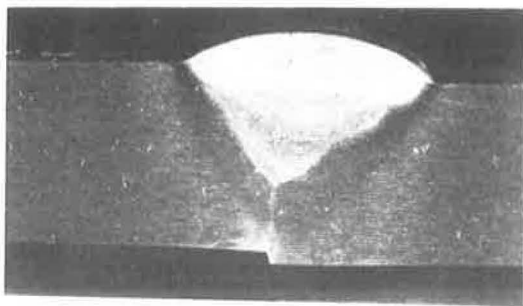
**S278488 - INCOMPLETE ROOT PENE-  
TRATION (Etch 10% NaOH)**

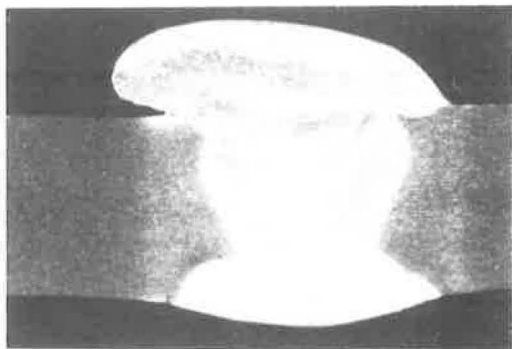
**S278519 - WELD BEAD OVERLAP**  
(Etch 10% NaOH)

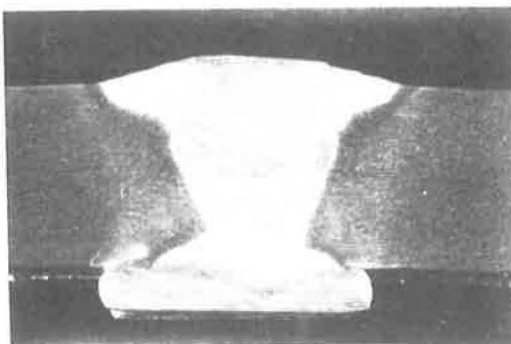
**S278502 - UNDERBEAD FOLD**  
(Etch 10% NaOH)

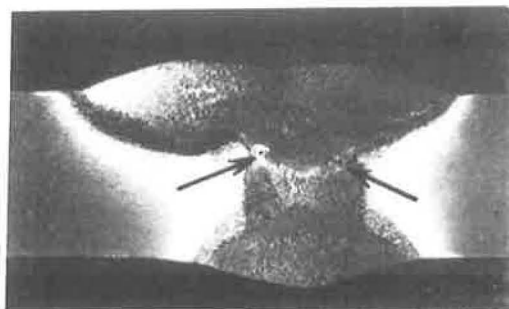
**S278597 - LACK OF SIDE FUSION**  
(Etch Keller's)

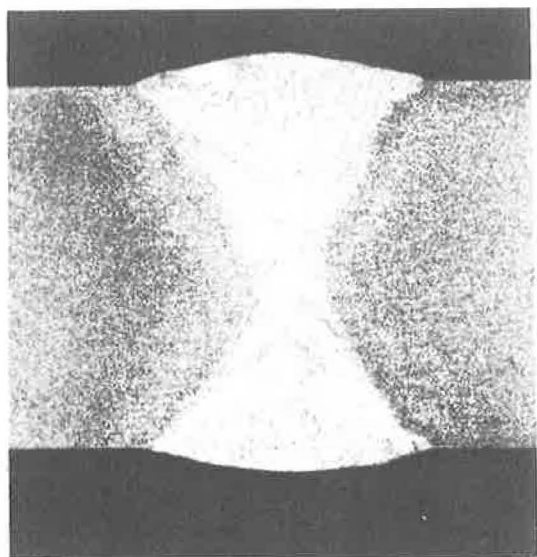
**278515 - RELATIVELY SOUND WELD**

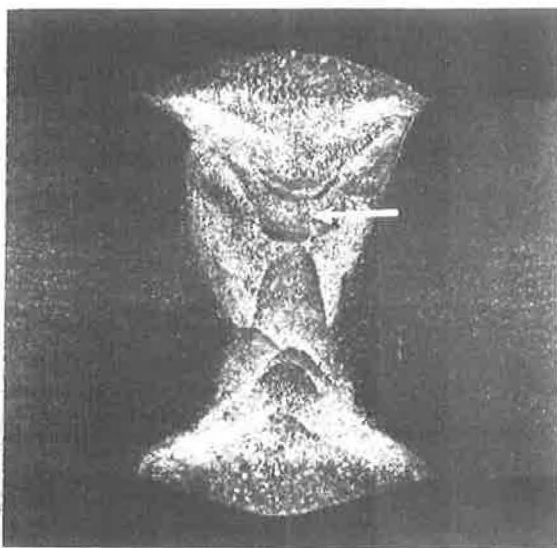
**S278495 - INTERNAL LONGITUDINAL CRACK**

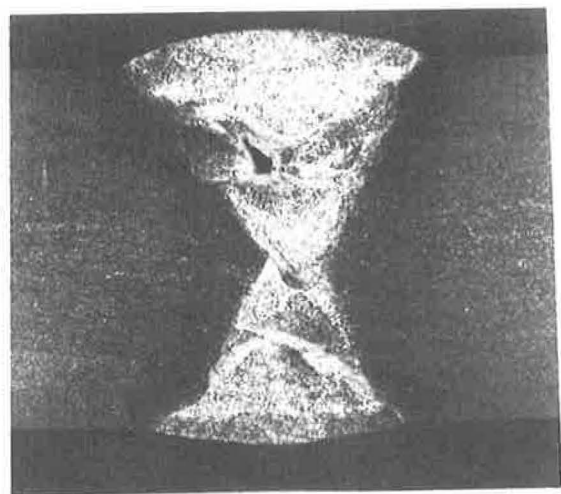
**S278516 - LACK OF INTERPASS FUSION**

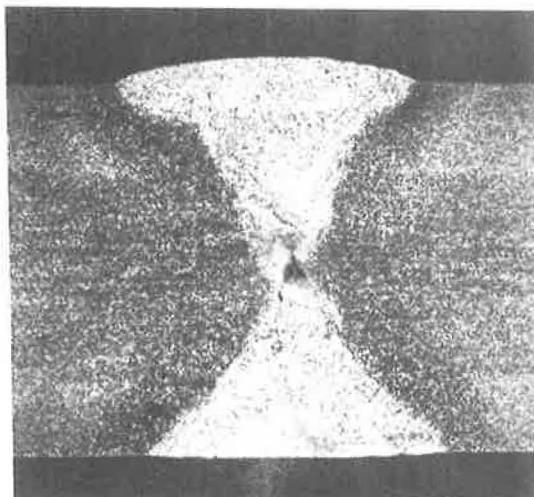
**S278511 - LACK OF ROOT FUSION**

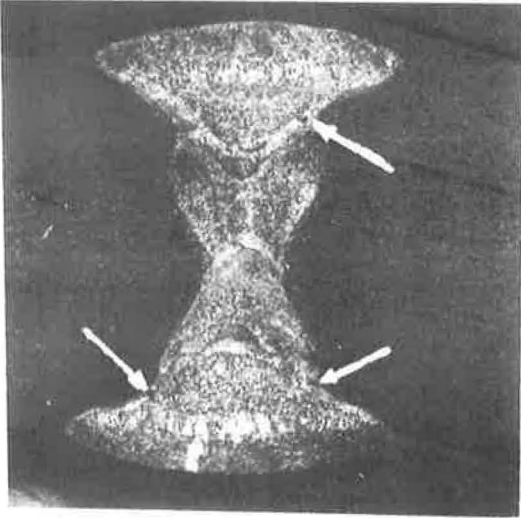
**S278518 — LACK OF SIDE FUSION**  
(Etch 10% NaOH)

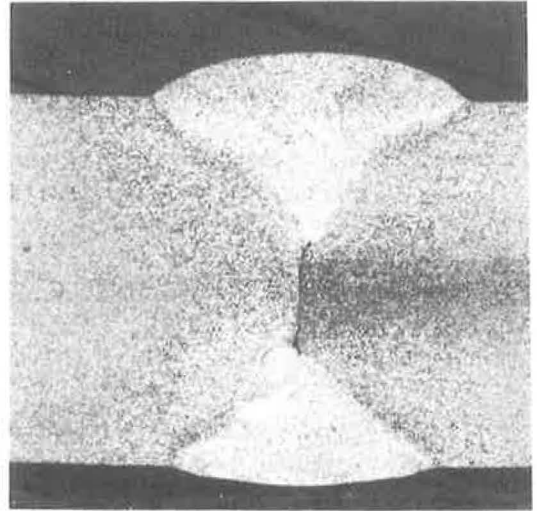
**S278504 — INCOMPLETE ROOT PENE-  
TRATION (Etch 10% NaOH)**

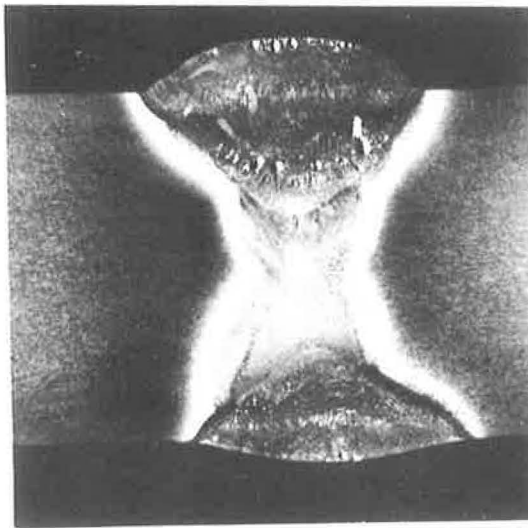
**S278596 — SCATTERED POROSITY**  
(Etch Keller's)

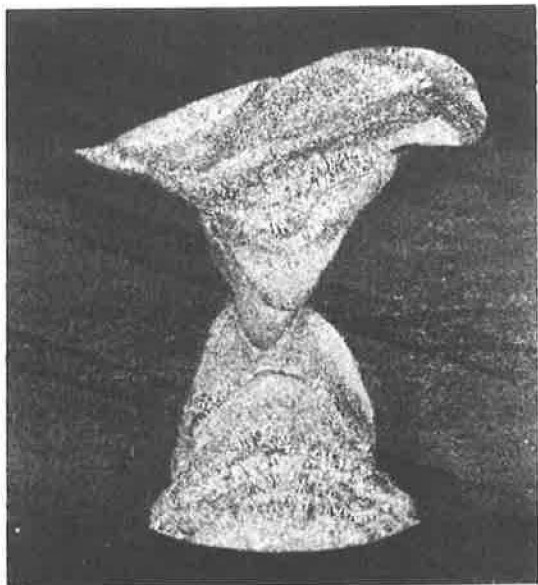
**S278512 - WELD BEAD OVERLAP**

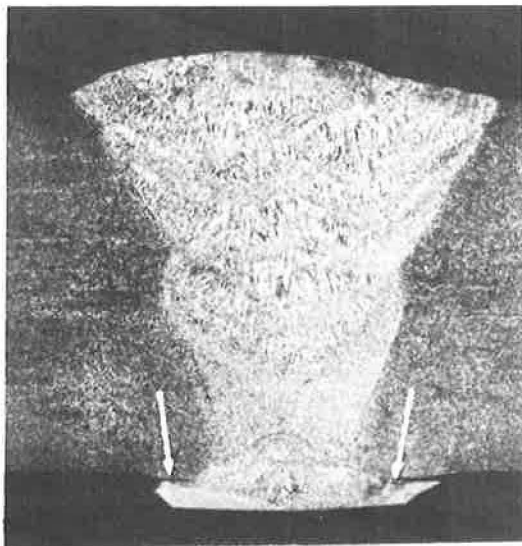
**S278505 - UNDERBEAD FOLD**

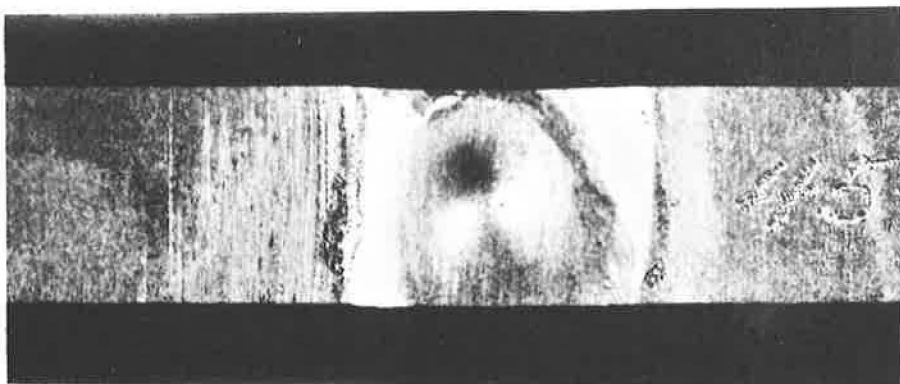
Figure 22. Crater on root pass of TIG butt weld in 2219-T87 plate (S-278457, mag. 2X).

Figure 22 is a 2X photograph of a crater on the root pass of a TIG butt weld in  $\frac{1}{2}$ -in. plate. A macrosection through the weld and crater appears in Figure 23. Fine porosity is rather generally distributed through the weld bead on the face side but the root side bead is comparatively sound. A more detailed metallographic examination of the section failed to reveal any significant effect of the crater on the structure of the surrounding weld metal.

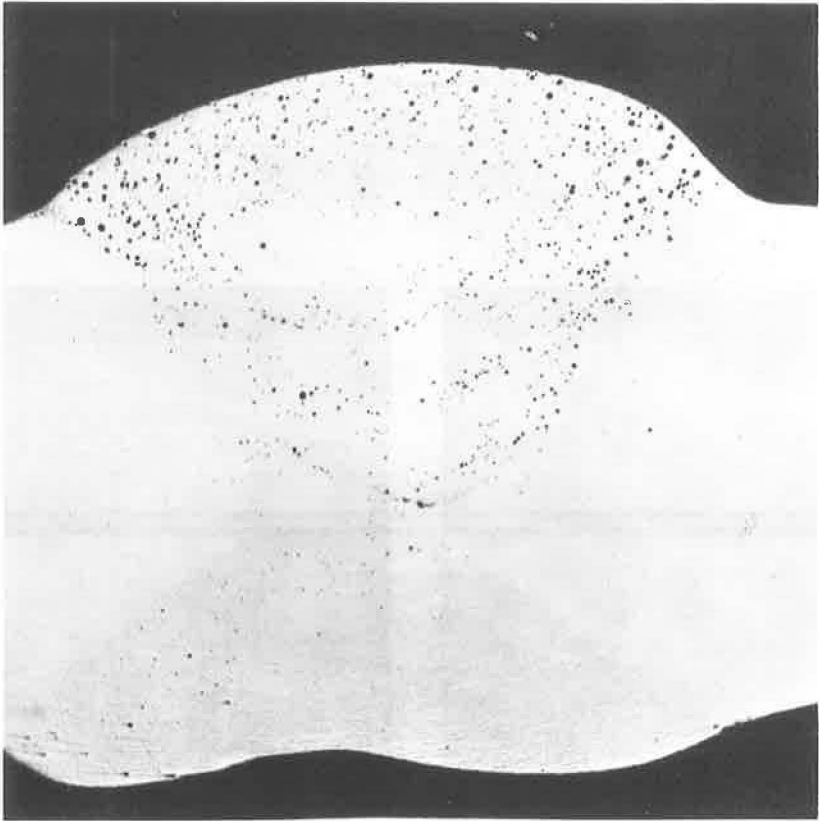
Figure 23. Macrograph of section through weld and crater (max. 5X, as-polished).

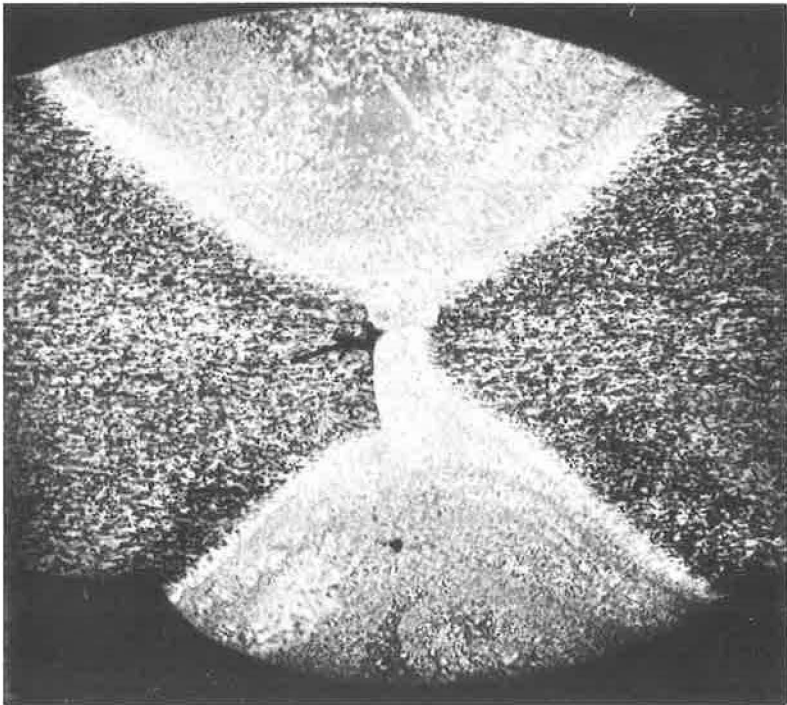
Figure 24. Macrograph of section through TIG weld in  $\frac{1}{2}$ -in. 2219-T87 plate; arrow indicates lack of root fusion (S-278459, mag. 5X, etch Keller's).

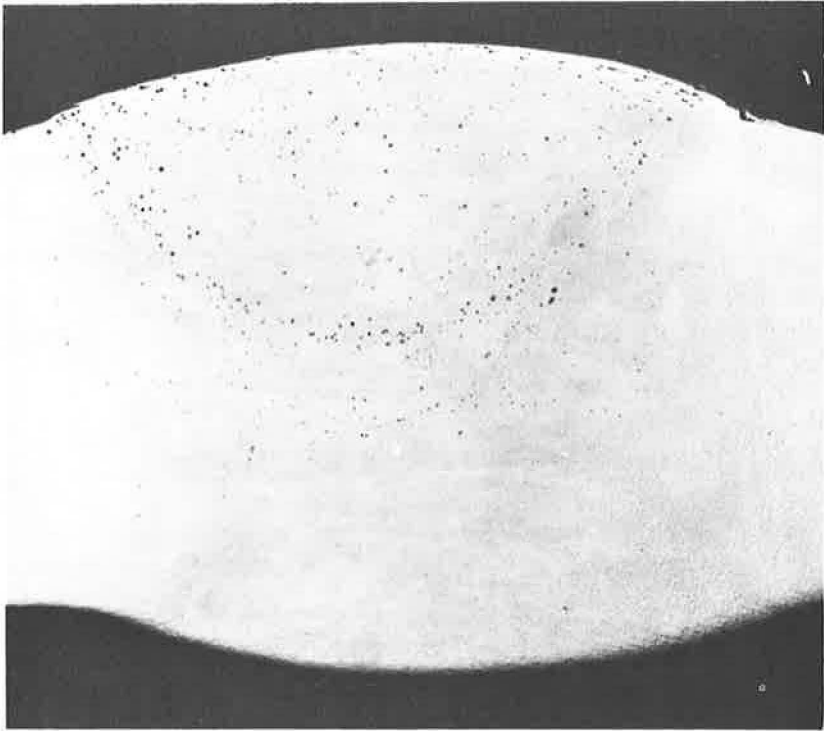
Figure 25. Macrograph showing microporosity in an otherwise sound TIG weld in  $\frac{1}{2}$ -in. 2219-T87 plate (S-278454, mag. 5X, as-polished).

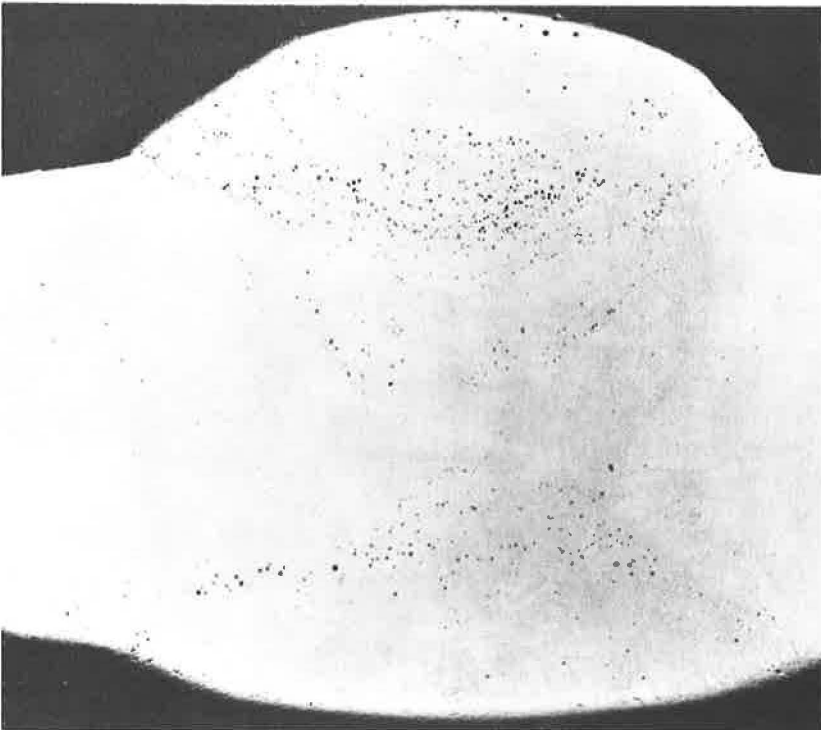
Figure 26. Macrograph showing microporosity in a MIG weld in  $\frac{1}{2}$ -in. 2219-T87 plate (S-278490, mag. 5X, as-polished).

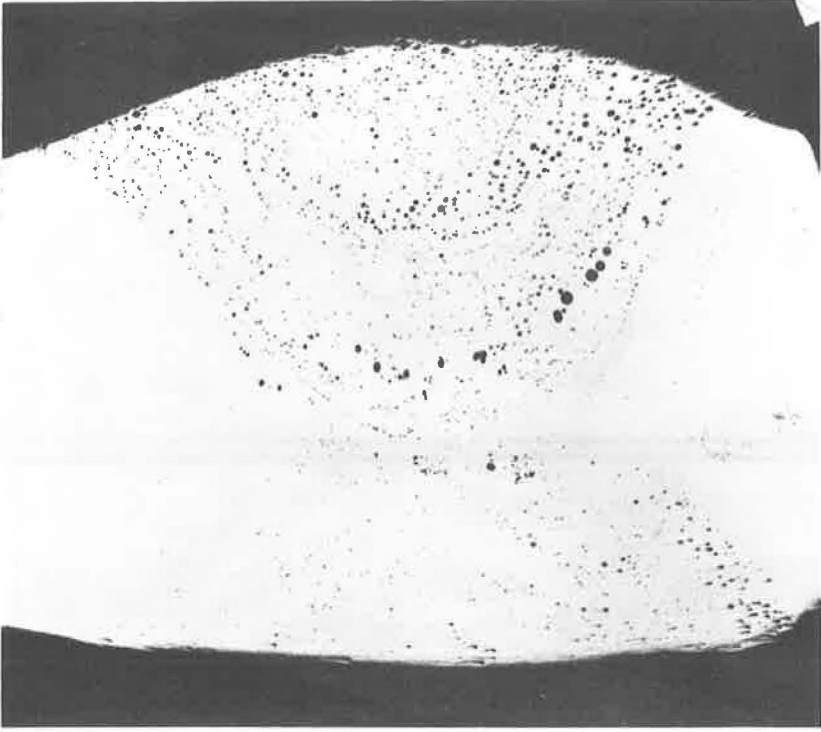
Figure 27. Macrograph showing porosity in a TIG weld in  $\frac{1}{2}$ -in. 2219-T87 plate (S-278462, mag. 5X, as-polished).

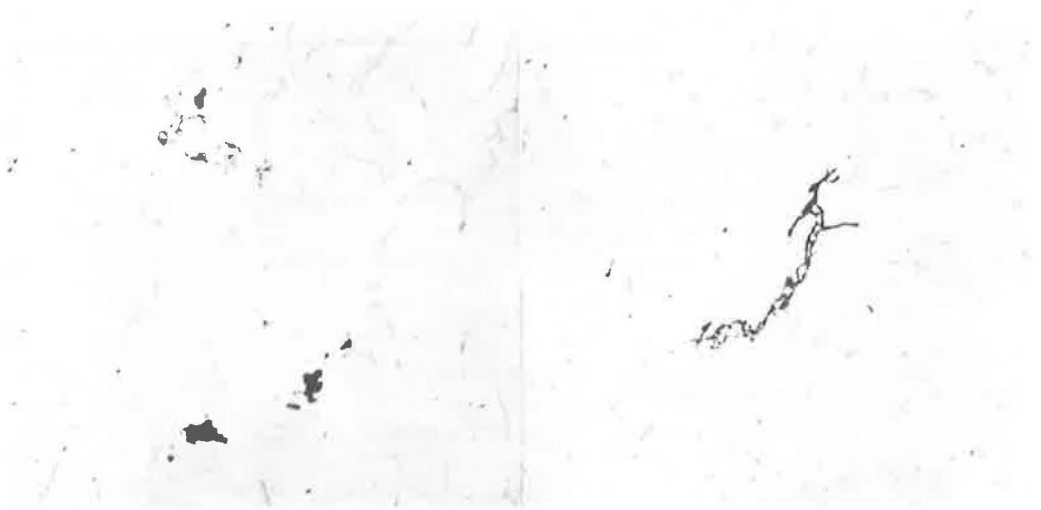
Figure 28. Micrographs showing oxide inclusions in MIG weld in  $\frac{1}{2}$ -in. 2219-T87 plate (S-278598, mag. 500X, etch Keller's).

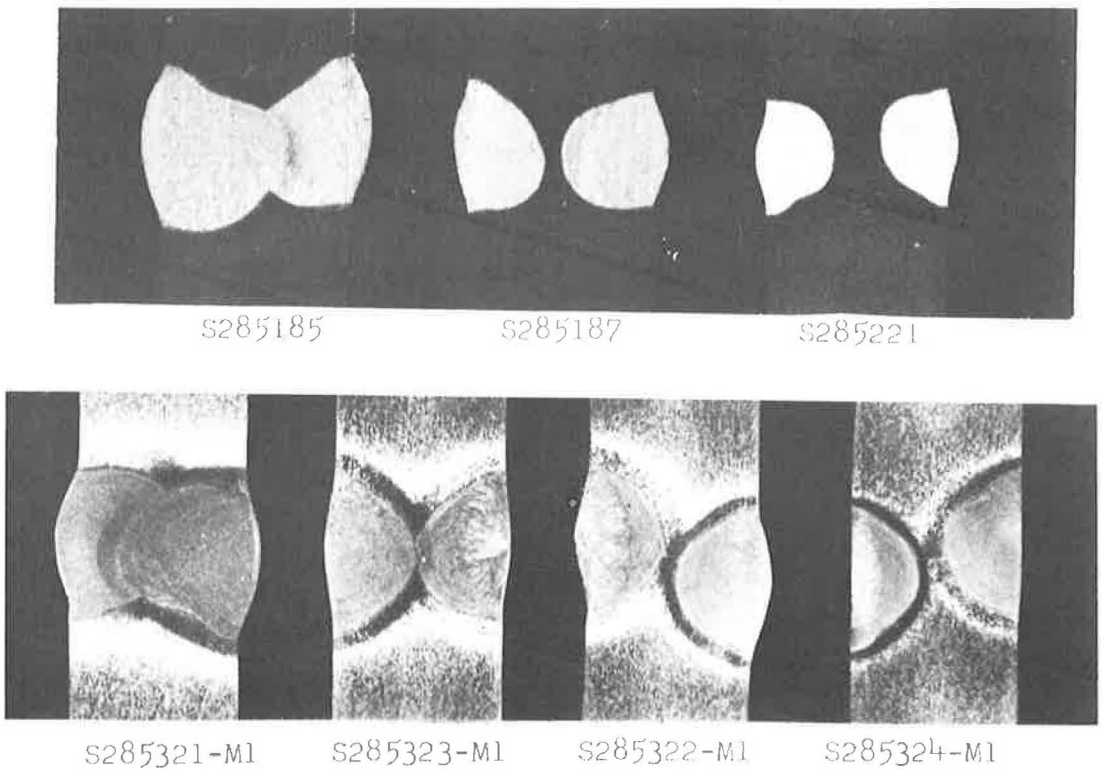
Figure 29. Macrographs of sections through square butt TIG welds in 2219-T87 plate showing various degrees of penetration (mag. 2X, etch: top row 10% NaOH, bottom row Keller's).

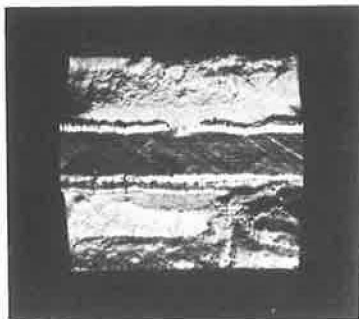
The first fracture in Figure 32 is associated with incomplete root penetration. The surface of the unpenetrated land in S278504 forms a conspicuous band about  $\frac{1}{4}$ -in. wide extending completely across the fracture. The dark areas just above the horizontal centerline in fracture S278511 are cavities associated with the lack of root fusion that this specimen exemplifies.

**S278504**  
**INCOMPLETE**  
**ROOT PENETRATION**

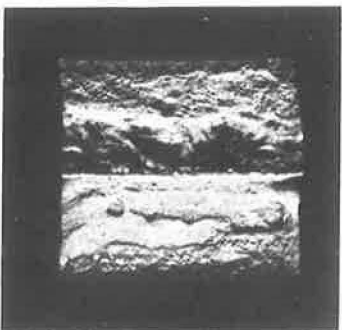
**S278511**  
**LACK OF ROOT FUSION**

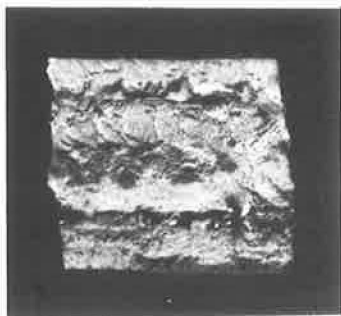
In the fracture of S278516 (lack of interpass fusion) a narrow band that is generally dark but which contains some small white spots extends horizontally across the fracture about  $\frac{5}{16}$ -in. above the lower edge. This band represents an unsound region associated with the lack of interpass fusion. Fracture S278518 (lack of side fusion) exhibits a narrow band that is generally dark but which contains small light spots and patches. This band extends across the greater part of the fracture about  $\frac{3}{16}$  in. above the lower edge. It represents an unsound portion of the joint associated with the lack of side fusion. The scattered porosity in fracture S278596 is conspicuously evident in a zone about  $\frac{3}{16}$ -in. extending horizontally across the fracture a short distance below the top edge.

**S278516**  
**LACK OF**  
**INTERPASS FUSION**

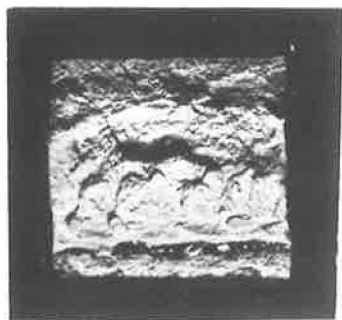
**S278518**  
**LACK OF SIDE FUSION**

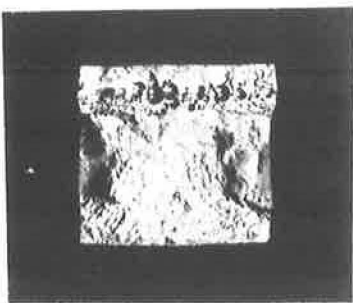
**S278596**  
**SCATTERED POROSITY**

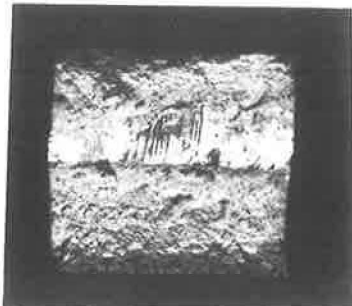
**S278549**  
**OXIDE FILM**
