Comparative Freeway Study

JOHN VOSTREZ and RICHARD A. LUNDY, California Division of Highways

Thirty-three sections (200 mi) of freeways with widely divergent accident rates were analyzed. A total of 11,384 accidents were included. These accidents occurred during the course of 9,198 million vehicle-miles (MVM) of travel. The average accident rate for the 33 sections is 1.24 accidents per MVM. The accident rates for the individual sections range from 4.52 to 0.60 accidents per MVM.

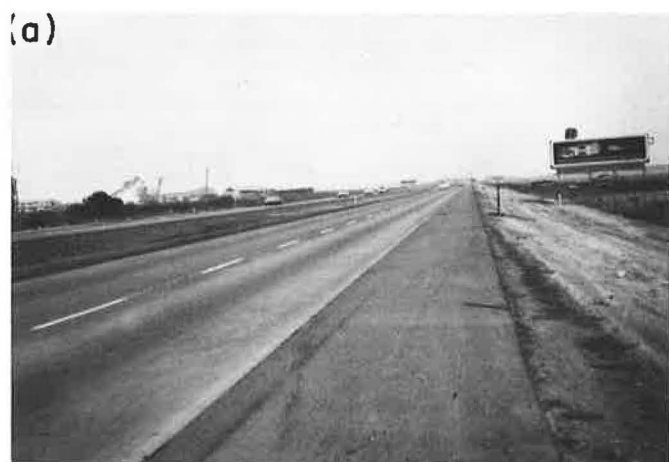
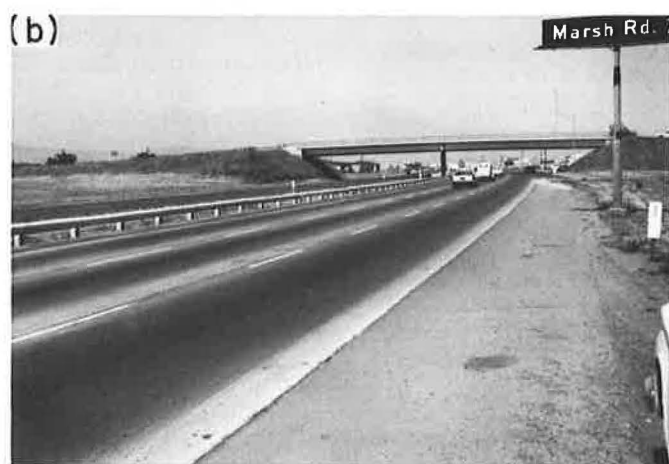
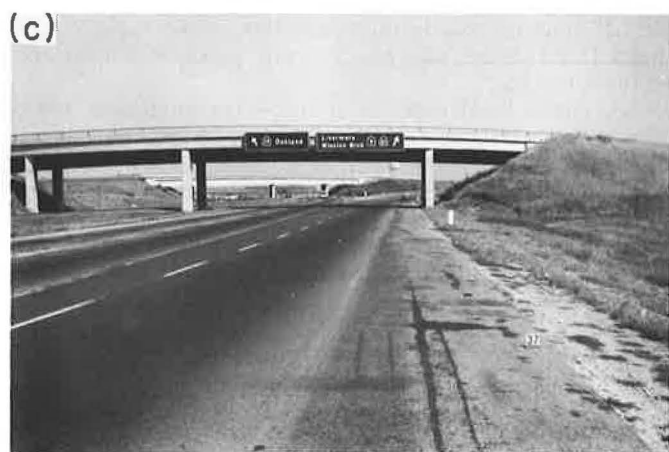
Figure 4. (a) Clear, firm roadside; (b) no pier at shoulder edge (but with sign pole); and (c) pier at shoulder edge.

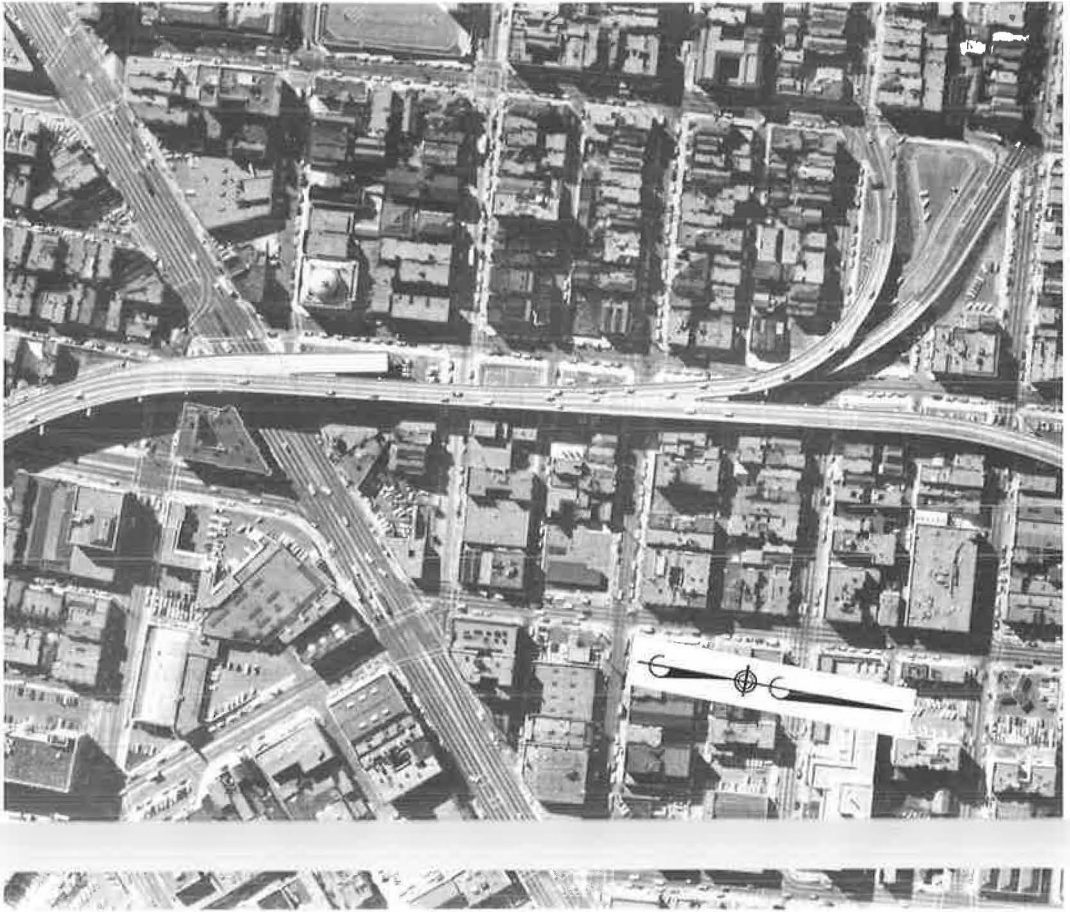
Figure 5. Central Skyway, San Francisco.

1. 57,800 ADT, 62 MVM (1960-61), 280 accidents.
2. Accident rates—expected, 1.20; actual, 4.52 or 375 percent of expected rate.
3. The section is basically six lanes with a short portion of eight lanes. It is an

Table 11 indicates that the motorists using this section are better than average from the standpoint of drinking or dozing. Violation, movement, and peak hour accidents are relatively average. Stopped vehicles show a slightly higher than normal percentage because disabled vehicles have no place to park safely. A larger percentage of accidents occurred at lower speeds than normal; however, with short radius alignment, the average speed is less than normal. When driving on an elevated freeway such as the Central, the stable objects around the driver are not as apparent as they are on a ground-level freeway. Some people believe that this sensation subconsciously increases driving speed. In other words, the sense of speed is lost much as it is when riding in an airplane. This section does not seem to bear this out; however, the speed may actually be excessive for the existing design standards. A more detailed study of viaducts involving a much larger sample may be of some value.

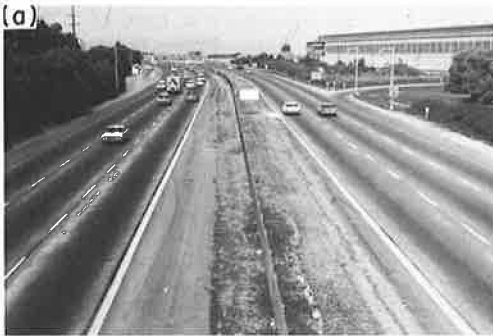
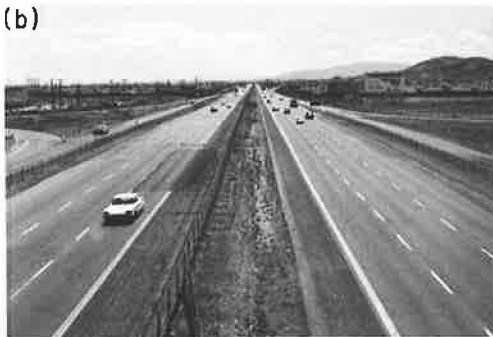
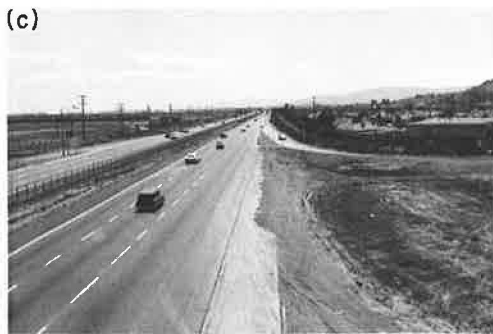
Figure 6. Bayshore Freeway: (a) north end section 1, Butler Rd. O.C., rate 1.06; (b) center section 1, 19th Ave. O.C., rate 0.79; south end section 1, East Hillsdale Ave., rate 0.61.

0.79 (expected rate, 1.26). The remaining $3\frac{1}{4}$ -mi section has a rate of 0.61 (expected rate, 1.25) (Fig. 6).

the freeway has an accident rate of 1.06 (expected rate, 1.27). From that point (3rd and 4th St. interchange in San Mateo), and for the next $2\frac{1}{4}$ mi, it has a rate of

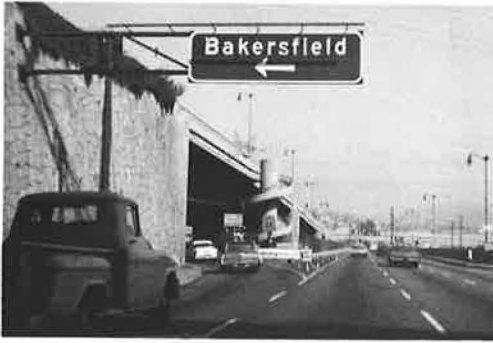
Figure 16. Eastbound on Pasadena Freeway, showing left-hand off-ramp to Golden State Freeway.

were in better condition. The percentage of accidents involving fixed objects is high because of the lack of shoulders and the large number of fixed objects close to the traveled way, including continuous lighting. A congestion problem is suggested by the high percentage of unsafe lane change violations and rear-end accidents.

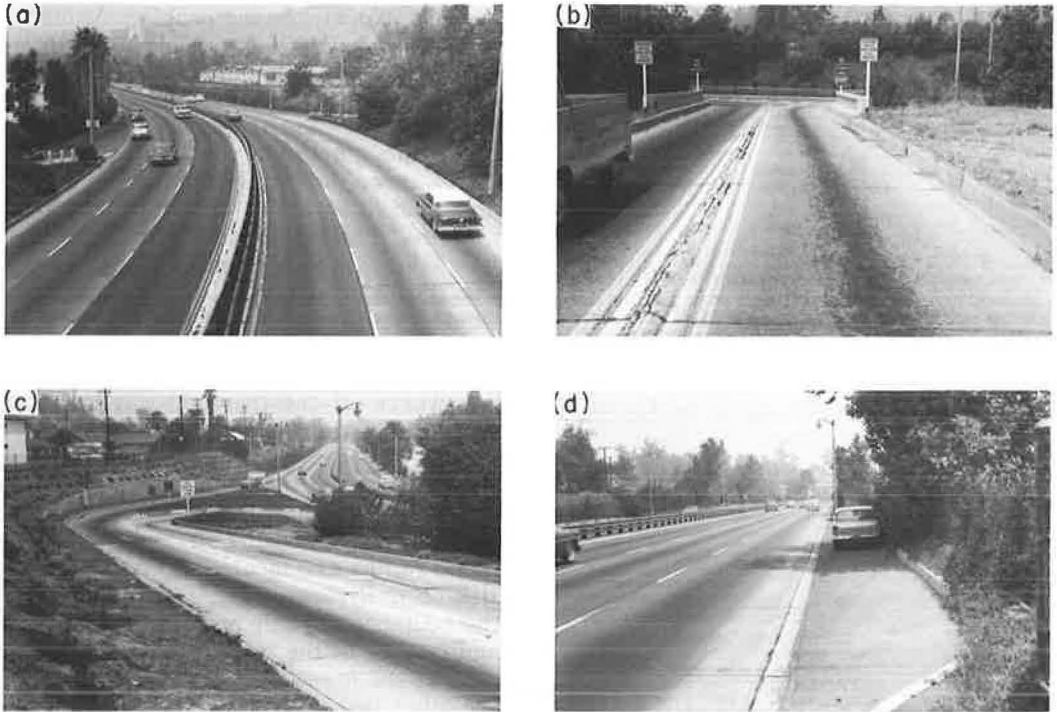
Figure 17. Section 17: (a) Pasadena Freeway; (b) northbound off- and on-ramp at Ave. 43; (c) southbound off- and on-ramp at Ave. 43; and (d) emergency parking area.

grades up to 5 percent. Forty-seven percent of the horizontal alignment is on curves with less than 5,000-ft radius (Fig. 17a). Ramp acceleration and deceleration lanes are far below present standards with some on-ramps having stop signs at the nose (Fig. 17b and c). Figure 17d shows one of the emergency parking areas which are almost the only possibility for off-the-traveled-way maneuvering. In spite of the apparent design deficiencies, this section operates with an average accident rate (Table 25).

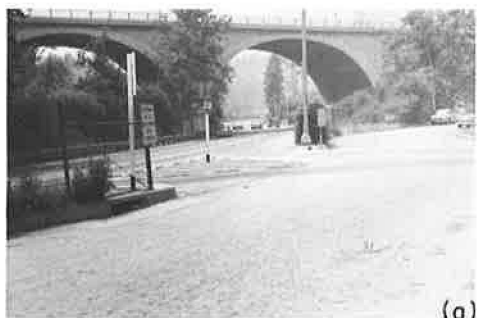
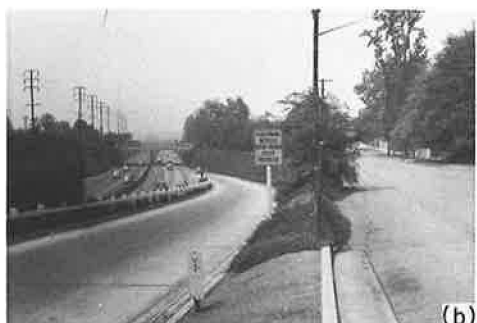
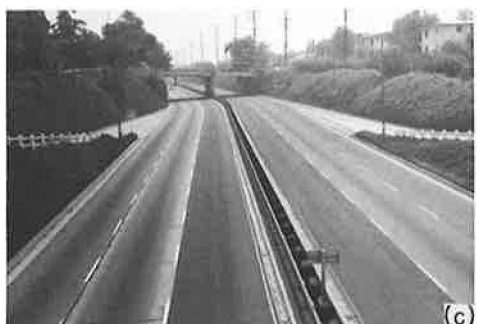
Figure 18. Section 11: (a) at Salonica Ave.; (b) southbound on-ramp at Orange Grove Ave., with stop sign; and (c) northbound on-ramp, with stop sign, and southbound off-ramp at Orange Grove Ave.

design deficiencies. Both sections 10 and 11 are lacking in potential off-the-traveled-way maneuverability as indicated by the high percentage of accidents which involved fixed objects (Table 26).

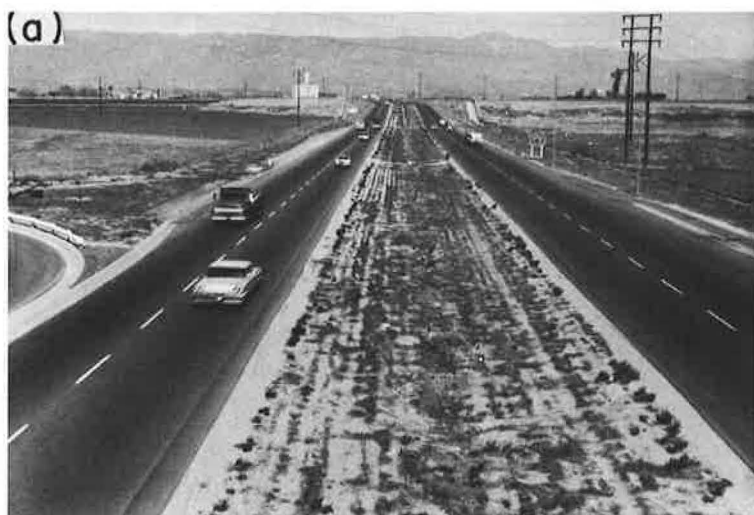
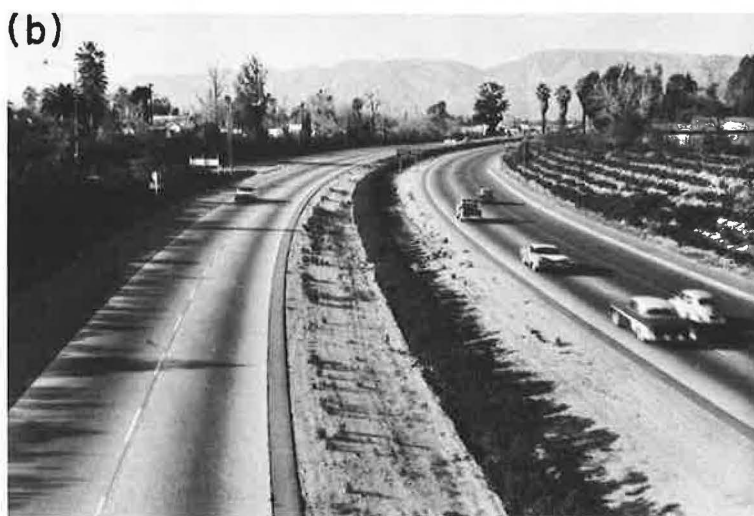
Figure 23. Section 31: (a) near south city limits of Colton (accident rate, 1.07); and (b) near Colton Ave. (accident rate, 1.62).

The 2.25-mi portion from the junction of Rt. 26 to Mill St. (Table 2, section 31b) has an above average accident rate. The remainder of the section (Table 2, section 31a) is about average (Table 27, Fig. 23).

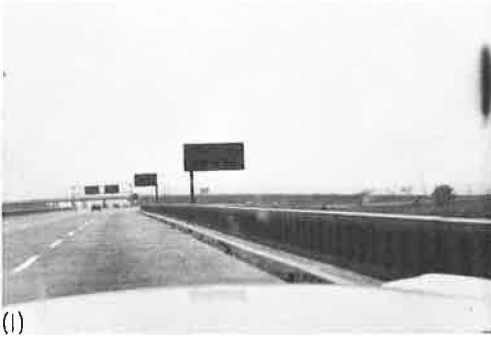
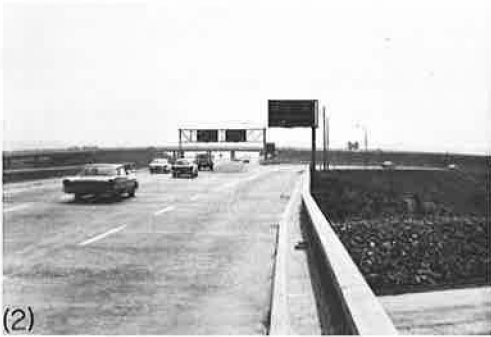
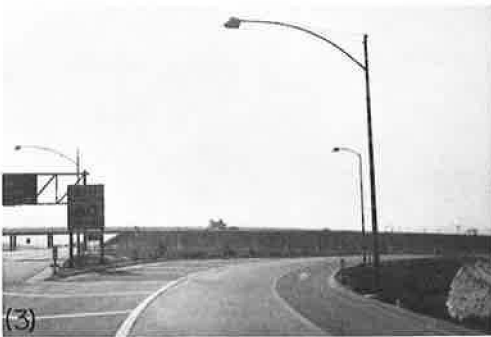
Figure 25. Drivers' view of off-ramp, southbound Rt. 43 to westbound Rt. 26.

illustrates the drivers' view. Construction has begun on a new structure that will bypass this ramp and provide a high-speed freeway-to-freeway connection (Fig. 26).

The southbound Rt. 43 to westbound Rt. 26 off-ramp is a major contributor to the high accident rate of section 31b (Fig. 24). The ramp accounted for 21 accidents with 5.3 MV entering (actual rate of 3.96 vs expected rate of 1.00). The vehicles apparently entered the ramp at too great a speed to negotiate the 400-ft ramp curve. The ramp is signed for 40 mph, but it has the appearance of being a higher speed ramp. The main line type overhead signing for the southbound-westbound turn may also contribute to the illusion. Figure 25

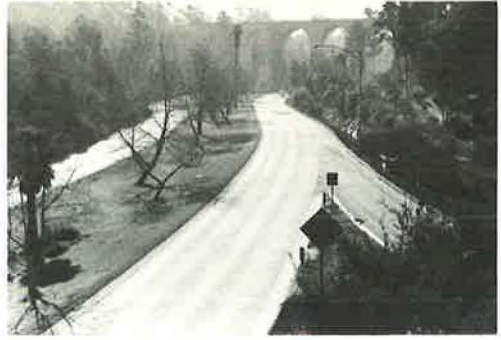
Figure 27. Section 28a.

Traveling from south to north, the first mile of section 28a has an accident rate of 1.25 and an expected rate of 1.00. It has a 54-ft traversable median, grades under 2 percent and over 1,400-ft radius curves. Off-the-traveled-way maneuverability to the right is poor and median traversability is hampered by trees (Fig. 27).

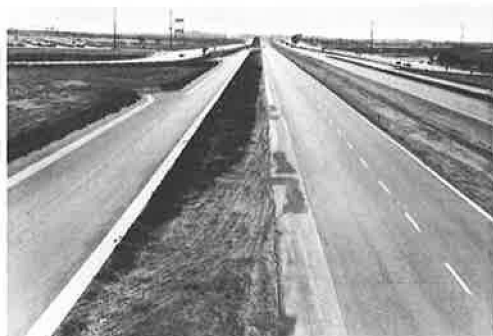
Figure 30. Section 28b; actual accident rate, 0.91; expected accident rate, 1.05.

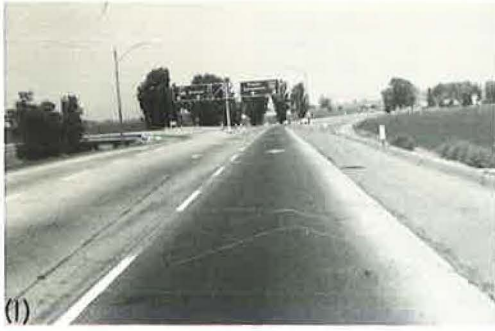
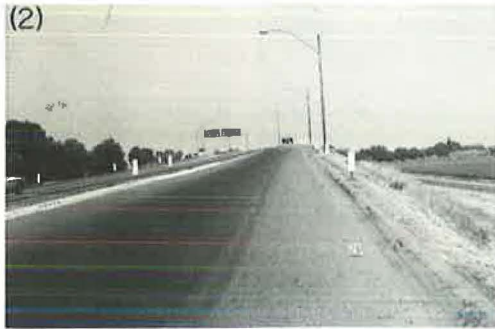
Figure 37. Ramps, Visalia Airport interchange.

0.85 mi long or 23 percent of the total section accounted for 60 percent of the accidents in the total section. Of the 54 accidents occurring in the interchange, 20 were directly attributed to the 7 ramps within the interchange. Two of these ramps (F & G) accounted for 13 of the 20 ramp accidents (Fig. 36). These accidents were all weaving accidents occurring in the weave between the two ramps (F & G) which is a two-lane weave across the main lane northbound freeway traffic. Some of the accidents occurred when vehicles in the outside main lane attempted to cross the inside lane into the left-hand off-ramp (G). Ramp (G) is a two-lane PCC left side off-ramp and it is confusing to the main line traffic as to which actually is the continuation of the main lanes (Fig. 37).
