Sulfate Attack on Concrete Pavements in Mississippi

FAY A. LOSSING, Assistant Testing Engineer, Mississippi State Highway Department

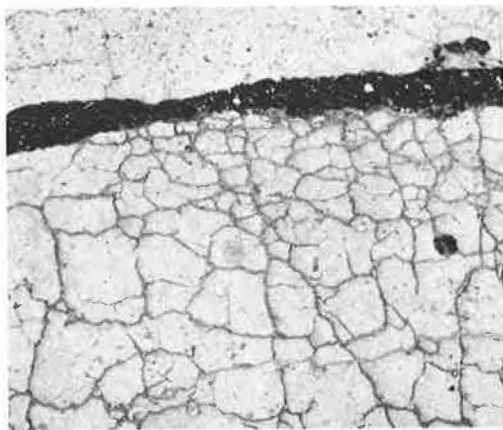
Figure 1. Typical appearance of intermediate stage of sulfate reaction in concrete.

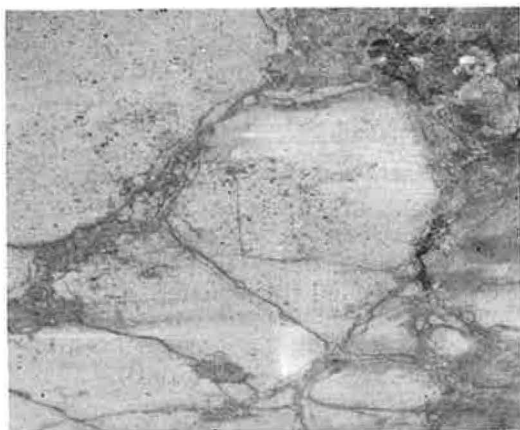
Figure 2. Close-up of cracking and spalling of concrete subjected to sulfate reaction.

separates from the lower portion and eventually spalls off (Fig. 2). It is believed that the original disruption occurs at the surface due to the more rapid evaporation of moisture from this area. The disintegration apparently progresses downward with time, finally resulting in disruption of the entire depth of concrete.

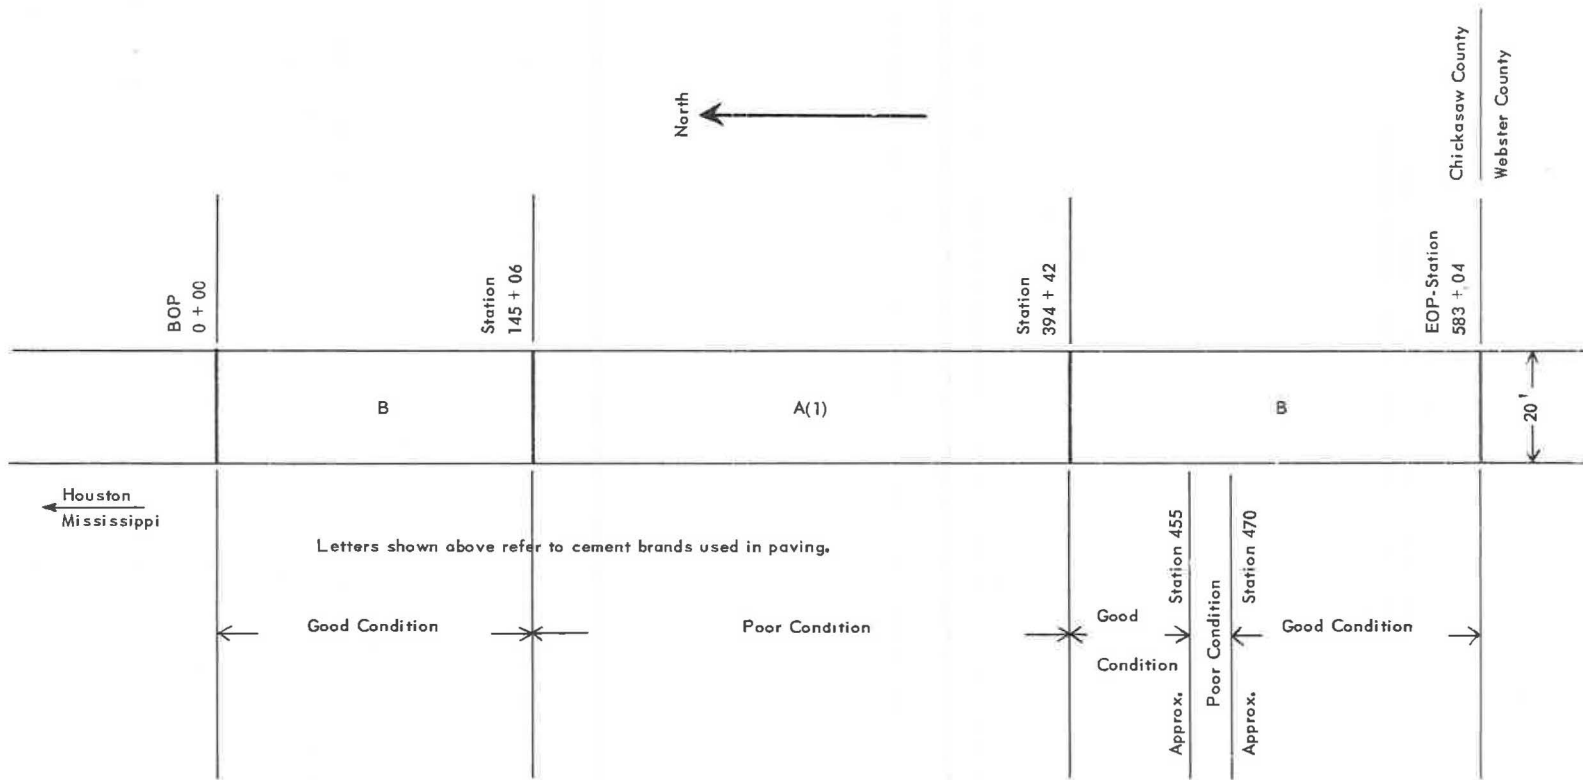
As will be noted from Table 1, this 25-yr-old pavement was paved with two brands of cement: the south 2.75 mi and the north 3.57 mi with Brand B, the center 4.72 mi with Brand A(1). All other factors were the same (Fig. 3). According to the data furnished by the cement companies (Table 2), at the time of production for this project Brand A(1) contained an average of 17.2 percent C_3A ; Brand B, an average of 11.3 percent. (Whenever a value for C_3A is stated here it is the calculated value.)

Figure 3. Project FWA 75 and 327A, Chickasaw County, Miss. 15.

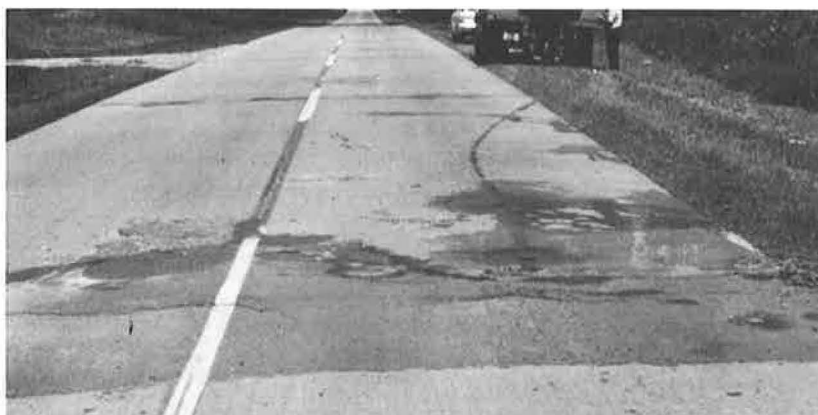
In August 1964, a second detailed survey was made; in the section paved with Brand A(1) cement, it was noted that almost every transverse joint was seriously broken and spalled with the spalled area in most cases extending several feet from the joint. In numerous places the area adjacent to the longitudinal joint, between transverse joints, was badly spalled. Figure 4 is a typical example of the conditions existing on this section of highway.

Figure 4. Typical view of 25-yr-old concrete pavement on project PWA 75 and 327A, Miss. 15, showing patching at transverse joint and spalling at left; two cores previously drilled from area.

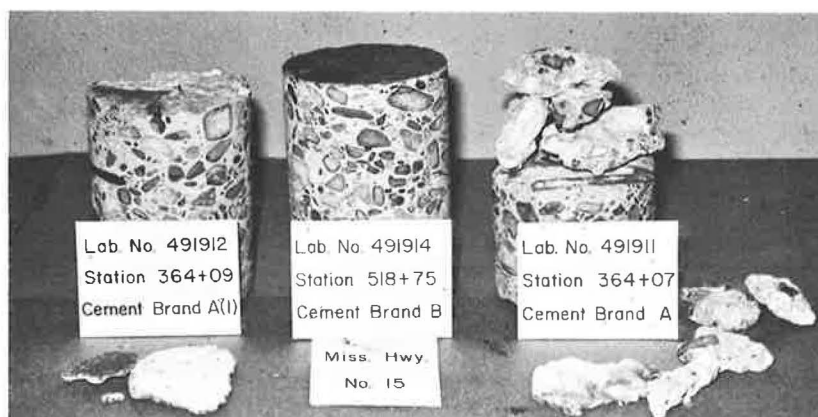
Cores were drilled recently from this pavement, in both good and bad areas. Figure 5 shows typical examples of the condition of the concrete. An examination of the cores obtained shows the following:

1. Station 463 + 55 (in the 1,500-ft section of distressed concrete made from Brand B cement, according to our records)—concrete contains an abundance of ettringite, some gel and indication of frost damage, all suggesting the possibility of minor alkali-silica reaction as a result of previous cracking of the concrete;
2. Station 518 + 75 (Brand B cement, concrete in good condition)—concrete contains some gel and ettringite; and
3. Station 364 + 09 (Brand A(1) cement, concrete spalled and broken badly)—concrete contains a considerable amount of ettringite and some gel; a large amount of calcite is present in surface cracks.

Figure 5. Cores drilled from Project 75 and 327A, Miss. 15; concrete in cores on left and right made from cement Brand A(1), center core from Brand B.

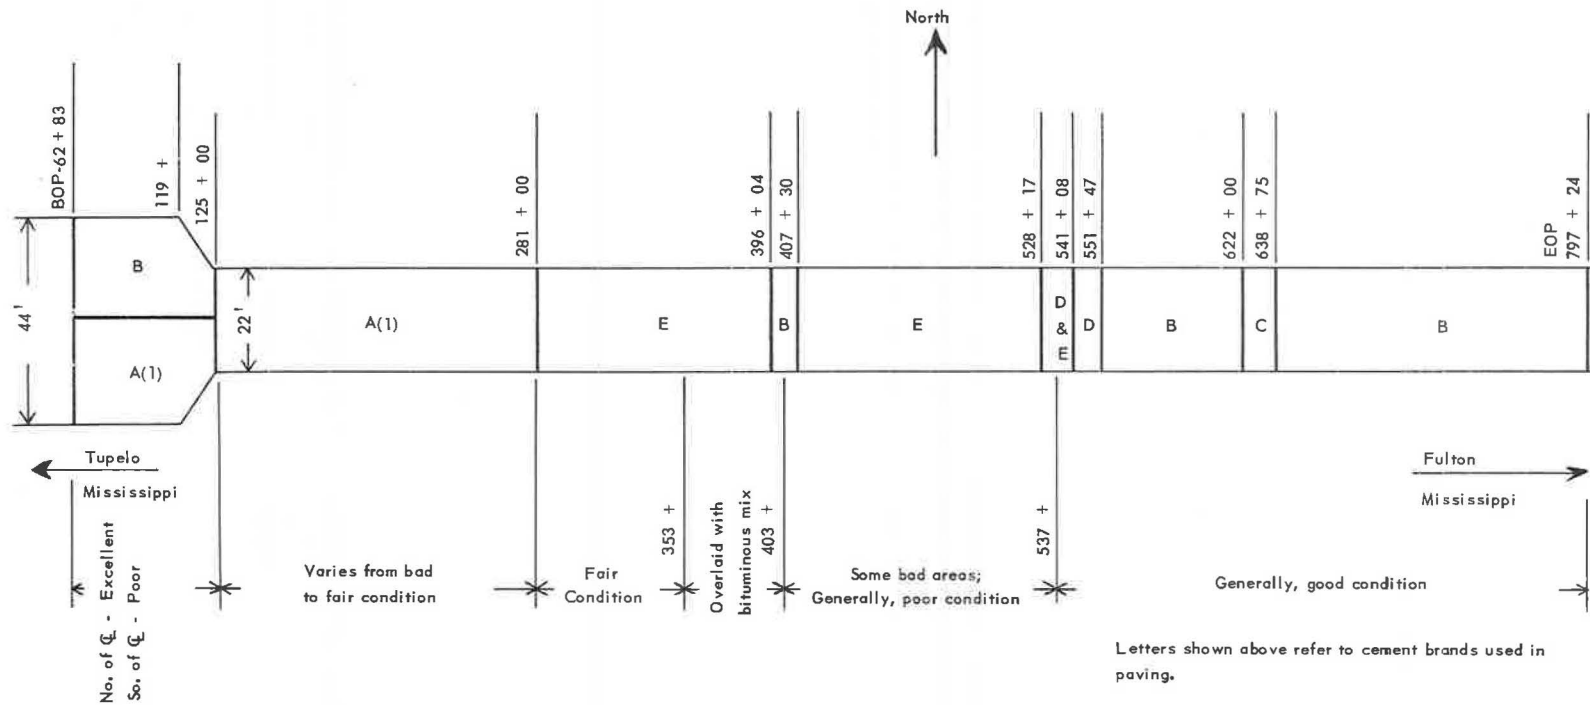
Figure 6. Project F1(5), F32(4), U32(5), Lee and Itawamba Counties, US 78.

supply and, consequently, several brands of cement were used intermittently in the construction as shown in Figure 6.

A spectacular example of contrasting conditions exists from station 62 + 83 to station 125. In this section, as shown in Figure 6, Brand B cement was used in the westbound lane and Brand A(1) in the eastbound lane. The former shows no deterioration, whereas every transverse joint in the eastbound lane exhibits advanced symptoms of sulfate reaction (Figs. 7 and 8). The difference cannot be attributed to traffic since reliable information indicates that the westbound lane has been subjected to very much heavier wheel loads by the hauling of gravel to Tupelo and projects to the west. Where Brand E was used, the distressed areas are somewhat intermittent; Figure 6 indicates that nearly 1 mi of Brand E cement concrete has been covered with a bituminous overlay because of the poor condition of the concrete.

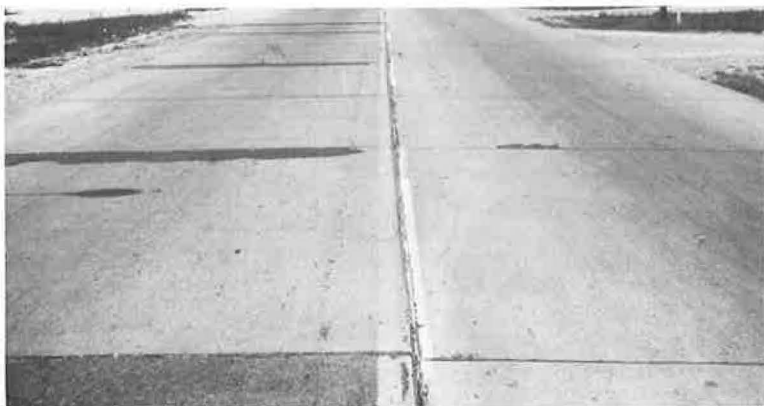
Figure 7. Project Fl(5), 32(4), U32(5), US 78, facing west; concrete on right of centerline made from Brand B cement, on left from Brand A(1) cement; pavement age 16 yrs.

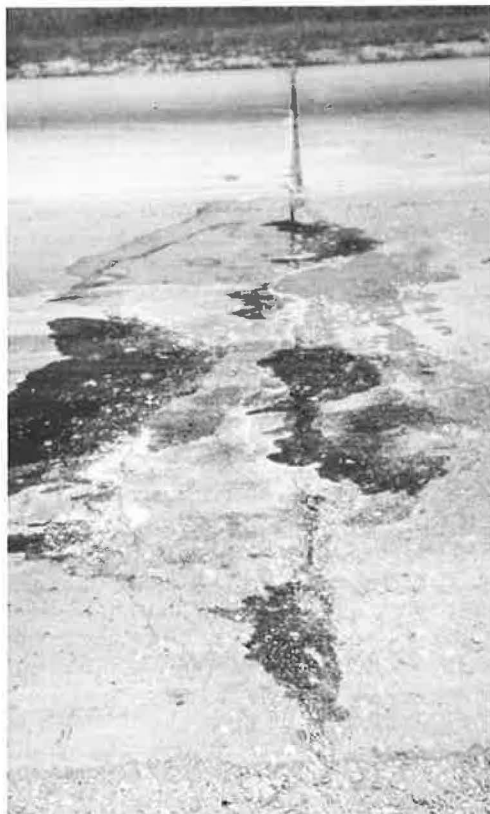
Figure 8. Project Fl(5), 32(4), U32(5), US 78; view of transverse joint, facing north; concrete in foreground from Brand A(1) cement, beyond centerline from Brand B; typical of joints in widened portion of project; pavement age 16 yrs.

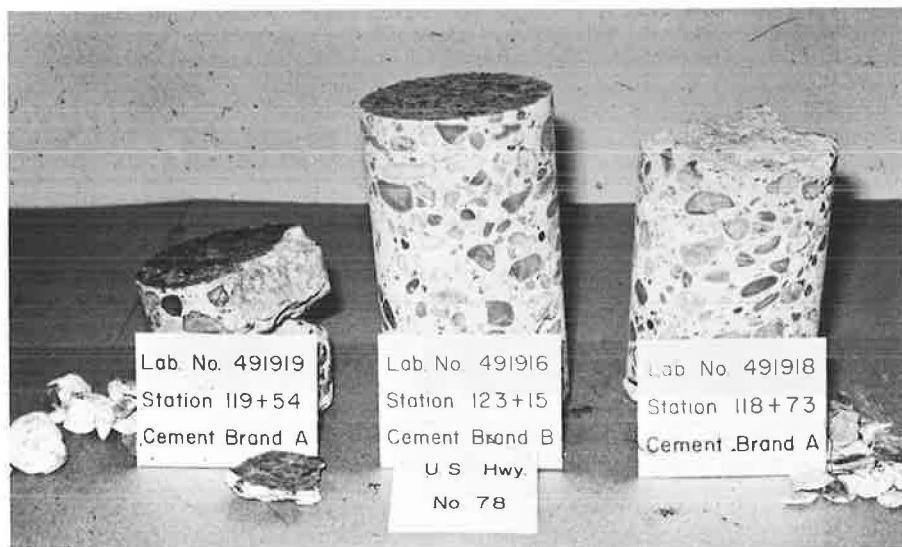
Figure 9. Project F1(5), F32(4), U32(5), US 78; cores on right and left represent concrete made from Brand A(1) cement, in middle from Brand B.

concrete at various locations. Figure 9 shows typical examples of the condition of the concrete at this time. Examinations of these cores reveal the following:

1. Station 123 + 15 (Brand B cement; pavement in good condition)—concrete contains a very small amount of gel and ettringite;
2. Station 118 + 73 (Brand A(1) cement, pavement badly broken)—concrete contains a large amount of ettringite and shows cracking, top and bottom of the core, parallel to the surface; and
3. Station 407 + 57 (Brand E cement, concrete in a short section of distressed pavement)—concrete contains more ettringite than that at station 123 + 15, but less than that at station 118 + 73.

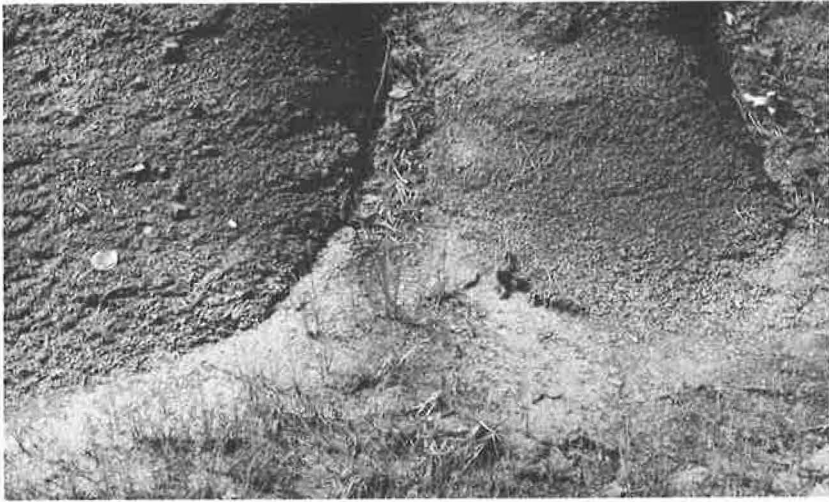
Figure 10 is a photograph of the Mooreville chalk taken at the base of a ditch back-slope, after more than 16 yrs. of exposure.

Figure 10. Project Fl(5), 32(4), U32(5), US 78; typical appearance of Mooreville chalk in backslope of ditch after 16 yr of exposure (note scant vegetation).

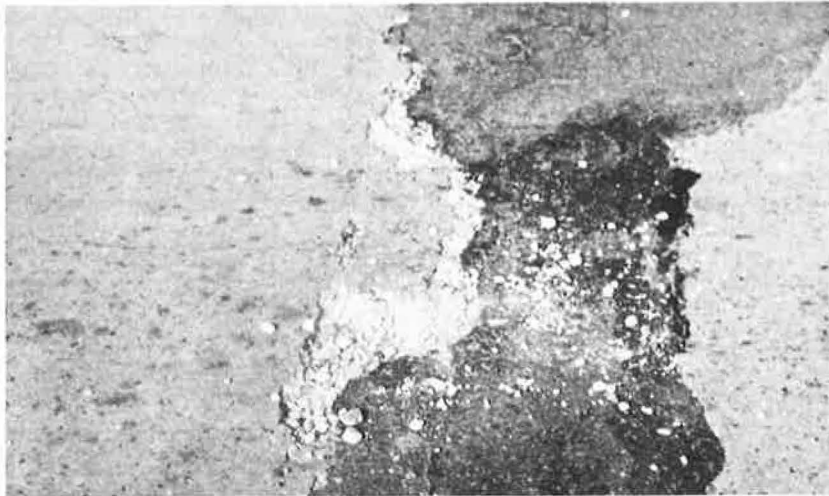
Figure 11. Project PWS 50A, US 61; close-up of concrete attacked by sulfates showing patched and spalled areas, typical of transverse joints on this project; pavement age 26 yr.

Samples of the surface concrete were obtained from a spalled area. Examination of these samples shows thorough deterioration and the presence of large amounts of ettringite. This project lies in the floodplains of the Mississippi River, in an area containing soils usually referred to as "delta gumbo." The water table in the area is high. The soils contain considerable organic material and a large percentage of soluble sulfates; a sample of the soil from beneath the edge of the slab contained 0.43 percent with a pH value of 5.0 (Table 3). Cores of the soil, taken at depths of 3 to 20 ft, were found to contain a very large quantity of gypsum and iron sulfate. The greatest concentration of these chemicals is in the upper 3 to 5 ft.

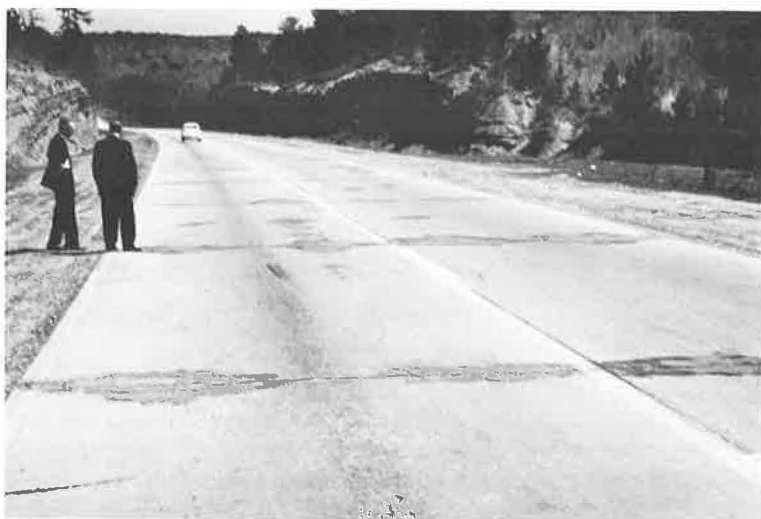
Figure 12. General view of US 80; project UI-251(7), showing effects of sulfate reaction; pavement age 15 yr.

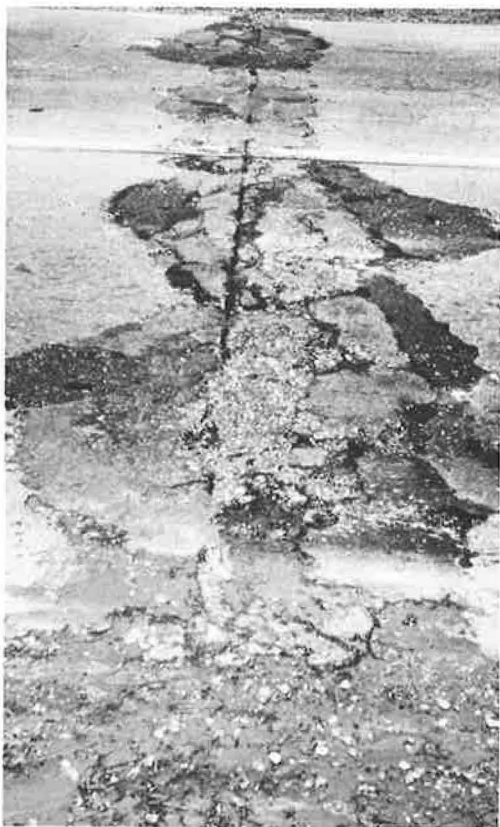
Figure 13. Close-up of transverse joint on project UI-251(7), US 80; pavement age 15 yr.

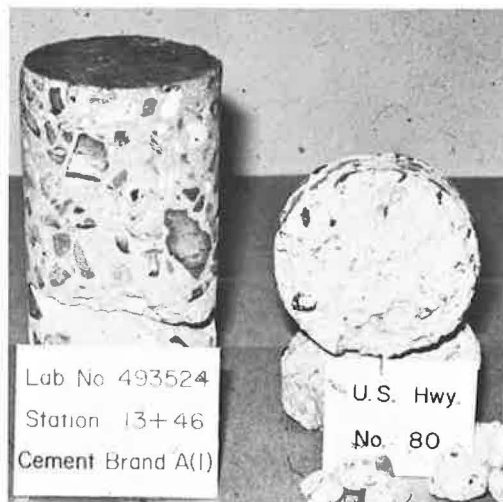
Figure 14 shows the typical condition of cores drilled from this pavement. Examination of the cores and the samples obtained during the removal of the pavement indicates the presence of large amounts of ettringite. The cores were badly broken with numerous cracks parallel to the surface at various depths. Some of these cracks extended almost entirely around the periphery of the core.

Figure 14. Two cores drilled from concrete pavement on US 80, project UI-251(7); concrete in both cores made from Brand A(1) cement.

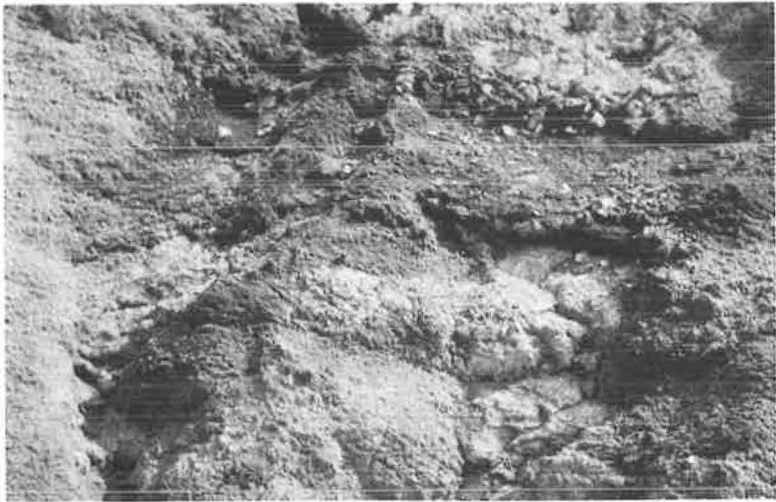
This project lies principally in the Zilpha and Tallahatta formations. Zilpha clay is a chocolate color and contains some glauconite, large amounts of marcasite and considerable gypsum, which weathers very rapidly to melanterite. Tallahatta clay is a glauconitic clay and siltstone with lenses of sand and some sandstone, highly cross-bedded, blocky, with numerous joints throughout. Tallahatta clay also contains considerable lenses of marcasite, as well as elemental sulfur. Figure 15 is a typical view of a cutbank in the vicinity of this project.

Figure 15. Project UI-251(7), US 80; typical appearance of Zilpha clay in cutbank, showing lack of vegetation and light-colored areas with covering of melanterite.

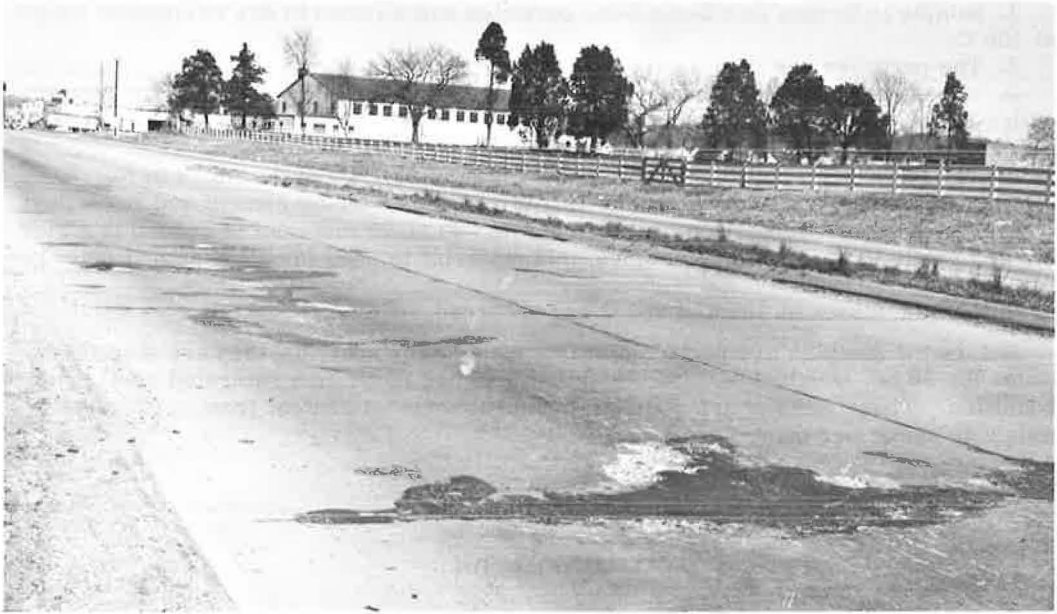
Figure 16. Views of project showing type of distress associated with concrete (cement C), with lane on far side of median showing no distress (cement A).

The behavior of the most affected concrete at an age of 6 yr is shown in Figures 16 and 17. The similarity to the behavior described by Mr. Lossing is apparent.

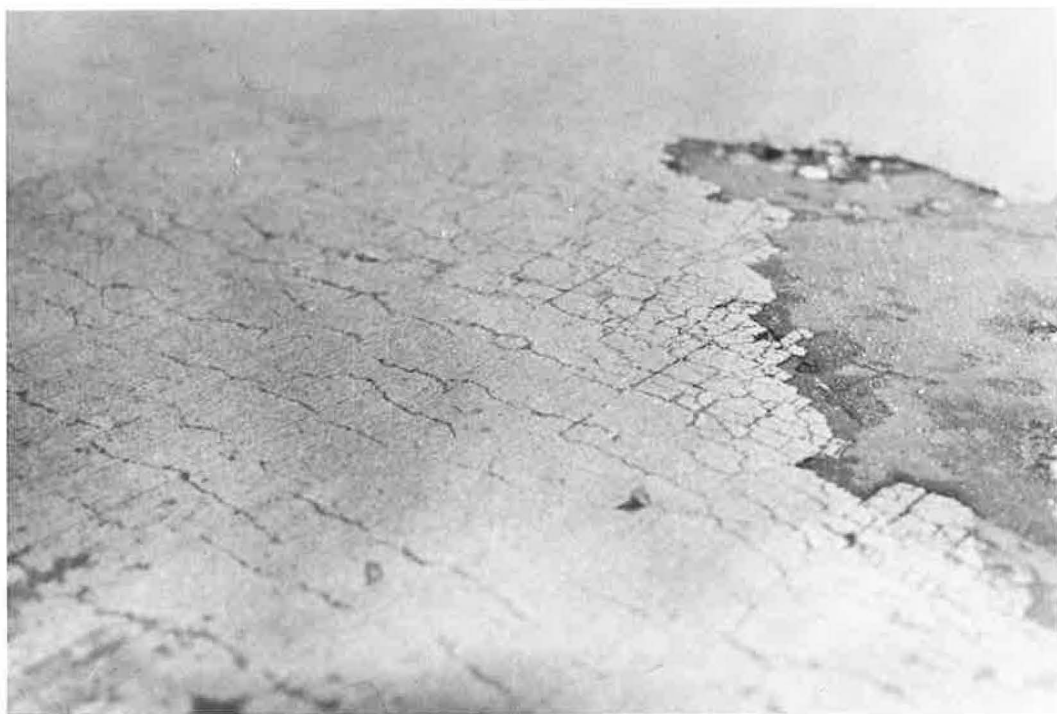
Figure 17. Close-up of distressed concrete from Figure 16.

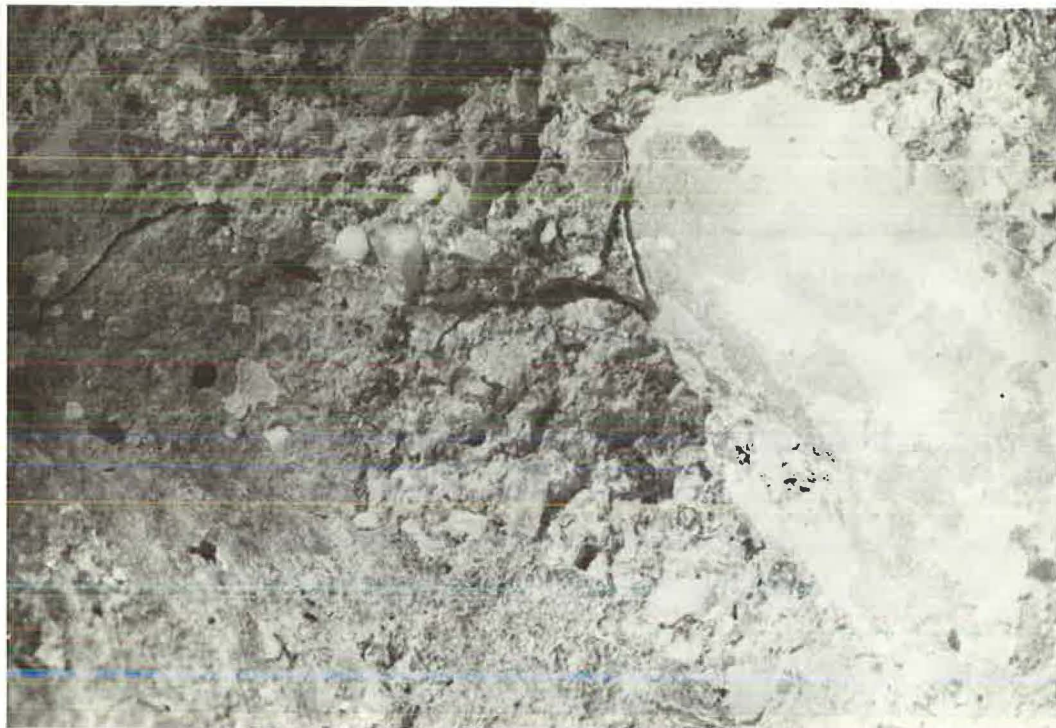
Figure 18. View of fractured concrete removed from the pavement shown in Figure 16, showing the white secondary deposits coating aggregate particle and socket and forming two small nodules shown in upper center.
