The Hydraulic Design of Bridges for River Crossings—A Case History

ALVIN G. ANDERSON, University of Minnesota, St. Anthony Falls Hydraulic Laboratory

Following collapse of one of the I-29 bridges on April 1, 1962, a model study was performed to define hydraulic conditions that led to collapse and to test proposed protective works. The collapse was initiated by the undermining by erosion of one of the piers of the upstream bridge. A consequence of the erosion pattern was the subsidence of a portion of the left bank, which was left without support when the bed downstream of the bridges eroded to a considerable depth.

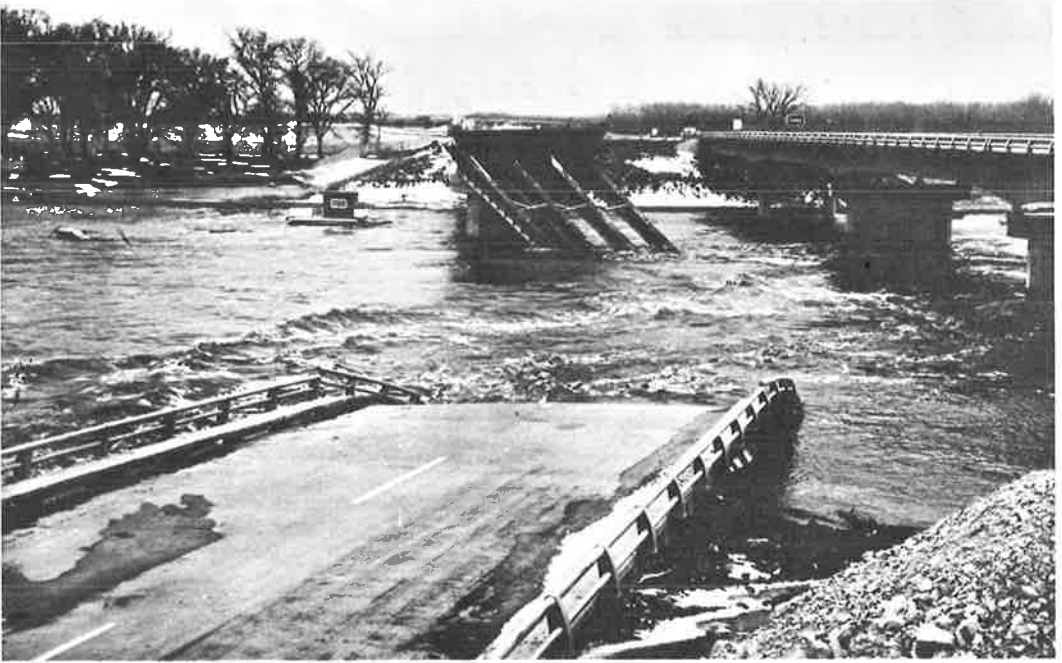
On April 1, 1962, during a flood, the upstream bridge of the pier collapsed. The initial failure occurred about 3:30 a.m. and from the evidence available it appears to have been the result of the undermining of pier 3 (Fig. 1). This in turn resulted in the rupture of the adjacent spans with the consequent failure of pier 4 about 12 hr later. An outstanding hydraulic characteristic of the failure aside from the undermining of pier 3 was the development of a very deep and extensive scour hole downstream of the structure. In this area the bed scoured to a depth of approximately 40 ft, which was considerably deeper than the section at the bridge centerline.

Figure 1. Upstream I-29 bridge after collapse of pier 3 and before collapse of pier 4; river flow is from left to right. (Photo courtesy South Dakota Department of Highways)

The upstream bridge was reconstructed with cylindrical piers spaced 225 ft apart so that the flow obstruction was greatly reduced. The downstream bridge was strengthened by underpinning. For both bridges additional H piles were driven to provide ample support for the piers from further scour. In addition riprap and timber piles were placed on the left bank to prevent further subsidence of the bank and to protect the piers of the downstream bridge.

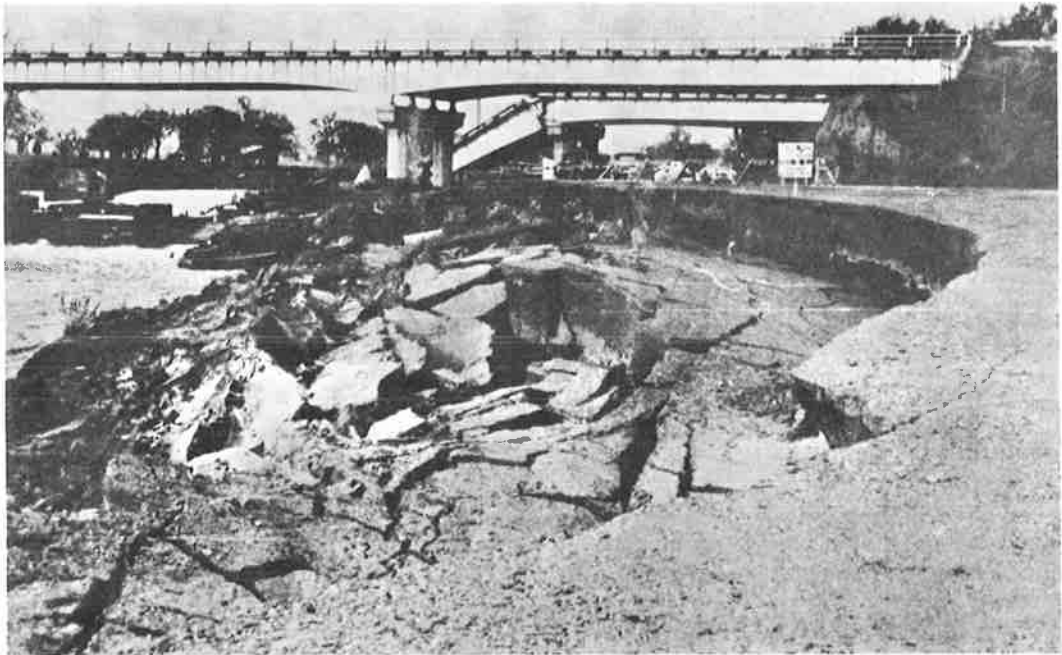
Figure 2. Subsidence of left bank following collapse of upstream I-29 bridge.

A secondary consequence of the conditions that caused the collapse of the bridge was the subsidence of the left bank just downstream of the highway spans and opposite the large scour hole that developed downstream of the structure. Figure 2 shows the area in which the subsidence occurred and the character of the settlement near the pier of the downstream bridge. Figure 3 shows the results of borings made in the left bank near where the subsidence occurred. The material labeled "soft silty clay" underlying the surface layer is significant. It might be concluded that the subsidence resulted from the removal of the lateral support of the left bank by the large hole eroded downstream of the bridge at the time of the collapse. The overburden then tended to squeeze the soft clay out into the river with the consequent subsidence of the bank itself. Some concern was felt at the time of reconstruction of the upstream bridge that the area of subsidence might be enlarged and endanger the nearby piers of the downstream bridge.

was to be used might also constitute a solution for the first.) Stability studies indicated that the material required to stabilize the bank would have to be much more extensive than that previously proposed. Based upon this study the highway department proposed the plan shown in Figure 11. It consisted of rather extensive, coarse gravel berms protected by riprap revetment. These berms and revetment were to be placed on both sides of the river at the bridge cross-sections and extend downstream on the left

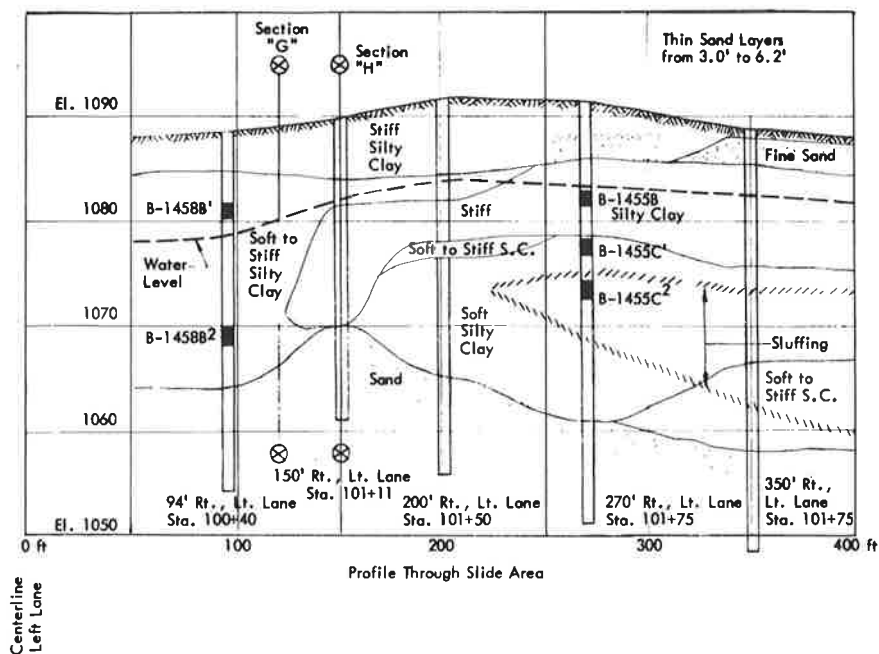
Figure 3. Soil profile through slide area south of bridge failure.

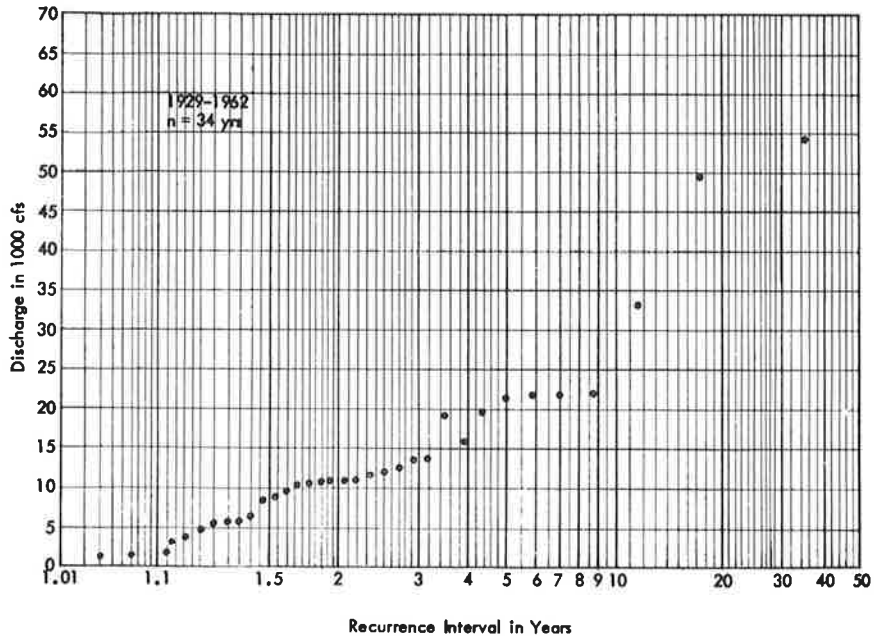
The first unusual factor involved in the collapse was the flood discharge, which was larger than any previously recorded for the Big Sioux River. The maximum discharge at Akron, Iowa, the USGS Gaging Station, was 54,200 cfs. The previous peak discharge was 49,500 cfs in 1960. Previously the maximum discharge, which occurred in 1952, was only 33,000 cfs so that the flood of 1962 was 1.64 times as large as the maximum recorded discharge prior to 1960 and at the time of the original design. The frequency distribution of annual floods based on the records prior to the design of the bridge indicated that the 50-yr flood was about 42,000 cfs. This was approximately the discharge for which the bridge was designed. The frequency distribution based upon all of the records up to and including the 1962 flood is plotted in Figure 4, showing a distinct upward curvature as the maximum floods are plotted in relation to the previous record. These results suggest that the 1960 and 1962 peak discharges represent floods of a much longer return period than might be expected from the present record. It is also conceivable although extremely doubtful that some pronounced change may have taken place in the Big Sioux watershed so that the magnitude of the annual floods is now considerably greater than in the past.

Figure 4. Flood-frequency curve for Big Sioux River at Akron, Iowa, 1929-1962.

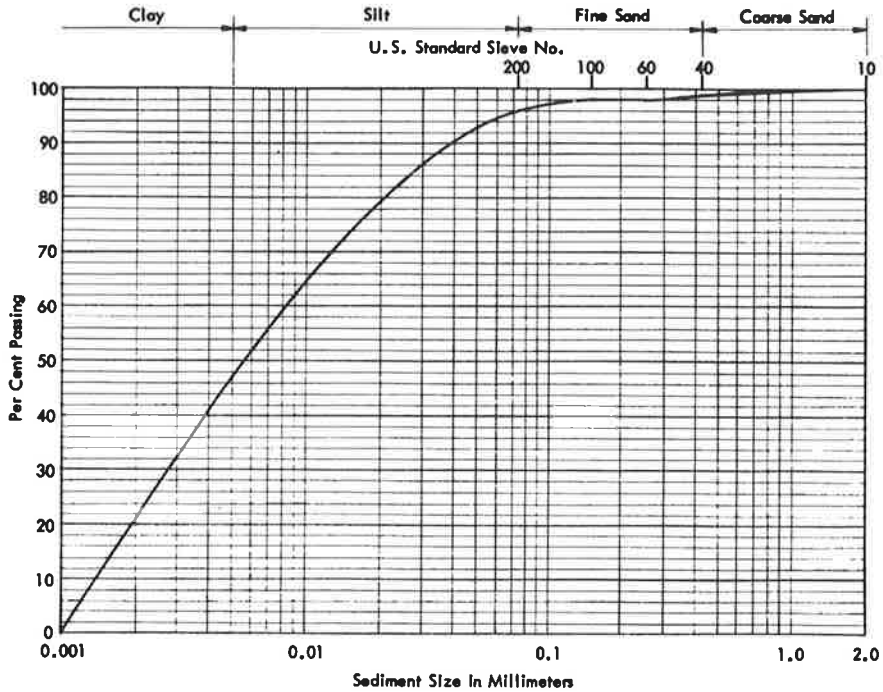
Figure 5. Size analysis of composite sample of Big Sioux bed sediment.

The second factor involved in the local scour is the character of the bed sediment. In the Big Sioux River, it consists of material approximately 50 percent clay and 50 percent silt. The distribution curve of this material as obtained from a composite sample is shown in Figure 5. That the bed sediment of this composition is in a natural stream suggests very strongly that it possesses a high degree of cohesiveness and that the clay acts as a binder for the coarser particles. This implies that the resistivity of the bed to erosion depends primarily on the strength of the cohesive bond rather than the properties of the individual particles. While for noncohesive sediment the critical boundary shear at which movement begins depends primarily on the properties of the individual particles (size, shape, and density); for cohesive sediment the influence of size and other properties on the critical shear is masked by the greater bond strength. As a consequence greater force is necessary to erode initially the particles of a cohesive bed than for equivalent noncohesive beds, but once the bond has been broken the subsequent behavior of the bed particles in the flow depends on the particle properties only.

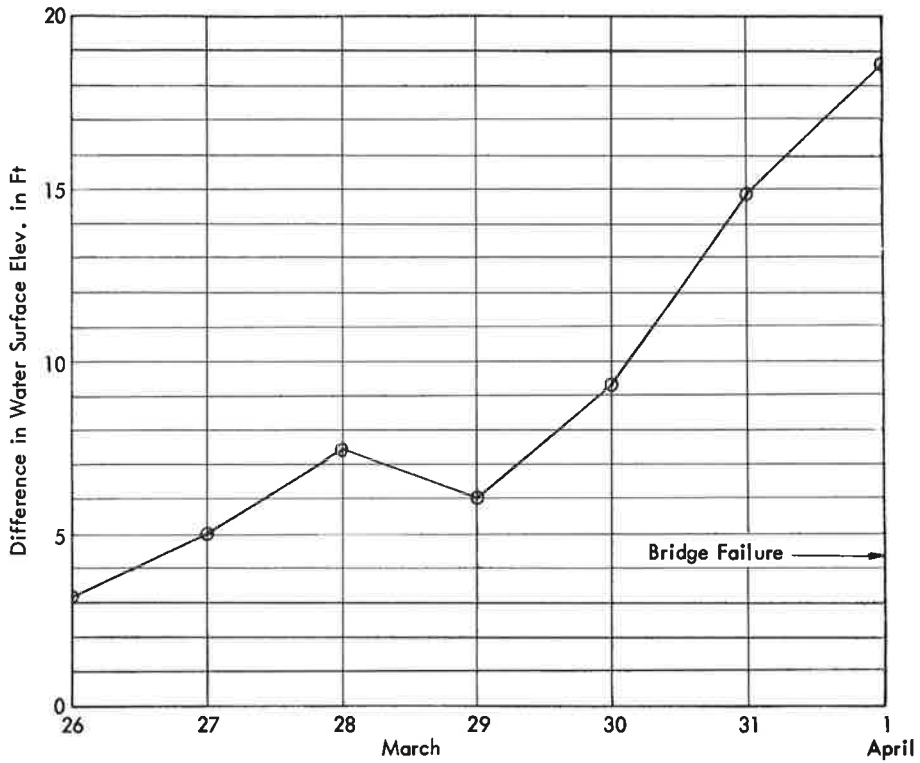
Figure 6. Difference in water surface elevations between Highway 77 bridge at Big Sioux River and combination bridge of Missouri River at Sioux City for week preceding bridge failure.

pendent on the artificial release of water from the upstream reservoirs and thus was relatively independent of the stages of the smaller tributaries during the flood season. In the case of the Big Sioux River during the 1962 flood at Sioux City the difference in elevation between gaging stations on the Big Sioux and on the Missouri increased from about 3.2 ft on March 26, 1962, to 18.6 ft on April 1, 1962 (Fig. 6). In this particular instance the stage of the Missouri remained relatively constant while that of the Big Sioux during the course of the flood increased very appreciably.

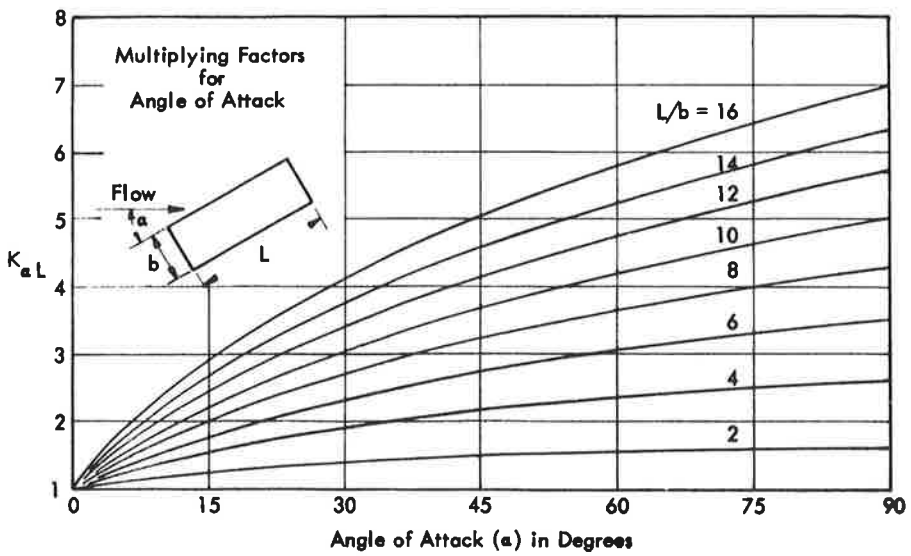
Figure 7. Design factors for piers not aligned with flow.

Research on the erosion around bridge piers (1) has shown that the angle at which a pier is aligned to the flow is very significant in the extent of erosion that takes place around it. The two factors involved are the angle of attack and the length-breadth ratio of the pier. These results are shown in Figure 7 (1). Thus for an L/b ratio of 10 and an angle of attack of 30 deg, one could expect about three times as much scour as would occur if the pier had been aligned to the flow. For a cylinder in which the L/b ratio is unity, the multiplying factor is also unity since all orientations are equally favorable. Figure 7 clearly shows the importance of alignment of the piers in causing potential scour. It has been stated that the skewed alignment of the piers of the bridge was in anticipation of remedial work to be done on the Big Sioux River in which the reach through the bridges would be straightened by changing the location of the confluence of the Big Sioux with the Missouri River. If this change had been made, the degree of skewness or the angle of attack of the flow would have been considerably reduced.

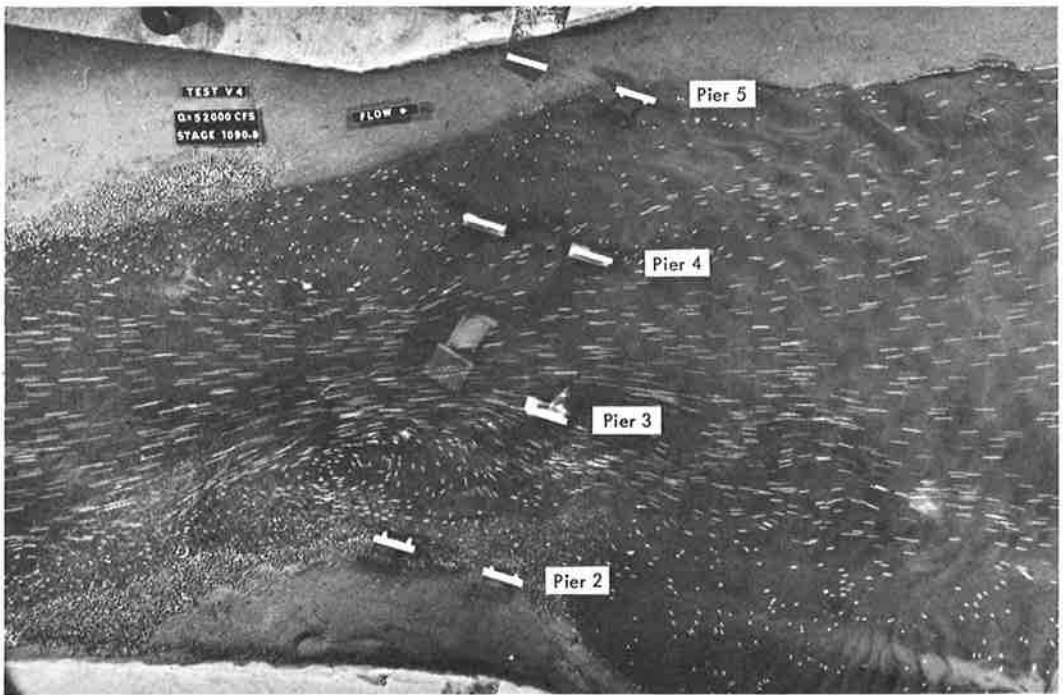
Figure 9. Verification test of hydraulic model showing collapse of pier 3 due to undermining; flow pattern delineated by confetti on water surface.

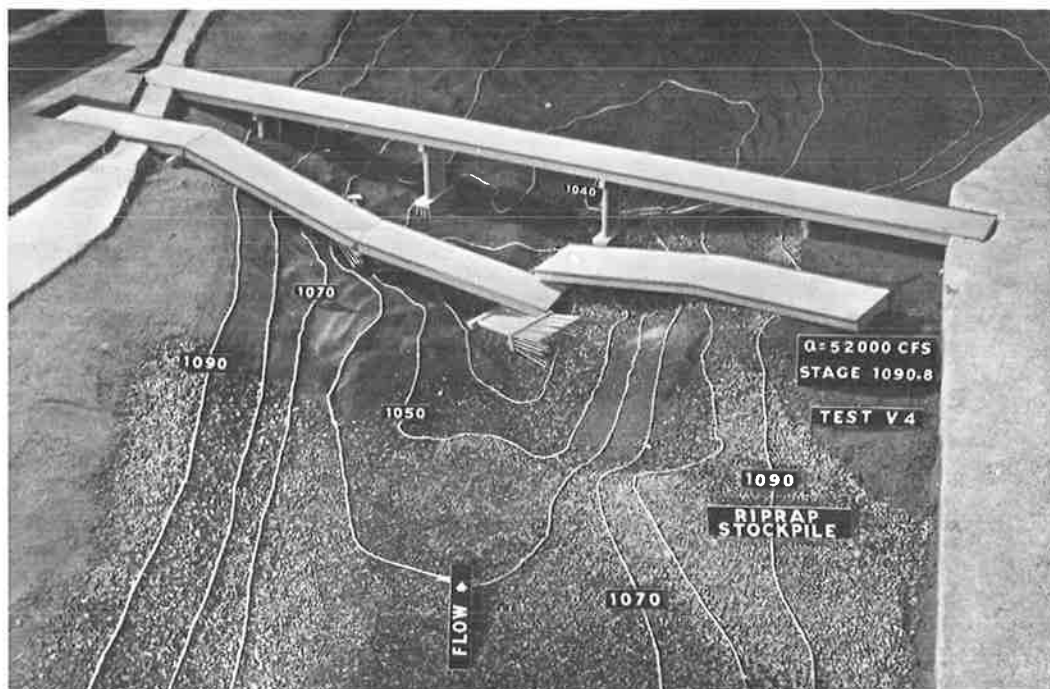
Figure 10. Erosion pattern following verification tests.

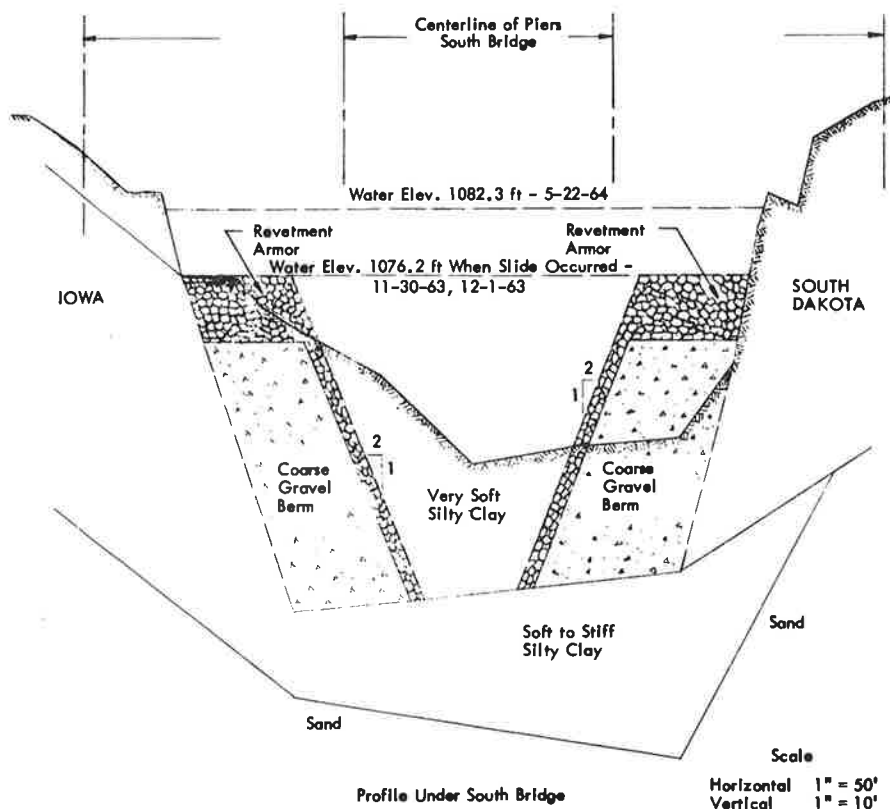
Figure 11. Stabilization proposal of Big Sioux channel for I-29 bridges.

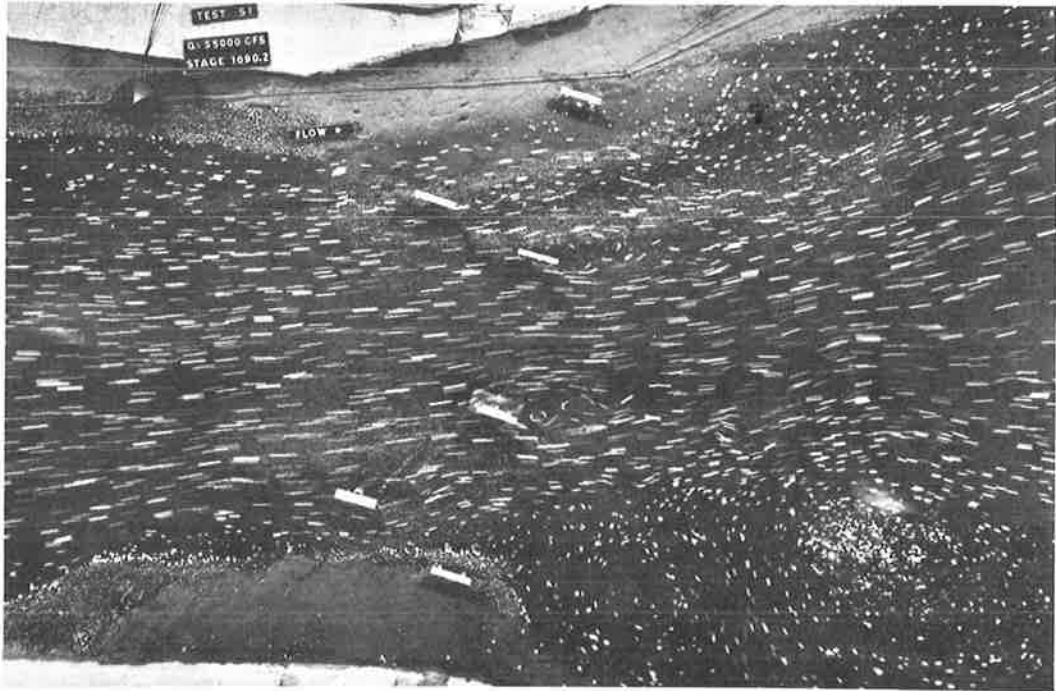
Figure 12. Flow pattern through bridge section with reconstructed bridges and with proposed berms and revetment in place.

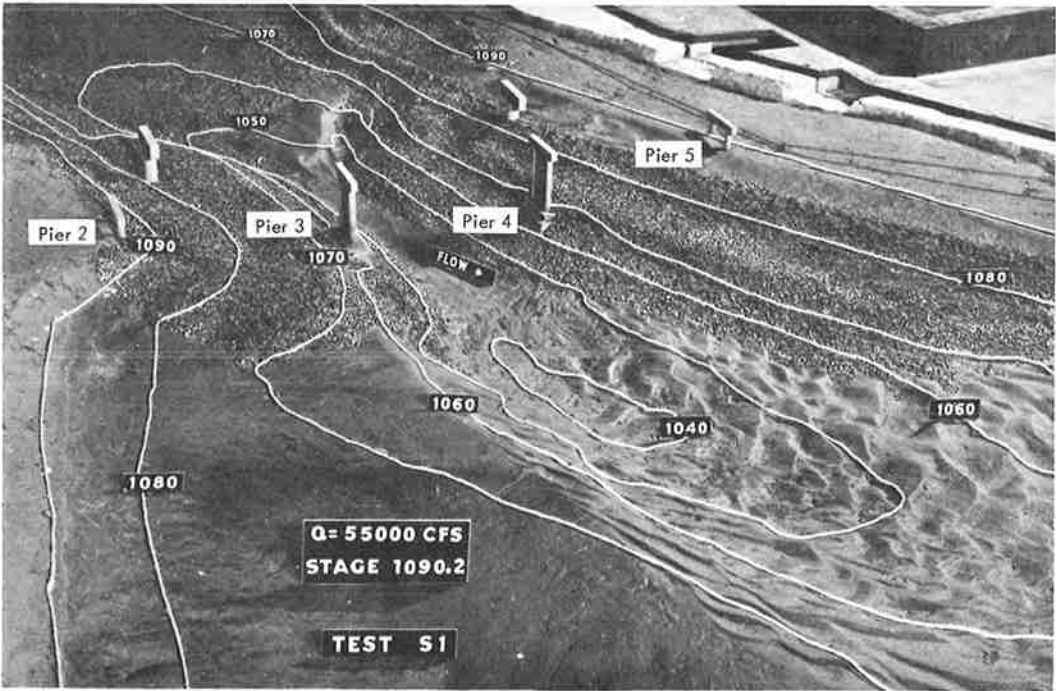
Figure 13. Erosion pattern resulting from flow through reconstructed bridges and protective works.

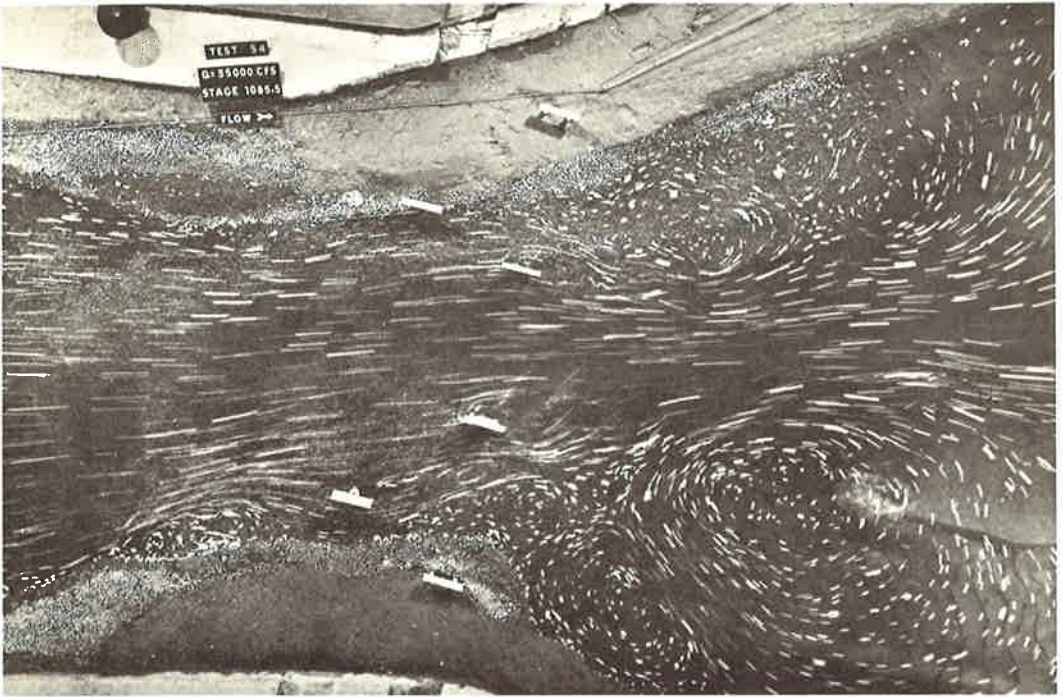
Figure 14. Flow pattern through bridge section with reconstructed bridges and proposed berms and revetment for maximum discharge simulating very low stage in Missouri River.

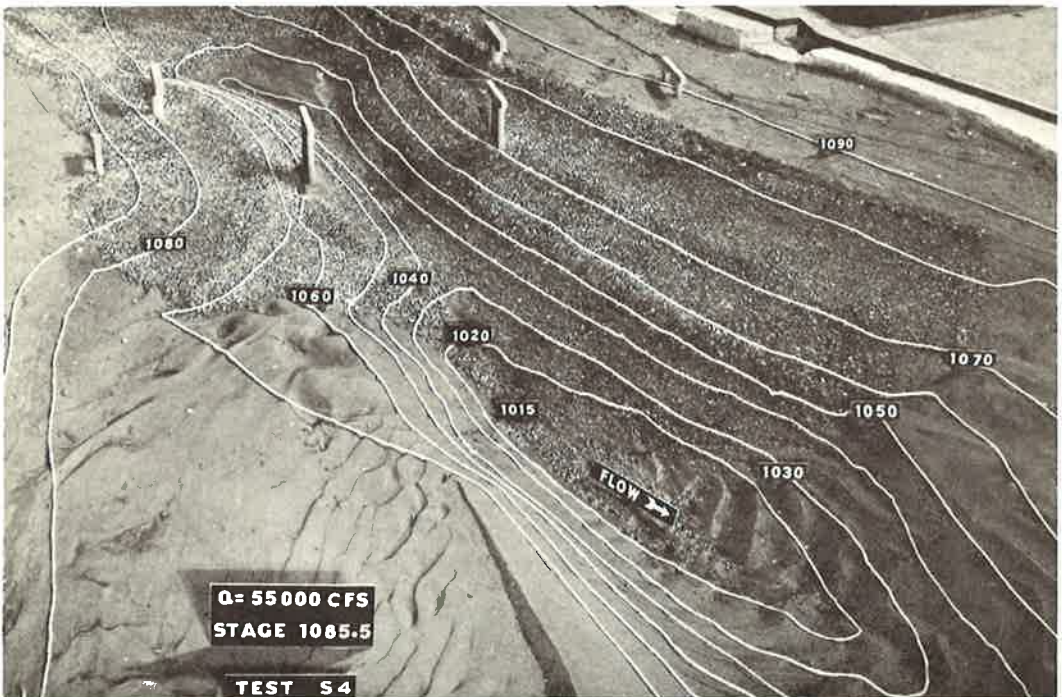
Figure 15. Erosion pattern resulting from maximum flow and low tailwater.

These results were the outcome of experiments in which the stage at the bridges was maintained at a level corresponding to the stage measured in the prototype. It appeared desirable to observe the effect on the bridge protection of a still lower stage as would be the case if the stage of the Missouri were artificially lowered. Such conditions are shown in Figures 14 and 15. Figure 14 shows the flow pattern for a discharge of 55,000 cfs when the stage at the bridge has been reduced to elevation 1085.5 ft. The separation zones are more distinct and the strength of the downstream whirl has increased. The jet effect caused by the piers of the downstream bridge is clearly shown as well as the high velocities initiating vortices at the inside bank of the bend. The erosion pattern created by this flow is shown in Figure 15. For these extreme conditions some of the riprap has raveled into the channel between the piers and in a downstream direction. The jet (Fig. 14) has eroded an excessively deep hole downstream of the piers. In spite of this, however, the piers themselves appear to be unaffected by the flow.

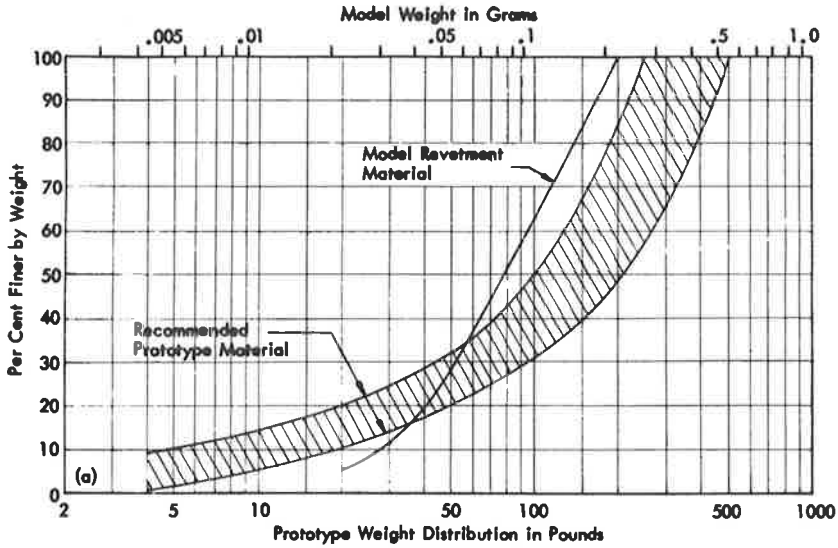
Figure 16. Revetment material weight distribution.

The effectiveness of the riprap revetment in protecting the piers depends on its ability to resist the dynamic forces generated by the flow. Experiment and experience have established a relationship between the velocity near the boundary and the size of the riprap necessary to resist movement. Figure 16 shows the size distribution curve of the model sediment transferred to prototype sizes. This material was stable in the

model. Using the graph in Figure 17 as a guide and considering the practical limits of quarry production, a recommended riprap size distribution is also shown in Figure 16 for comparison with the model riprap.

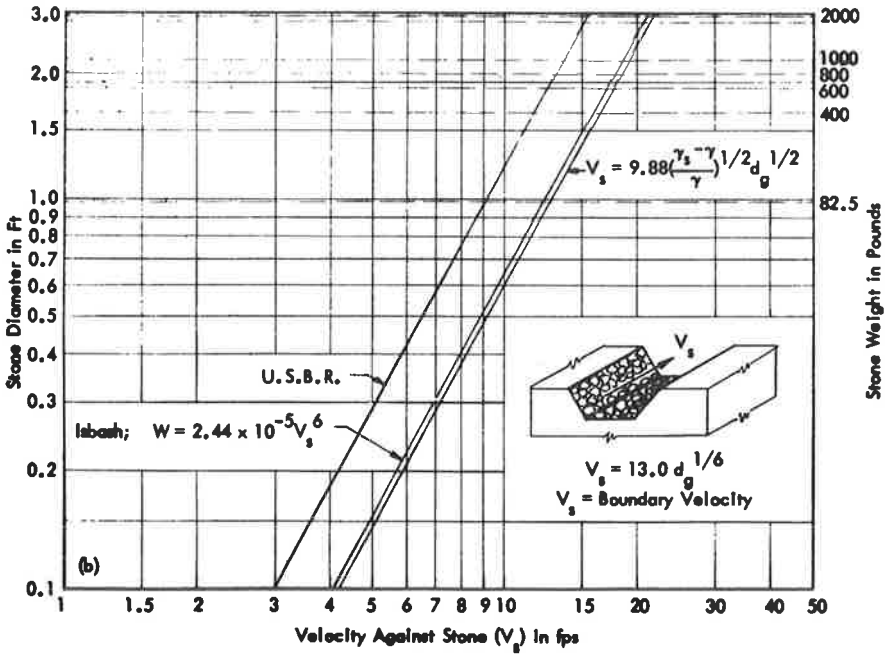
Figure 17. Critical velocities against stones.
