HIGHWAY RESEARCH RECORD

Number 136

Studded
Tires

7 Reports

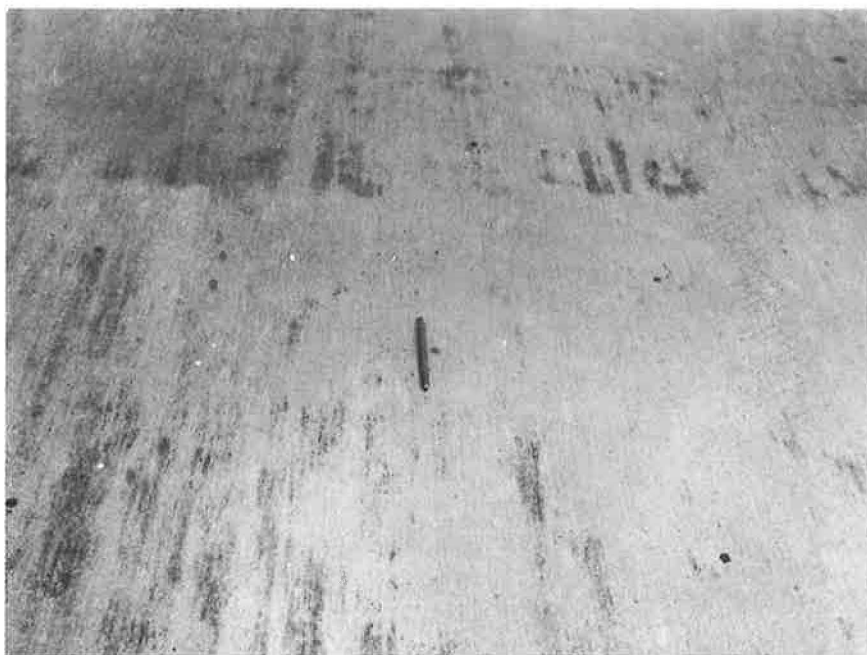
Normal Stops.—The location of the test section where normal stops were made on the concrete pavement is shown in Figure 3. The white bar in the picture indicates the location of a hypothetical stop sign. The vehicle approached this section at 30 mph, traveling in the direction indicated by the arrow and braked to a complete stop at the white bar. The surface condition of the concrete pavement after 210 normal stops is shown in Figure 4. There was little or no apparent difference in the surface condition of the pavement in the wheelpath (area to the left of pencil in Fig. 4) and the untested concrete pavement (area to the right of pencil). The dark spots evident on the pavement surface in this picture are oxidized residues from snow plow blades. There was no visible change in the condition of the concrete surface after 310 normal stops.

Figure 4. Surface of concrete after 210 normal stops.

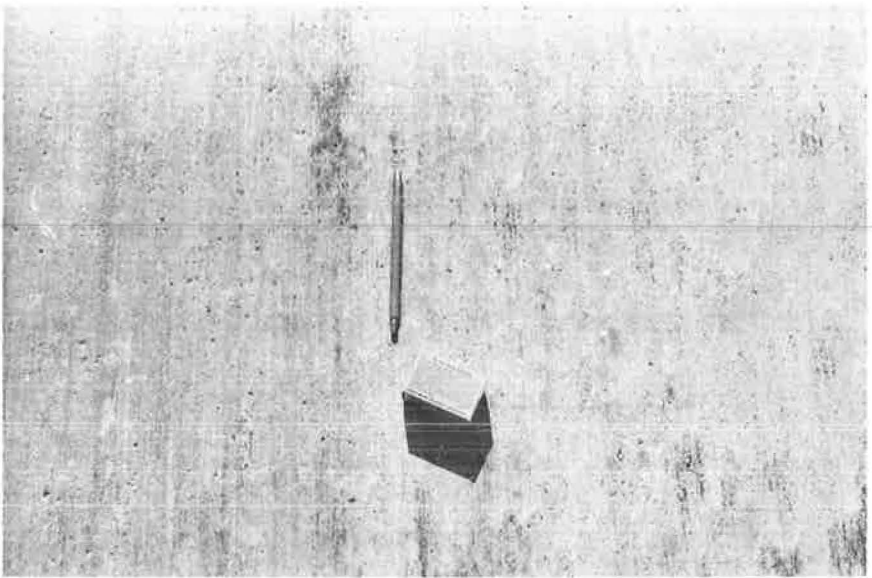
Figure 6 shows the condition of the concrete surface after 310 panic stops had been made from a speed of 20 mph. The wheelpath is shown on the left in the picture and the

Figure 6. Surface of concrete after 310 panic stops.

untested surface on the right. The concrete had become quite polished in the wheelpath but the abrasion was limited to loss of the surface finish produced by the burlap drag. There was no measurable amount of rutting evident when a straightedge was laid across the wheelpath.

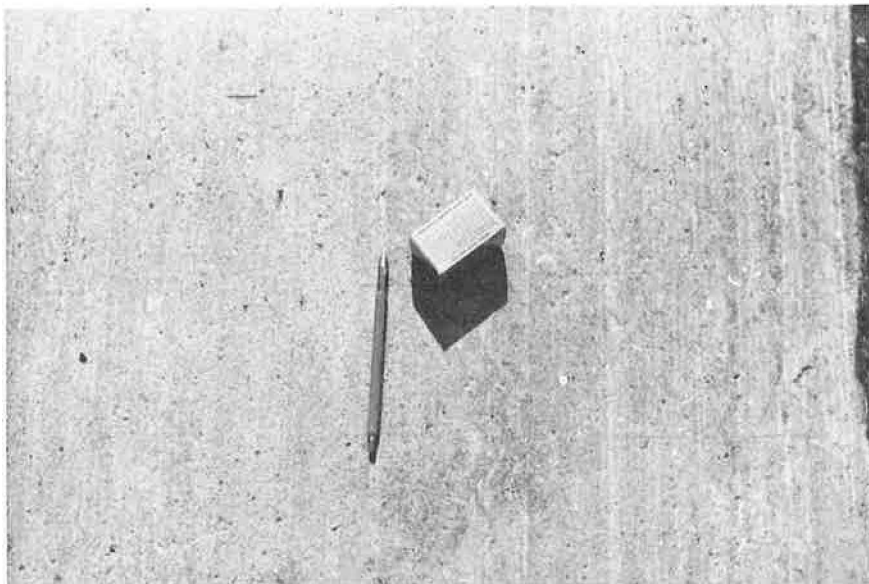
Figure 7. Surface of concrete after 310 rapid starts.

Rapid Starts.—Rapid starts had about the same effect on the concrete as did the panic stops. The surface became quite polished and the burlap drag surface finish was lost. There was no measurable rutting. The condition of the concrete surface after 310 rapid starts is shown in Figure 7. The wheelpath is on the right in this picture.

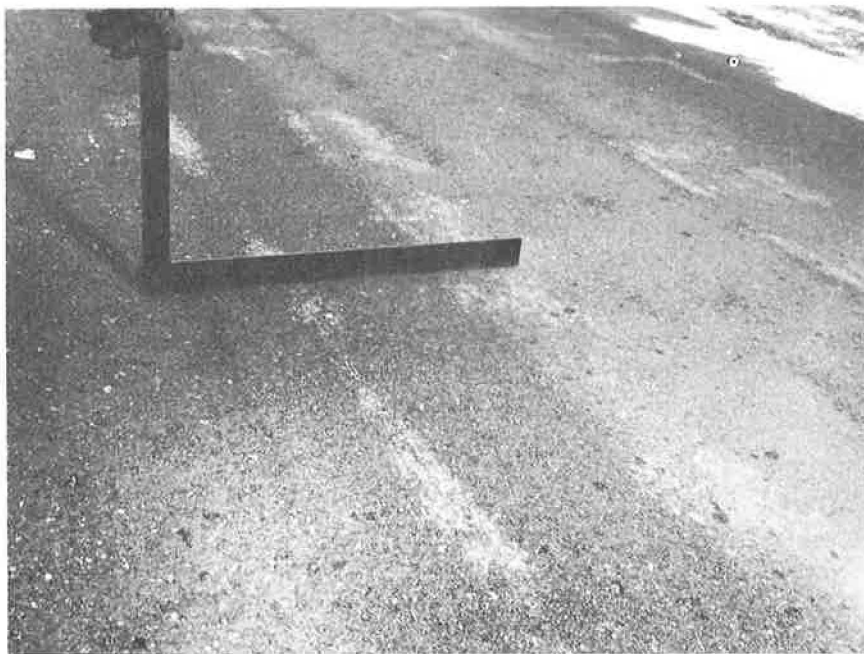
Figure 8. Surface of bituminous pavement after 210 normal stops.

Normal Stops. — No significant damage was done to the bituminous surface after 310 normal stops, although the first signs of some surface abrasion were beginning to appear. In Figure 8, little difference can be detected between the condition of the surface in the wheelpath (covered by the carpenter's square) and the untested surface to the left, but there is a difference in surface texture of the untested surface to the right of the wheelpath. The carpenter's square, placed across the wheelpath, shows that no rutting occurred.

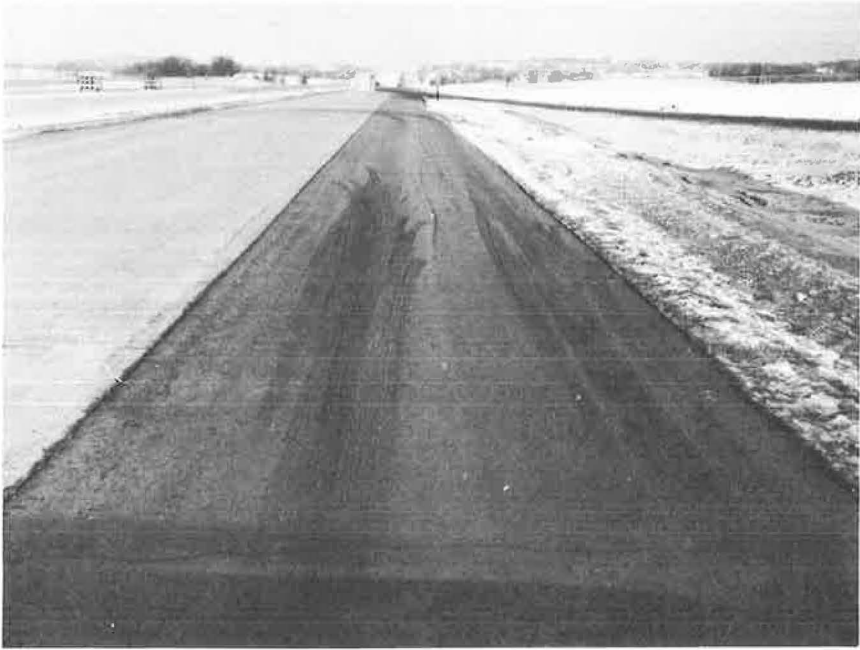
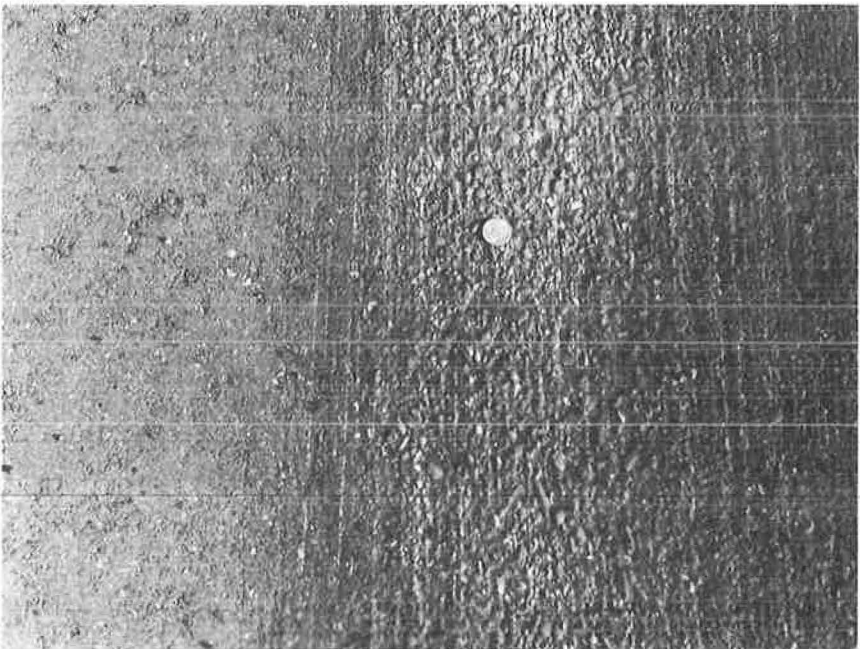
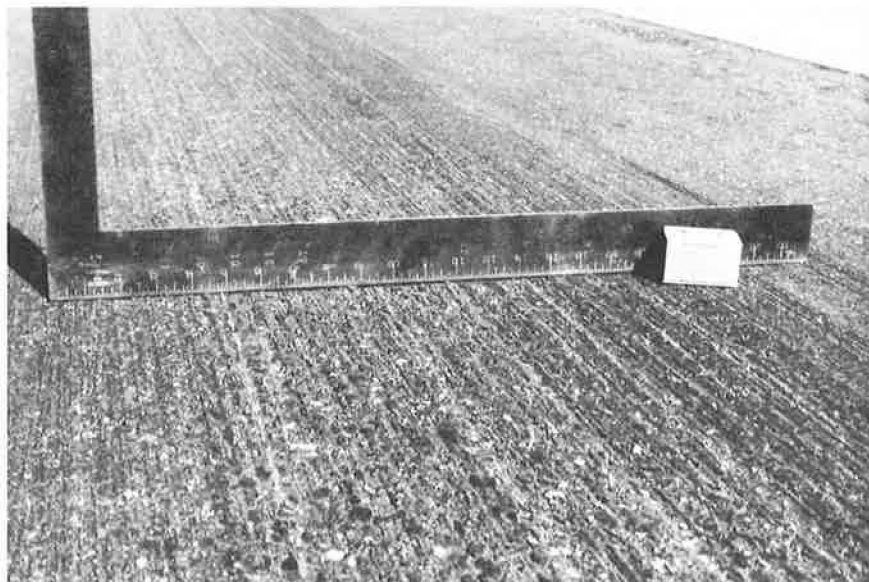
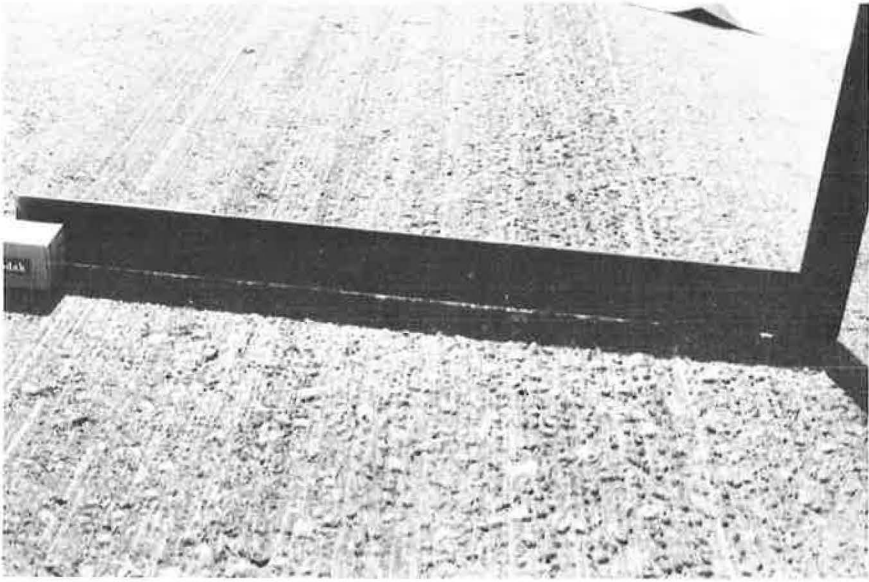
Figure 9. Bituminous surface after 210 panic stops.

Figure 10. Bituminous surface after 210 panic stops.

Figure 11. Bituminous surface after 310 panic stops.

Panic Stops. — The bituminous pavement was significantly damaged from repetitions of panic stops. The damage progressed from single gouges produced by each of the four rows of studs in each tire to severely abraded wheelpaths. Figures 9 through 12 show the condition of the bituminous surface after 210 and 310 panic stops from a speed of 20 mph. The abrasive damage was principally loss of fine aggregate and bitumen from between the coarse aggregate particles leaving a very rough, open-textured surface. There was little, if any, actual rutting (Fig. 12). Many of the coarse aggregate particles are still touching the straightedge.

Figure 12. Bituminous surface after 310 panic stops.

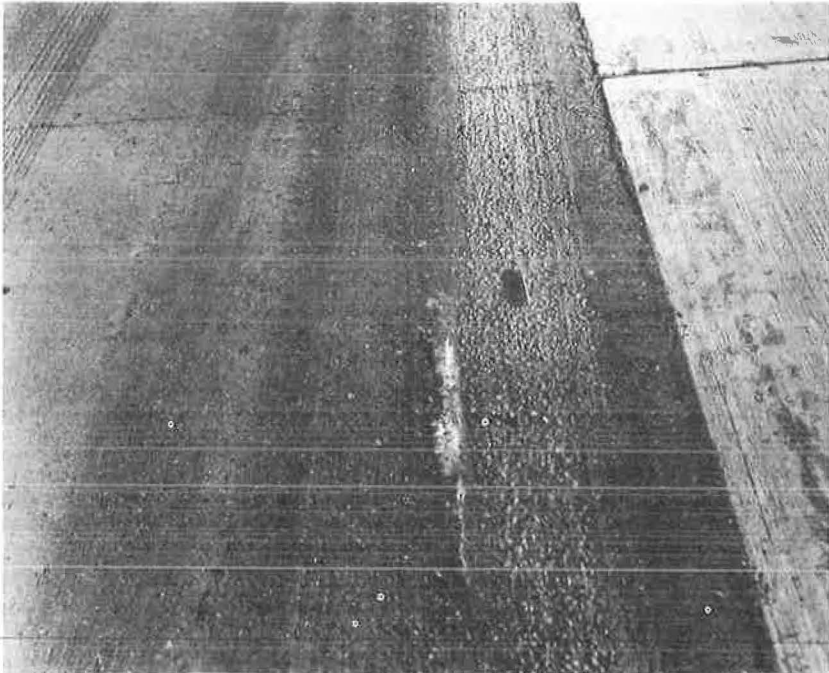
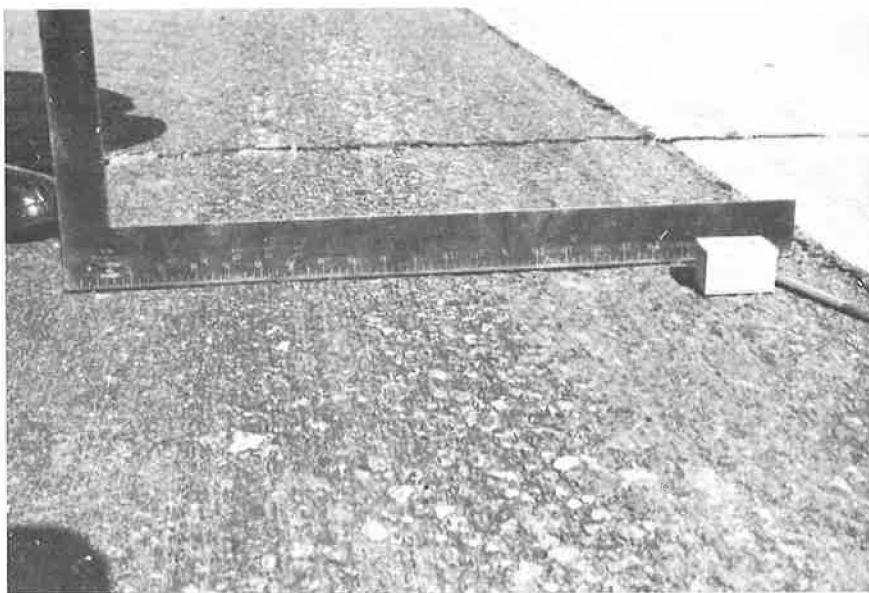
Rapid Starts. — There was a significant amount of damage to the bituminous pavement from repetitions of panic starts. The damage started and progressed similarly to that produced by the panic stops. Figures 13 and 14 show the condition of the bituminous surface after 210 and 310 rapid starts, respectively. In Figure 13 the pencil is lying in the wheelpath where most of the repetitions were made. To the left of this main wheelpath is an area where only a few rapid starts were made. The damage to the surface from this test was very similar to the damage done in the panic stop tests. Although in Figure 14 it appears that some very shallow rutting has occurred, this is not positive, since it is not known whether the surface was a true plane at this location before testing started.

Figure 13. Bituminous surface after 210 rapid starts.

Figure 14. Bituminous surface after 310 rapid starts.

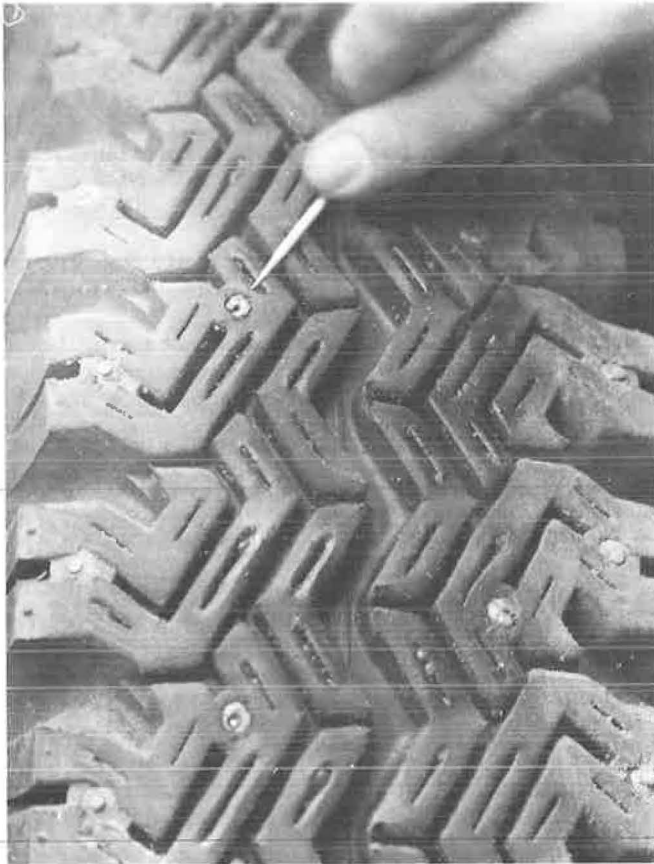
Figure 19. Condition of plastic encasement type studs after 21 series of stops and starts.

Plastic Encasement Type. — After 21 series of stops and starts (168 panic stops from various speeds and 63 rapid starts), a total of five cores was missing from the right rear tire (the tire on which plastic encasement type studs were used). All of these were from the inner two rows. In some cases, only the tungsten carbide core was missing, but in other cases, the plastic encasement was gone also. A number of other cores were thrust part way through the side wall of the plastic encasement. The cores which were not missing had rounded-off edges but were still in fair condition. At this

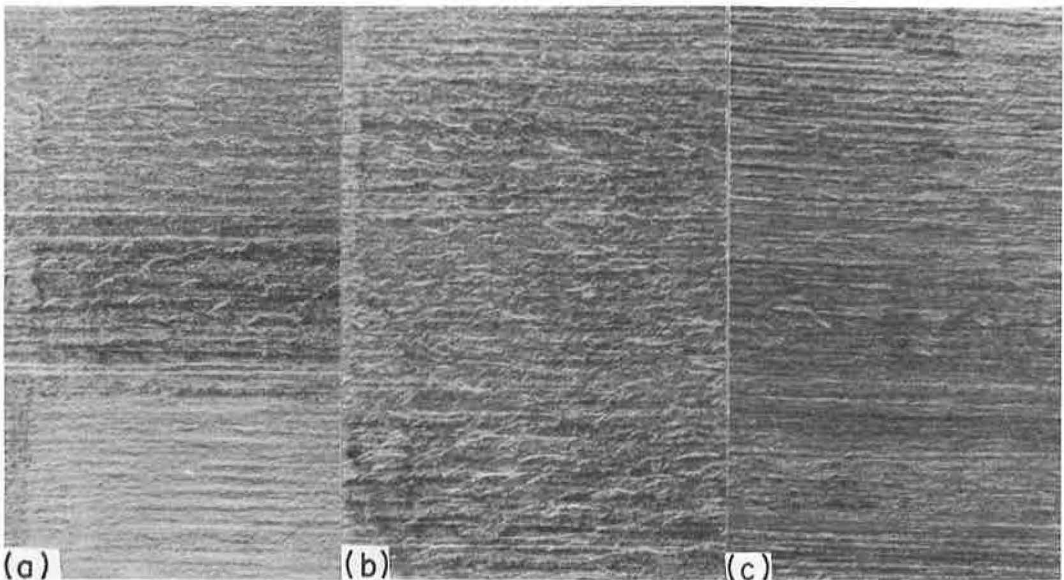
The progression of damage to the surface of the portland cement concrete pavement with succeeding applications of stops is shown in Figure 7. The light-colored marks in Figures 7a and 7b were made by the studs when brakes were applied without locking the wheels. Inadvertently, brakes tended to lock and some sliding of the tires occurred during the normal stops. Figure 7c was taken after application of 175 normal stops

Figure 7. Portland cement concrete pavement surface after (a) 25 normal stops, (b) 125 normal stops, and (c) 175 normal stops plus 75 emergency stops.

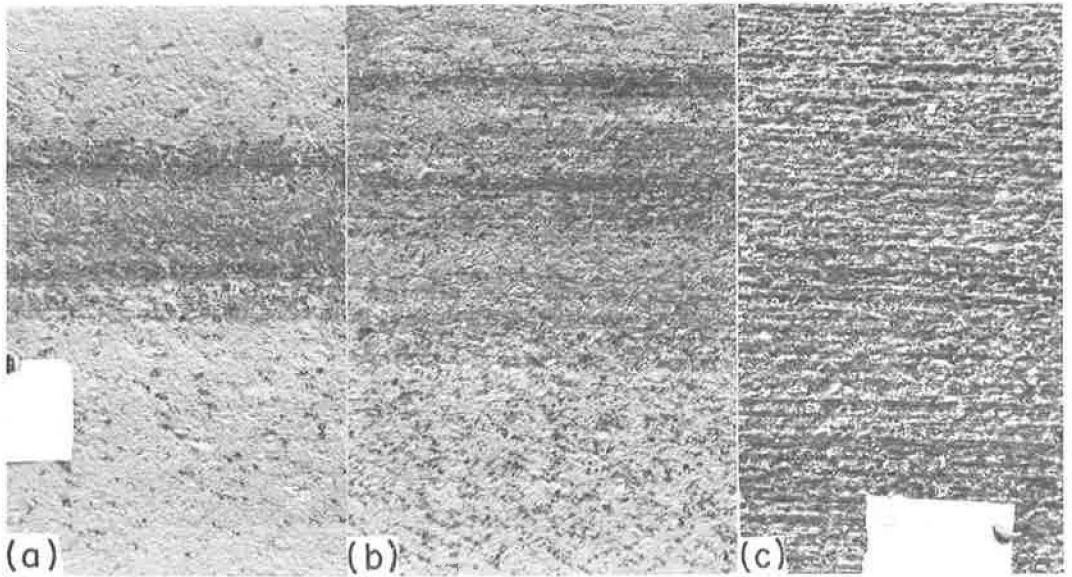
Figure 8. Bituminous-concrete pavement surface after (a) 25 normal stops, (b) 125 normal stops, and (c) 175 normal stops plus 75 emergency stops.

Similar results were obtained during the stopping tests on the bituminous-concrete surface (Fig. 8). As with the stopping tests on the portland cement concrete surface, emergency stops with the wheels locked caused the greatest amount of abrasion of the pavement surface (Figs. 8a and 8b).

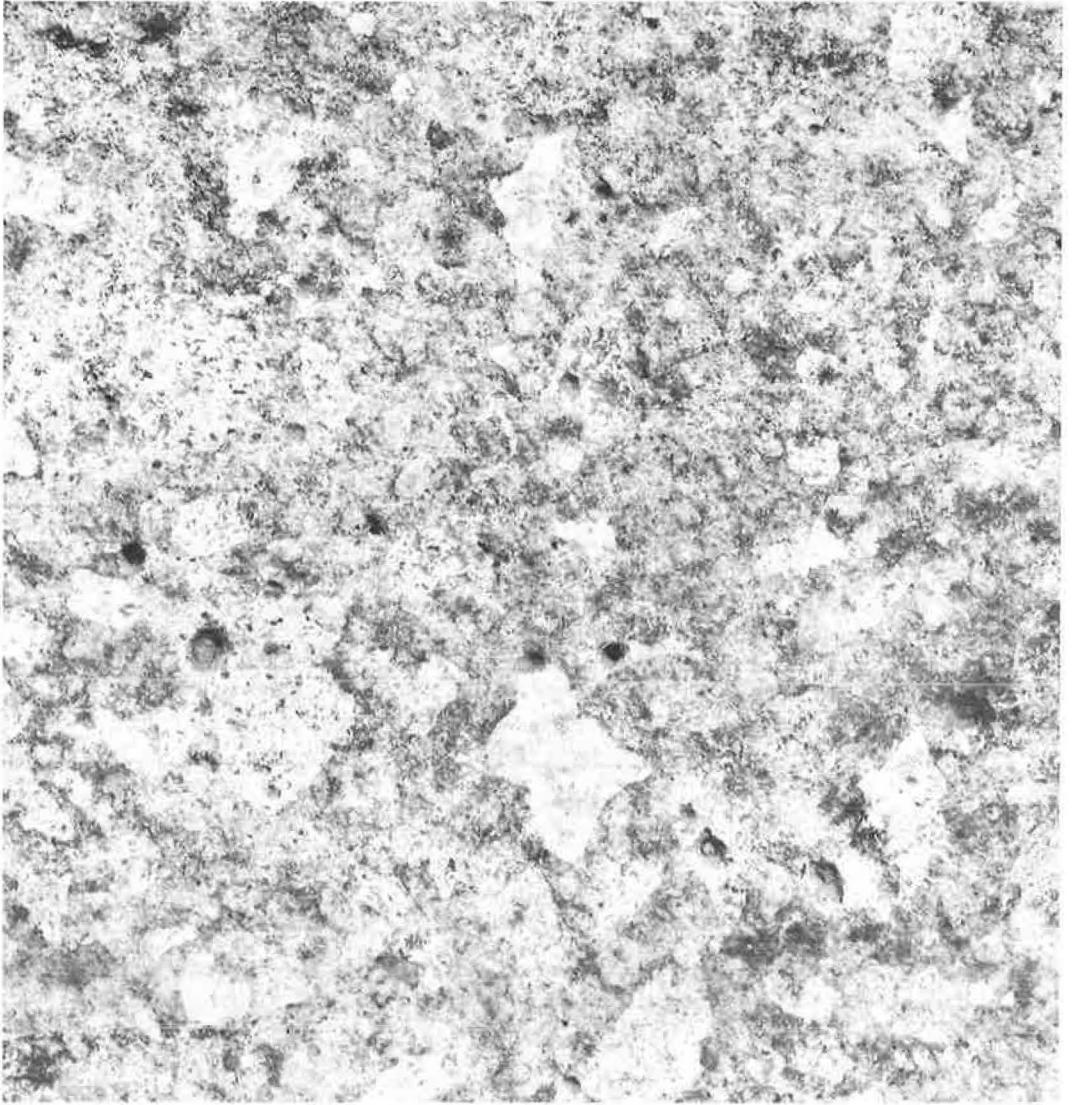
Figure 16. Inner wheelpath on curved ramp, exposed aggregate, end of test, Md. 7 and Baltimore Beltway.
