Design Features of an 18.5-Foot Diameter Culvert Installation in Montana and Data on Subsequent Failure

ALBERT N. KRAFT and HAROLD L. EAGLE, Morrison-Maierle, Inc.,
Helena, Montana

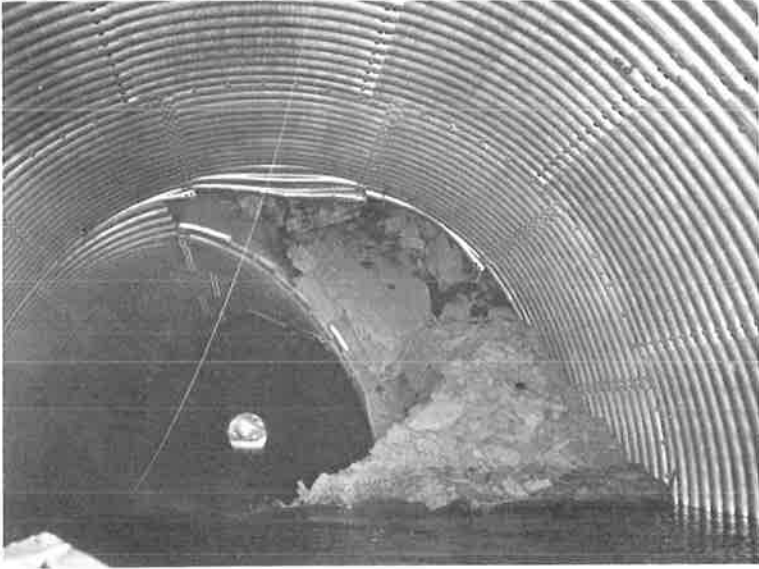
Figure 7. Looking downstream toward failure at ring 58.

clearing the creek channel. Subsequent inspection inside of the pipe revealed that two major ruptures and displacements in the circumferential ring seams had occurred. The upstream one was 90 ft from the inlet and occurred between the first and second rings of $\frac{3}{8}$ -in. plate at this end. A lateral displacement of 5 ft had taken place on one side of the pipe at midheight. A large amount of embankment material moved into the pipe through this opening forming a dam 7 ft high inside the pipe causing water to back upstream from the inlet (Fig. 7). A small depression on the surface of the embankment slope was noticeable above this area. The depth of cover over this location was 35 ft. The downstream displacement of 2.4 ft was of the same type, except that a smaller amount of material moved into the pipe and was washed away (Fig. 8). There were 58 ft of fill above this rupture. It also occurred in the $\frac{3}{8}$ -in. plate between the seventh

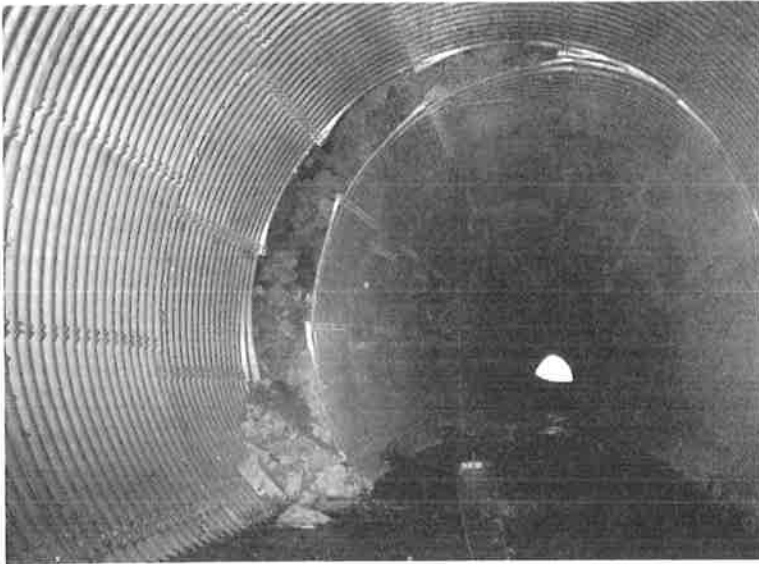
Figure 8. Looking upstream toward failure at ring 25.

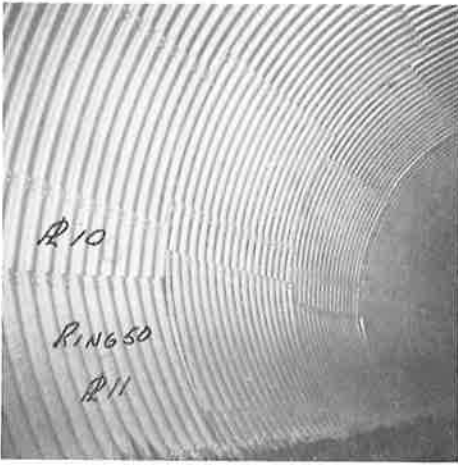
Figure 9. Failure of longitudinal seam allowed plate slippage.

Between the ruptures a longitudinal seam failure had occurred in each ring. The overlapping plates moved past each other 4 to 5 ft, producing a reduction in culvert diameter to 16 ft (Fig. 9). Bolts were sheared and missing not only in the longitudinal seams that had bypassed each other but in other seams that did not have a complete failure. The failure occurred only where the ASTM A 354 bolts were used, which was in all of the $\frac{3}{8}$ -in. plates. The embankment material above the pipe arched and stabilized because the pipe with ruptured seams would have been incapable of supporting the load had this not occurred. There was no way of knowing how long prior to discovery of the rupture that the failure occurred and whether it was relatively instantaneous or over some period of time (Fig. 10).

From an evaluation of the available alternates for repair or replacement it was determined that the only feasible operation would be to uncover the pipe. This was done and reconstruction of the pipe has been completed. This included the replacement of damaged plates and replacement of all $\frac{3}{4}$ -in. ASTM A 354 bolts with $\frac{7}{8}$ -in. ASTM A 325 bolts. The granular backfill envelope around the pipe was replaced and the bed was shaped to fit the bottom of the pipe to the greatest extent possible. An imperfect trench effect was constructed with baled straw placed over the pipe from 5 ft to 7.5 ft above the pipe and for the full width of the pipe. It extends for almost the full length of the pipe. The embankment material above the baled straw was loosely placed for a height of 6 ft. The placement of embankment to full height was completed in January 1966, and traffic has been using it since then.

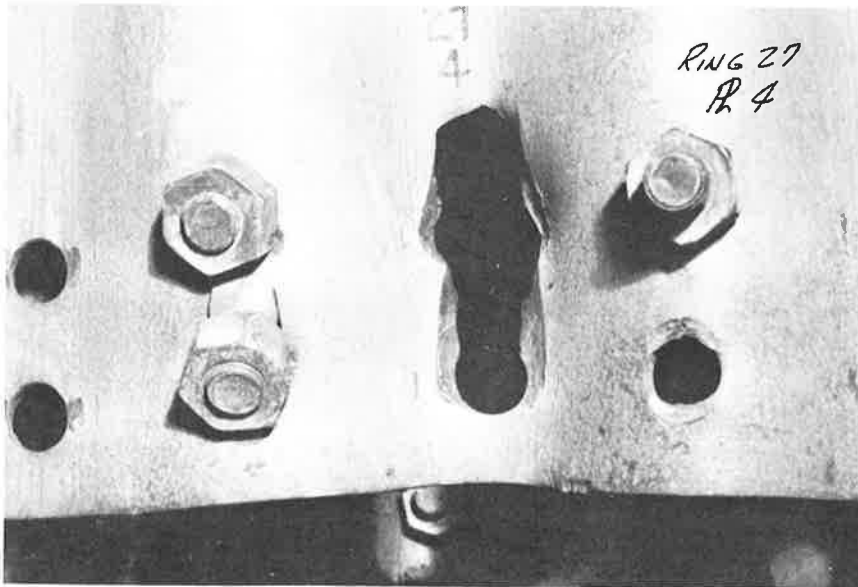
Figure 10. Evidence of plate galling at bolt holes.

Extensive testing of ASTM A 354 bolts revealed that under a certain combination of environment conditions a phenomenon known as hydrogen embrittlement can occur, which results in reduced strength of the bolts (1). A paper covering this subject as it applies to the ASTM A 354 bolts and bolting procedures used on the Wolf Creek culvert project has been prepared by the Armco Steel Corporation and should be consulted for complete information.

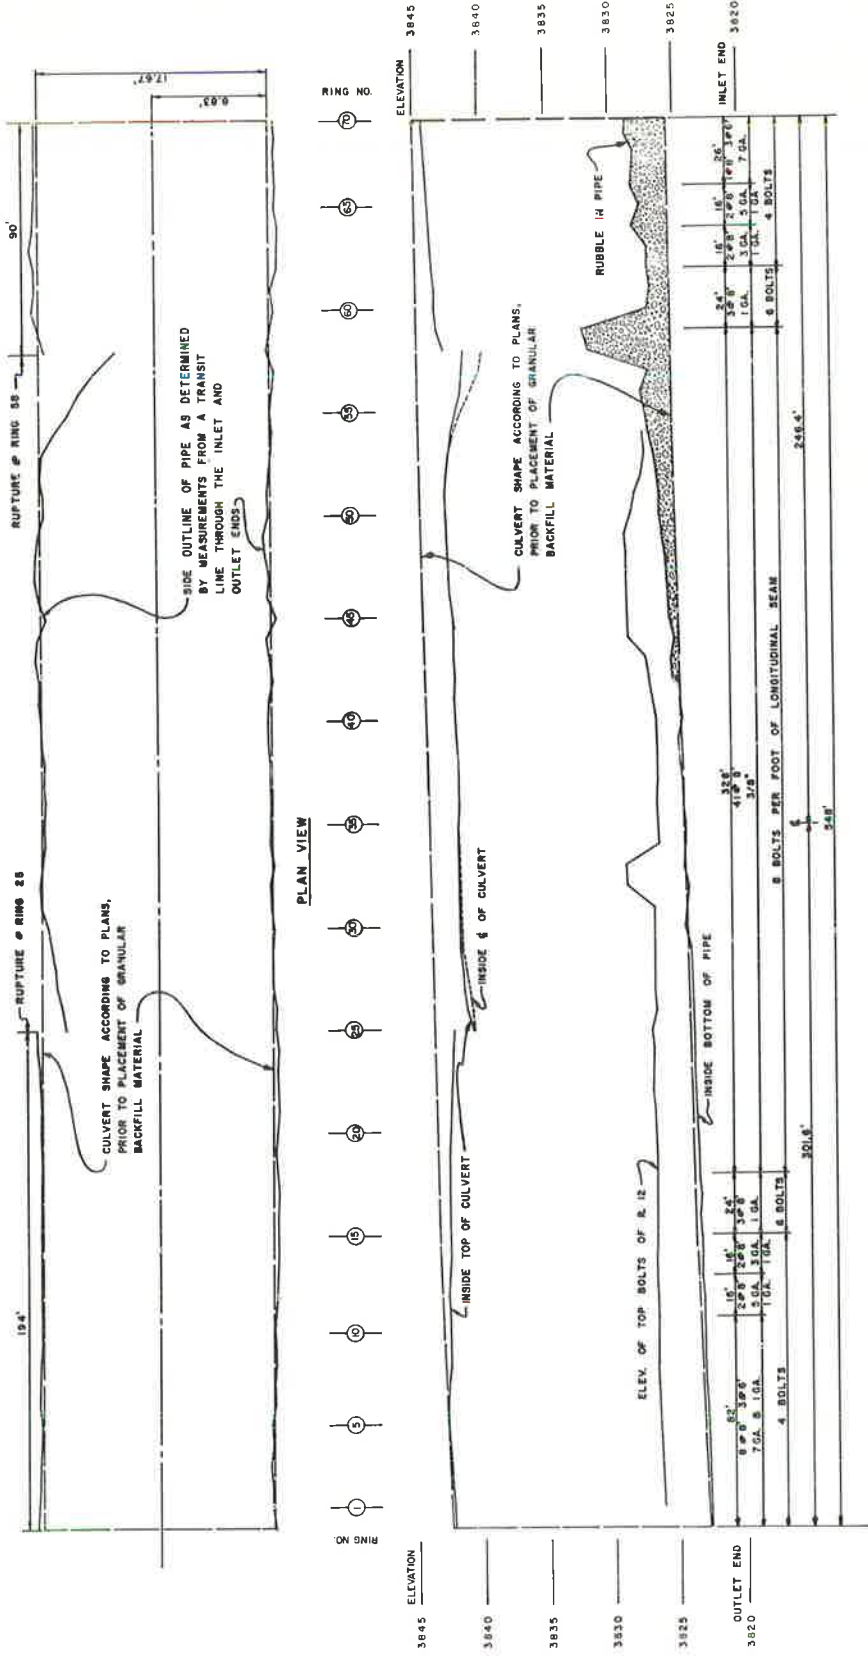
S1

Figure 11. Deflections in pipe after rupture.

A survey crew was immediately assigned to obtain measurements to determine the magnitude of movements. The results showed that the lowest invert elevations were not over a few tenths below the plan elevations of the pipe, which indicated very little settlement had occurred in the subgrade below the pipe. The alignment of the sides of the pipe in plan view showed that they had moved out of position very little except at the locations of the 2 major circumferential ruptures. Most of the extensive failure in the longitudinal joints occurred in the first 2 seams below midheight of the pipe and did not occur consistently on one side of the pipe (Fig. 11).
