# HIGHWAY RESEARCH RECORD

Pipe Culverts

# Design Features of an 18.5-Foot Diameter Culvert Installation in Montana and Data on Subsequent Failure

# Research on Bolt Failures in Wolf Creek Structural Plate Pipe

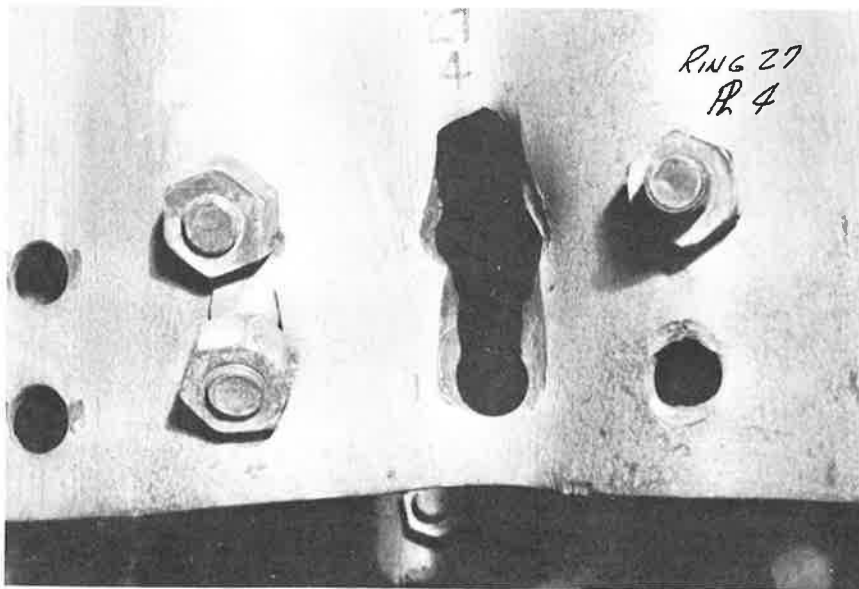
Figure 10. Evidence of plate galling at bolt holes.

Between the ruptures a longitudinal seam failure had occurred in each ring. The overlapping plates moved past each other 4 to 5 ft, producing a reduction in culvert diameter to 16 ft (Fig. 9). Bolts were sheared and missing not only in the longitudinal seams that had bypassed each other but in other seams that did not have a complete failure. The failure occurred only where the ASTM A 354 bolts were used, which was in all of the  $\frac{3}{8}$ -in. plates. The embankment material above the pipe arched and stabilized because the pipe with ruptured seams would have been incapable of supporting the load had this not occurred. There was no way of knowing how long prior to discovery of the rupture that the failure occurred and whether it was relatively instantaneous or over some period of time (Fig. 10).

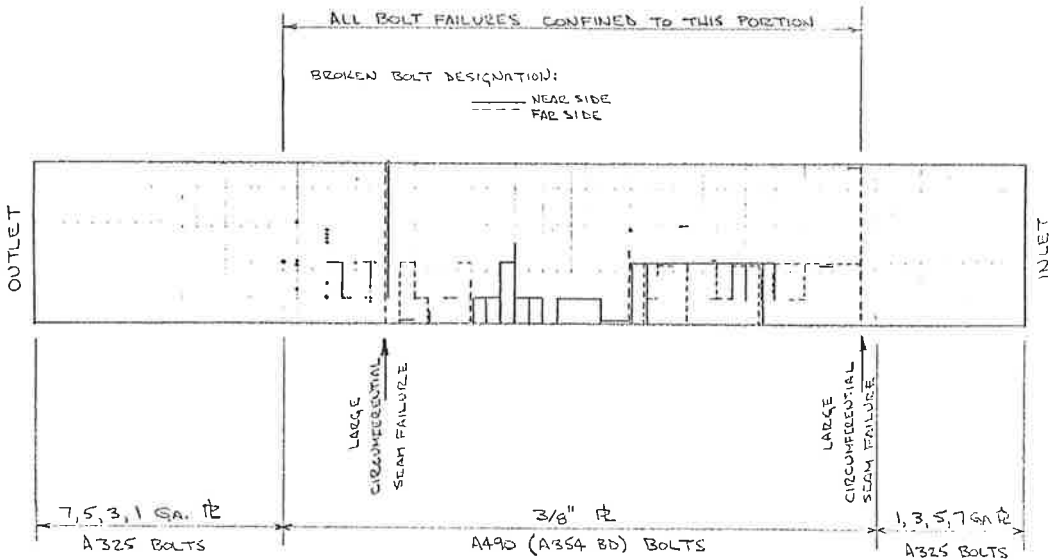
Figure 2. Diagram of failure.

Figure 2 is a diagram of the failure showing the location of broken bolts and the pattern of failure.

Because the failures (Fig. 2) were near or below the water level, it appeared that an environmental effect such as corrosion might be the primary cause of failure.

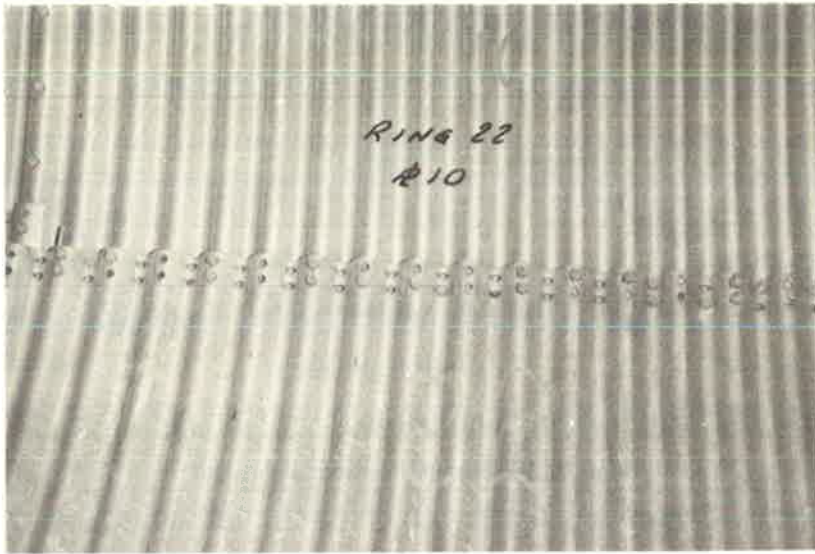
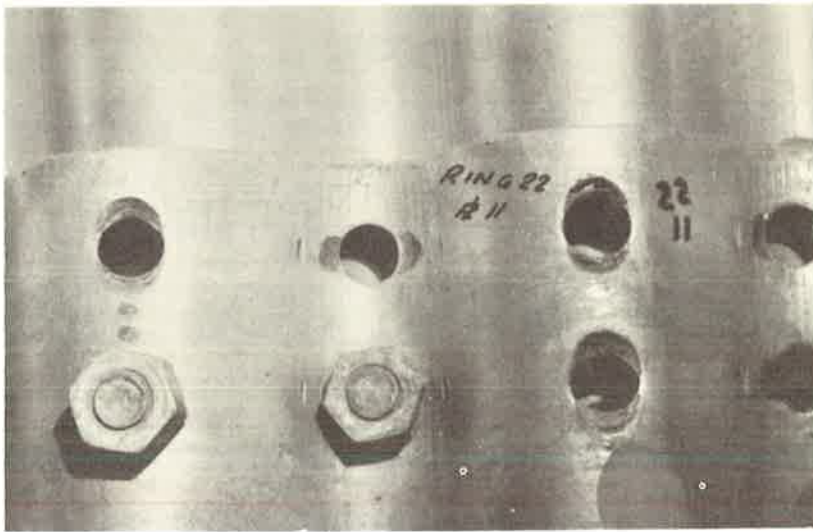
Figure 3. Longitudinal seam—no deformation of plate material at bolt holes.

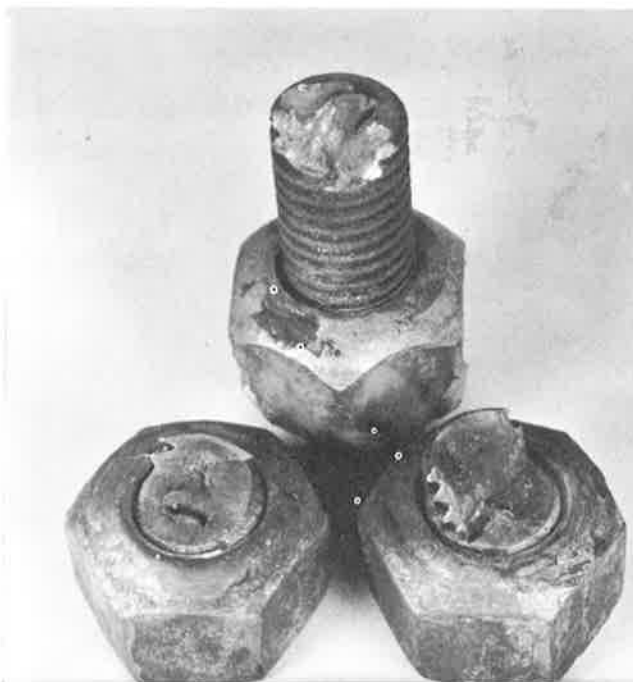
All failed bolts were A 490 in  $\frac{3}{8}$ -in. plate. No failures occurred among the A 325 bolts used in the lighter gage plates. Beginning at the first ring of  $\frac{3}{8}$ -in. plate from the outlet end of the pipe, a few bolts were broken in the seams in the lower half of the pipe. No movement of the plates had occurred up to 194 ft from the outlet end, at which point there was a large circumferential seam failure. Another large circumferential seam separation occurred 90 ft from the inlet end of the pipe, which was one ring removed from the juncture of  $\frac{3}{8}$ -in. and 1-gage rings. Between these 2 circumferential failures, the plates in the lower half of the pipe had telescoped to within 1 to 2 ft of each other at longitudinal seams, reducing the pipe diameter to approximately 16 to 17 ft. These seams were boltless with the nut or head of bolt missing. Several other longitudinal and circumferential seams had failed bolts in this portion of the structure.

Figure 4. Broken bolts obtained from Wolf Creek.

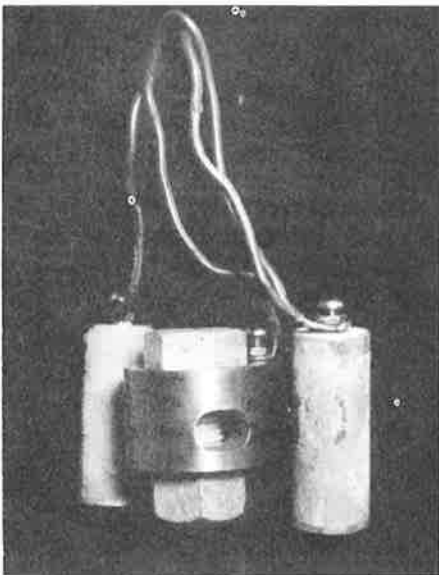
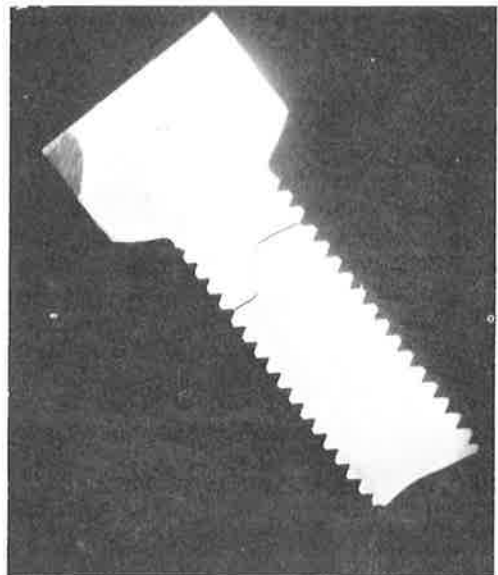
ultimate torque cracked after 4 days (Fig. 15). A softer bolt ( $R_C$  30) tested in the same manner had not cracked after 70 days. Numerous other tests on the low and high hardness bolts were made with attempts to vary the magnitude of stress, the electrolyte, and the method of charging. The same trend of results was obtained; i. e., the high hardness A 490 bolts (approximately  $R_C$  38) showed much greater susceptibility to hydrogen-stress cracking than the softer A 325 bolts (approximately  $R_C$  30).

Figure 15. Bolt stressed by tightening in "solid" block: at right, cracks in  $R_C$  38 (A 490) bolt after 4 days in tap water.
