A New Patching Material for Pavement Failures

CHARLES H. McDONALD, Engineering Supervisor, City of Phoenix, Arizona

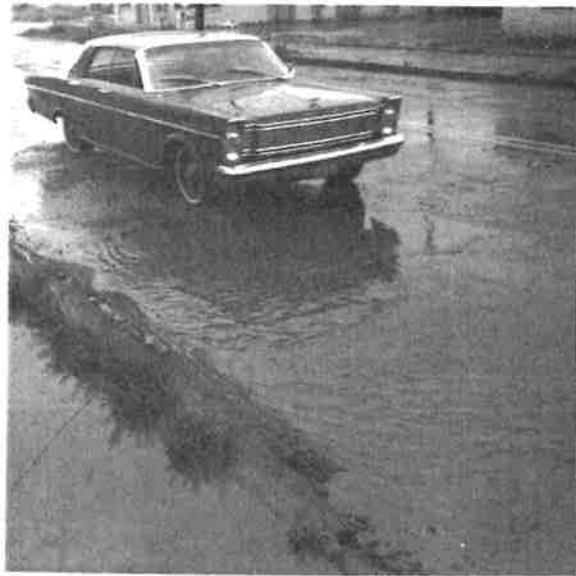
Figure 1. General area occupied by test panels Nos. 4,5,6, and 10, showing poor drainage.

surface was generally covered by alligator-pattern cracking in an advanced state and the drainage was extremely poor. The cracking pattern was similar to that shown in Figure 2, and Figure 1 shows the poor drainage.

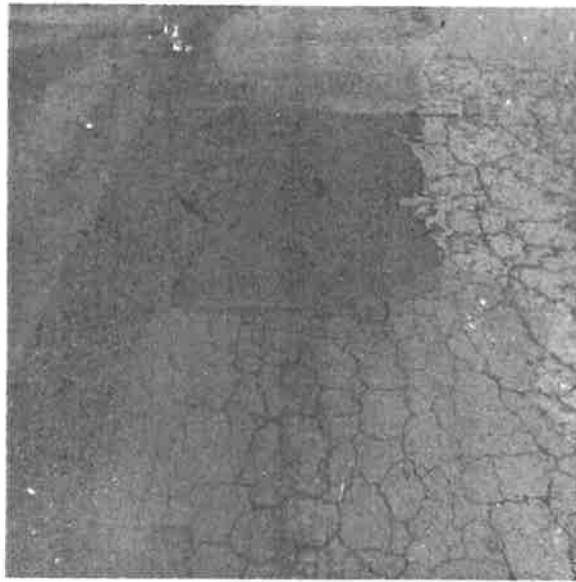
Figure 2. Test panel No. 11, showing reclaimed rubber asphalt still in good condition, whereas sand-asphalt patch is failing.

3. Test panel No. 11 was placed on Washington Street which has a traffic count of 18,500 veh/day. Many of these vehicles are of the commercial and industrial type. This section was in an area which had given continuous trouble for some time. Figure 2 shows test panel No. 11 in upper center and hot mixed sand-asphalt patch in lower half; both were placed the same day but the reclaimed rubber asphalt is still in good condition whereas the sand asphalt patch is failing.

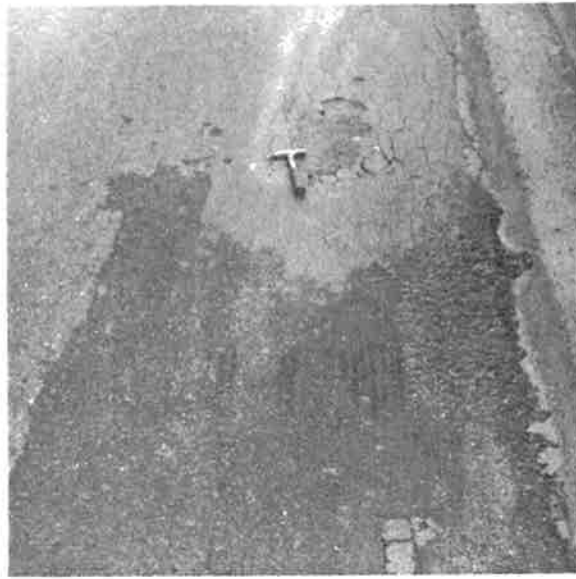
Figure 3. Test panel No. 9 showing superior condition of rubber-asphalt repair.

2. Test sections Nos. 8 and 9 were located on north Central Avenue with daily traffic volumes of 30,800 and 38,400, respectively. Most of this traffic is of passenger type. There was severe alligator-type cracking in the wheel tracks but it was not spread as generally over the street as in the previous case. Test panel No. 9 (Fig. 3) shows par-

tially devulcanized rubber-asphalt patch in foreground and slurry seal patch, made approximately one week later, in background. The rubber-asphalt repair is clearly superior. In Figure 4 test panel No. 9 shows the arrest of cracking with less than a $\frac{1}{4}$ -in. thickness of partially devulcanized rubber-asphalt compound.

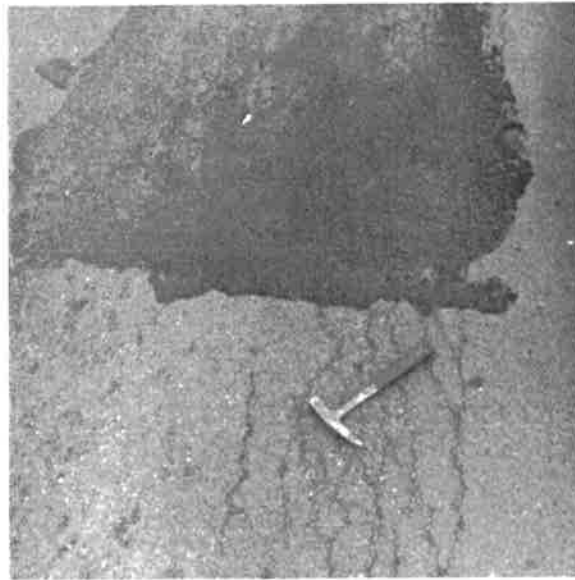
Figure 4. Test panel No. 9 (in background) showing arrest of cracking.

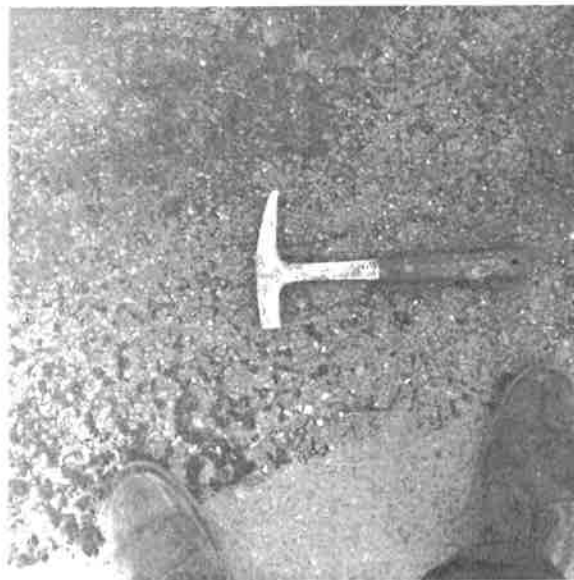
Test panel No. 9 again consisted of 2 parts of 85-100 penetration grade asphalt and 1 part of partially devulcanized reclaimed rubber, a commercial product, spread at the rate of 1 gal/sq yd of mixture followed by a cover aggregate. This was placed over a portion of a long strip of failed area. The remaining portion of this strip was repaired by a conventional maintenance slurry seal patch approximately a week later. The slurry seal patch had already shown distress only a week after replacement, and had completely failed after a few months (Fig. 3). It was replaced April 14, 1965, by maintenance forces with a hot asphaltic-concrete mix. However, the rubber-asphalt test panel was still in good condition except for a few spots which had been "picked up" by the roller during placement. One of these spots is right of center, on the lower edge of Figure 3. Maintenance had also placed some slurry seal patches nearby which contained 2 percent synthetic latex emulsion but these also failed early as the rubber content was insufficient to give it the required elasticity. All of the slurry seal patches had to be completely replaced approximately three months after placement. The test panel was in good condition except for a small exceptionally thin spot where reflection cracking showed up to a minor degree (Fig. 5). The $\frac{1}{4}$ -in. cover aggregate as used in these tests was completely covered by the rubber-asphalt mixture after a few days under traffic. In the spot where the cracking occurred the aggregate had not been covered as there was insufficient material to squeeze up around it. Where normal thickness was obtained, there was no reflection cracking.

Figure 5. Test panel No. 9, showing slight reflection cracking.
