HIGHWAY RESEARCH RECORD

Number 146

Pavement and Bridge
Maintenance

A New Patching Material for Pavement Failures

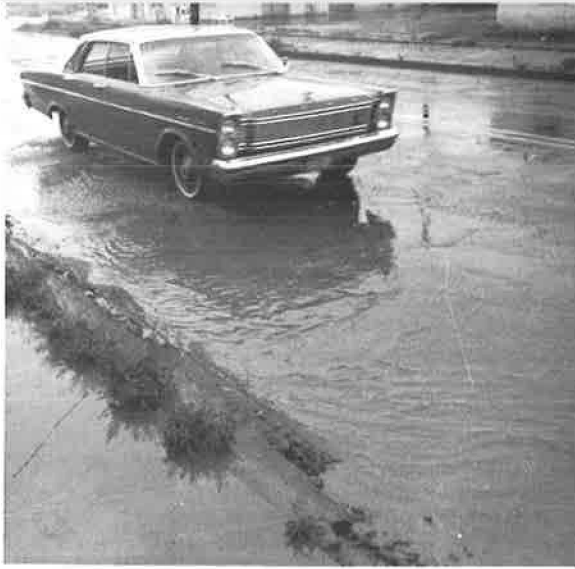
Figure 1. General area occupied by test panels Nos. 4,5,6, and 10, showing poor drainage.

surface was generally covered by alligator-pattern cracking in an advanced state and the drainage was extremely poor. The cracking pattern was similar to that shown in Figure 2, and Figure 1 shows the poor drainage.

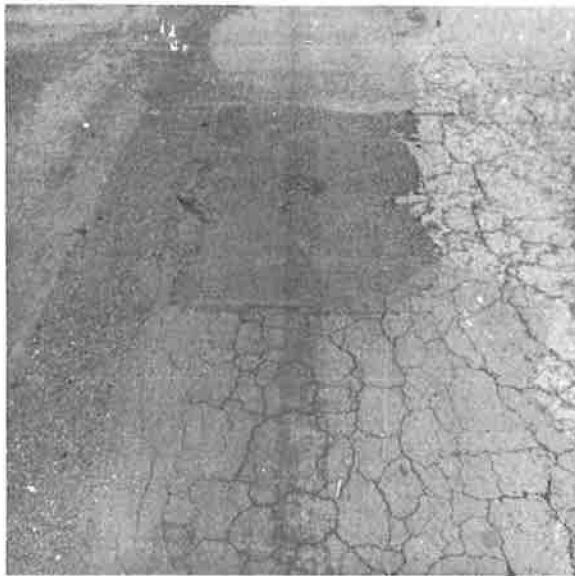
Figure 2. Test panel No. 11, showing reclaimed rubber asphalt still in good condition, whereas sand-asphalt patch is failing.

3. Test panel No. 11 was placed on Washington Street which has a traffic count of 18,500 veh/day. Many of these vehicles are of the commercial and industrial type. This section was in an area which had given continuous trouble for some time. Figure 2 shows test panel No. 11 in upper center and hot mixed sand-asphalt patch in lower half; both were placed the same day but the reclaimed rubber asphalt is still in good condition whereas the sand asphalt patch is failing.

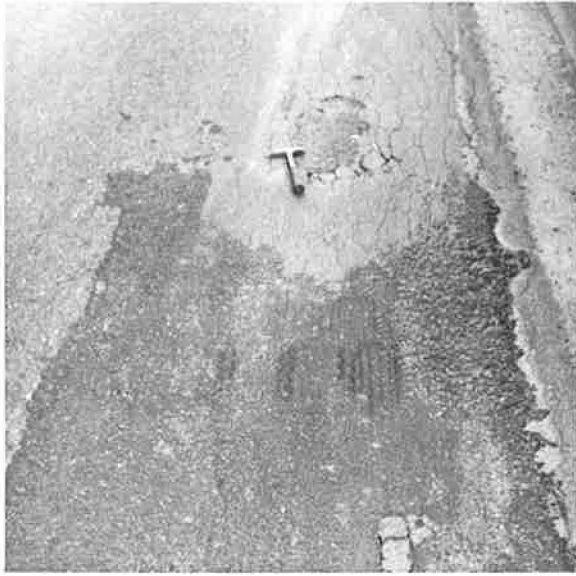
Figure 3. Test panel No. 9 showing superior condition of rubber-asphalt repair.

tially devulcanized rubber-asphalt patch in foreground and slurry seal patch, made approximately one week later, in background. The rubber-asphalt repair is clearly superior. In Figure 4 test panel No. 9 shows the arrest of cracking with less than a $\frac{1}{4}$ -in. thickness of partially devulcanized rubber-asphalt compound.

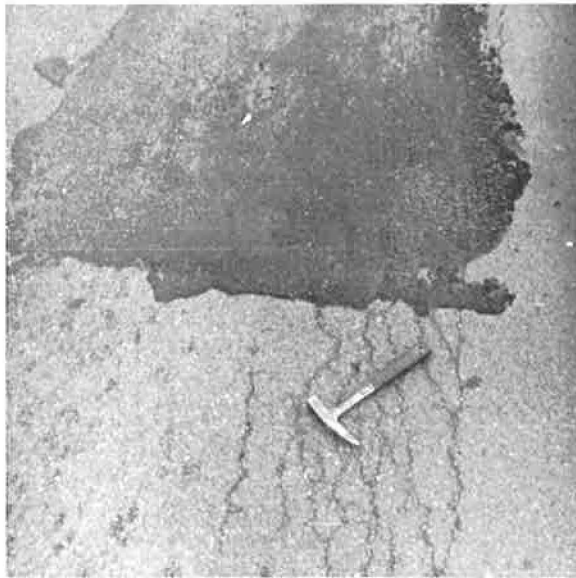
Figure 4. Test panel No. 9 (in background) showing arrest of cracking.

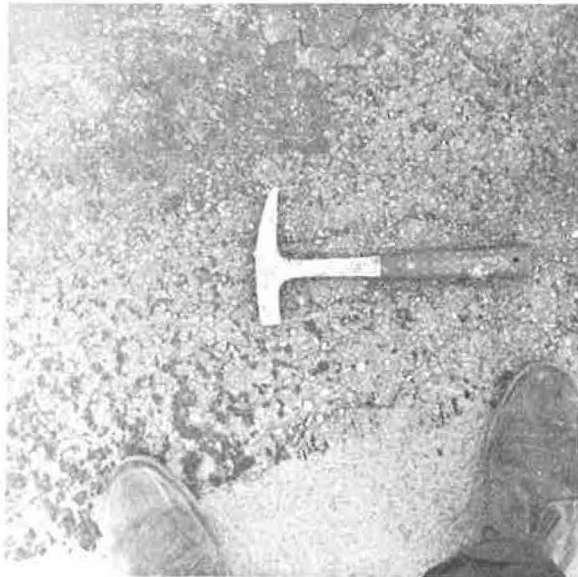
Test panel No. 9 again consisted of 2 parts of 85-100 penetration grade asphalt and 1 part of partially devulcanized reclaimed rubber, a commercial product, spread at the rate of 1 gal/sq yd of mixture followed by a cover aggregate. This was placed over a portion of a long strip of failed area. The remaining portion of this strip was repaired by a conventional maintenance slurry seal patch approximately a week later. The slurry seal patch had already shown distress only a week after replacement, and had completely failed after a few months (Fig. 3). It was replaced April 14, 1965, by maintenance forces with a hot asphaltic-concrete mix. However, the rubber-asphalt test panel was still in good condition except for a few spots which had been "picked up" by the roller during placement. One of these spots is right of center, on the lower edge of Figure 3. Maintenance had also placed some slurry seal patches nearby which contained 2 percent synthetic latex emulsion but these also failed early as the rubber content was insufficient to give it the required elasticity. All of the slurry seal patches had to be completely replaced approximately three months after placement. The test panel was in good condition except for a small exceptionally thin spot where reflection cracking showed up to a minor degree (Fig. 5). The $\frac{1}{4}$ -in. cover aggregate as used in these tests was completely covered by the rubber-asphalt mixture after a few days under traffic. In the spot where the cracking occurred the aggregate had not been covered as there was insufficient material to squeeze up around it. Where normal thickness was obtained, there was no reflection cracking.

Figure 5. Test panel No. 9, showing slight reflection cracking.

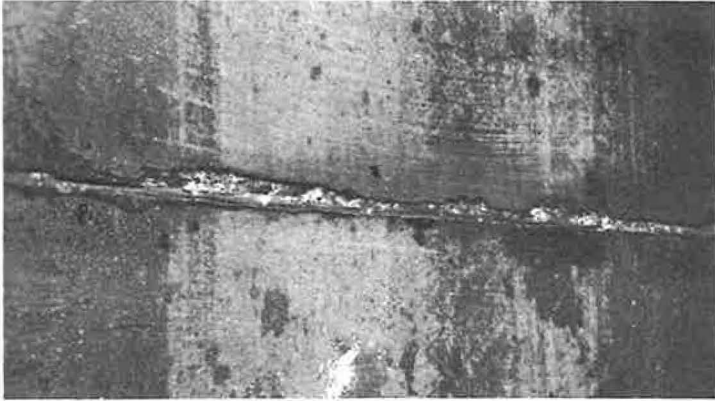
Figure 1. Slab expansion in hot weather.

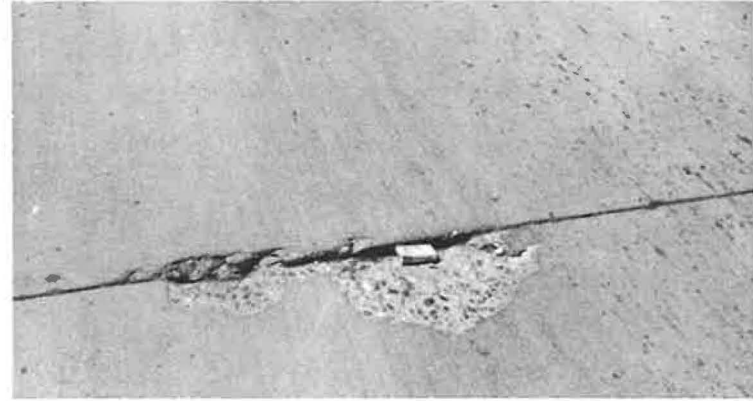
Figure 2. Spalled area at joint 2 years after construction; notice cigarette pack for reference.

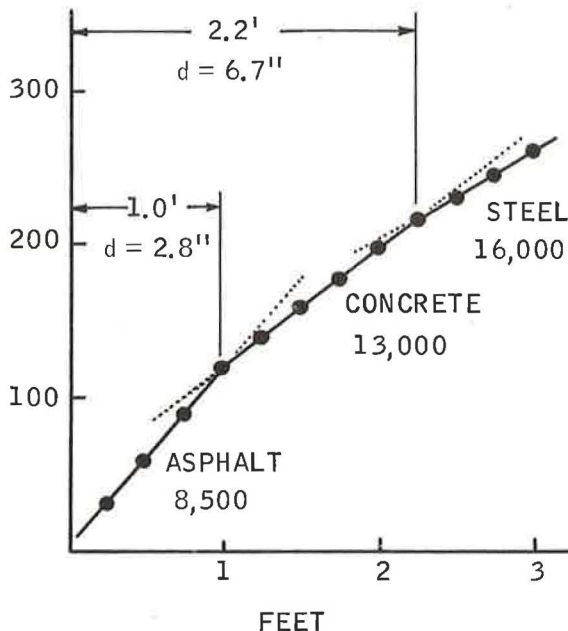
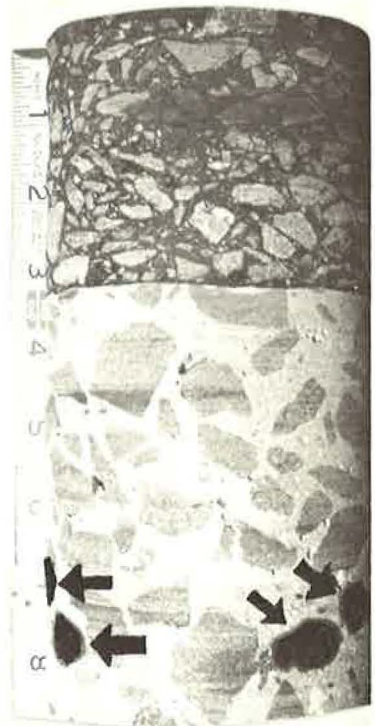
Figure 4. Good asphalt over good concrete.

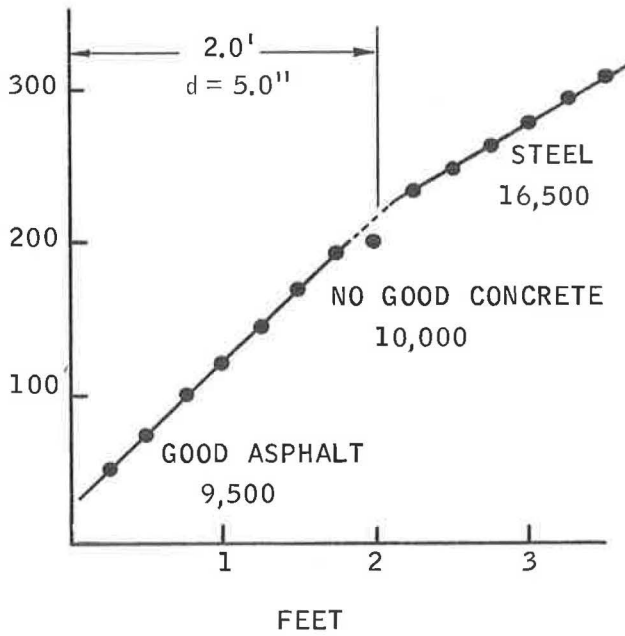
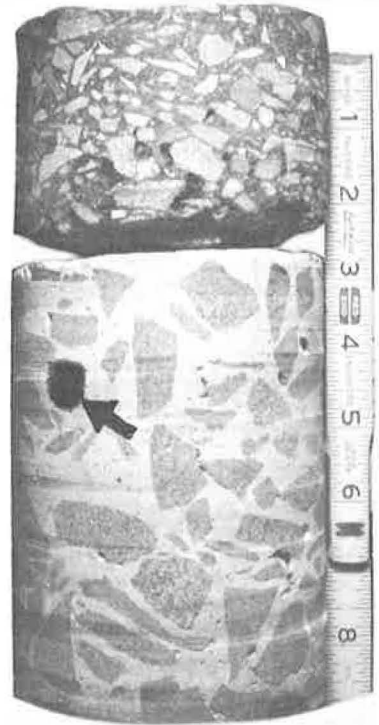
Figure 5. Some concrete deterioration beginning.

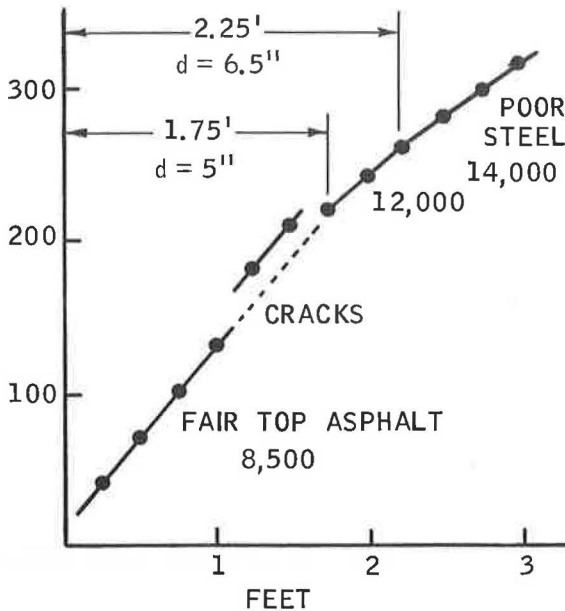
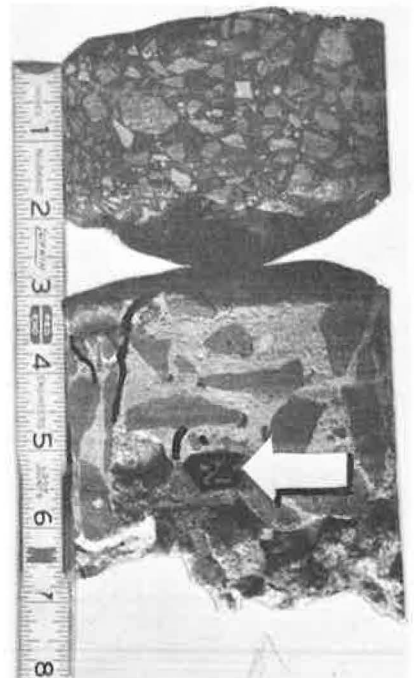
Figure 6. Concrete badly deteriorated.
